# Remediation Summary & Soil Closure Request

## Mewbourne Oil Company Red Hills West Unit 27 Battery

Lea County, New Mexico  
Unit Letter "O", Section 9, Township 26 South, Range 32 East  
Latitude 32.05274° North, Longitude 103.67691° West  
NMOCD Reference No. nAPP2521353327

October 10, 2025

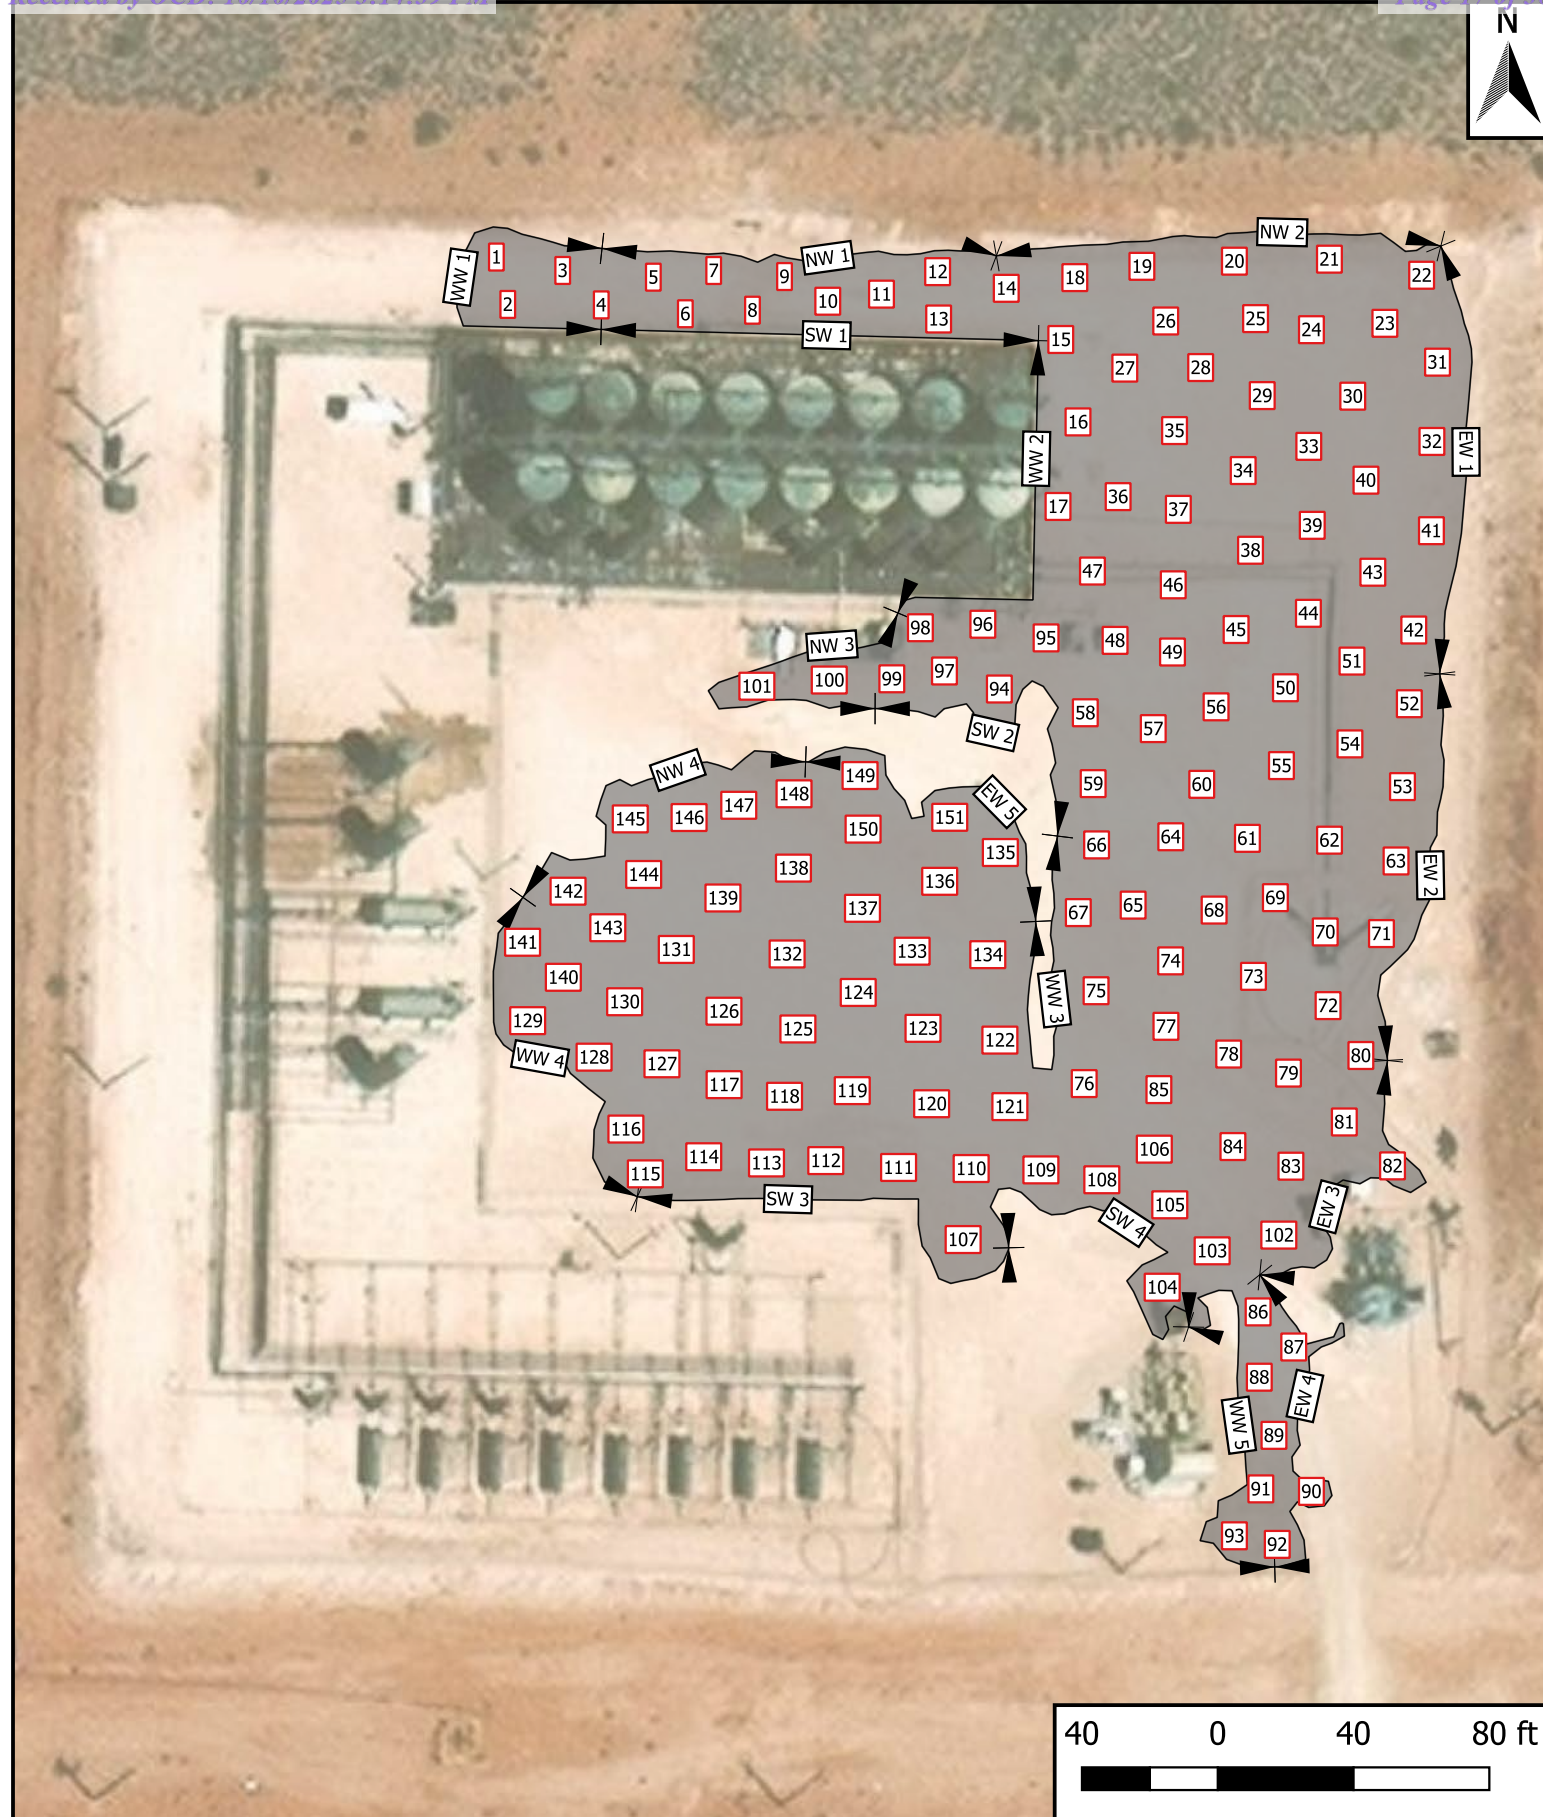
- Excavation Extent (~59,824 ft<sup>2</sup>)
- Composite Floor Sample
- ←→ Composite Wall Sample

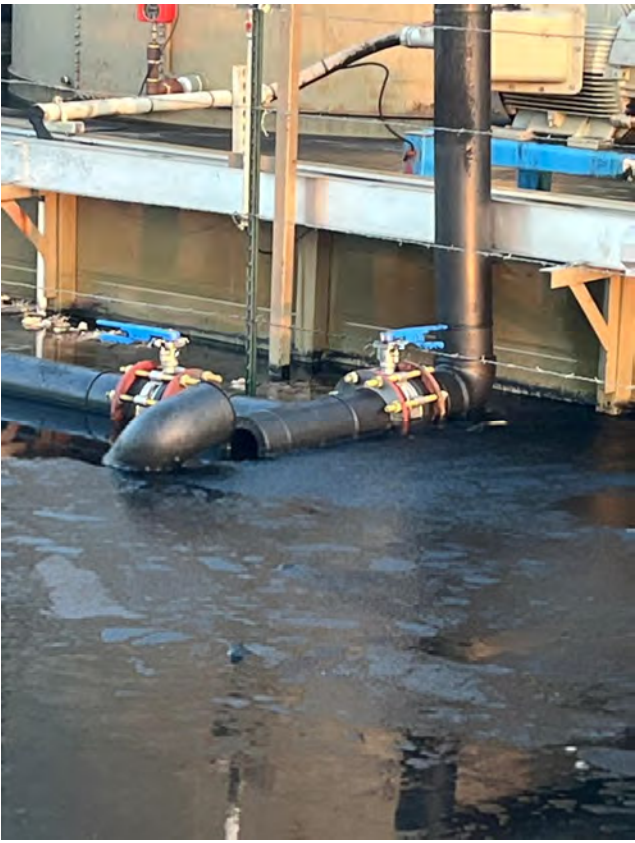
| <b>Photo Description:</b><br><br>Release point. | |

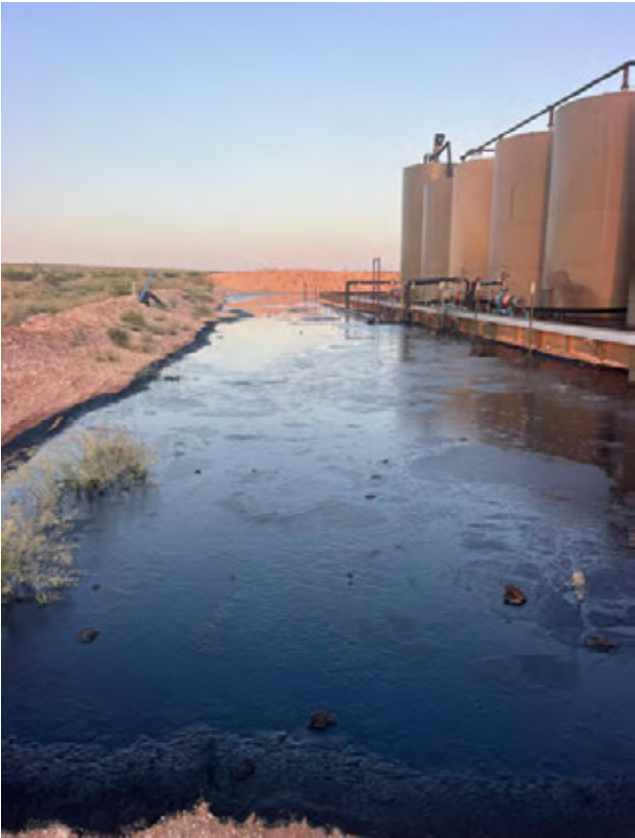
| <b>Photo Description:</b><br><br>View of the affected area. | |

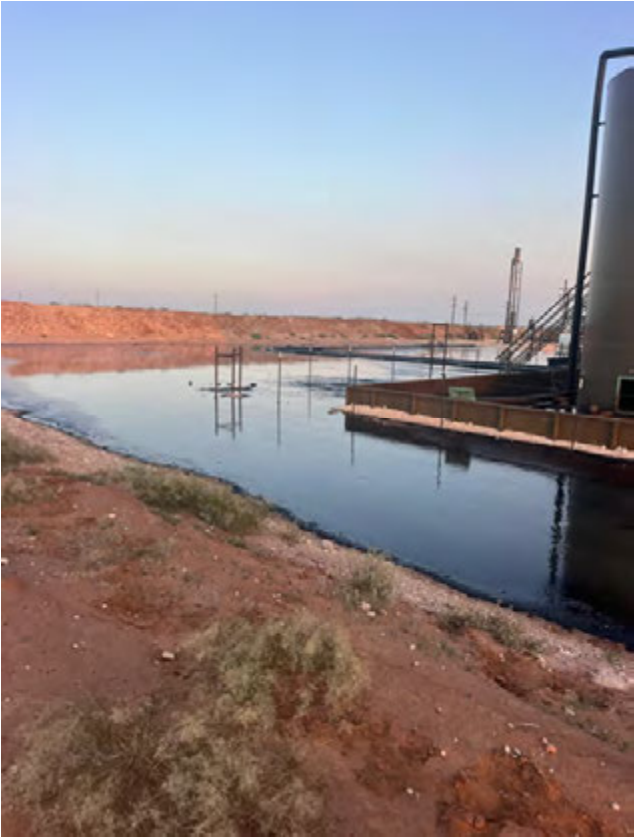
| <b>Photo Description:</b><br><br>View of the affected area. | |

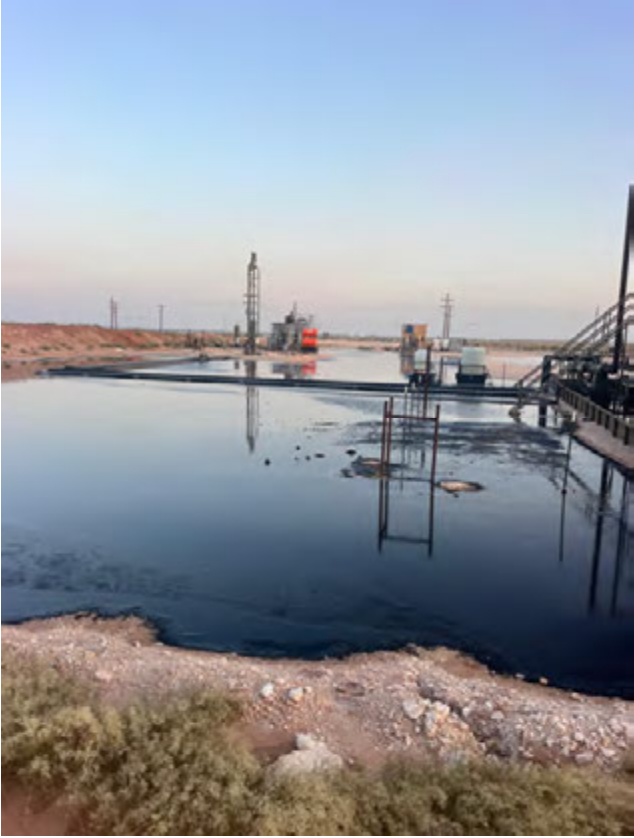
| <b>Photo Description:</b><br><br>View of the affected area. | |

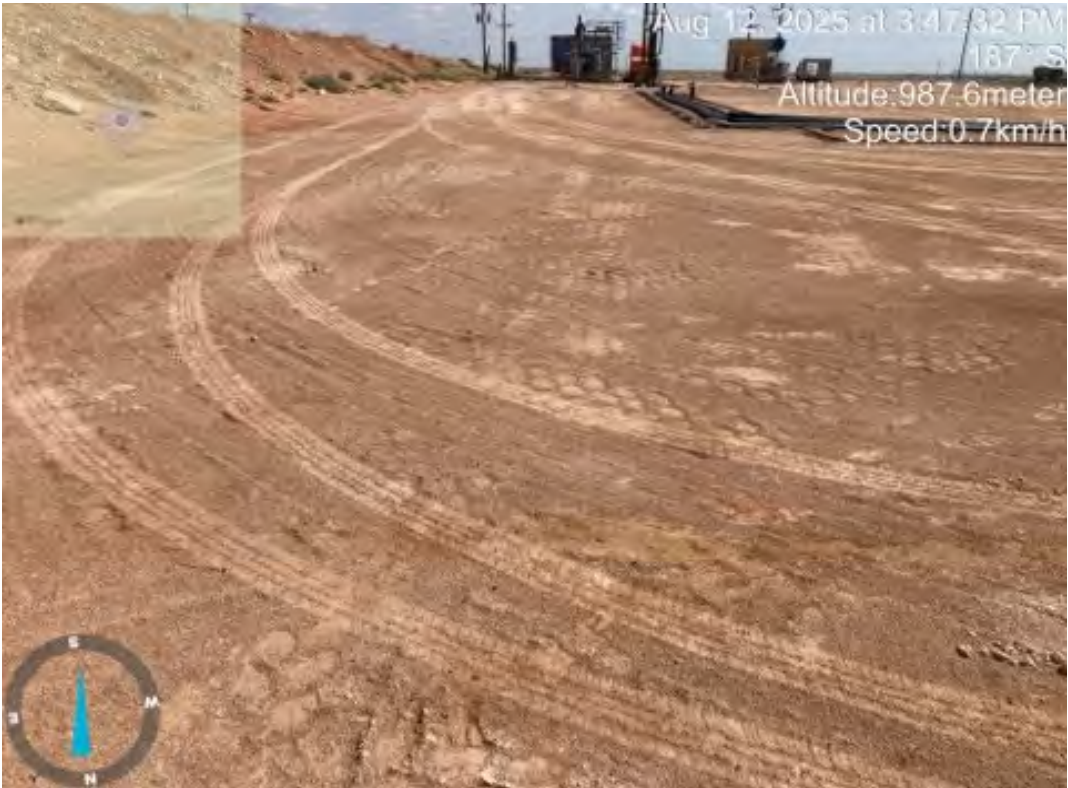
| <b>Photo Number:</b><br>5 | <p>Aug 12, 2025 at 3:47:32 PM<br/>187° S<br/>Altitude:987.6meter<br/>Speed:0.7km/h</p> <p>View of the excavated area.</p> |

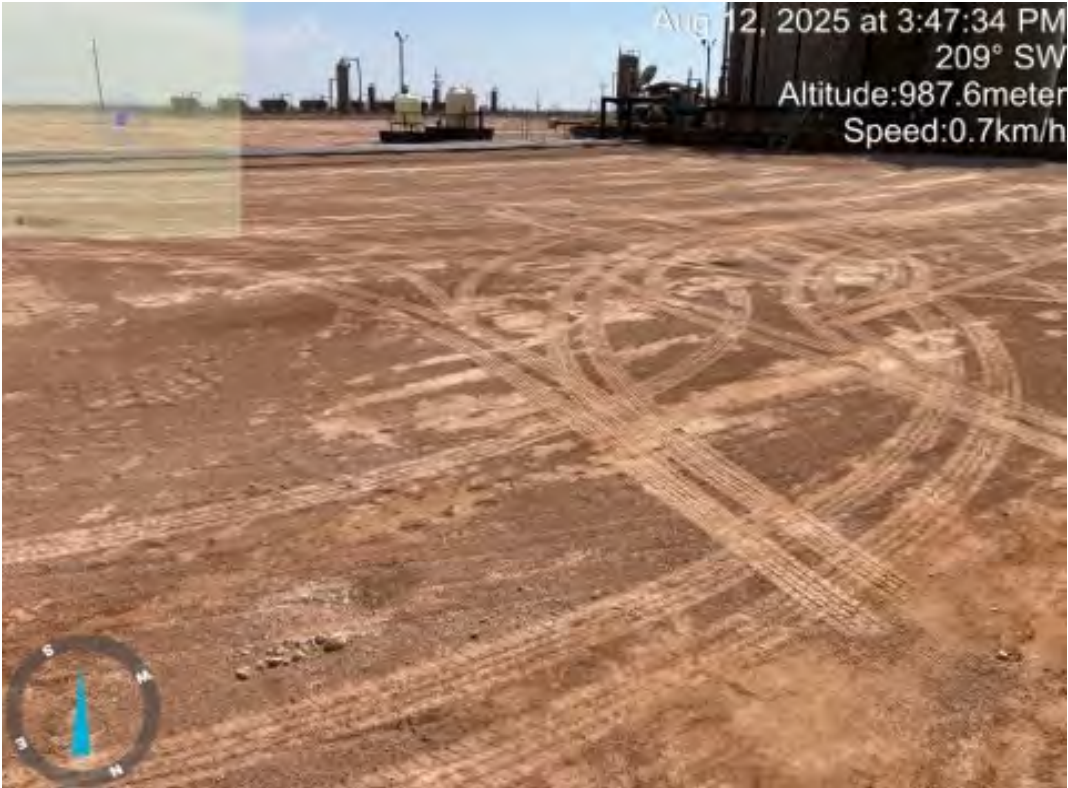
| <b>Photo Number:</b><br>6 | <p>Aug 12, 2025 at 3:47:34 PM<br/>209° SW<br/>Altitude:987.6meter<br/>Speed:0.7km/h</p> <p>View of the excavated area.</p> |

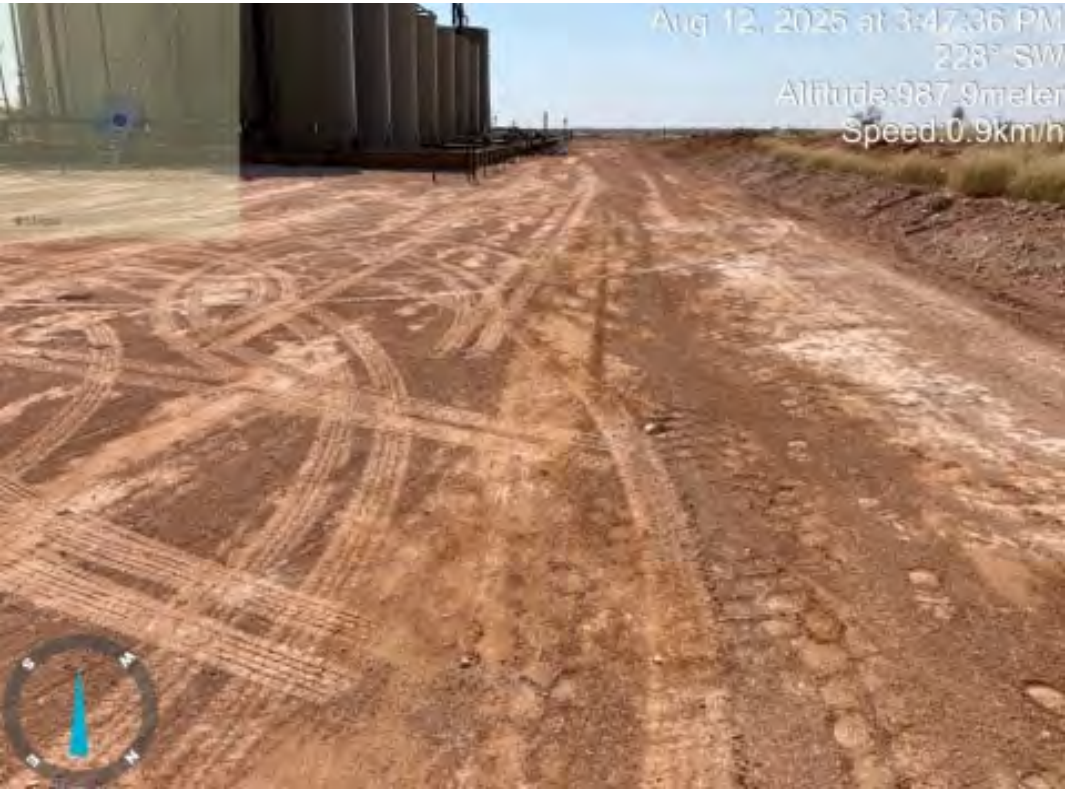
| <b>Photo Number:</b><br>7 | <p>Aug 12, 2025 at 3:47:36 PM<br/>228° SW<br/>Altitude: 987.9 meter<br/>Speed: 0.9 km/h</p> <p>View of the excavated area.</p> |

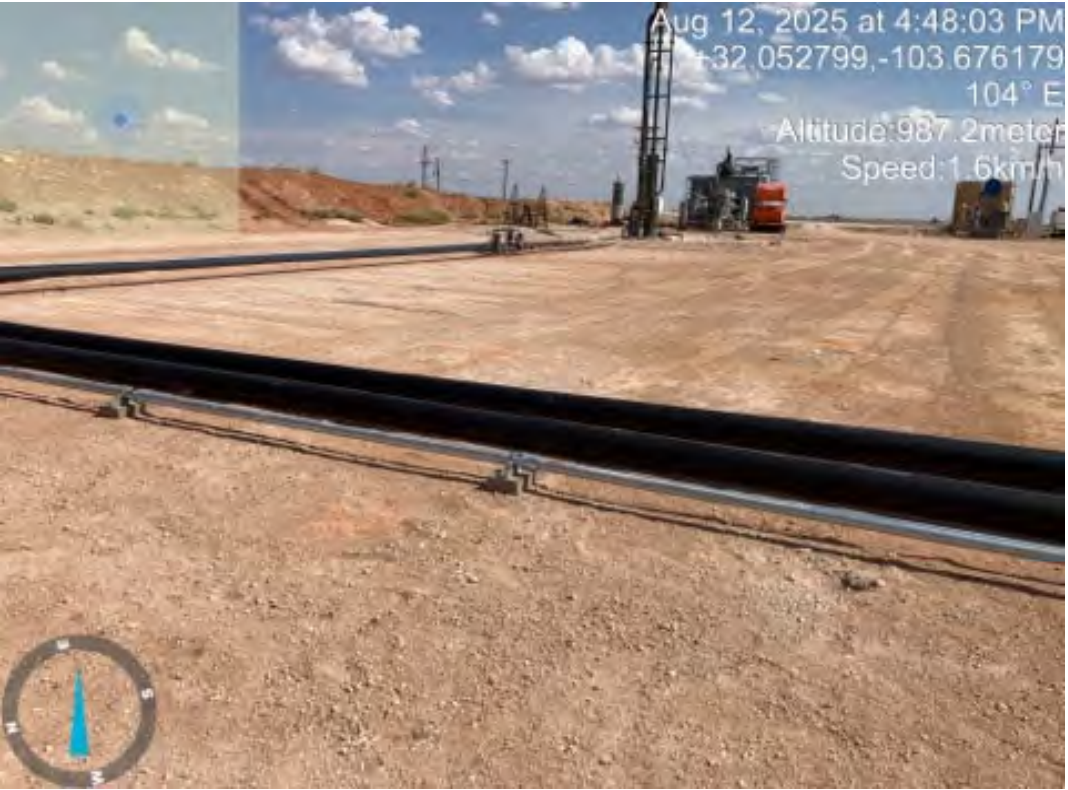
| <b>Photo Number:</b><br>8 | <p>Aug 12, 2025 at 4:48:03 PM<br/>+32.052799, -103.676179<br/>104° E<br/>Altitude: 987.2 meter<br/>Speed: 1.6 km/h</p> <p>View of the excavated area.</p> |

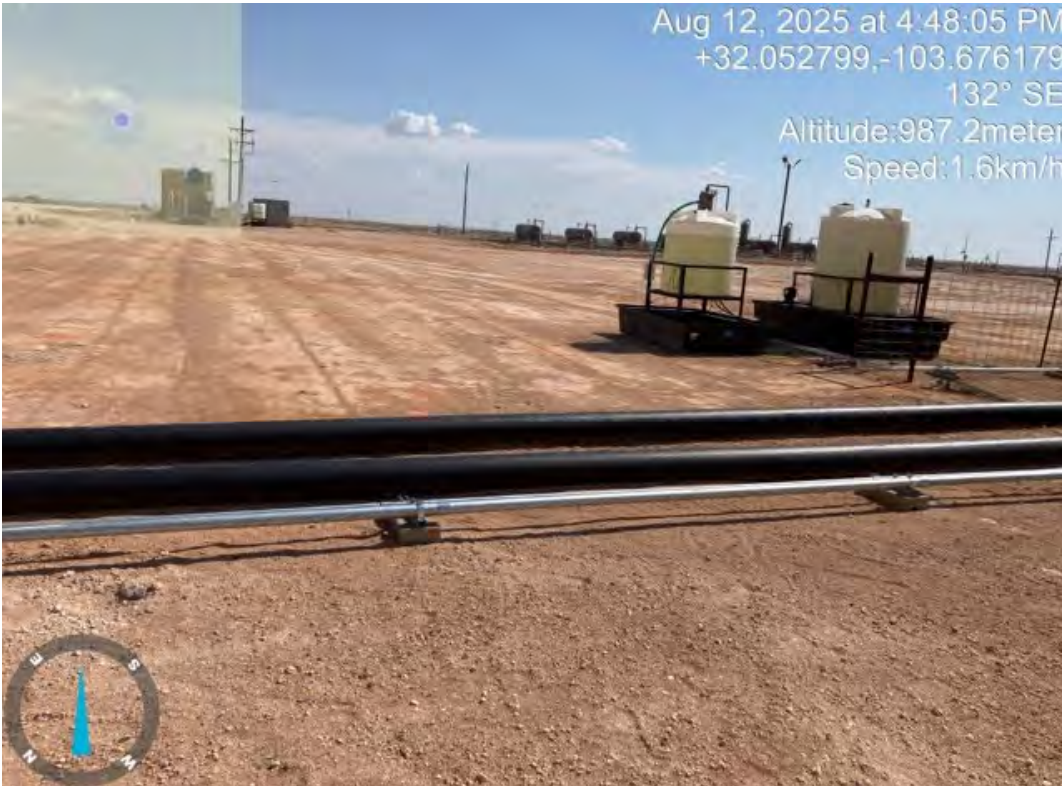
| <b>Photo Description:</b><br><br>View of the excavated area. | |

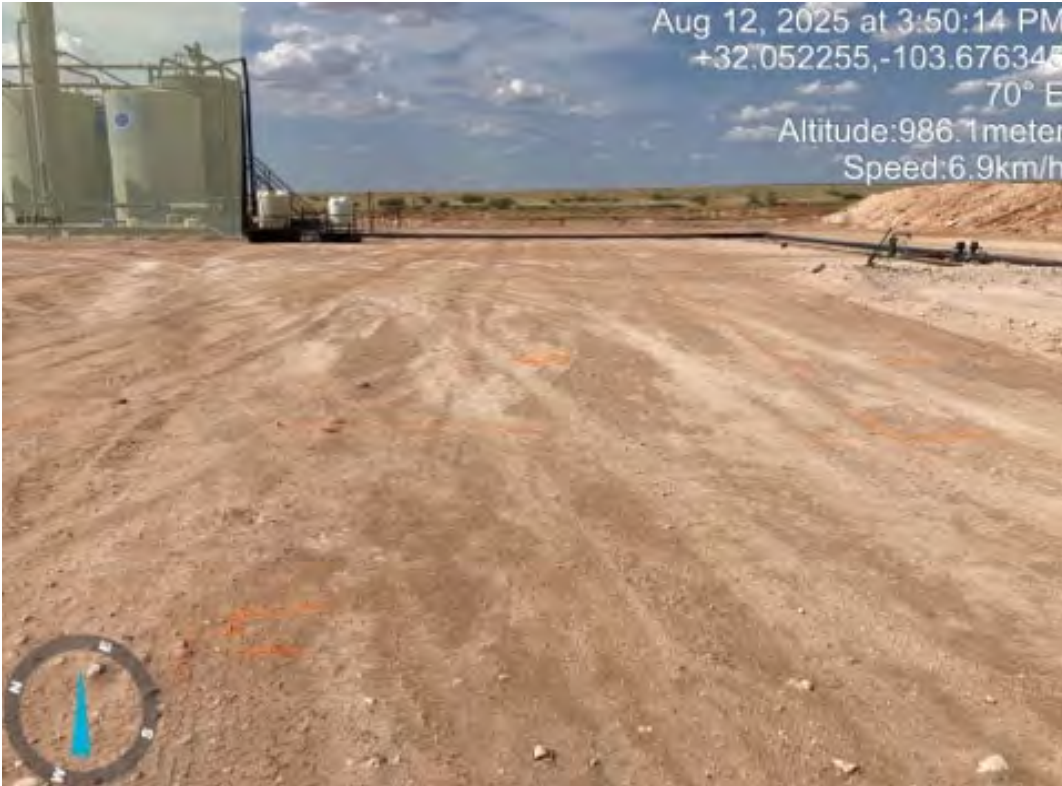
| <b>Photo Description:</b><br><br>View of the excavated area. | |

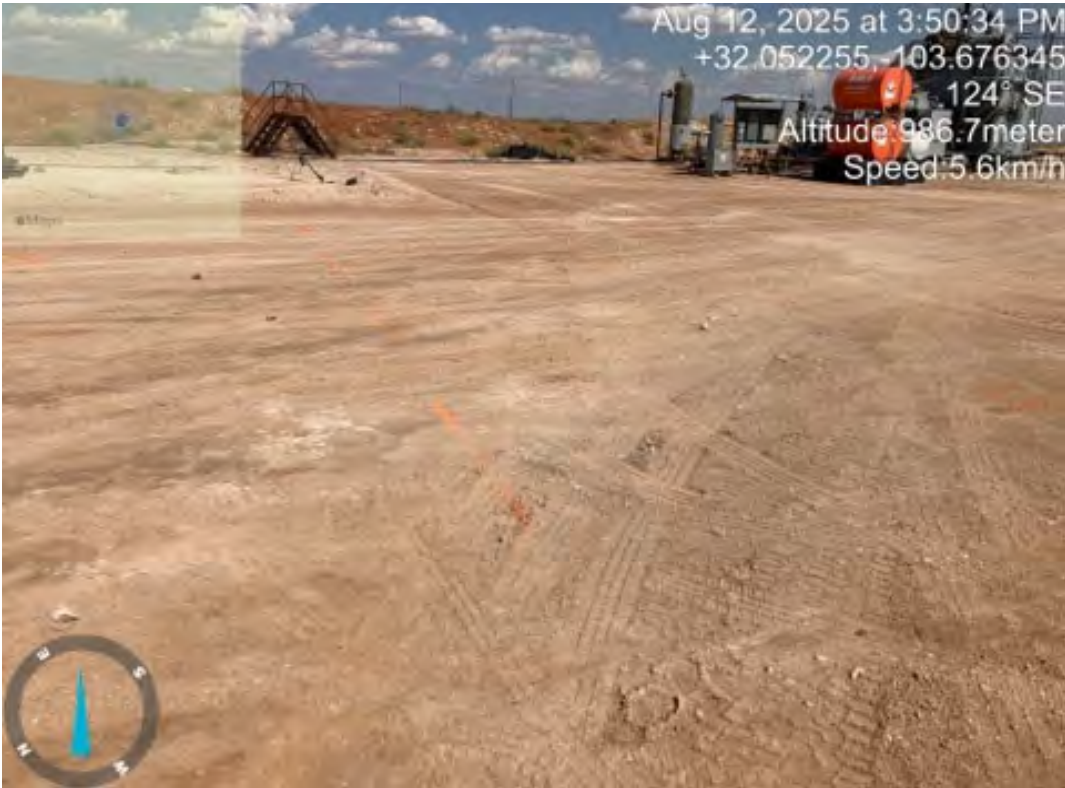
| <b>Photo Number:</b><br>11 | <p>Aug 12, 2025 at 3:50:34 PM<br/>+32.052255, 103.676345<br/>124° SE<br/>Altitude: 986.7 meter<br/>Speed: 5.6 km/h</p> <p>View of the excavated area.</p> |

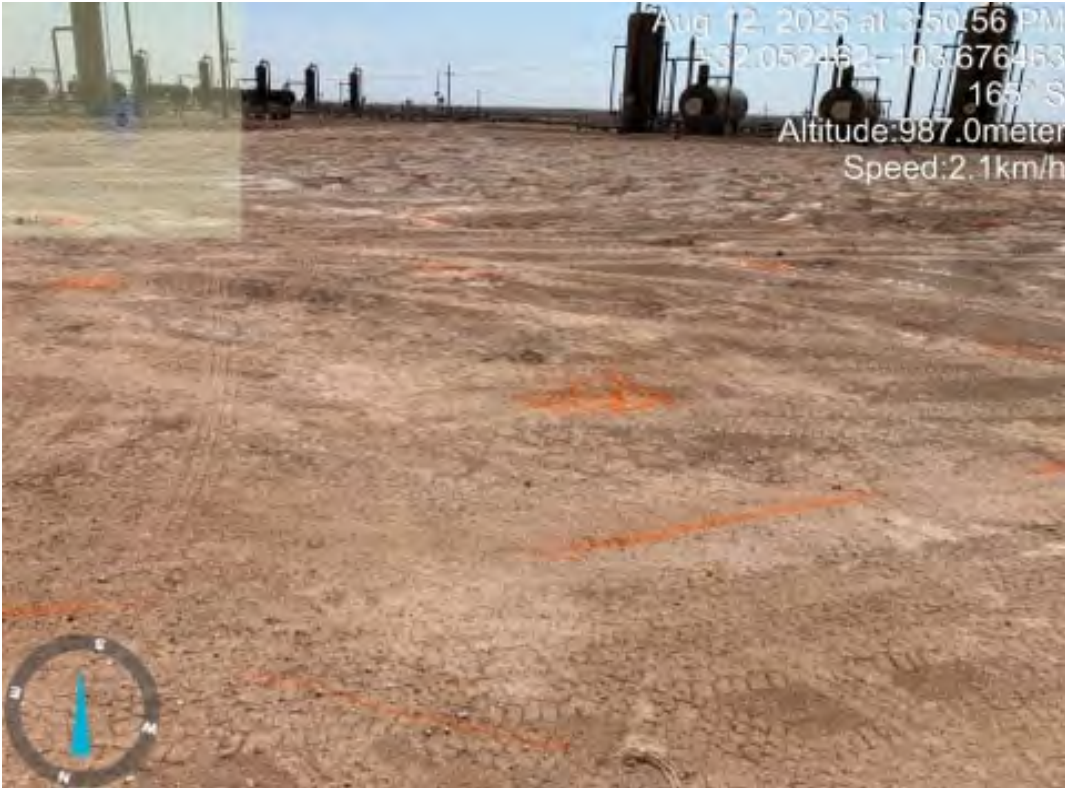
| <b>Photo Number:</b><br>12 | <p>Aug 12, 2025 at 3:50:56 PM<br/>+32.052462, 103.676463<br/>165° S<br/>Altitude: 987.0 meter<br/>Speed: 2.1 km/h</p> <p>View of the excavated area.</p> |

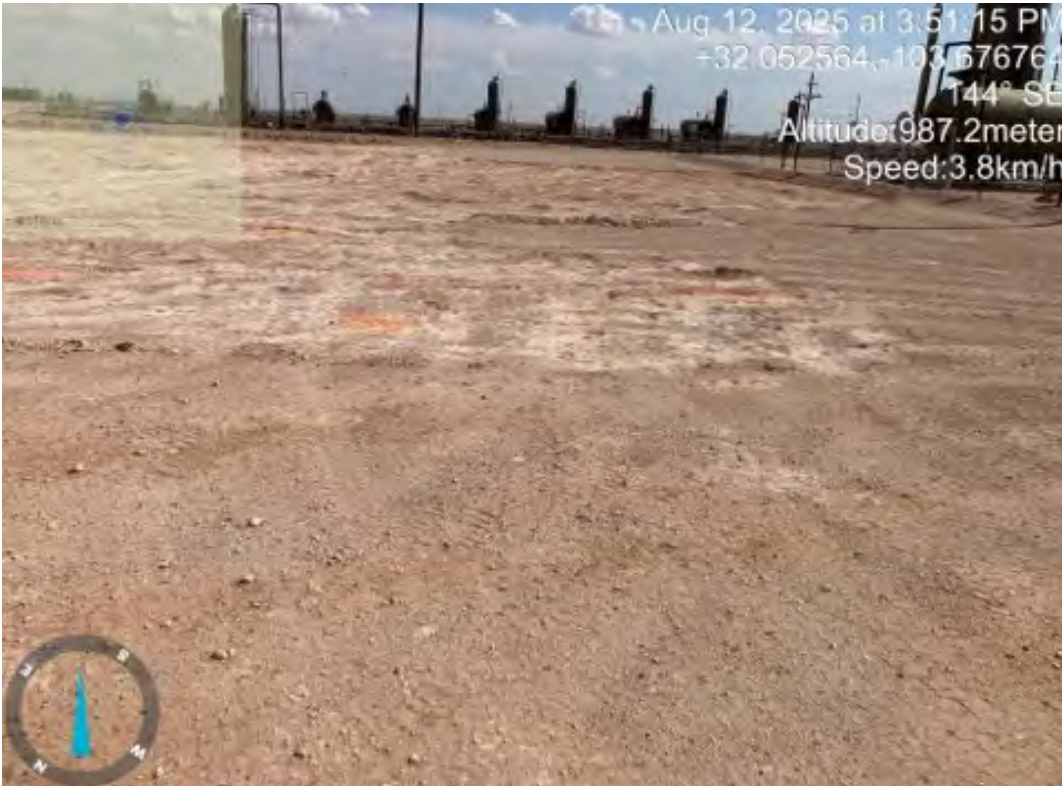
| <b>Photo Description:</b><br><br>View of the excavated area. | |

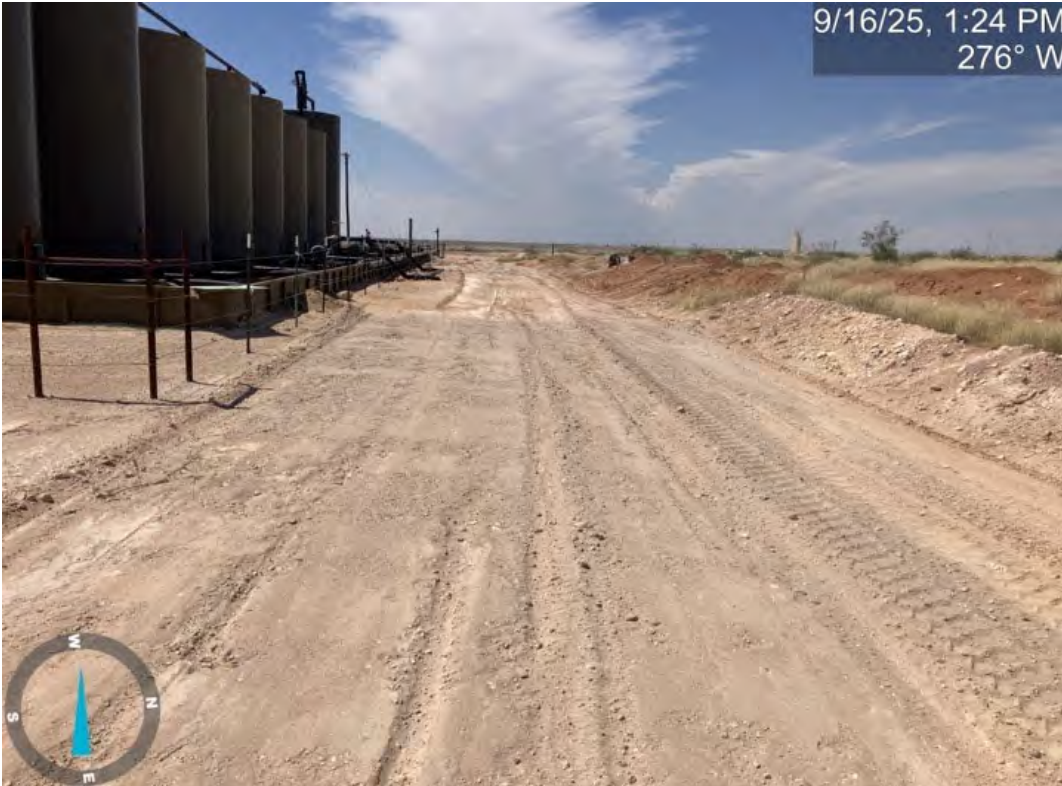
| <b>Photo Description:</b><br><br>View of the remediated area following backfill and regrading. | |

Upon receipt of all confirmation soil sample results, areas affected by remediation and closure activities were restored to the condition that existed prior to the release, to the extent practicable. The excavation was backfilled with non-impacted, "like" material sourced from the nearby Battle Axe Ranch borrow pit and emplaced at or near original relative positions. The affected areas were compacted and contoured to achieve erosion control, stability, and preservation of surface water flow, to the extent practicable.

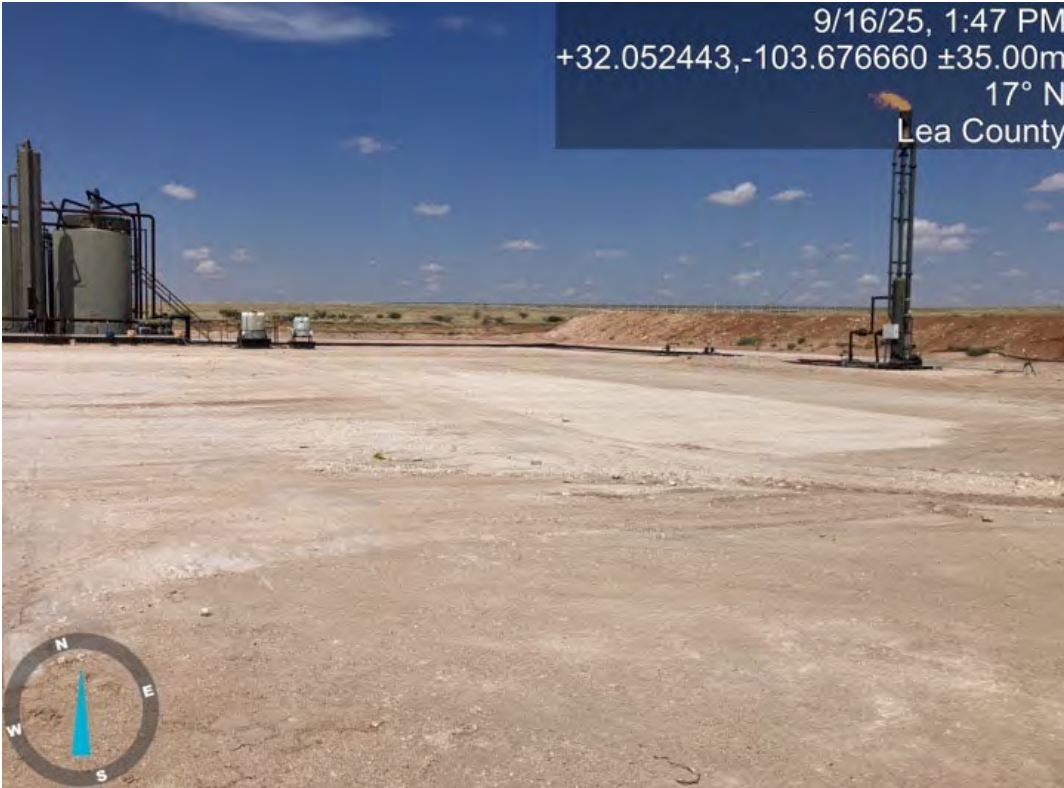
| <b>Photo Description:</b><br><br>View of the remediated area following backfill and regrading. | |
