## CLOSURE REPORT

**Valencia Canyon 45A**  
Unit Letter I, S34 T28N R4W  
Rio Arriba County, New Mexico

**New Mexico EMNRD OCD Incident ID No. NAPP2521837098**

**October 29, 2025**

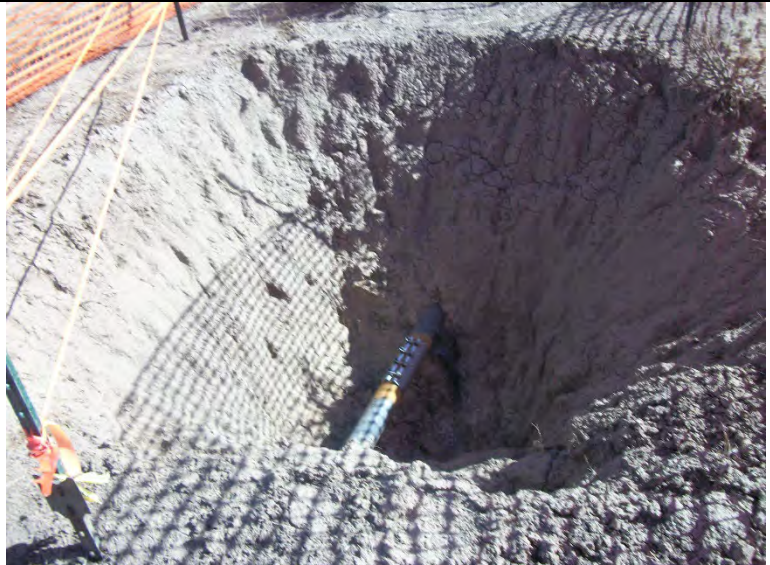
**Photograph 1**

Photograph Description: View of the initial excavation.

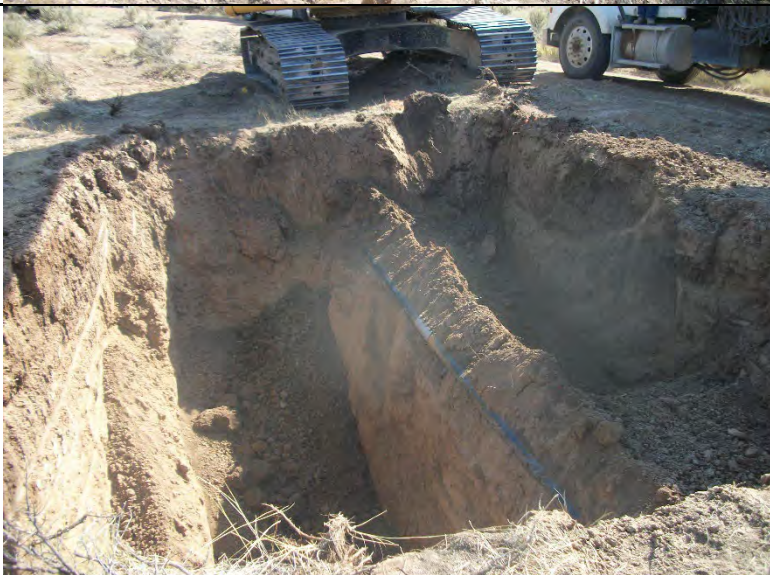
**Photograph 3**

Photograph Description: View of the in process excavation activities.

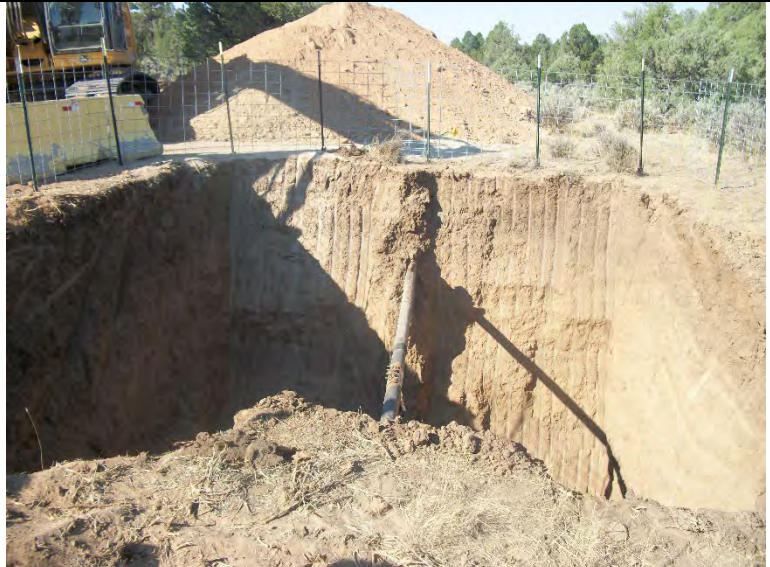
### Photograph 4

Photograph Description: View of the final excavation.

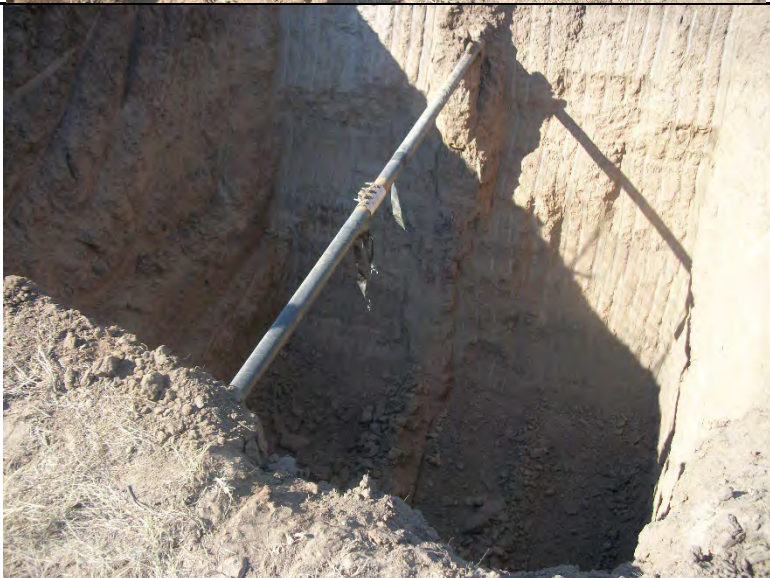
### Photograph 5

Photograph Description: View of the final excavation.
