**Closure Report**  
**Seldom Seen 15 Federal 1H**  
**Incident ID: NAPP2527954025**  
**Eddy County, New Mexico**  
**Unit E, Sec 15, T25S, R26E**  
**32.12428, -104.27366**

**Produced Water Release**  
**Point of Release: Corrosion on Valve around Separator**  
**Release Date: 10.05.2025**  
**Volume Released: 10 Barrels of Produced Water**  
**Volume Recovered: 5 Barrels of Produced Water**

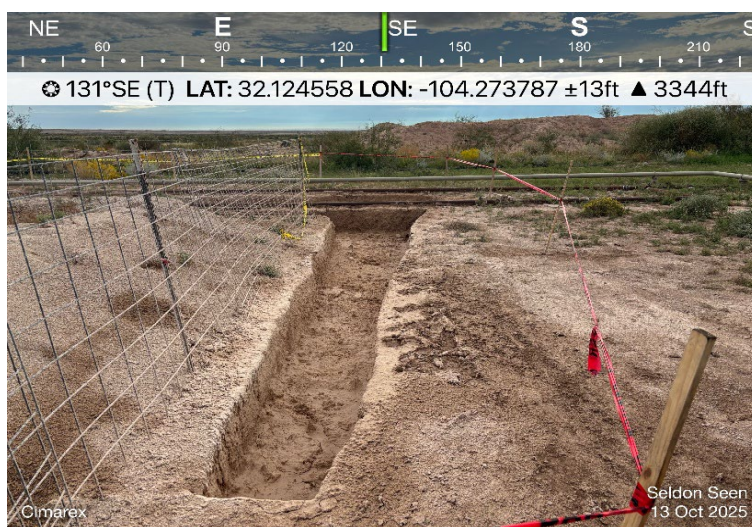
View Southeast, Area of CS-1 and CS-2.

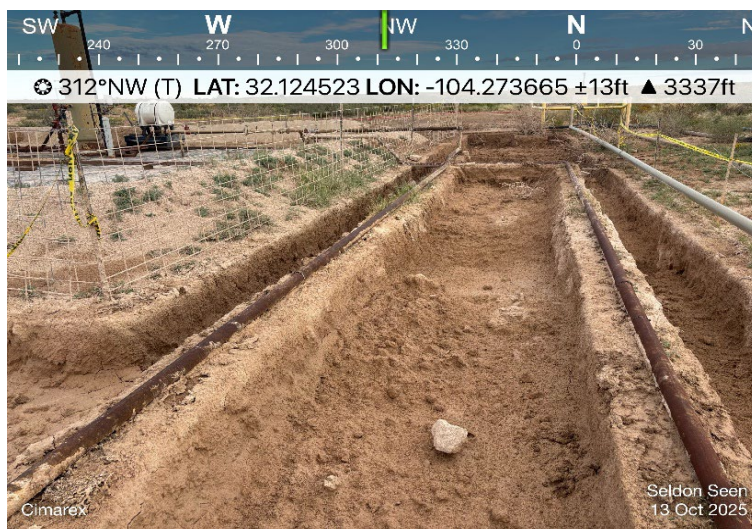
## Photograph No. 2

View Northwest, Area of CS-7.

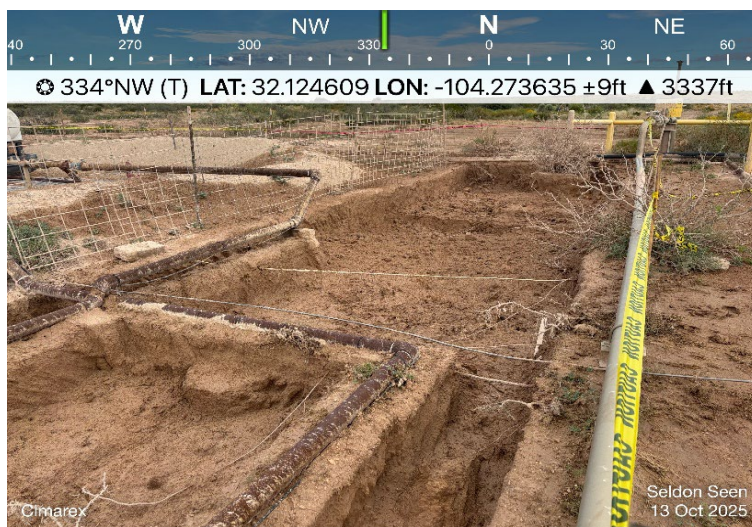
## Photograph No. 3

View Northwest, Area of CS-4 and CS-5

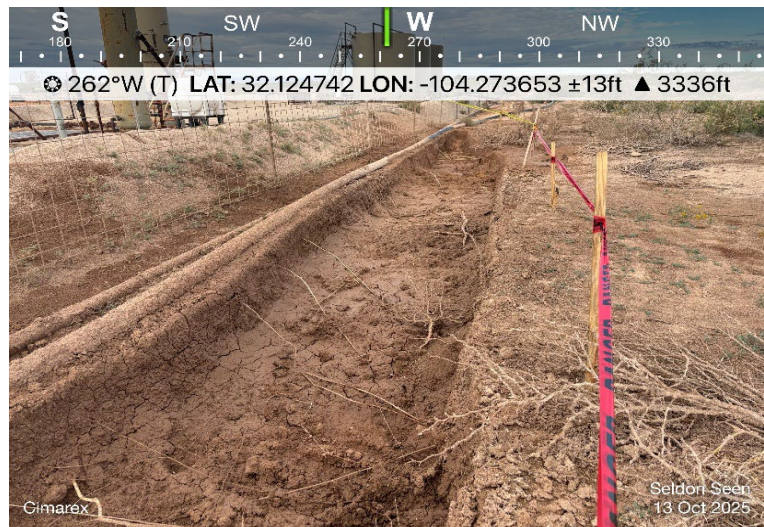
View West, Area of CS-8 and CS-9.

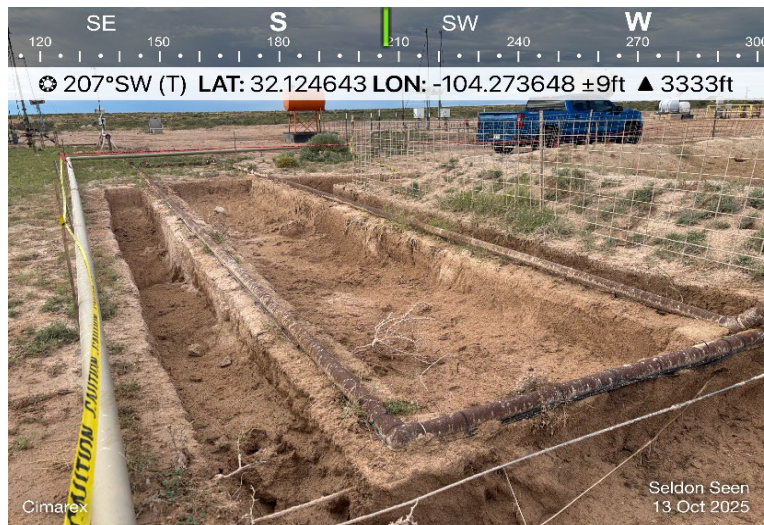
## Photograph No. 5

View Southwest, Area of CS-6 and CS-7.

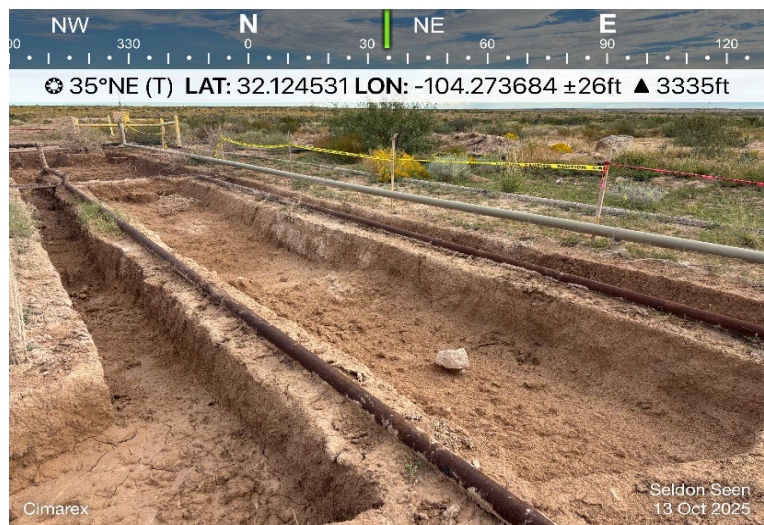
## Photograph No. 6

View Northeast, Area of CS-3 and CS-7.

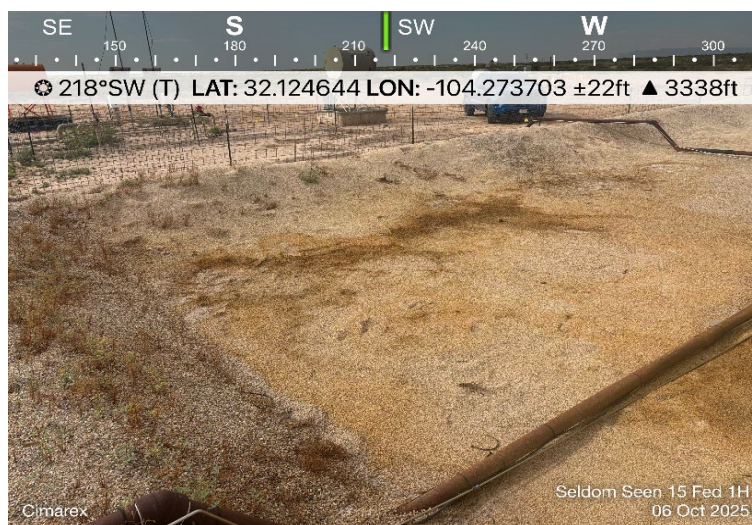
View Southwest of spill area within secondary containment.

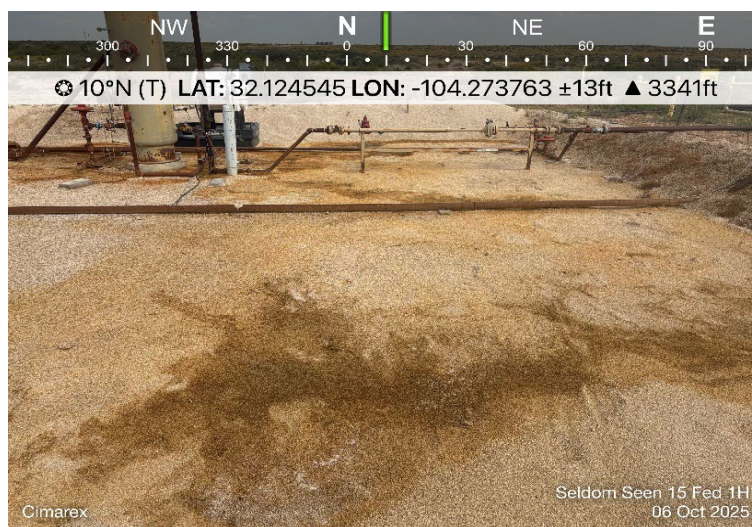
**Photograph No. 9**

View North of spill area within secondary containment.

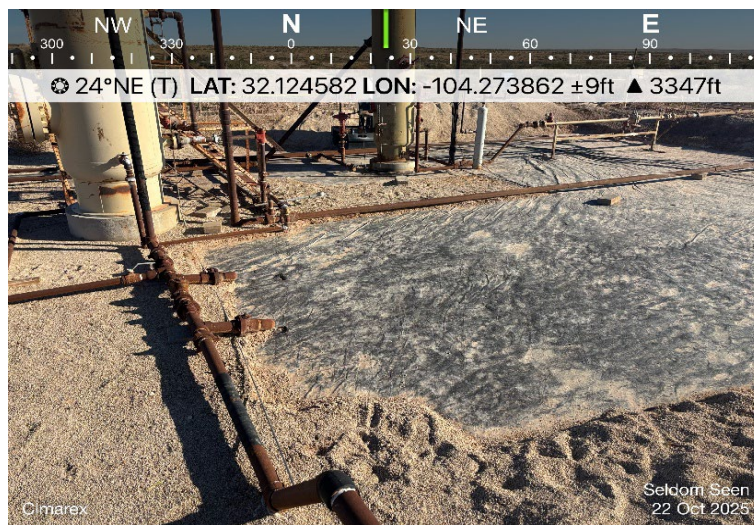
## Photograph No. 12

View Northeast of linear inspection with impacted gravel removed.
