**Re: Remediation Closure Request  
J R Oil, Ltd. Co.  
New Mexico A State #001  
Unit Letter E, Section 11, Township 10 South, Range 32 East  
Lea County, New Mexico  
Incident ID# nPAC0531140845**

Remediation Closure Request  
November 3, 2025

J R Oil, Ltd. Co.

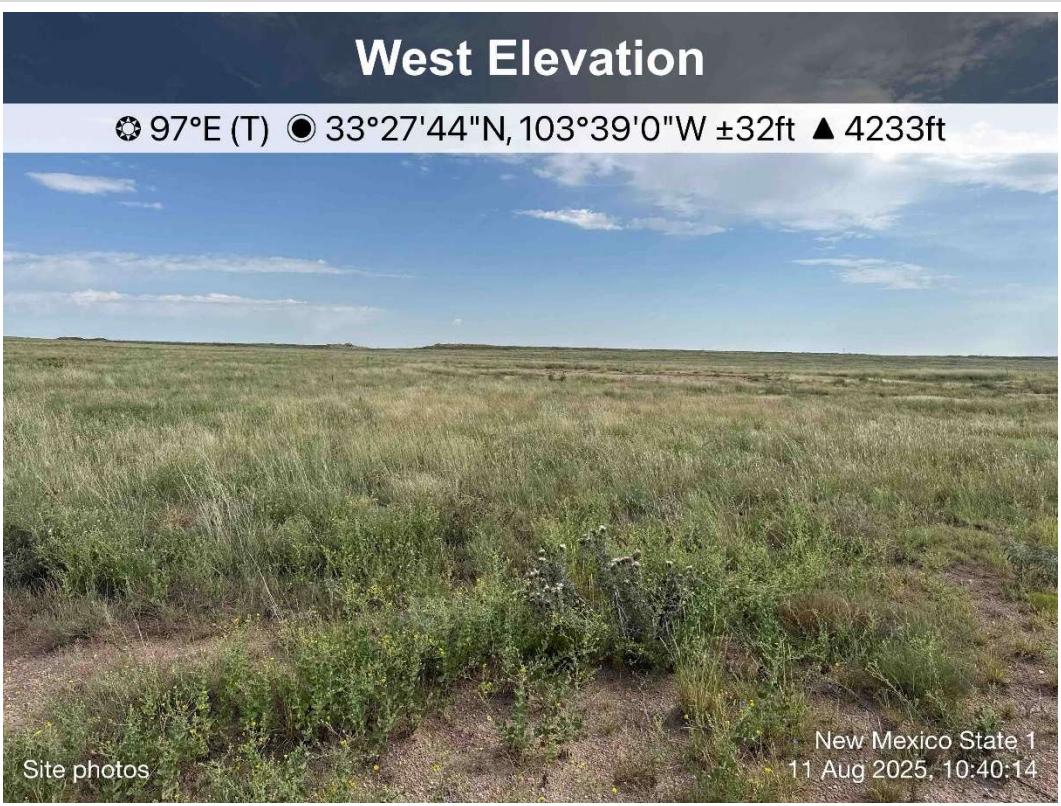
| TETRA TECH, INC.<br>PROJECT NO.<br>212C-MD-03777 | DESCRIPTION | View west-northwest. Area where former flowline occupied southwest of pad and lease road. | 1 |
