## Release Assessment and Incident Closure

Hat Mesa 31 State #002

Vertex File Number: 25A-01125

ExxonMobil Production Company

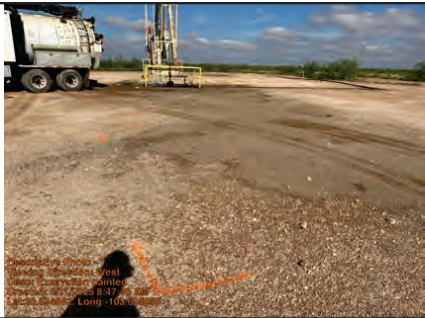
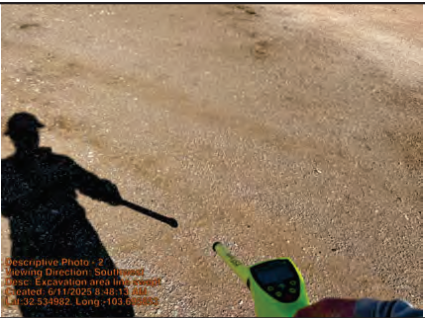
| <p>Excavation painted</p> | <p>Excavation area line swept</p> |

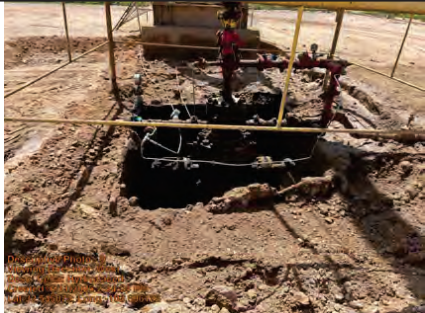
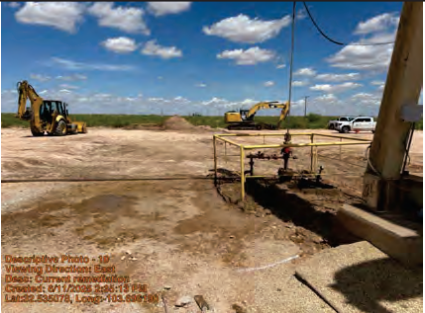
| Viewing Direction: West | Viewing Direction: East |
|---|---|
| Cellar Hydrovaced | Current remediation |

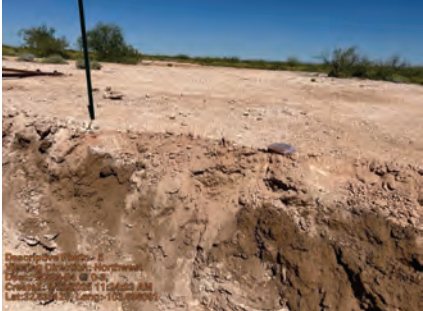
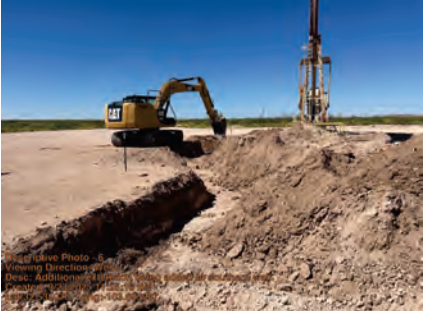
| <div>Viewing Direction: Northwest</div> <div><p>Descriptive Photo - 4<br/>Viewing Direction: Northwest<br/>Date: 9/23/25 11:42 AM<br/>Created: 9/23/25 11:42 AM<br/>Lat: 32.8306, Long: -102.5611</p></div> <div>WS25-04 @ 0-3'</div> | <div>Viewing Direction: West</div> <div><p>Descriptive Photo - 5<br/>Viewing Direction: West<br/>Date: 9/23/25 11:42 AM<br/>Created: 9/23/25 11:42 AM<br/>Lat: 32.8306, Long: -102.5611</p></div> <div>Additional extension being added to southern wall</div> |

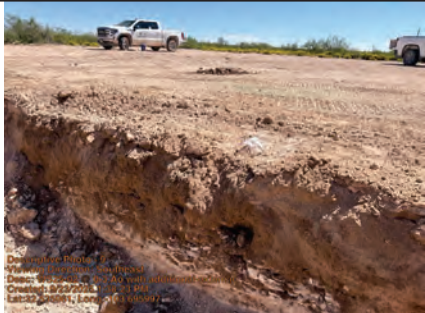
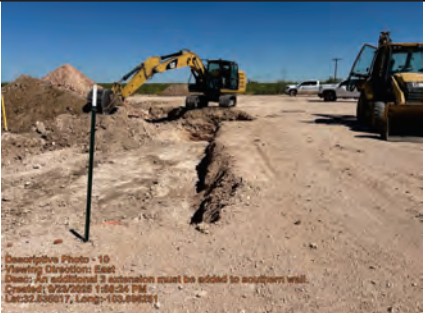
| Viewing Direction: Southeast | Viewing Direction: East |
|---|---|
| WS25-02 @ 0-3' with additional extension | An additional 3 extension must be added to southern wall |

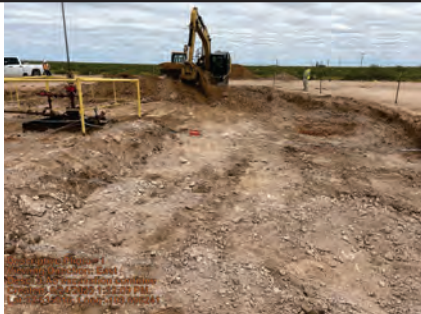
3' excavation continues

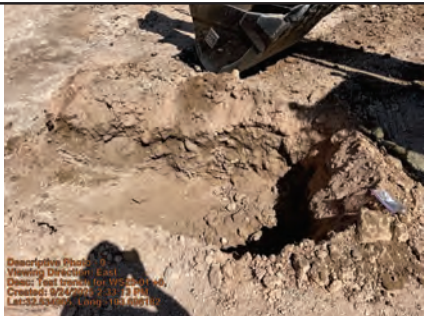
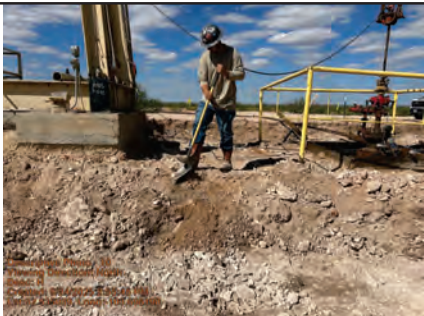
| Viewing Direction: East | Viewing Direction: North |
|---|---|
| Stepped out Test trench for WS25-01 by 6' | Area between pumpjack and well head was hand dug. |

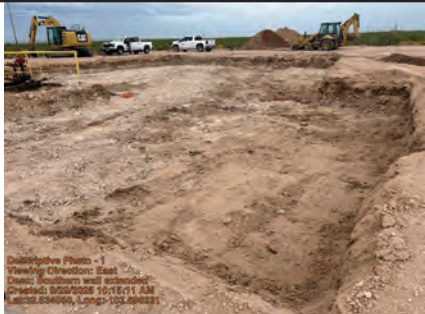
| <p>Southern wall extended</p> | <p>WS25-01 @ 0-3'</p> |

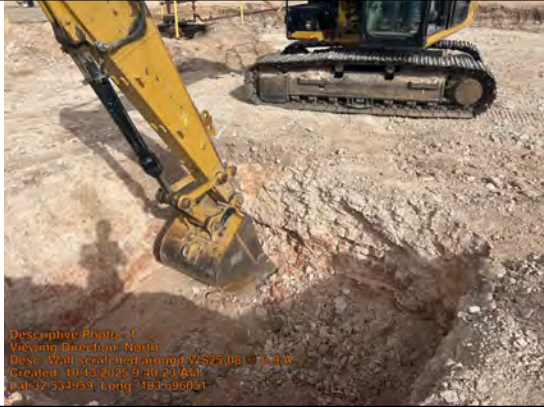
Excavation around WS25-08 @ 0-9'

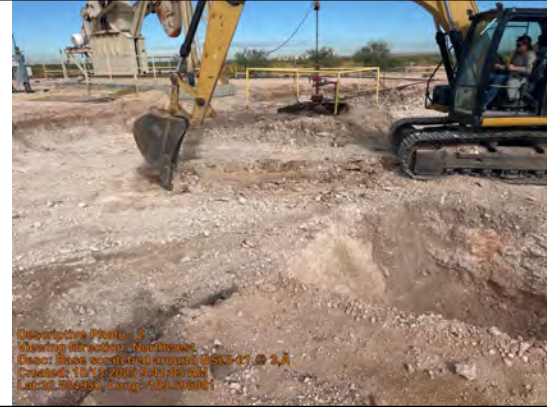
Excavation around BS25-21 @ 3'

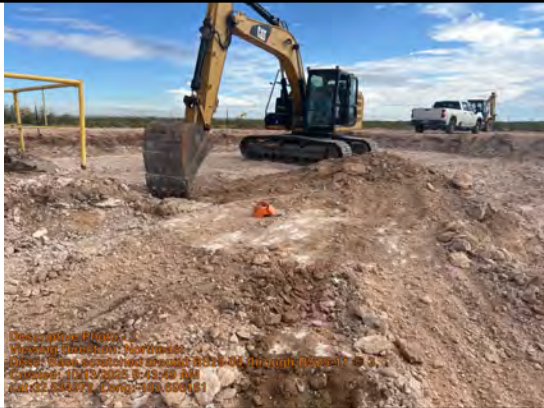
Excavation around BS25-04 through BS25-11 @ 3'

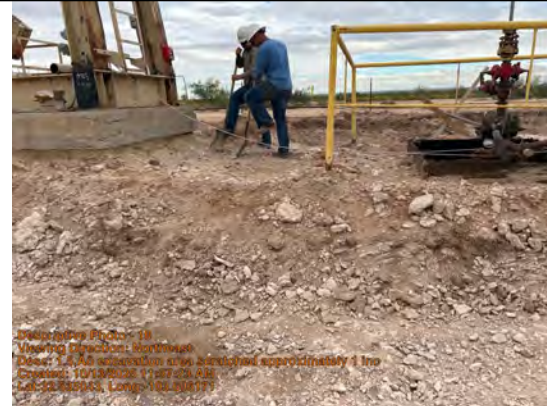
Hand Excavation. Excavation area to 1.6'

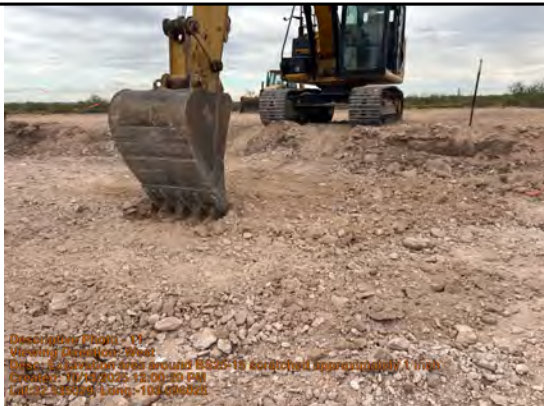
Excavation area around BS25-15
