C-141 Form  
Bridges State #15  
Lea County, New Mexico

Re: ExxonMobil Final C-141 and Closure Documentation  
Bridges State #15, Ref# 190007  
UL- J (NW¼ of the SE¼) of Section 26, T17S, R34E, Lea County, New Mexico  
Latitude: 32°48'15.85"N and Longitude: 103°31'46.13"W

## EXXONMOBIL BRIDGES STATE #15 CLOSURE DOCUMENTATION

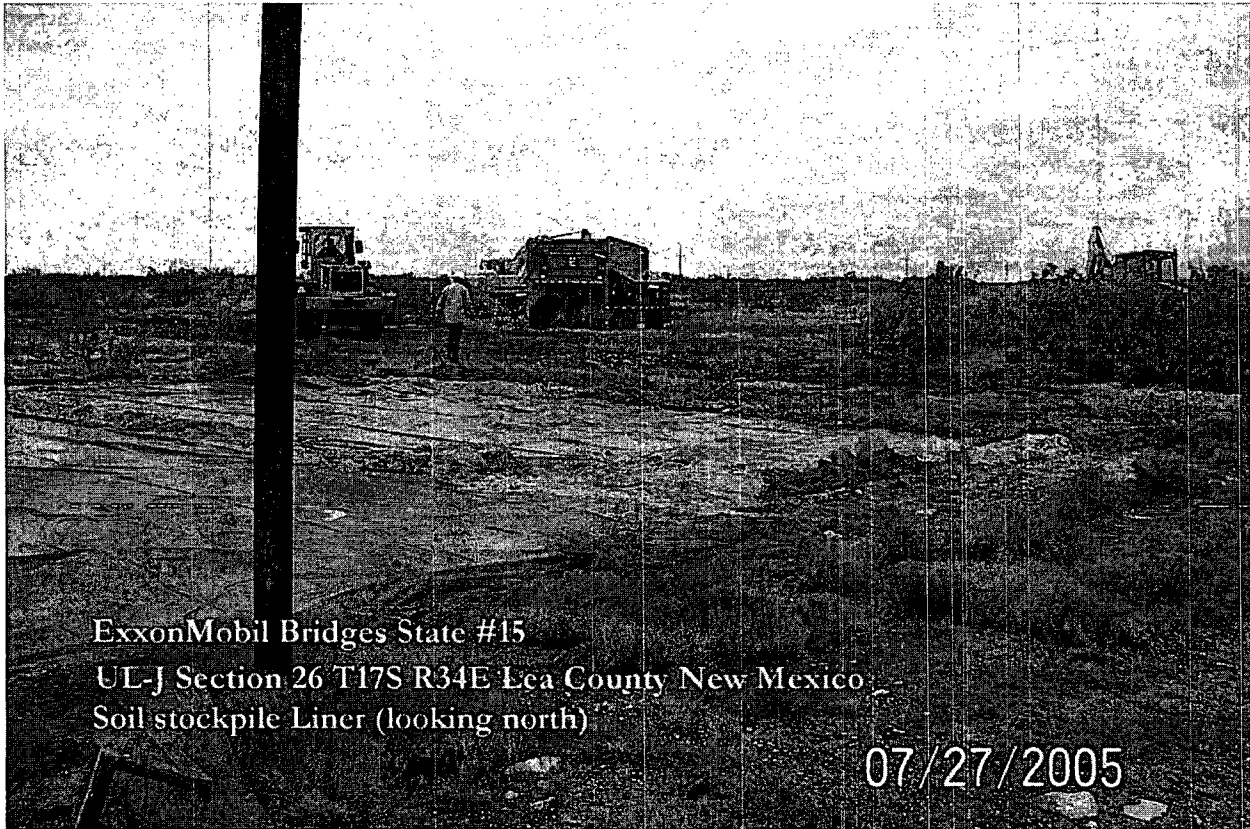
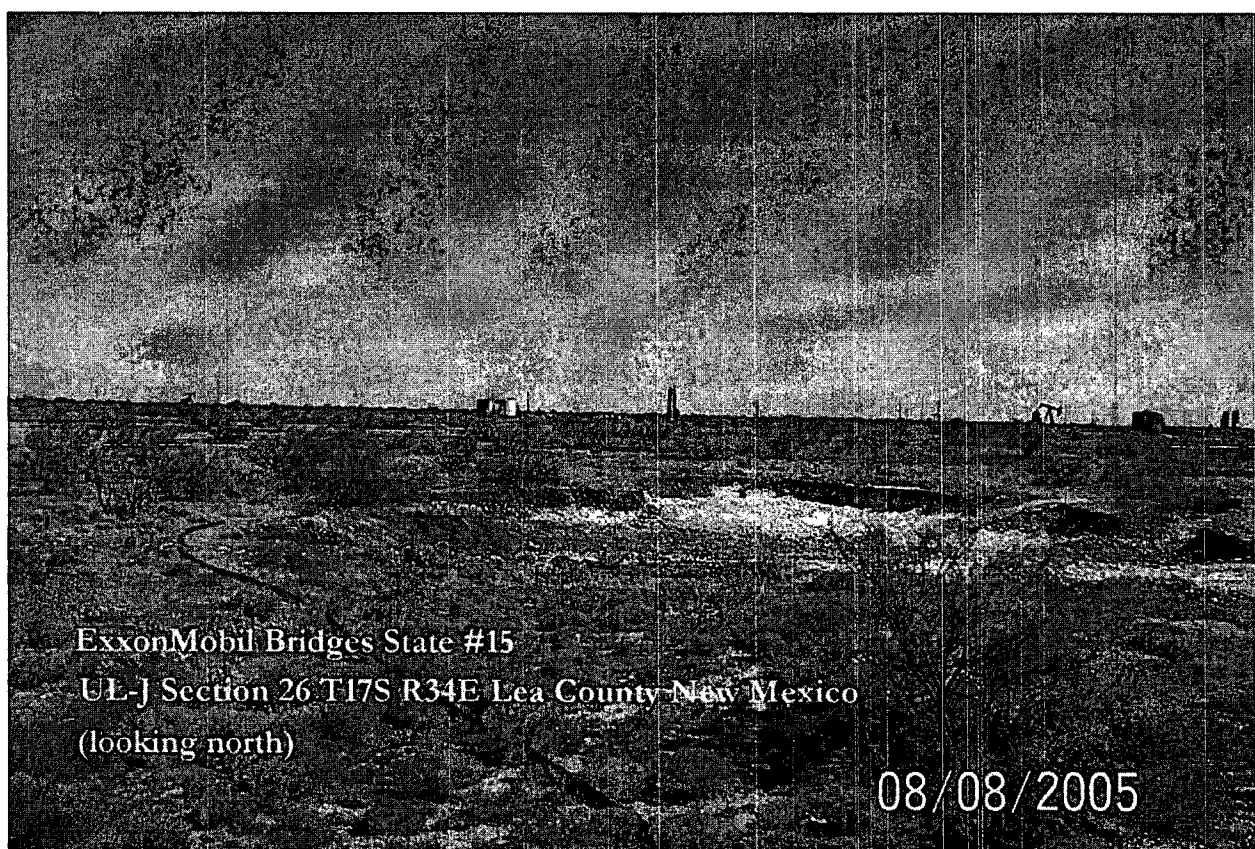
After the liner was installed and cushioned, the rock was placed in the excavation, brought to grade with 1,318 cubic yards of clean topsoil and contoured to the natural grade. Photographs are included after the Excavation Sample Location Map.

With timely notification provided to the NMOCD, the 20 mil polyethylene liner was installed on August 25, 2005. The smooth textured cushioning soil was purchased locally.
