**Re: Closure Request  
PLU Big Sinks 19-24-31 USA Battery  
Incident Numbers nAPP2430551104 & nAPP2434134681  
Eddy County, New Mexico**

Ensolum, LLC (Ensolum), on behalf of XTO Energy, Inc (XTO), has prepared this *Closure Request* to document the findings of a liner integrity inspection conducted at the PLU Big Sinks 19-24-31 USA Battery (Site) following two releases of produced water within a lined containment. Based on the liner integrity inspection activities and laboratory analytical results, XTO is submitting this *Closure Request*, describing the inspection results and requesting closure for Incident Numbers nAPP2430551104 and nAPP2434134681.

## LINER INTEGRITY INSPECTION ACTIVITIES

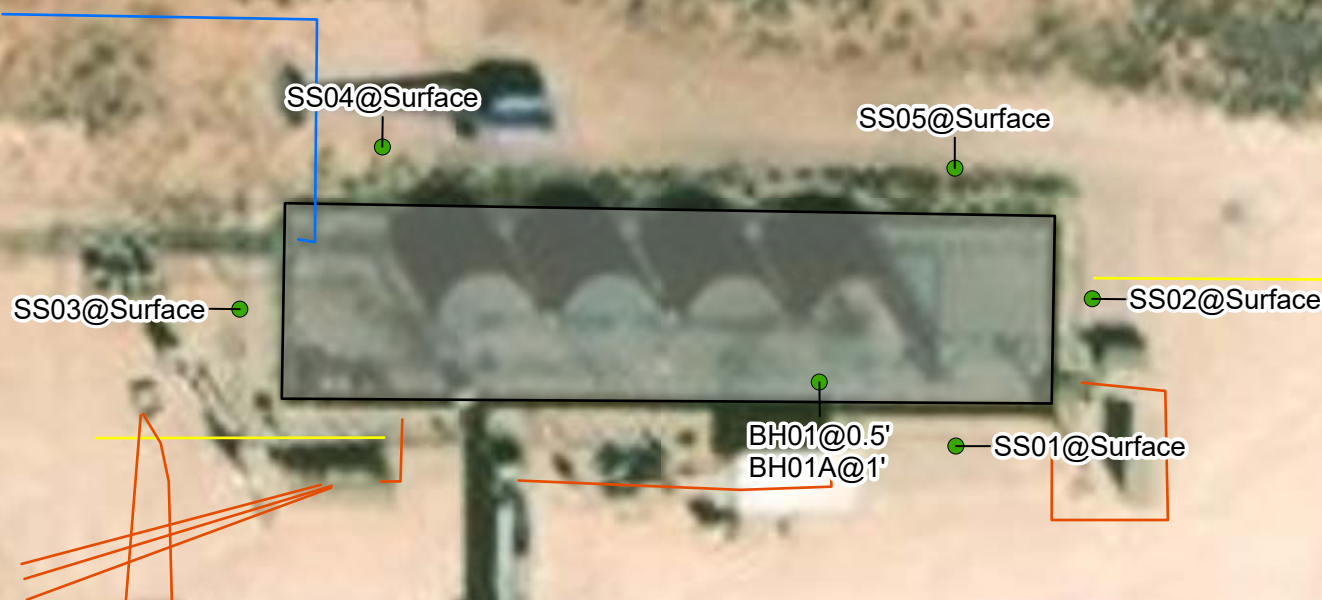
**2**

On August 27, 2025, Ensolum personnel were at the Site to oversee delineation activities. Five delineation soil samples (SS01 through SS05) were collected around the lined containment from ground surface to assess the lateral extent of the release. One borehole (BH01) was advanced via hand auger to a terminal depth of 1-foot bgs in the location of the liner hole. Discrete soil samples were collected from the borehole at depths ranging from 0.5 feet bgs to 1-foot bgs. All delineation soil samples were field screened for volatile organic compounds (VOCs) utilizing a calibrated photoionization detector (PID) and chloride utilizing Hach® chloride QuanTab® test strips. Field screening results and observations of the soil samples from the borehole were logged on a lithologic/soil sampling log, which is included in

Appendix C. The delineation soil sample locations were mapped utilizing a handheld Global Positioning System (GPS) unit and are depicted on Figure 2. Photographic documentation is included in Appendix B.

Notes:  
Sample ID @ Depth Below Ground Surface.

## Delineation Soil Sample Locations

Laboratory analytical results for delineation soil samples SS01 through SS05 indicated all COCs were in compliance with Site Closure Criteria and reclamation standards, confirming the lateral extent of the release. Delineation soil samples from borehole BH01 at 0.5 feet bgs and 1-foot bgs indicated all COCs were in compliance with Site Closure Criteria. Laboratory analytical results are summarized in Table 1 and the laboratory analytical reports are included in Appendix D.

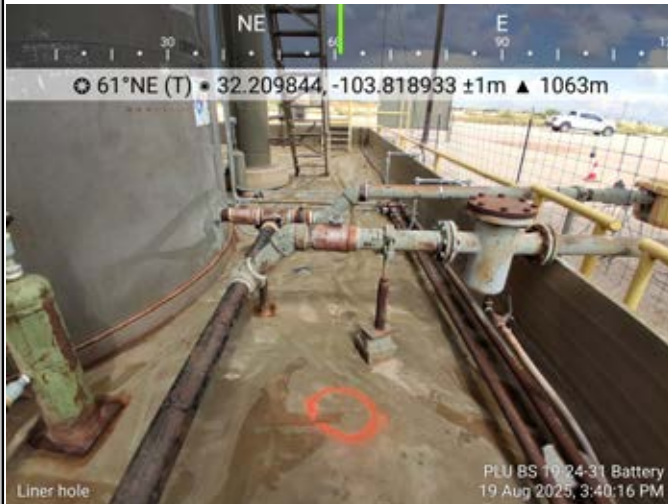
The lined containment was cleaned of all debris and power washed, and a liner integrity inspection was conducted by Ensolum personnel on August 19, 2025. The lined containment was inspected, and it was determined to contain a small hole. Delineation to determine the extent of the release was warranted. A site map of the lined containment is included in Figure 2. Photographic documentation of the inspection is included in Appendix B.

Photograph: 1 Date: 8/19/2025  
Description: Hole in Liner before cleaning activities  
View: Northeast

Liner integrity inspection and delineation activities were conducted at the Site to address the October 2024 and December 2024 releases of produced water. Laboratory analytical results for the soil samples collected indicated that all COC concentrations were compliant with the Site Closure Criteria and/or reclamation standards where applicable. Based on the soil sample analytical results, no impacted soil was identified, and no further remediation was required. XTO patched all holes and tears in the liner following completion of delineation activities.

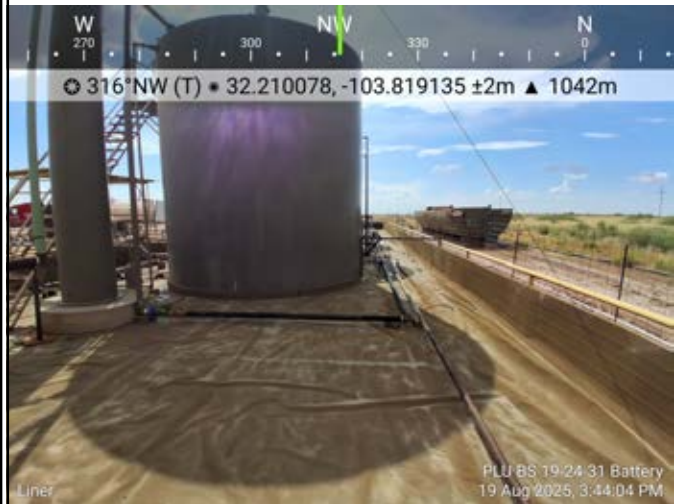
Photograph: 2 Date: 8/19/2025  
Description: Liner before cleaning and repairs  
View: Northwest

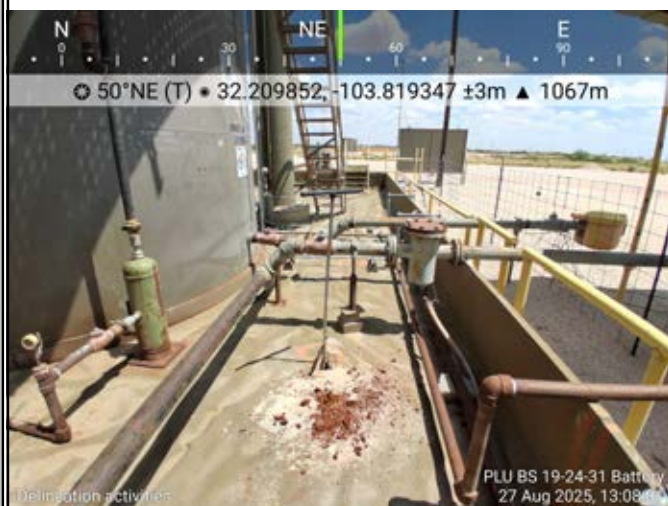
Photograph: 3 Date: 8/27/2025  
Description: Delineation activities near BH01  
View: Northeast

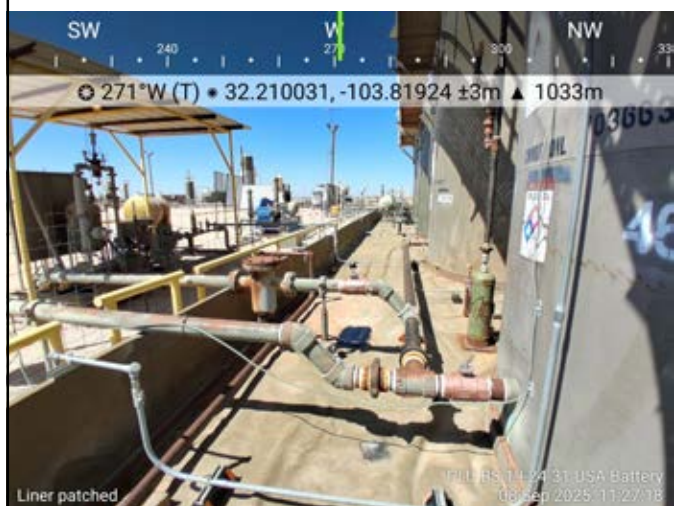
Photograph: 4 Date: 9/8/2025  
Description: Liner Patch near BH01  
View: West
