RE: **Maljamar Gas Plant - Closure Request Report**
Incident Number: nAPP2516756421
GPS: 32.8132754°, -103.7710426°
Lea County, New Mexico
ESRR Project No. 639

Earth Systems Response & Restoration (ESRR), on behalf of Kinetik Midstream (Kinetik), presents the following Closure Request Report (CRR) detailing excavation activities and subsequent soil sampling events associated with an inadvertent release of crude oil and condensate at the Maljamar Gas Plant (Site). Based on completed remedial actions and laboratory analytical results from recent soil sampling events, Kinetik is requesting No Further Action (NFA) at the Site.

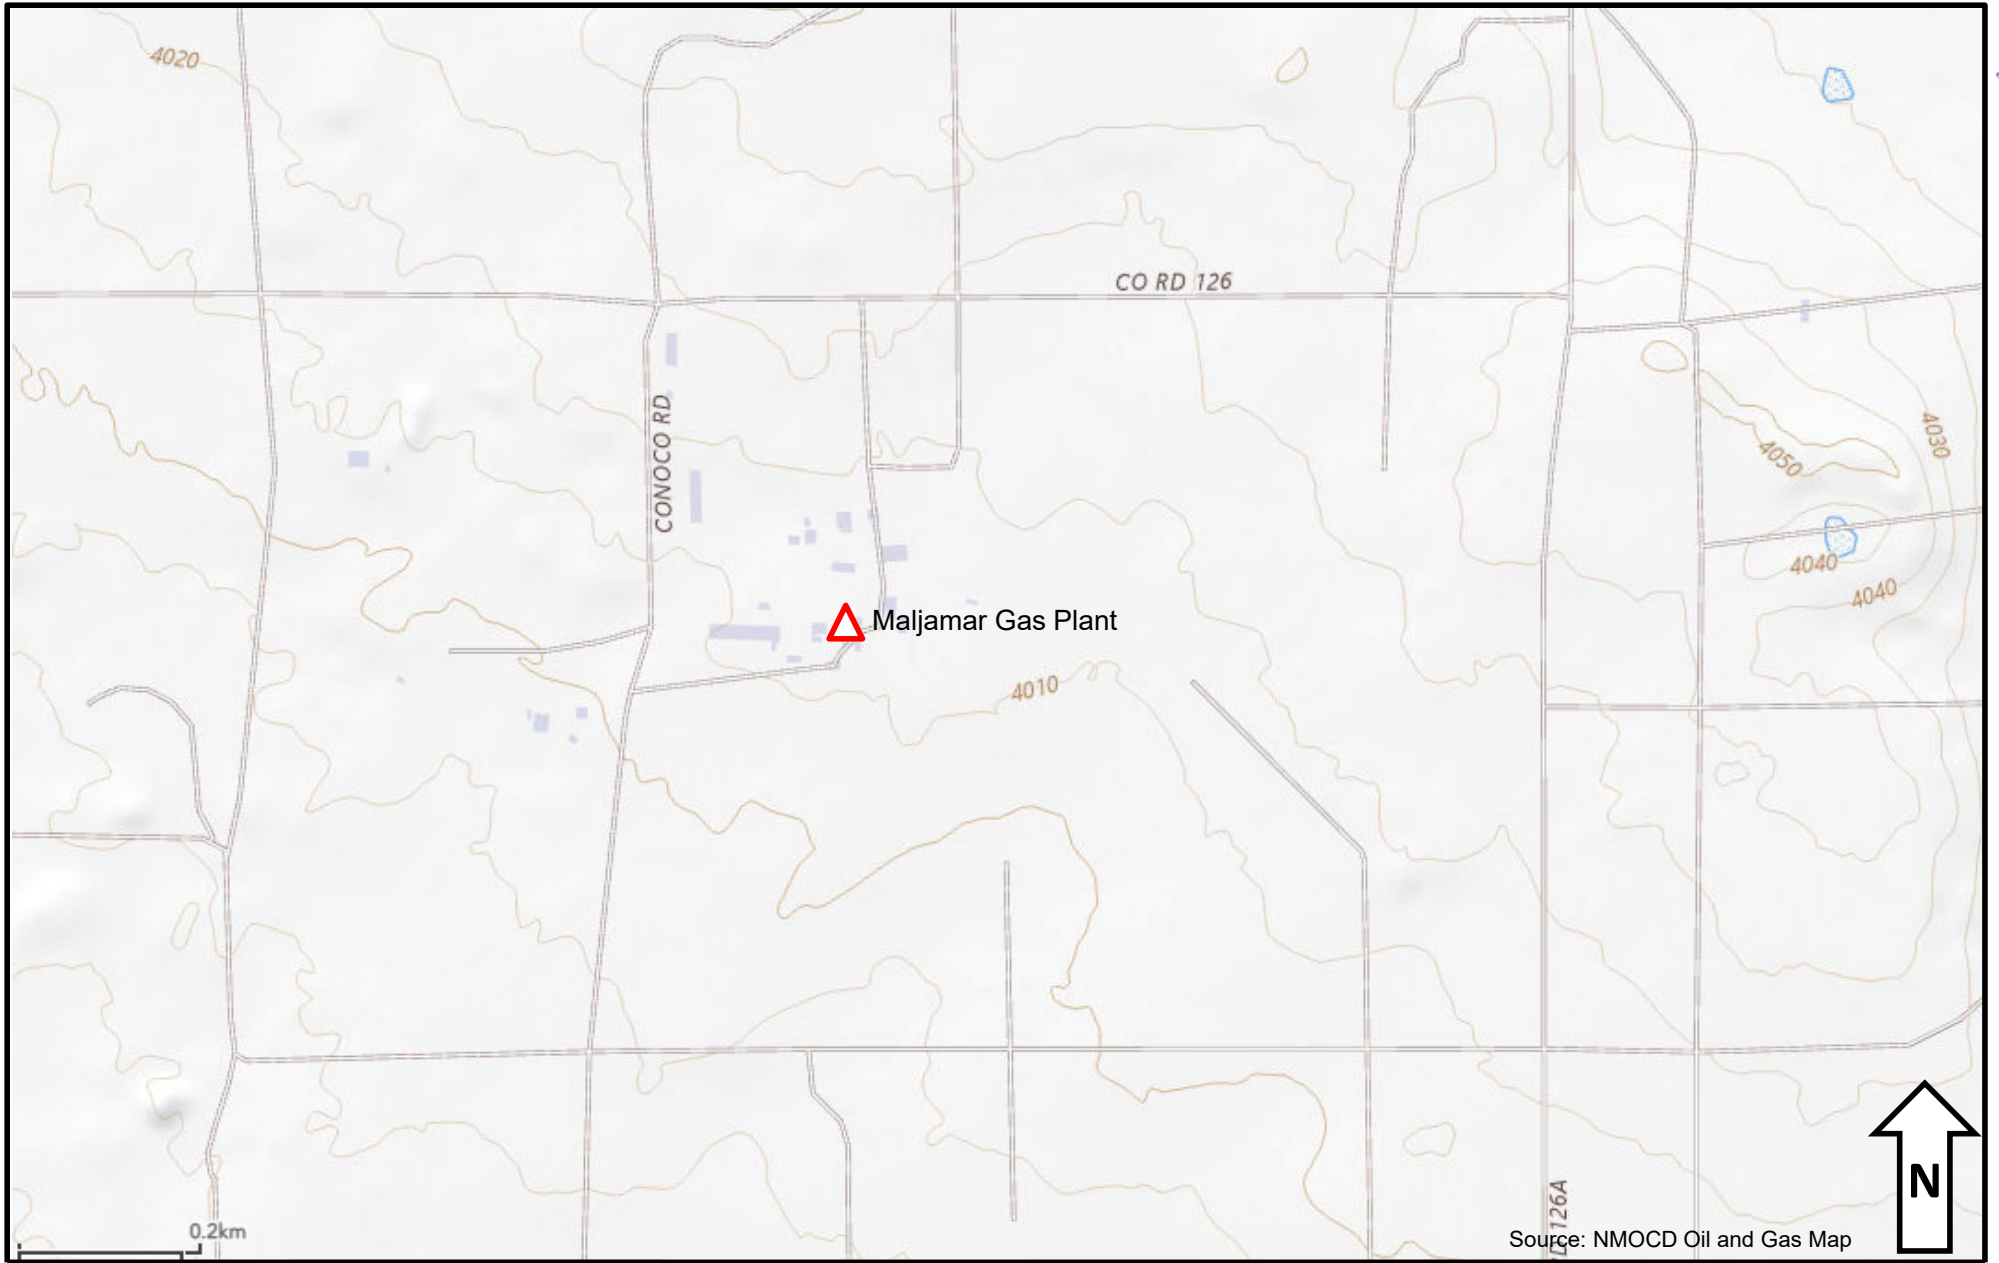
Figure 1 – Site Map

The Site is located in Unit O, Section 21, Township 17 South, Range 32 East, in Lea County, New Mexico (32.8132754°, -103.7710426°) and is associated with oil and gas exploration and production operations on Private Land (**Figure 1**).

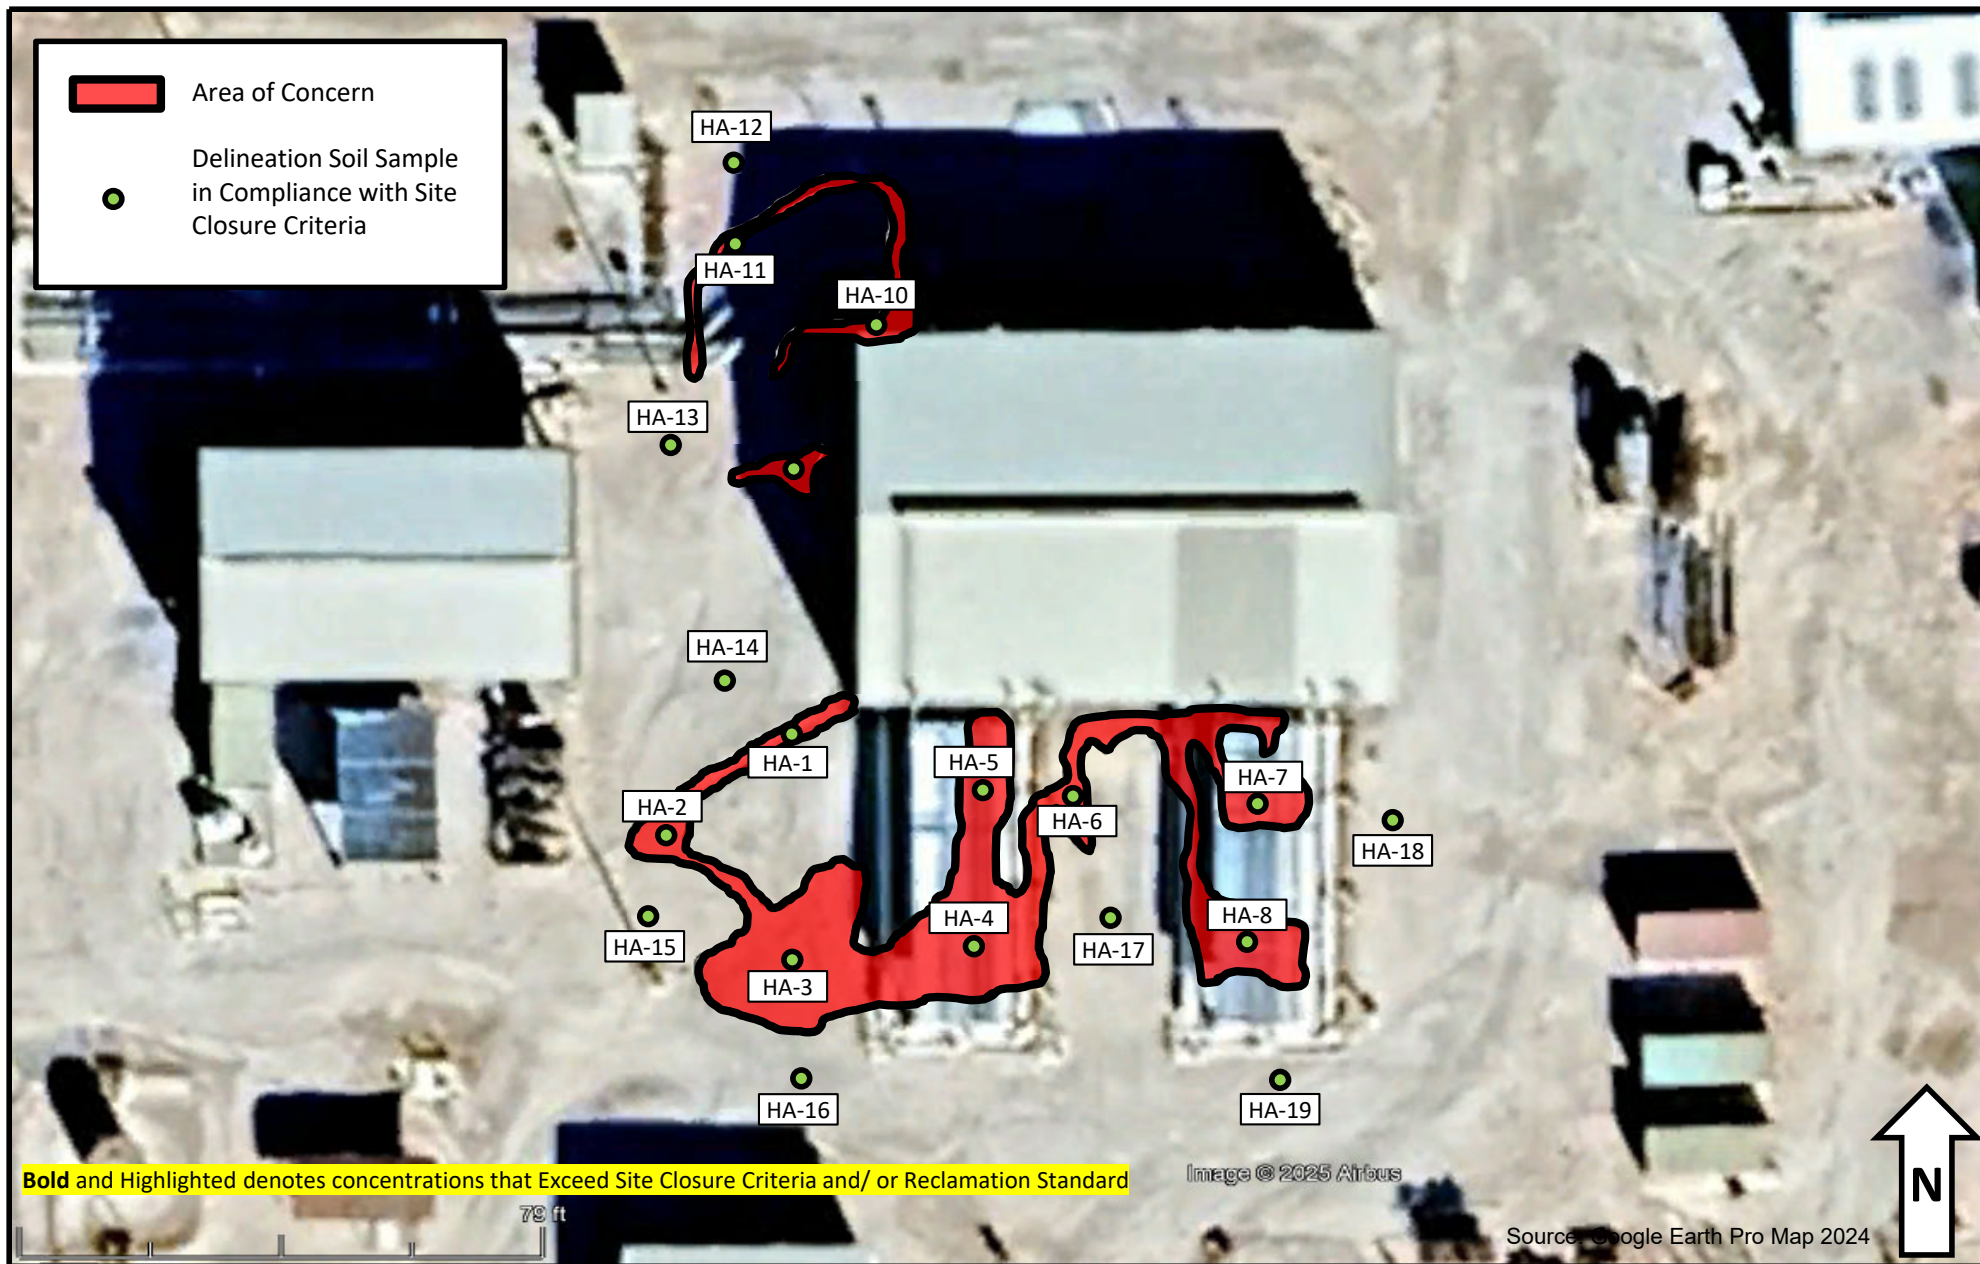
Figure 2 – Delineation Soil Sample Locations

On July 2 and 3, 2025, ESRR conducted delineation activities to assess the presence or absence of soil impacts associated with the AOC. Nineteen delineation boreholes (HA-1 through HA-19) were advanced via hand auger within and surrounding the AOC. Delineation activities were driven by field screening soil for chloride utilizing QuanTab® test strips. One soil sample was collected from each delineation borehole, representing the highest observed field screening concentrations. Delineation soil samples were placed directly into pre-cleaned jars, packed with minimal void space, labeled, and placed on ice. The delineation soil samples were transported under strict chain-of-custody procedures, to Eurofins in Carlsbad, New Mexico, for analysis of the COCs. **Photographic Documentation** of all activities are attached.

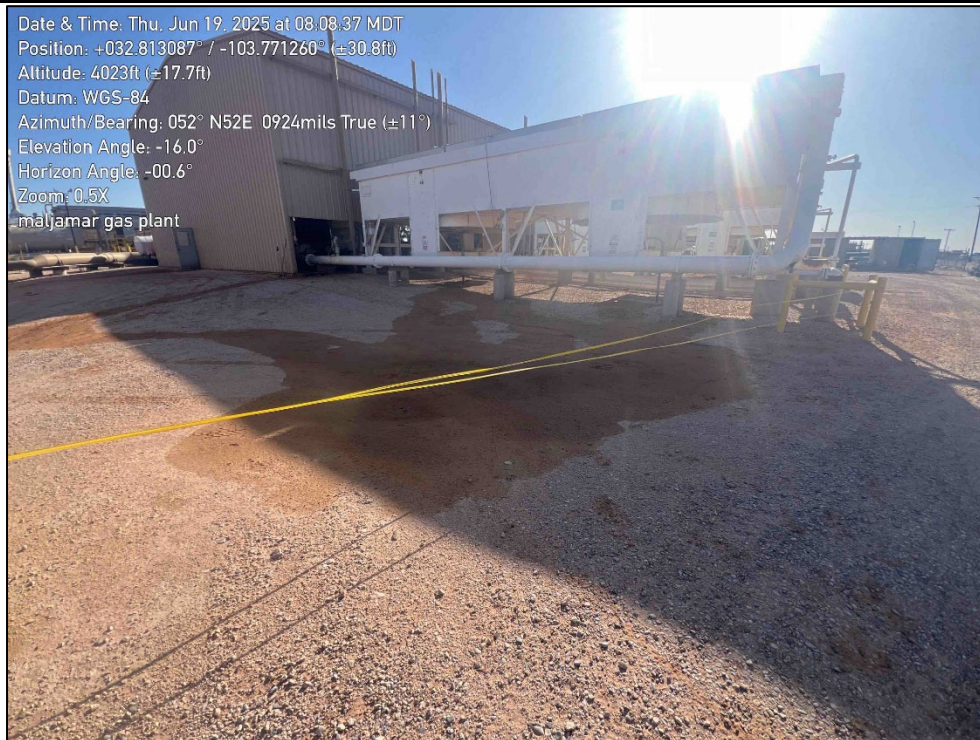
PHOTO 1: Northeastern view during initial site assessment. 6/19/2025

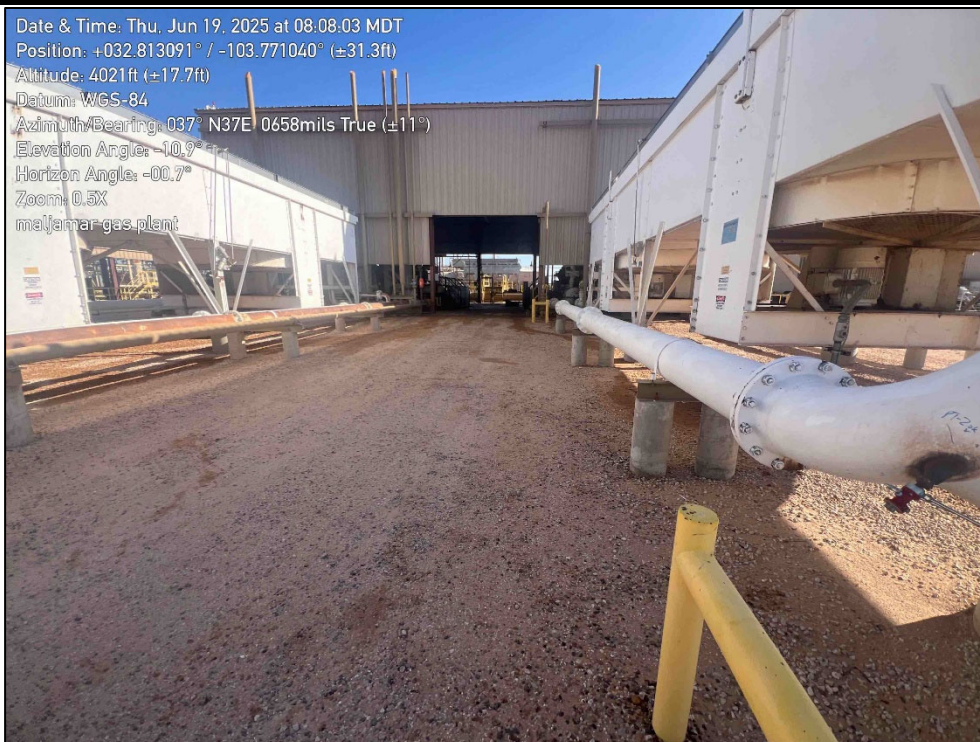
PHOTO 2: Northeastern view during initial site assessment. 6/19/2025

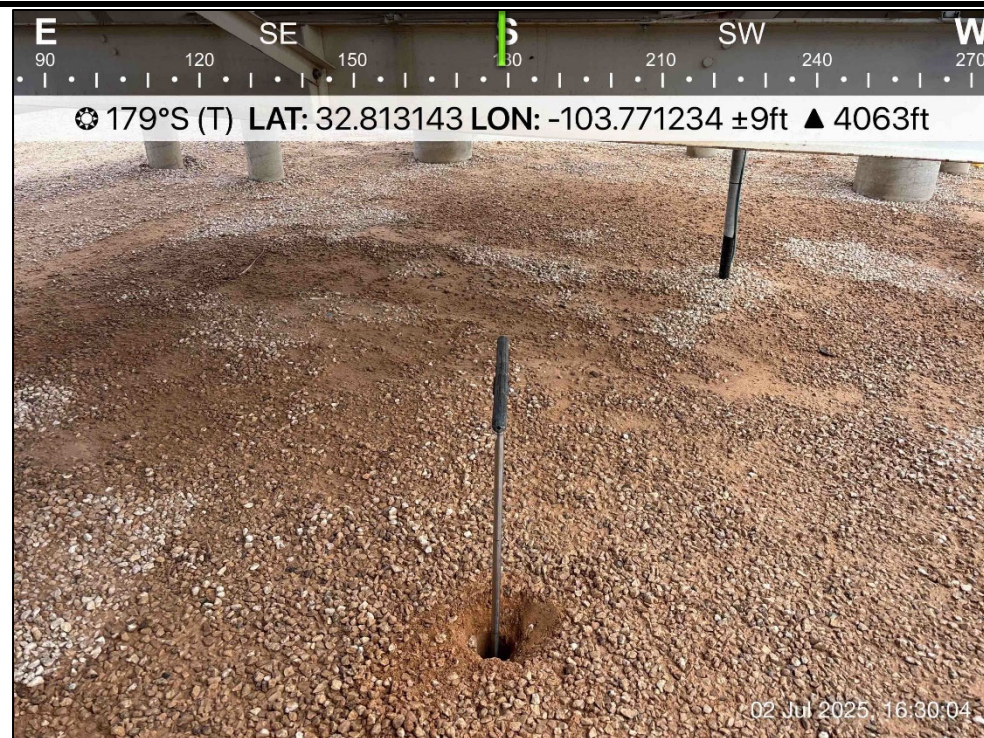
PHOTO 4: Southern view during delineation activities. 7/2/2025

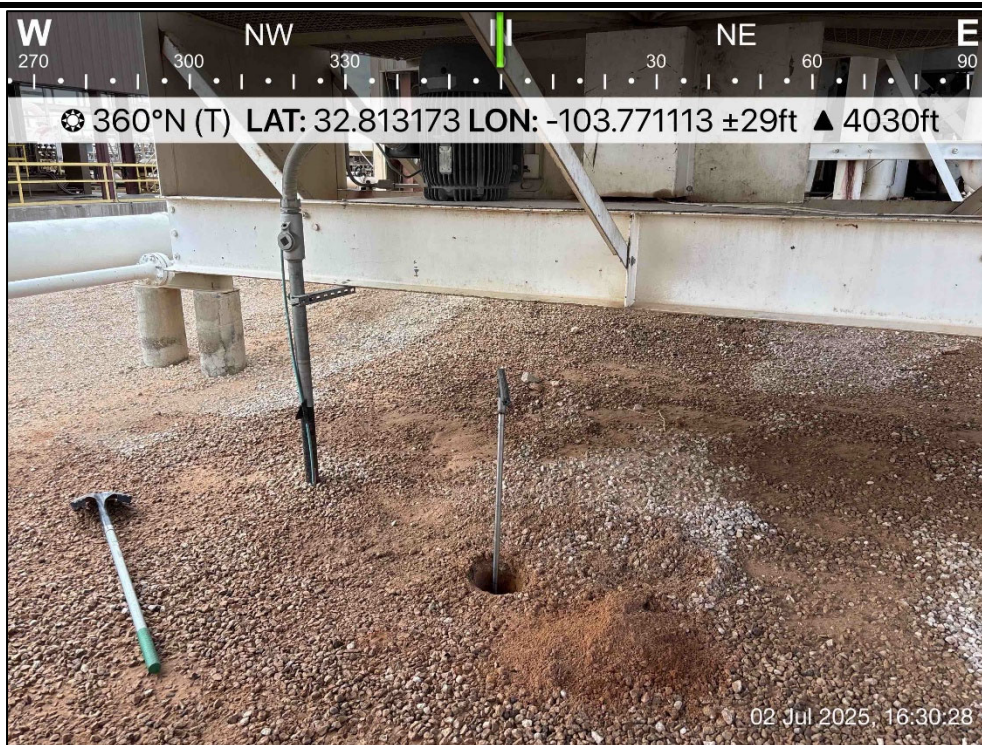
PHOTO 5: Northern view during delineation activities. 7/2/2025

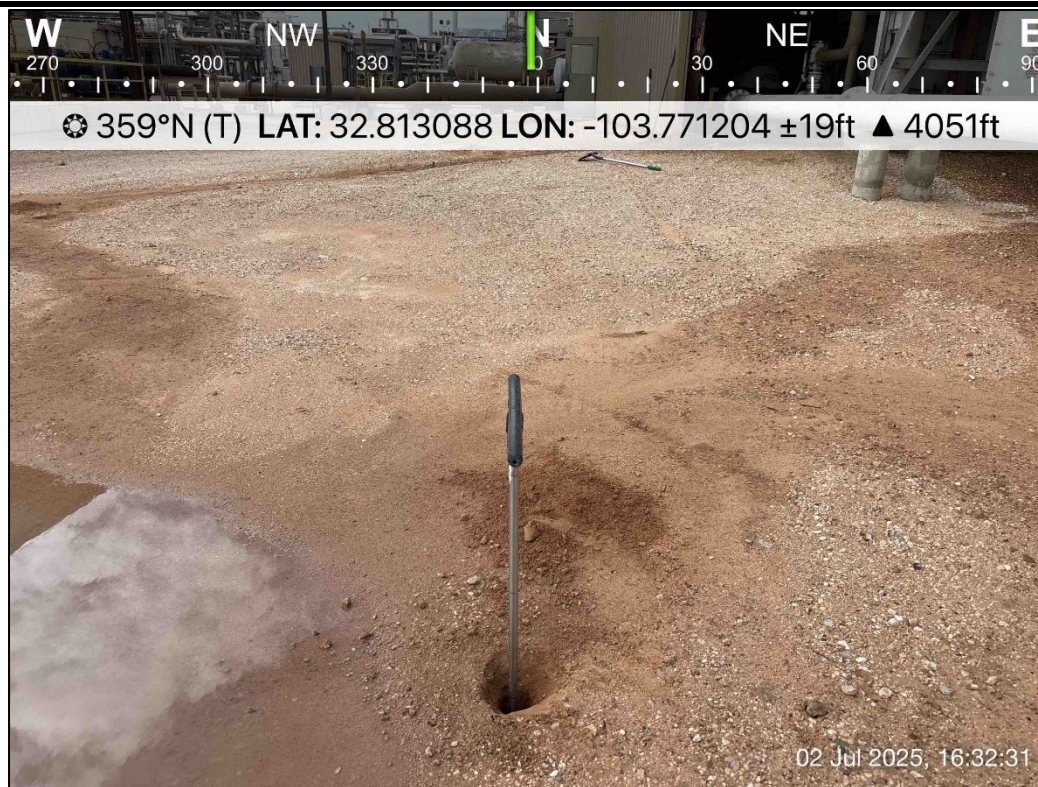
PHOTO 8: Northern view during delineation activities. 7/2/2025

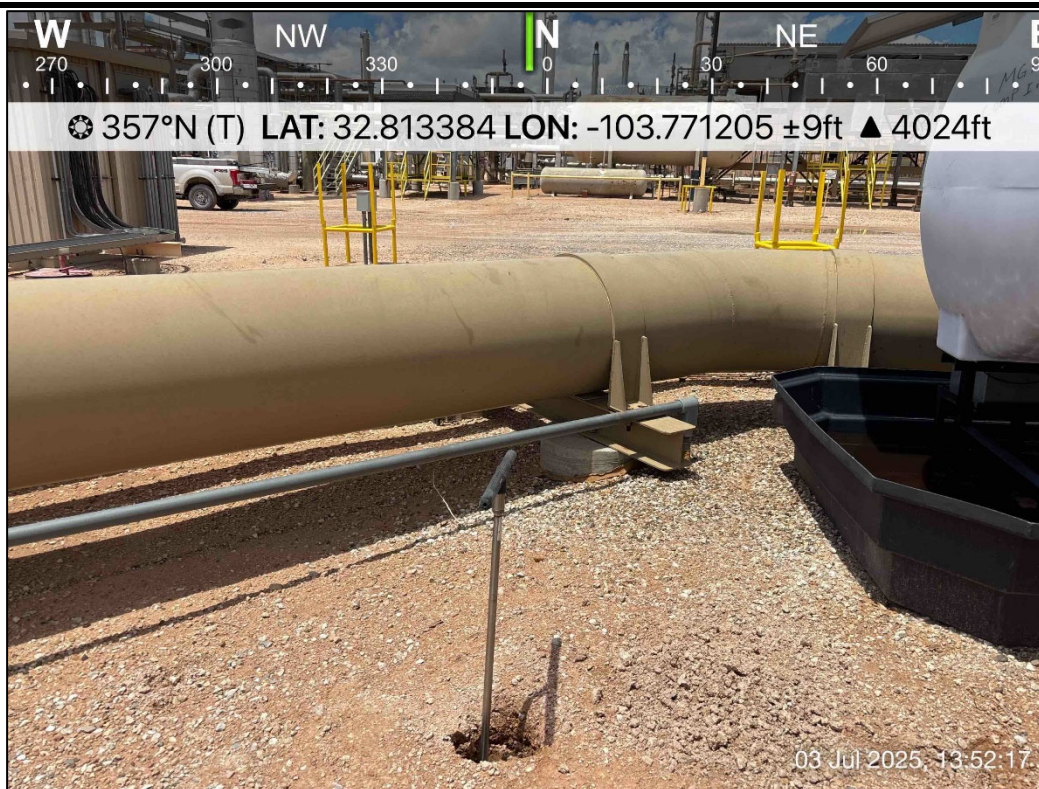
PHOTO 9: Northern view during delineation activities. 7/3/2025

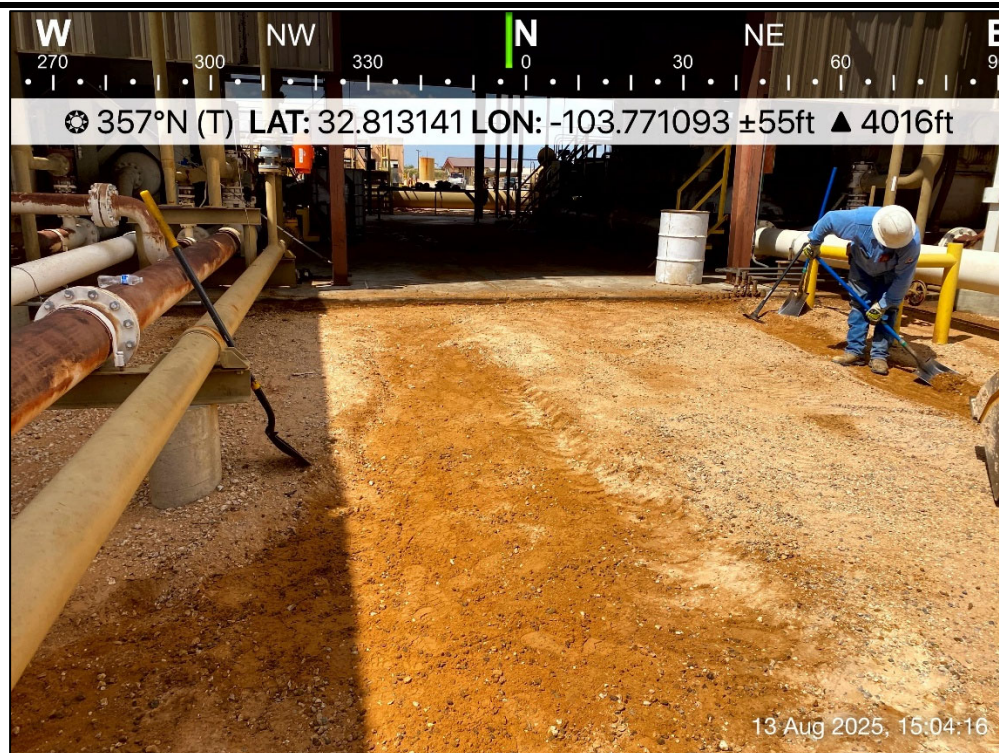
PHOTO 11: Northern view during excavation activities. 8/13/2025

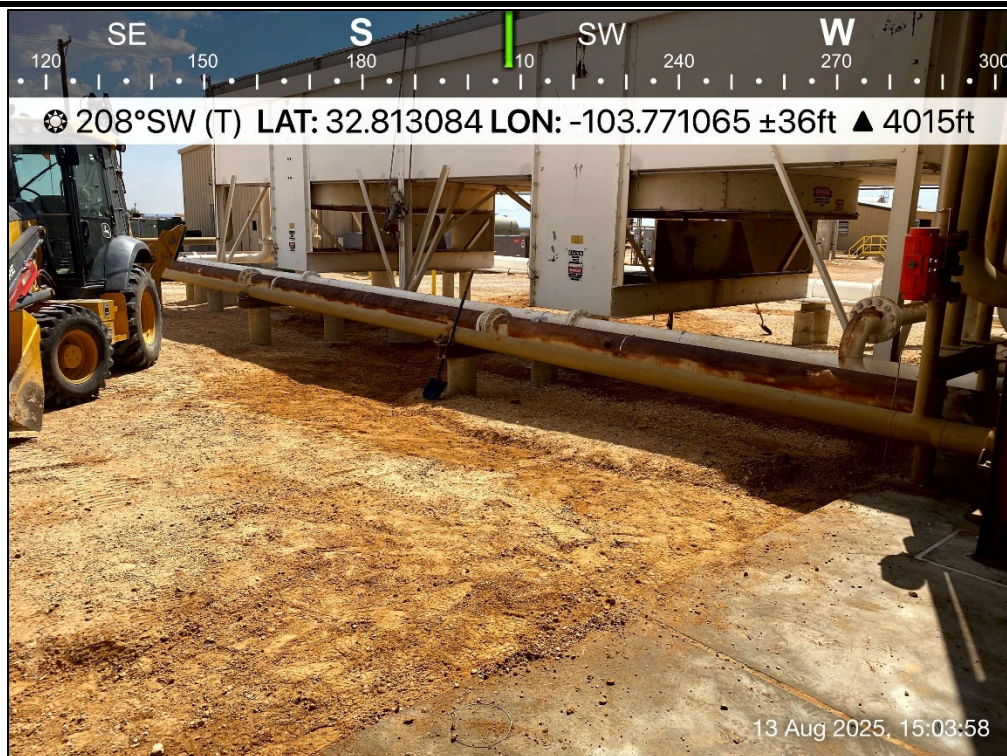
PHOTO 12: Southwestern view during excavation activities. 8/13/2025

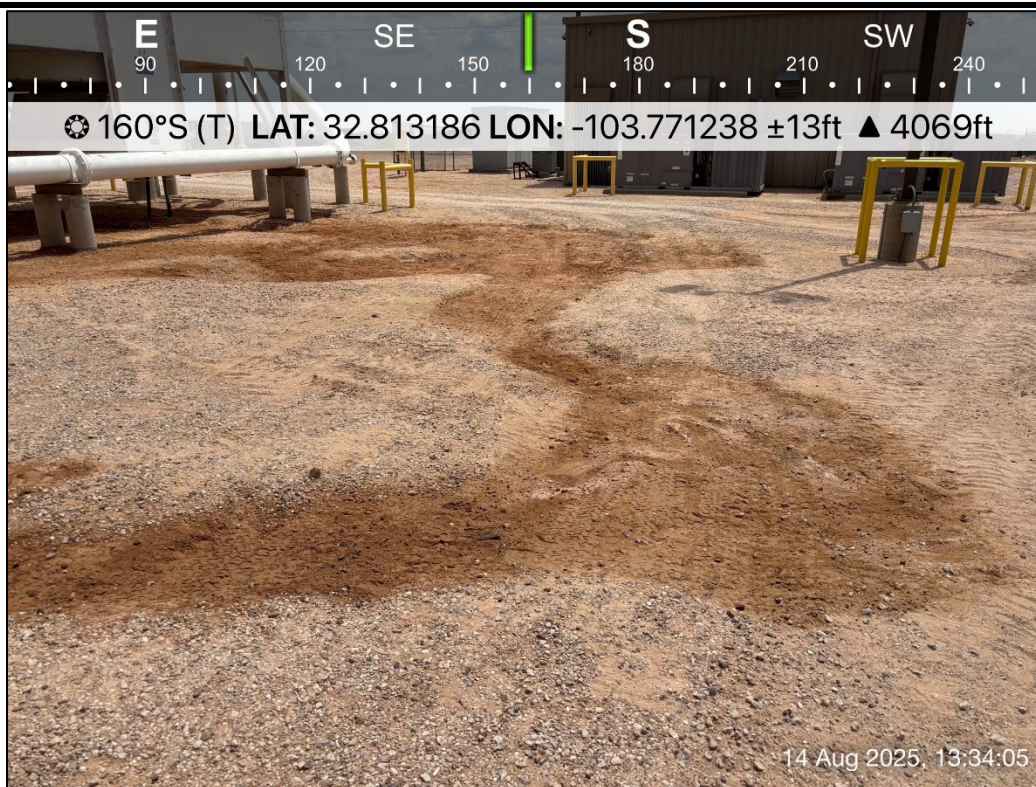
PHOTO 13: Southeastern view of excavation extent. 8/14/2025

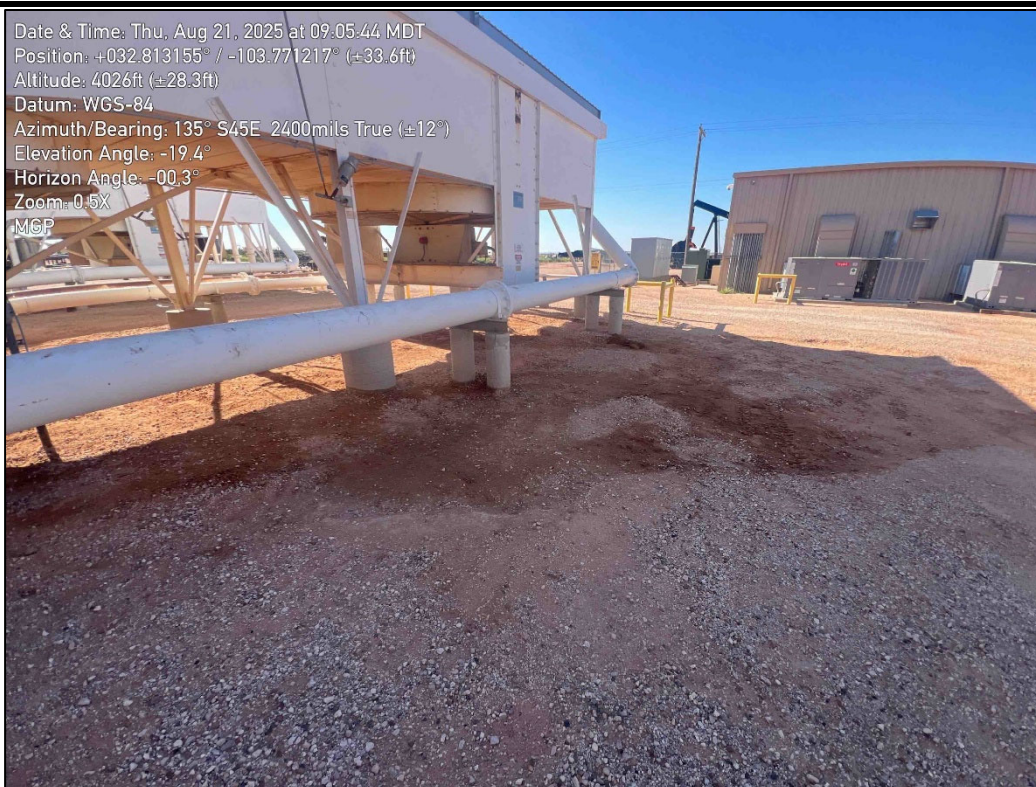
PHOTO 14: Southeastern view of excavation extent. 8/21/2025

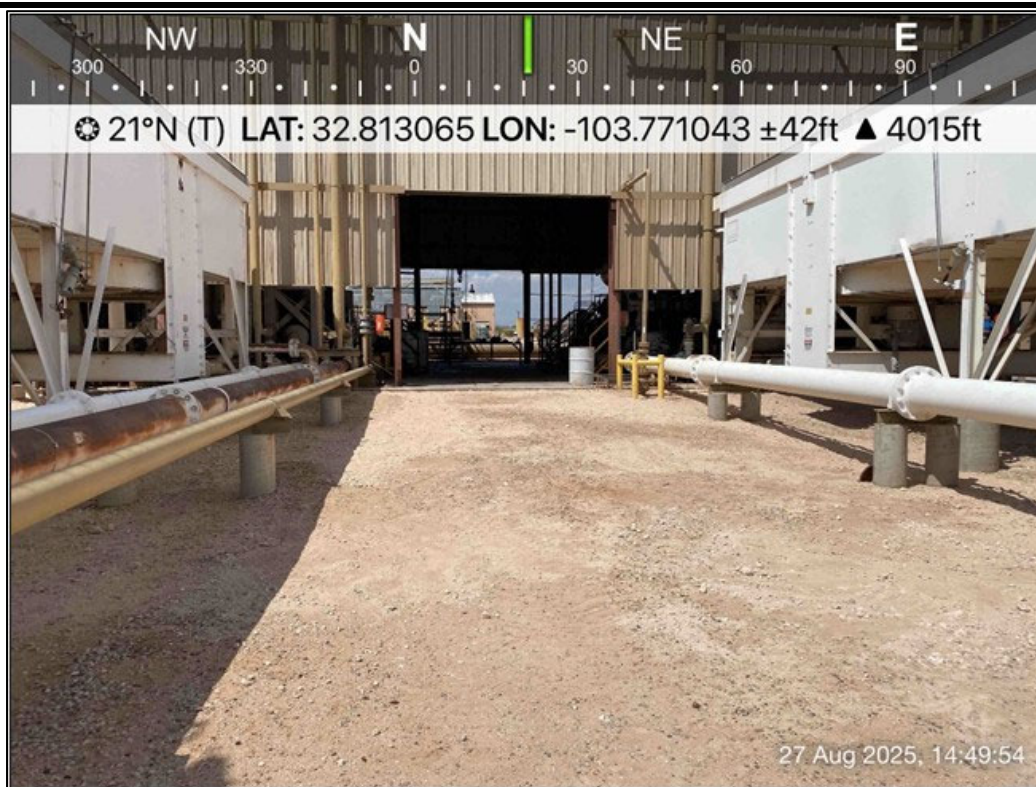
PHOTO 15: Northeastern view following restoration activities. 8/27/2025
