Re: Site Assessment, Remediation, and Closure Request
Pronghorn SWD #1
API No. 30-025-32735
GPS: Latitude 32.6521 Longitude -103.71645
UL "B", Sec. 24, T19S, R32E
Lea County, NM
NMOCD Ref. No. nAPP2418556332

Paragon Environmental, LLC (Paragon) has been contracted by Spur Energy Partners (Spur) to perform a spill assessment and conduct remediation activities for the release site known as the Pronghorn SWD #1 (Pronghorn). Details of the release are summarized below:

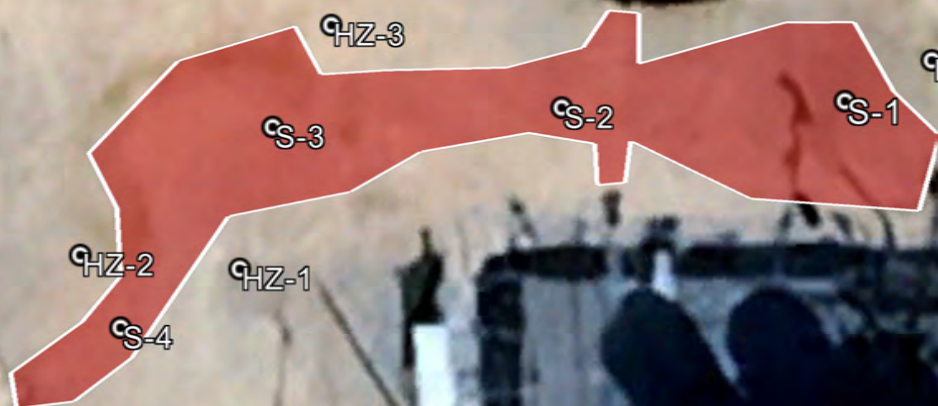
- Feature 1
- Pronghorn SWD #1 32.6521051,-103.7164501
- Spill Area - 3300 sq.ft.

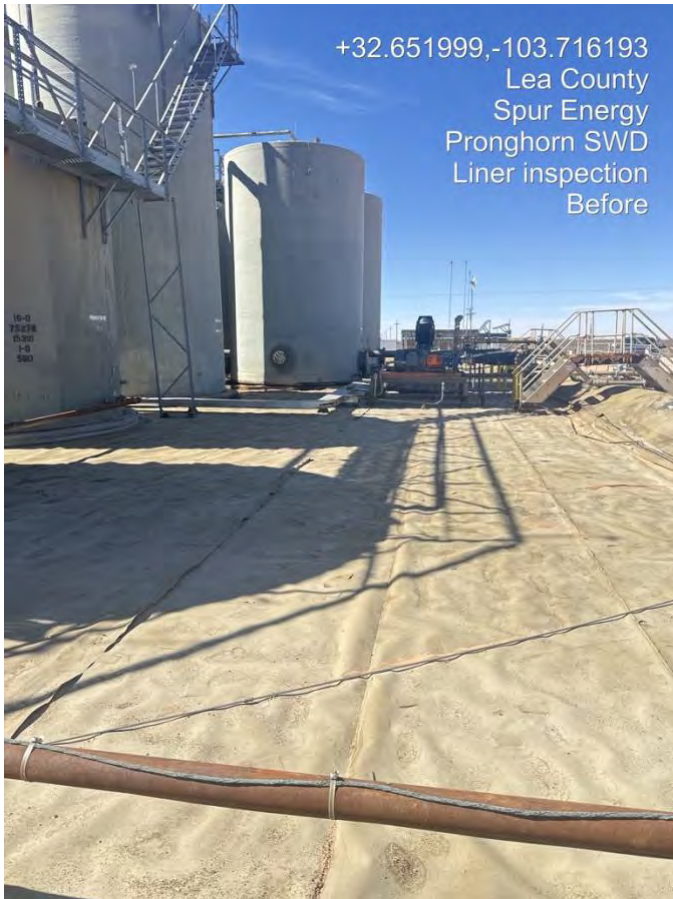
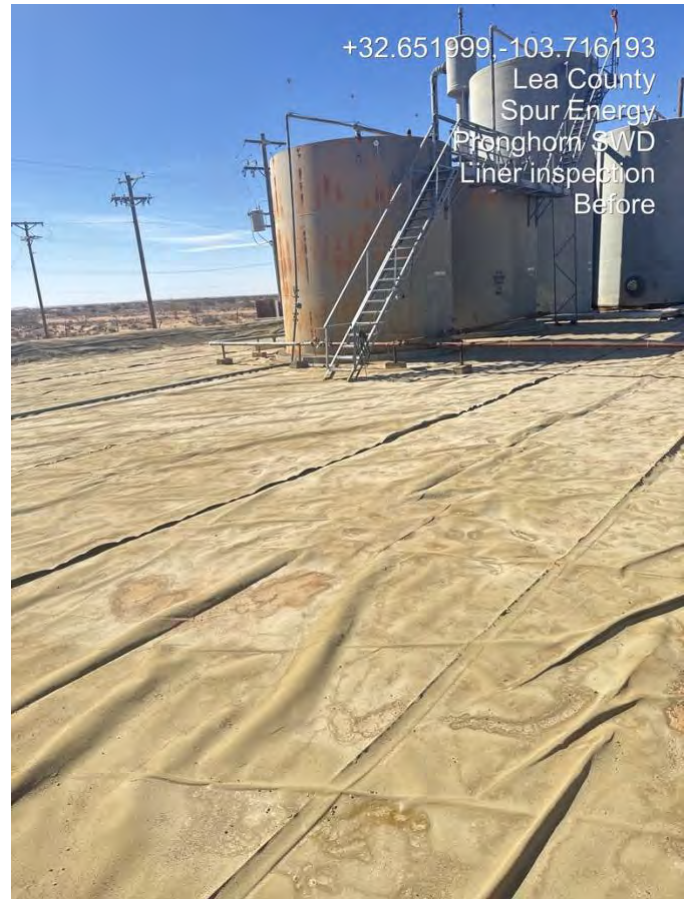
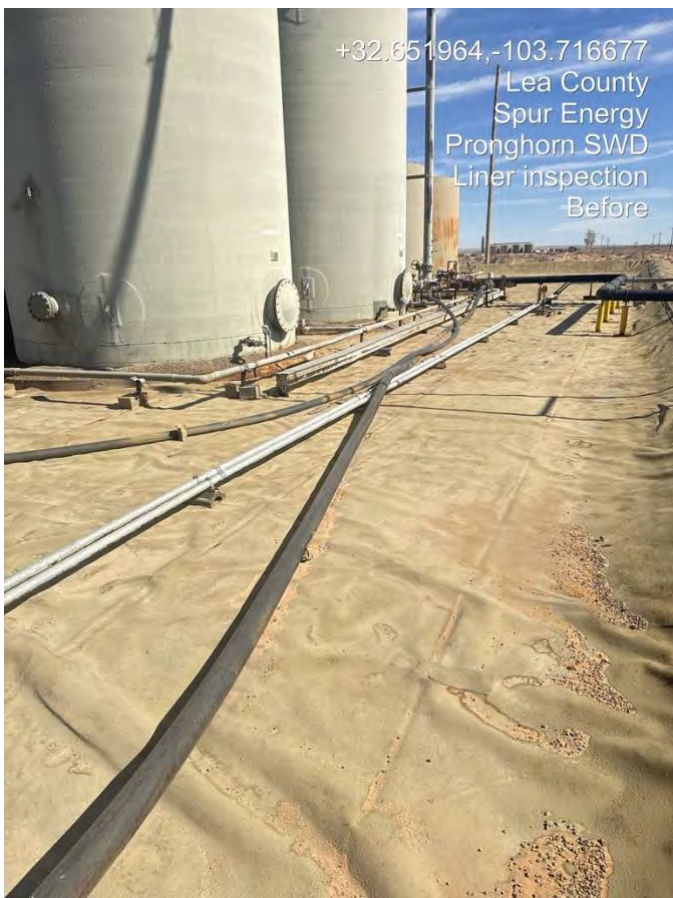
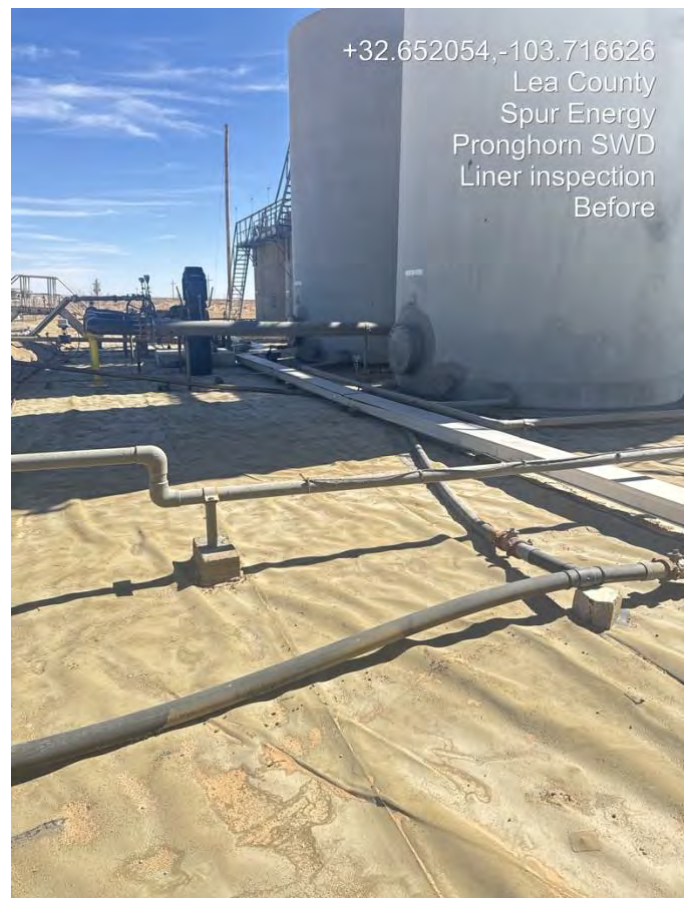
Liner Inspection

Visualization	Yes	No	Comments
Is there a tear in the liner?		x	
Are there holes in the liner?		x	
Is the liner retaining any fluids?		x	
Does the liner have integrity to contain a leak?	x
