**Re: Closure Report
BTA Oil Producers, LLC
Harroun Ranch East Tank Battery Release
Unit O, Section 20, Township 23 South, Range 29 East
Eddy County, New Mexico
Incident ID nAPP2202845563**

nAPP2202845563 Closure Report
Harroun Ranch East Tank Battery Release

BTA Oil Producers, LLC
October 6, 2025

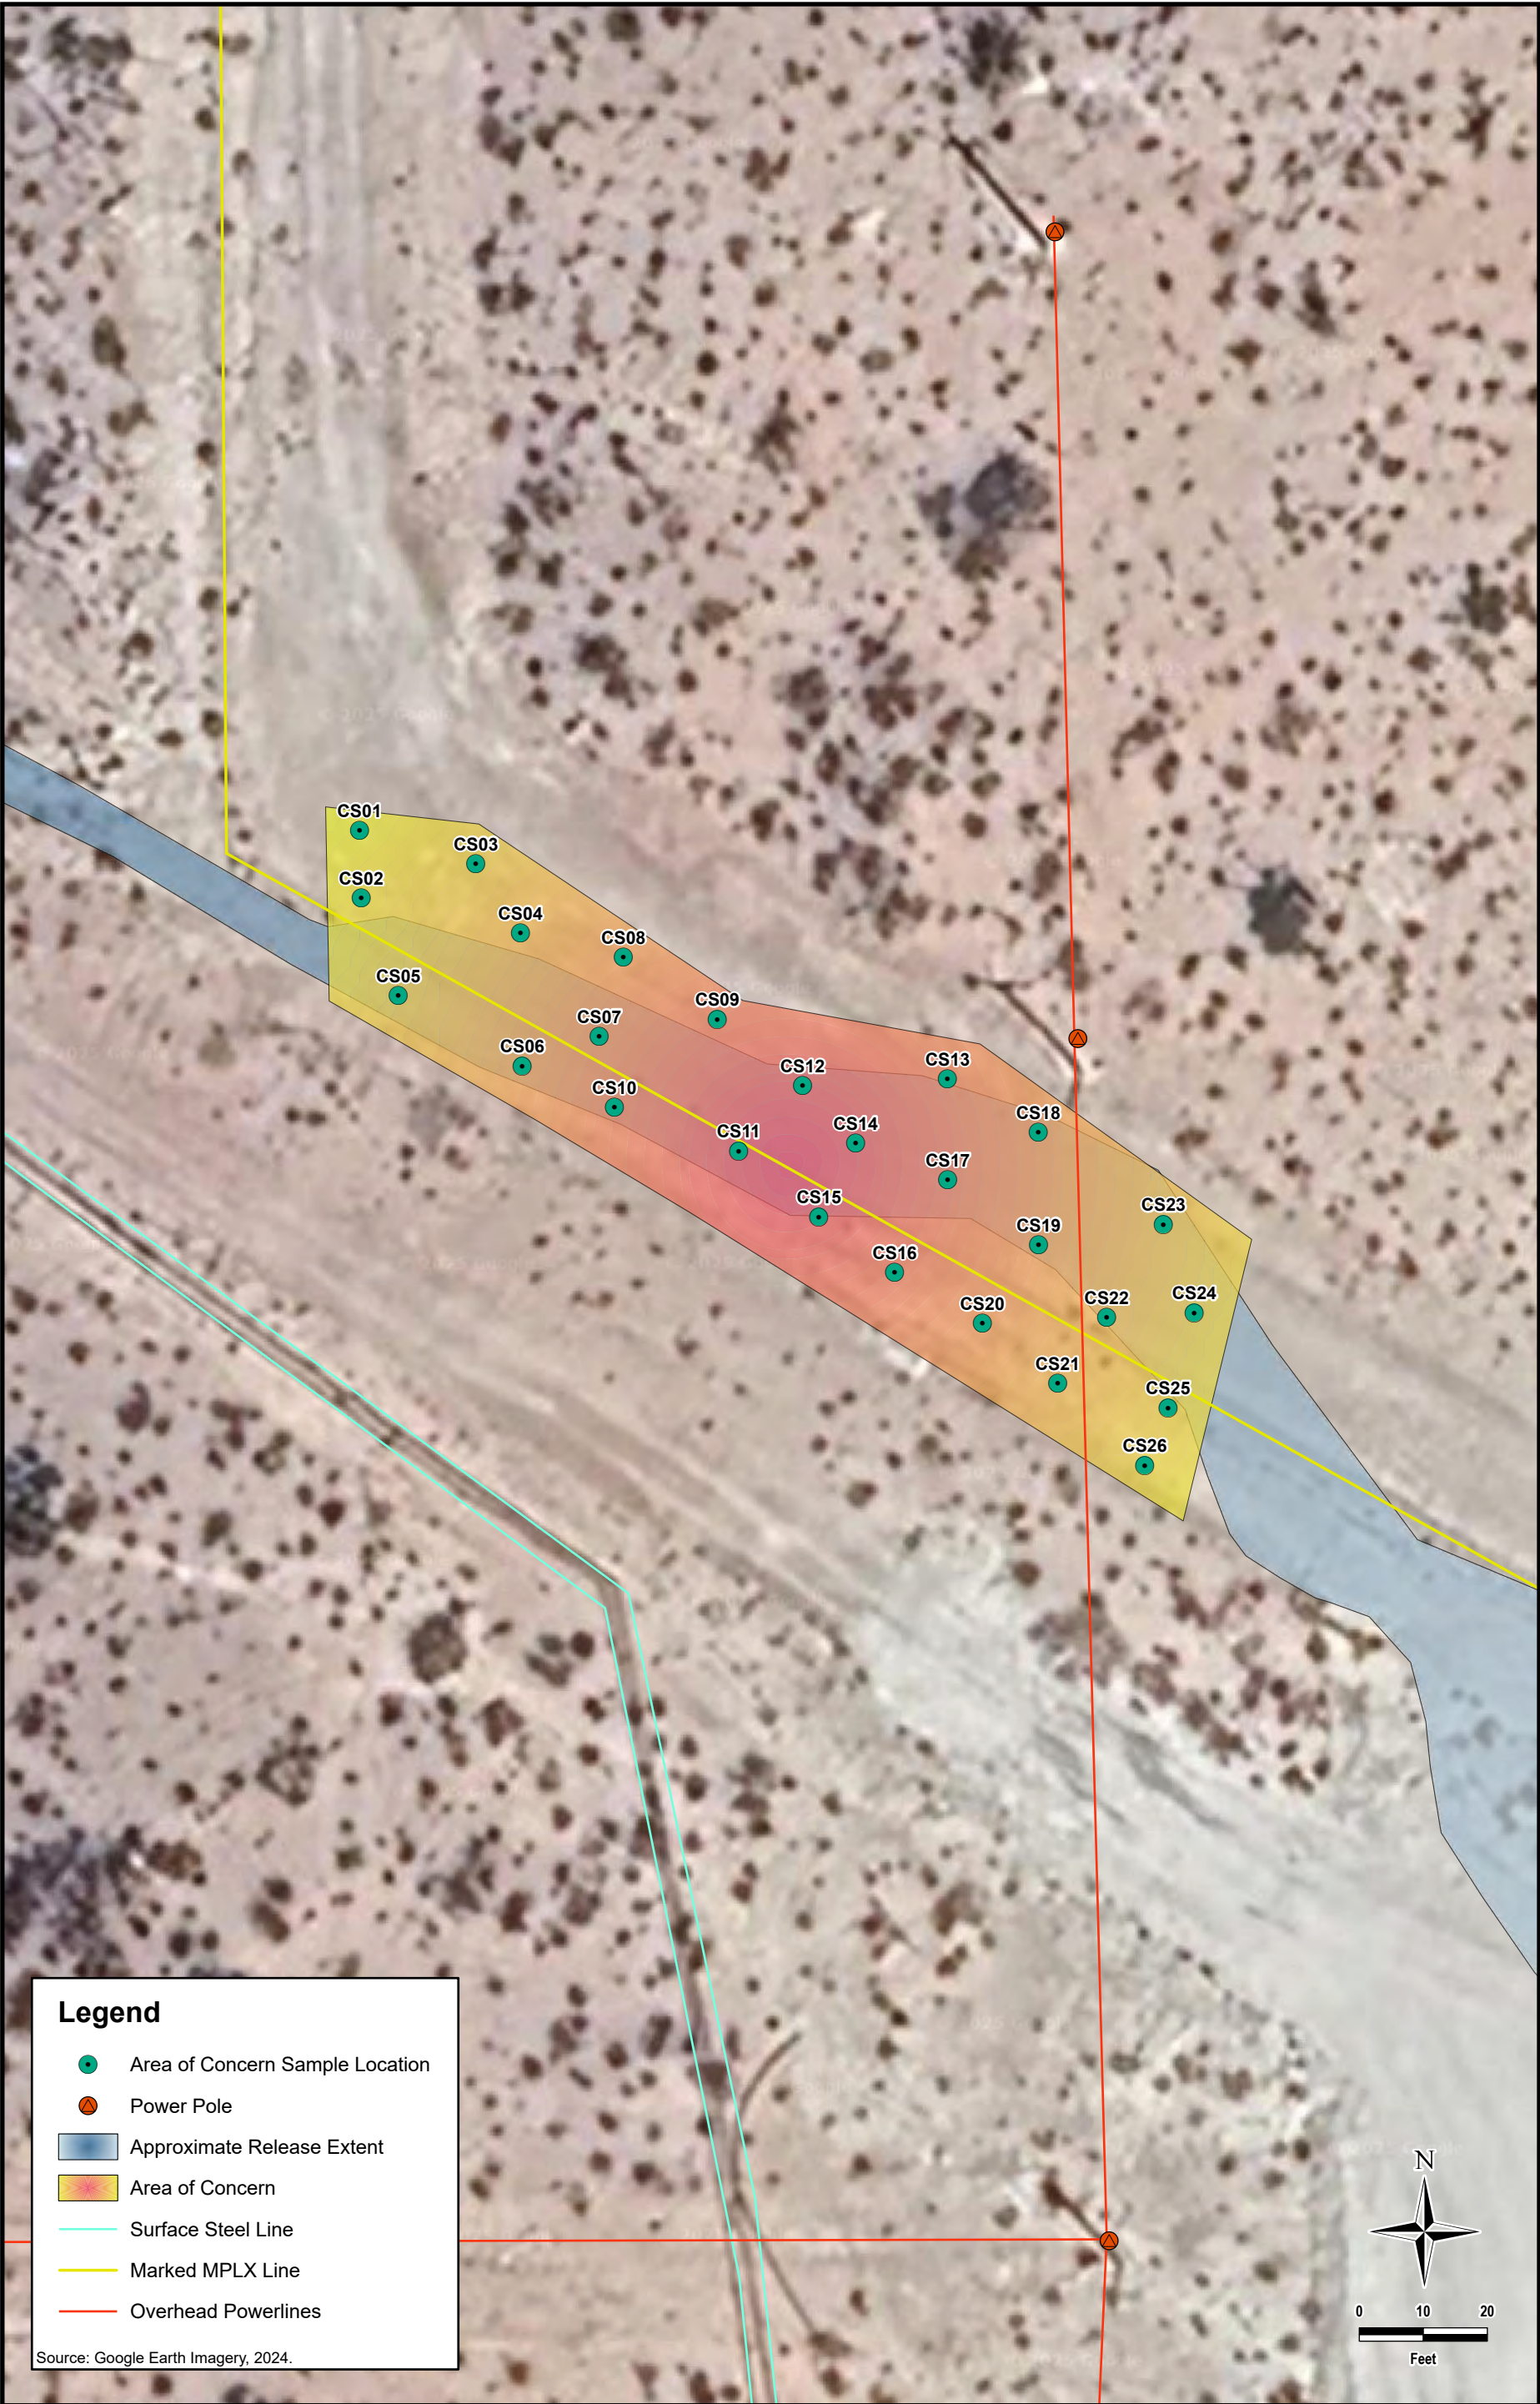
TETRA TECH www.tetrattech.com 901 West Wall Street, Suite 100 Midland, Texas 79701 Phone: (432) 682-4559 Fax: (432) 682-3946	BTA OIL PRODUCERS, LLC		PROJECT NO.: 212C-MD-03775
	NAPP2202845563 (32.284090°, -104.002948°) EDDY COUNTY, NEW MEXICO		DATE: SEPTEMBER 17, 2025
	HARROUN RANCH EAST TANK BATTERY REMEDIATION EXTENT AND CONFIRMATION SAMPLING (ENSOLUM)		DESIGNED BY: LMV
			Figure No. 4A

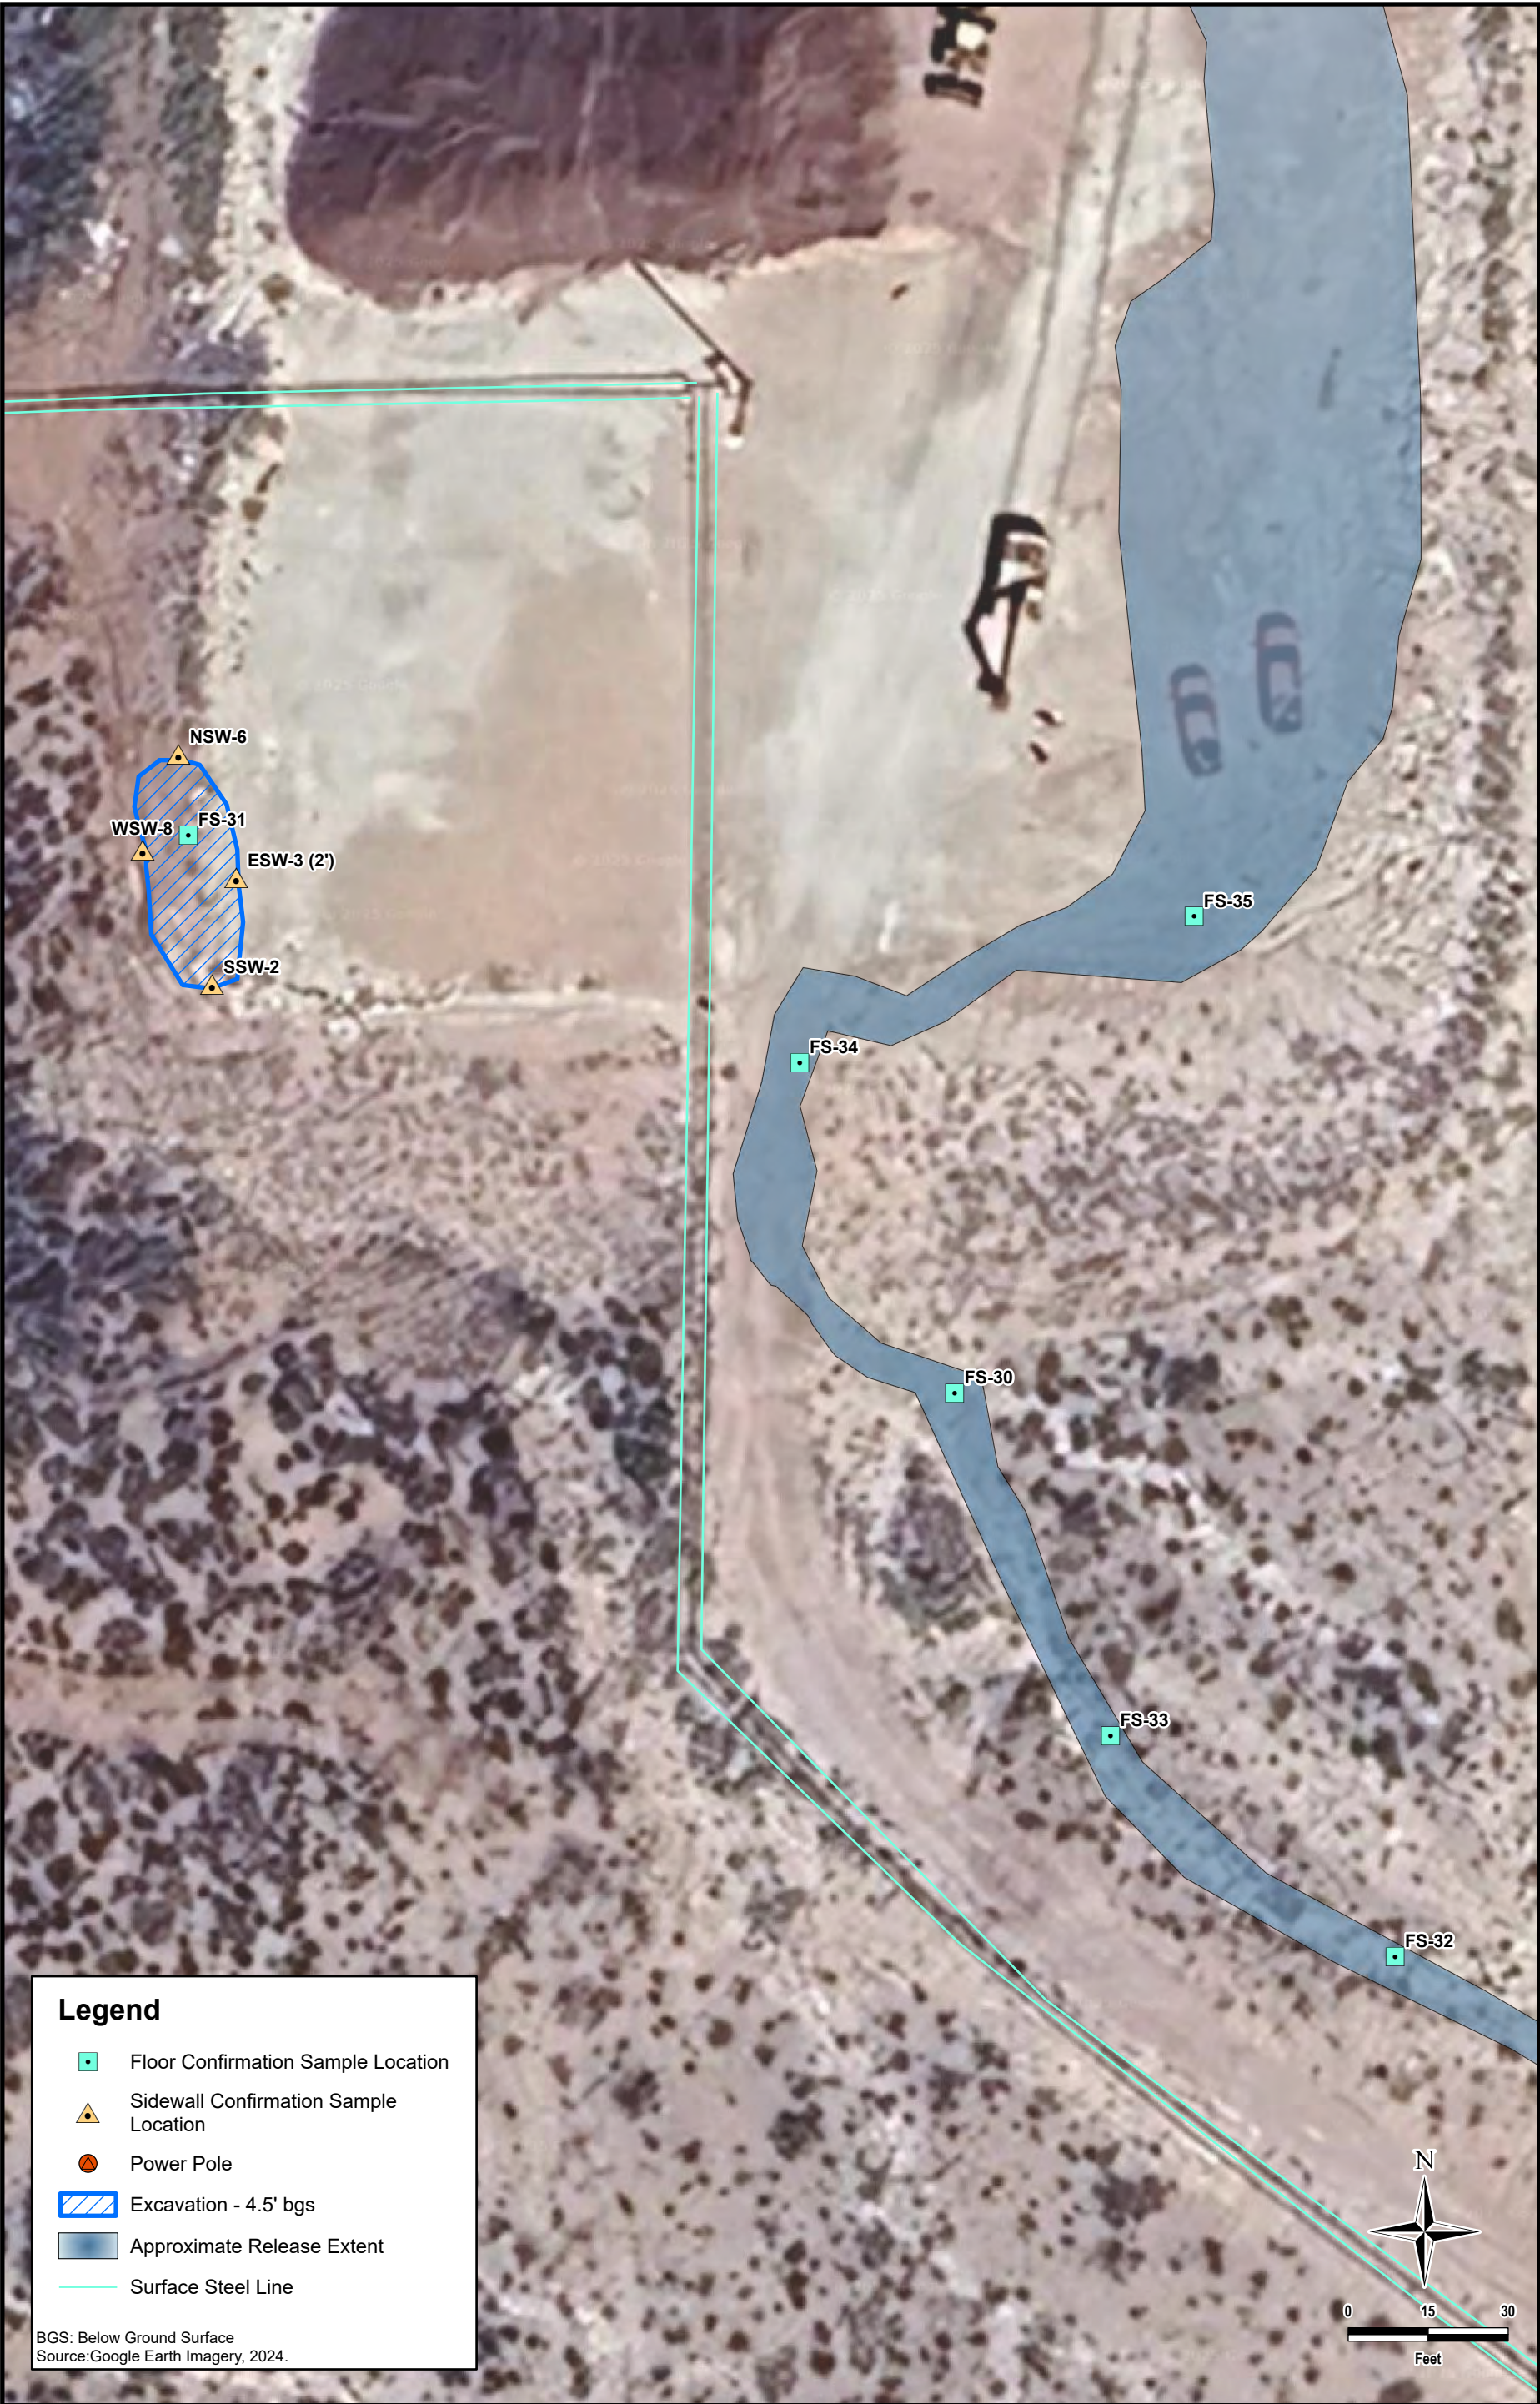
Floor Confirmation Sample Location

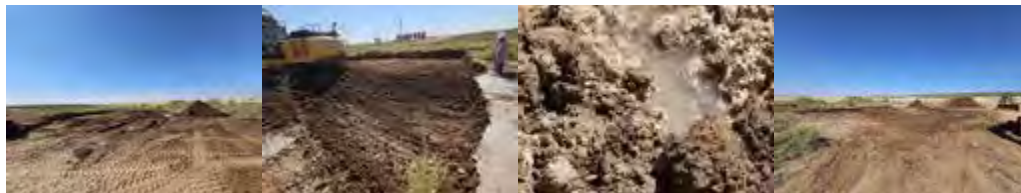
8.12.24 Day 1: Began excavation in the lower area of site found water table at 3.5'.

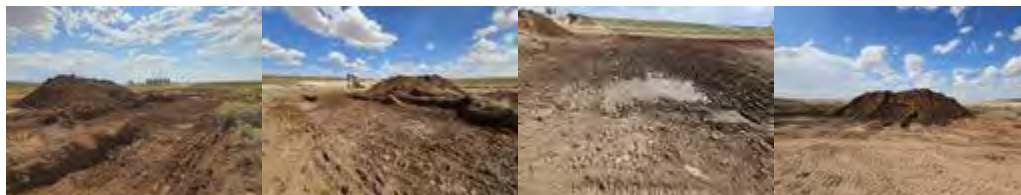
8.13.24 Day 2: Continued Excavating on the lower end of site and stockpiling Material on Plastic. Approx. 405 Yards of Material stockpiled ready to Haul out.

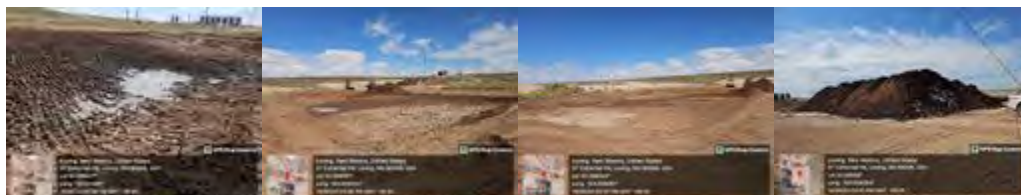
8.14.24 Day 3: Continued to excavate in the lower portion of site. Began hauling out Material to R-360 Halfway Facility 2 Mad 5 Trucks 8 Loads = 160 Cu. Yards. We have approx. 450 cu yards to haul out.

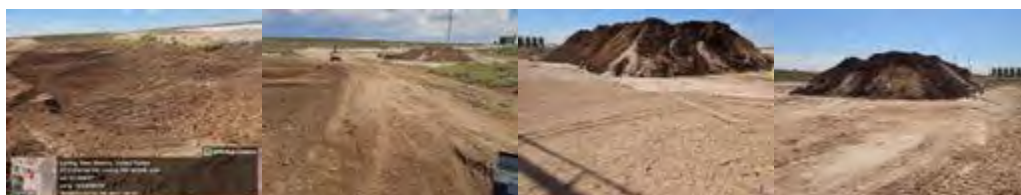
8.15.24 Day 4: Continued hauling out Material to R-360 Halfway Facility with 6 - 2 Mad 5 Trucks 16 Loads out = 320 Cu. Yards. Dug test pit in SS14 area down to 4'. Field screen came back clean and determined the SS14 area needs to go down 2'. Covered test pit. Current Excavation is Approx. 190' x65'x3.5'. We have approx. 1718 cu. Yards of impacted material stockpiled on site.

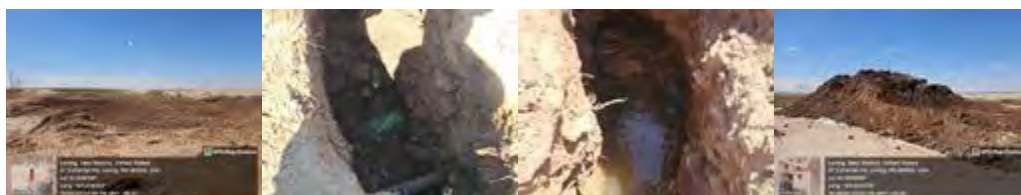
8.16.24 Day 5: Hydro vac showed up and began spotting lines, he did 4 holes at 5' deep and 4' wide Found lines at 5' and 4' but the holes fill with about 1' of water and collapse due to water table. Hydrovac only did one load.

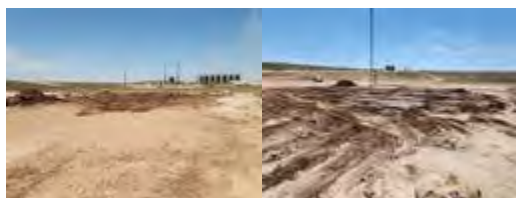
8.19.24 Day 7: Moved Material to Pad with loader.

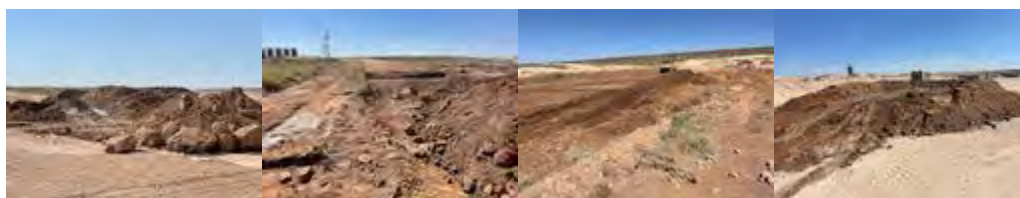
8.20.24 Day 8: Resumed Hydrovac operations, completed Hydrovac operations by end of day we will not need the Hydrovac back. We also continued excavations around lines until 1530 when the MPLX rep. left the site.

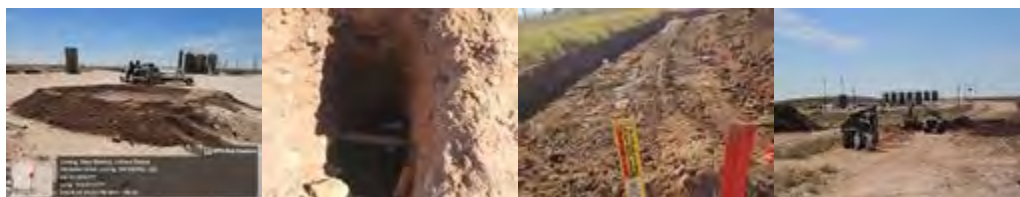
8.21.24 Day 9: Began excavating above the line and road and stopped close to the intersection for now so it can still be used for the haul out. We'll remove it when we are done hauling out on the bottom. Will make a new pile for the pad on the pad above by hydro vac containment.

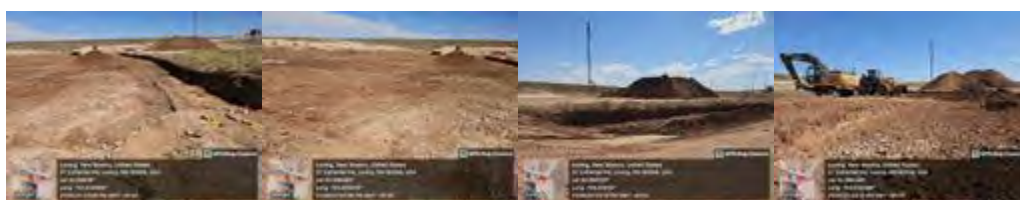
8.22.24 Day 10: We then continued the excavation up to the road. We stopped as we finished the segment in the fence line then began building a fence for the excavation on the pad.

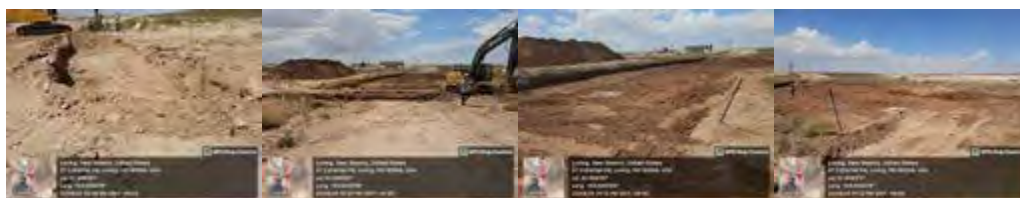
8.23.24 Day 11: Began excavating on the pad 2' and made a new stockpile. We then used material from the topsoil stockpile to fill up the hydrovac containment so it can be hauled out.

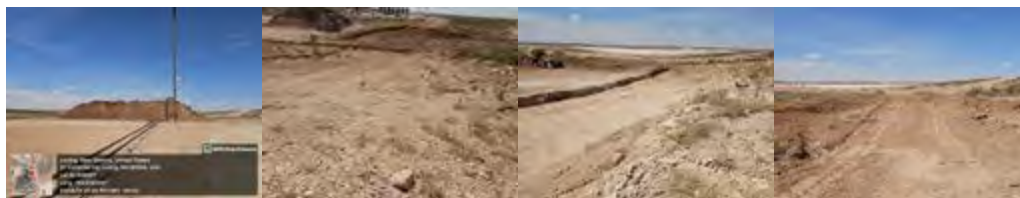
8.24.24 Day 12: We had 13 Trucks today hauled out 36 Loads= 720 cu. Yards

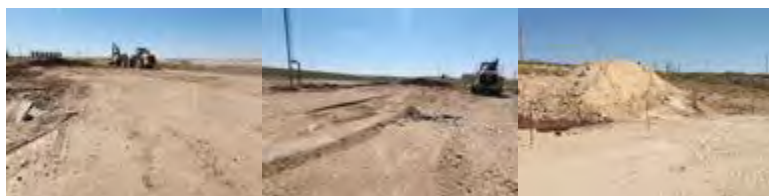
8.26.24 Day 14: We excavated the rest of the road connecting both excavations as well we sloped one excavation wall on the pad. We also started moving material to the pad up top to begin hauling out. We finished up excavating.

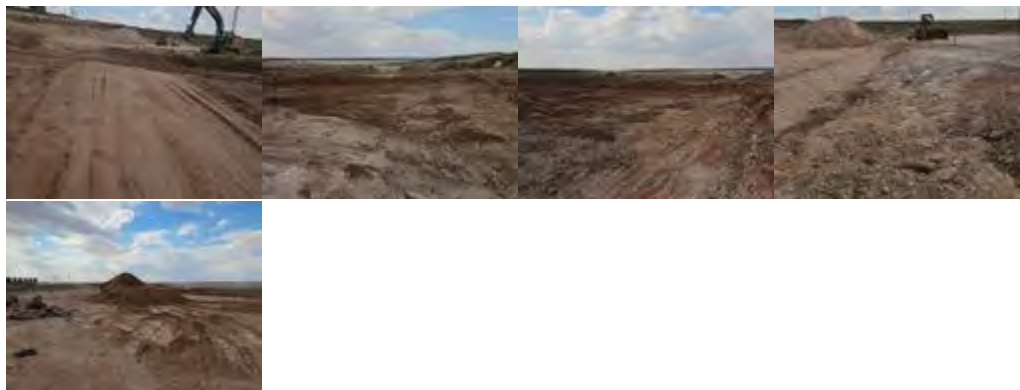
8.27.24 Day 15: We hauled out 572 yards of topsoil today. We still have a stockpile of topsoil that's about 27x40x15 and we have not touched the caliche pile yet. The caliche pile is about 40x40x15.

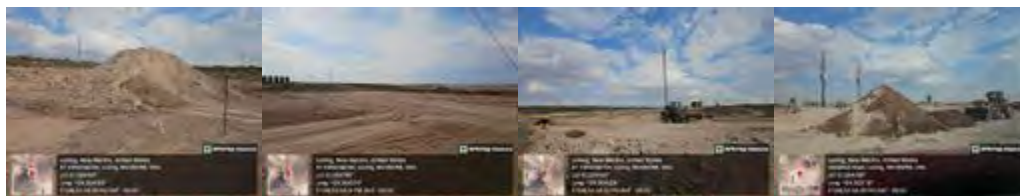
8.28.24 Day 16: There is Approx. 550 Cu. Yards left at the bottom, but we can't safely haul that out until we backfill the roadway.

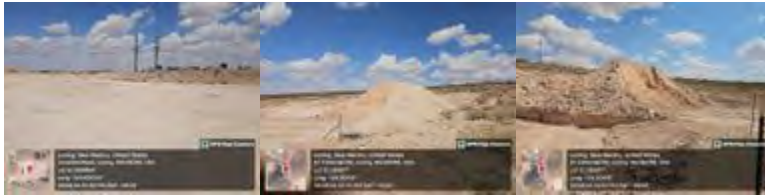
BTA Reps on site to observe severe leaching and salts:

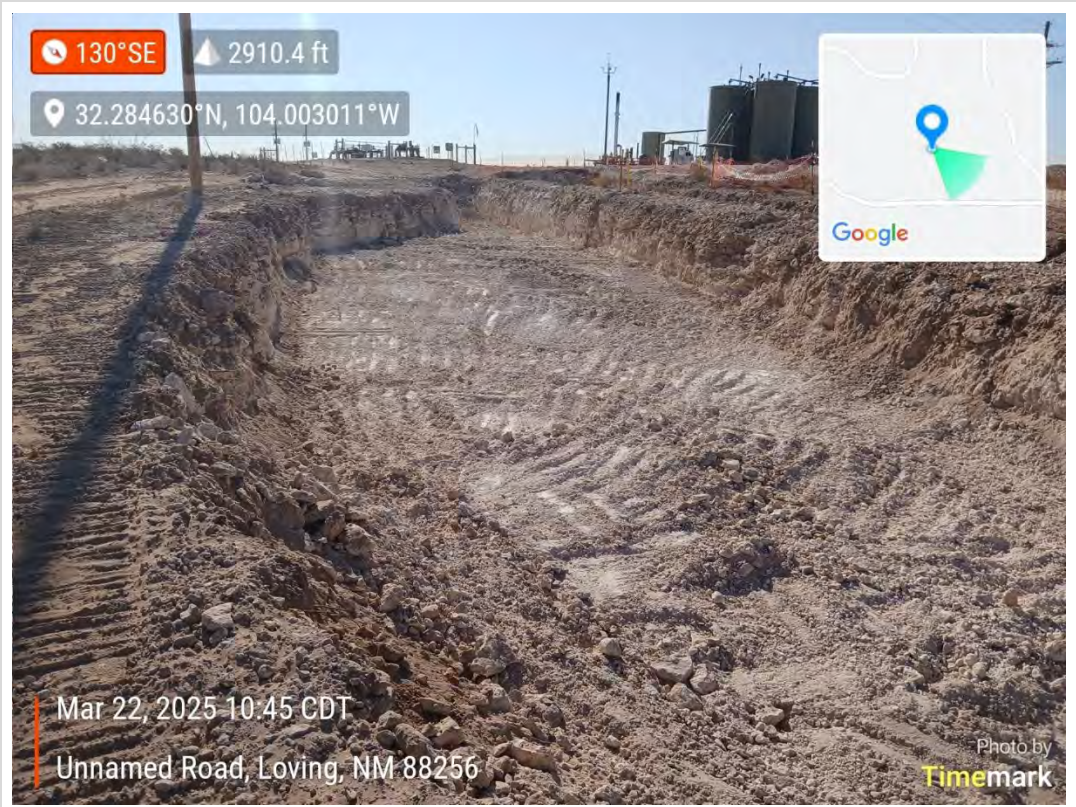
TETRA TECH, INC. PROJECT NO. 212C-MD-03775	DESCRIPTION	View southeast of 2025 excavation progress.	6
	SITE NAME	Harroun Ranch East Tank Battery Release	3/22/2025

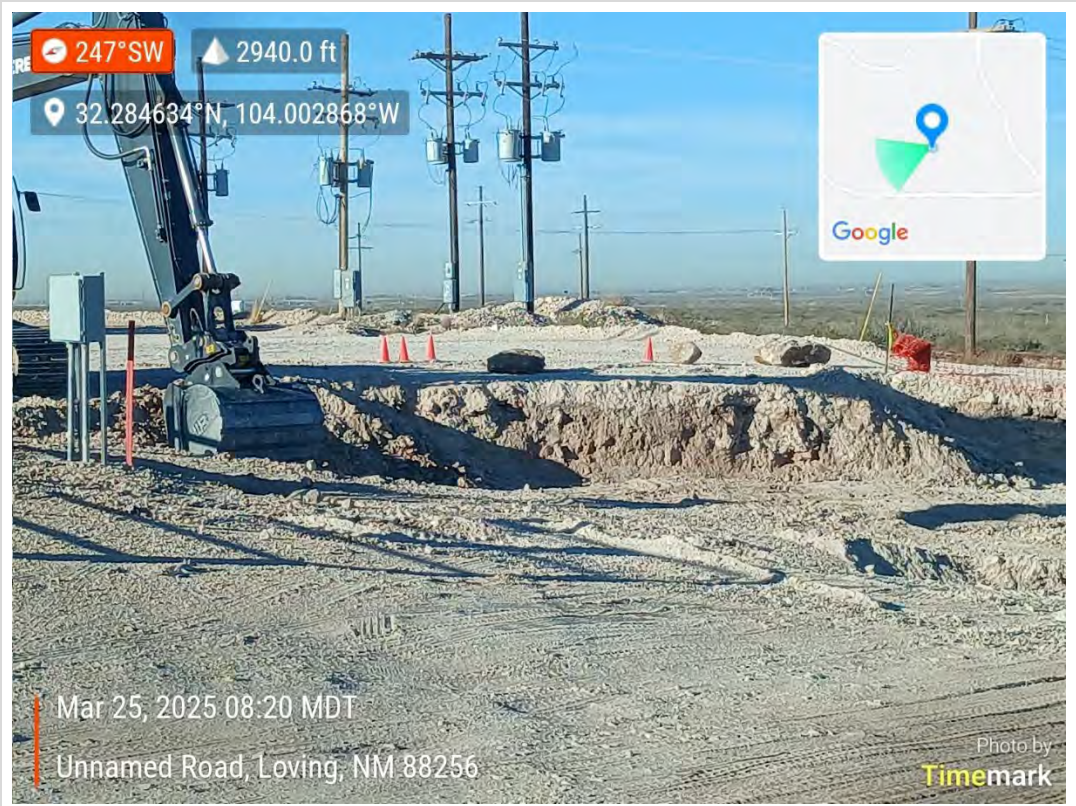
TETRA TECH, INC. PROJECT NO. 212C-MD-03775	DESCRIPTION	View southwest of 2025 excavation progress.	7
	SITE NAME	Harroun Ranch East Tank Battery Release	3/25/2025

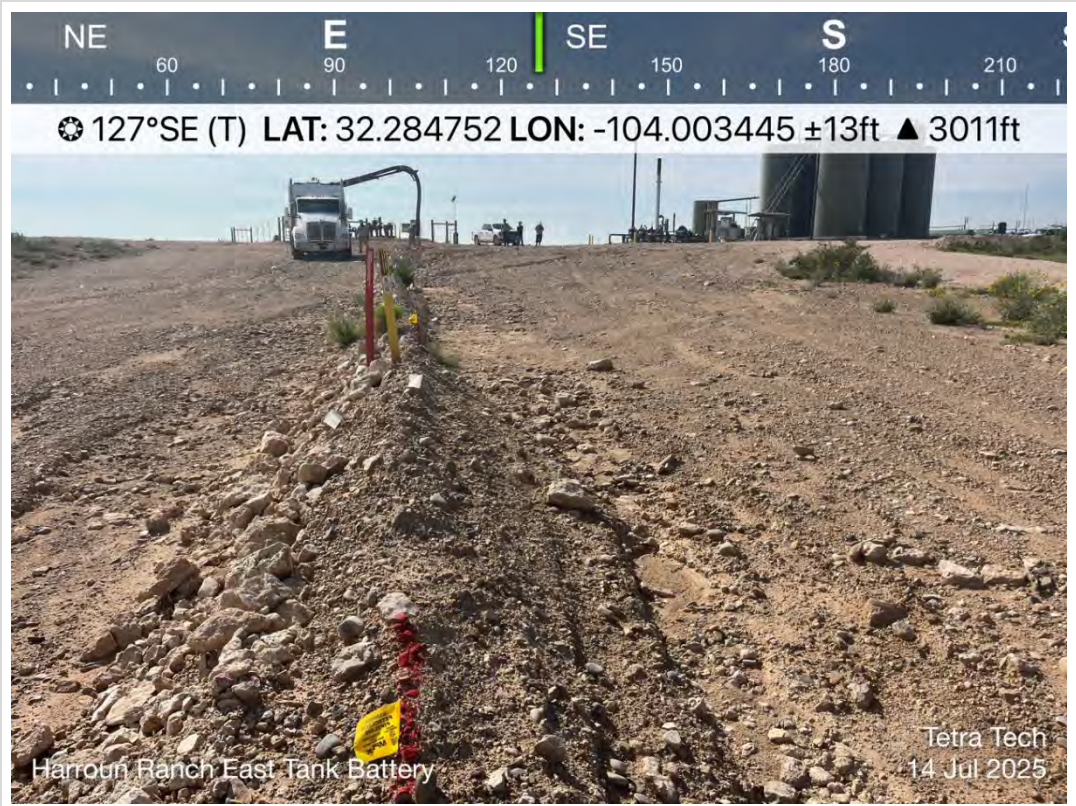
TETRA TECH, INC. PROJECT NO. 212C-MD-03775	DESCRIPTION	View southeast of hydroexcavation progress.	13
	SITE NAME	Harroun Ranch East Tank Battery Release	7/14/2025

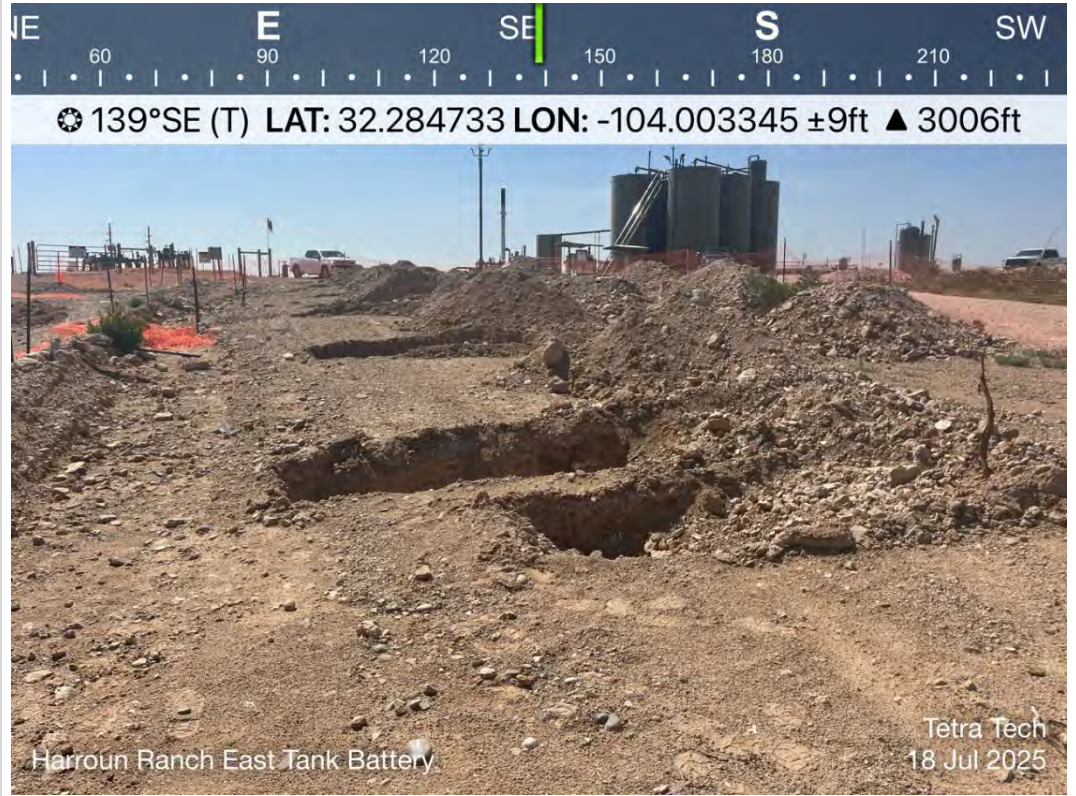
TETRA TECH, INC. PROJECT NO. 212C-MD-03775	DESCRIPTION	View southeast of trenching activities in previously backfilled excavation.	14
	SITE NAME	Harroun Ranch East Tank Battery Release	7/14/2025

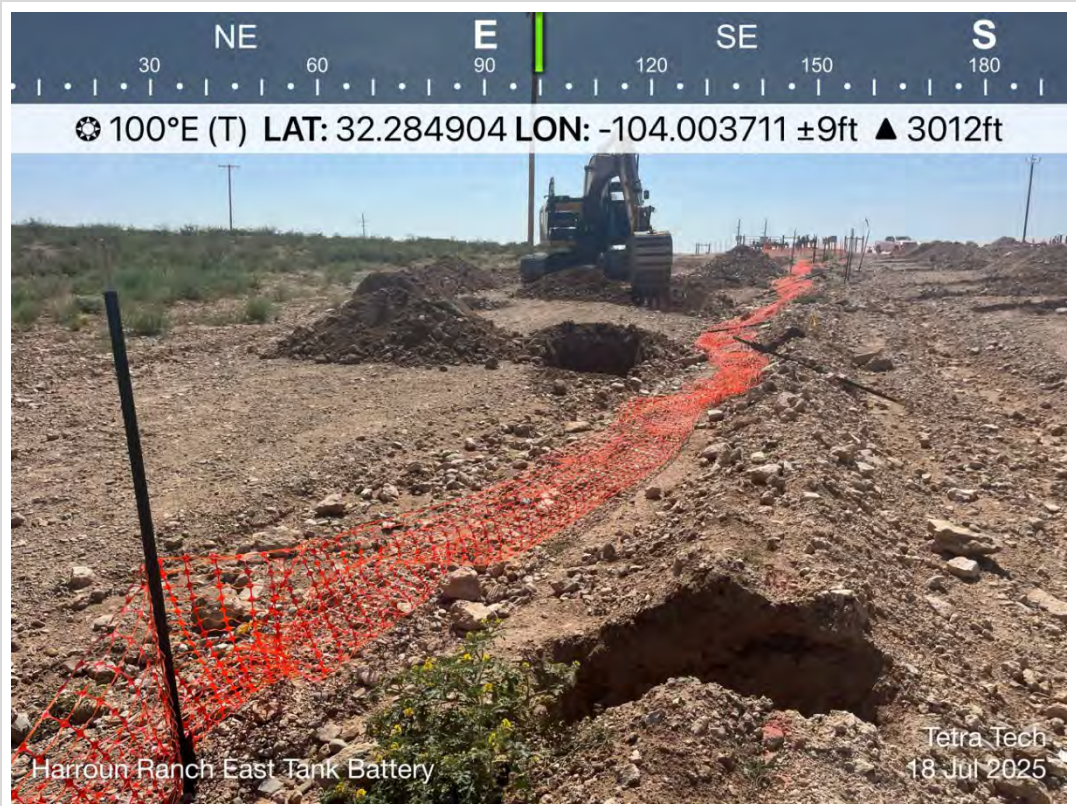
TETRA TECH, INC. PROJECT NO. 212C-MD-03775	DESCRIPTION	View east of trenching activities in previously backfilled excavation.	15
	SITE NAME	Harroun Ranch East Tank Battery Release	7/18/2025

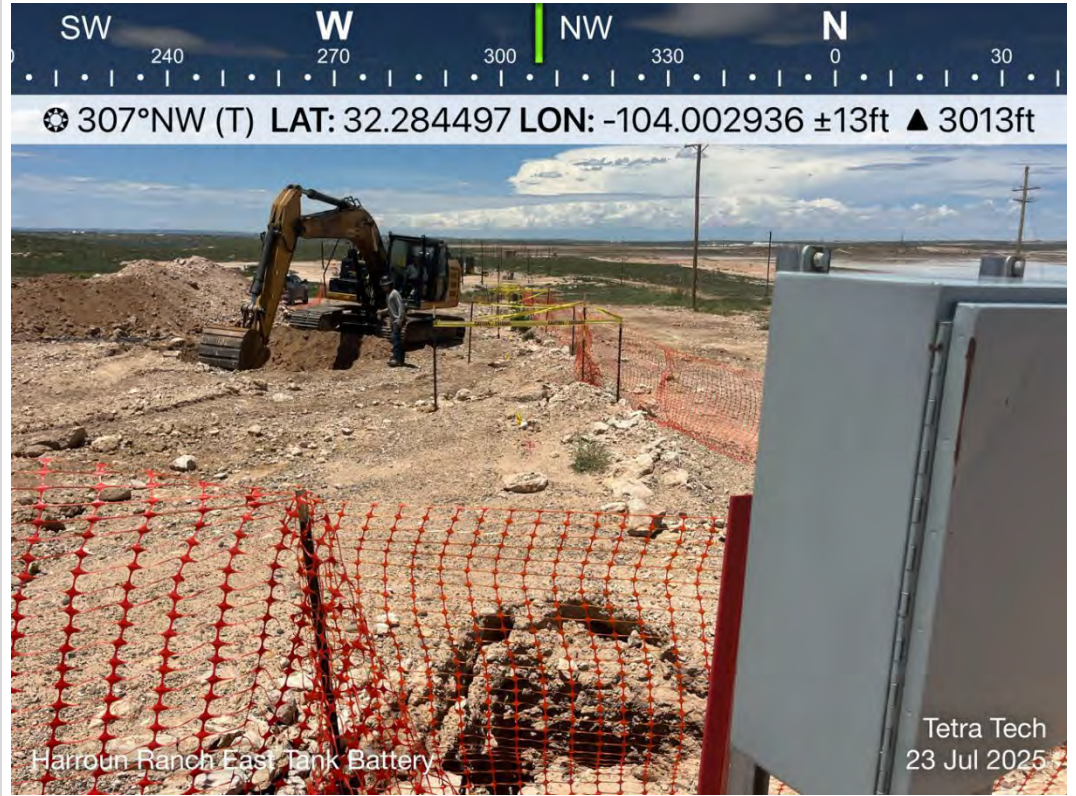
TETRA TECH, INC. PROJECT NO. 212C-MD-03775	DESCRIPTION	View northwest of additional excavation progress.	16
	SITE NAME	Harroun Ranch East Tank Battery Release	7/23/2025

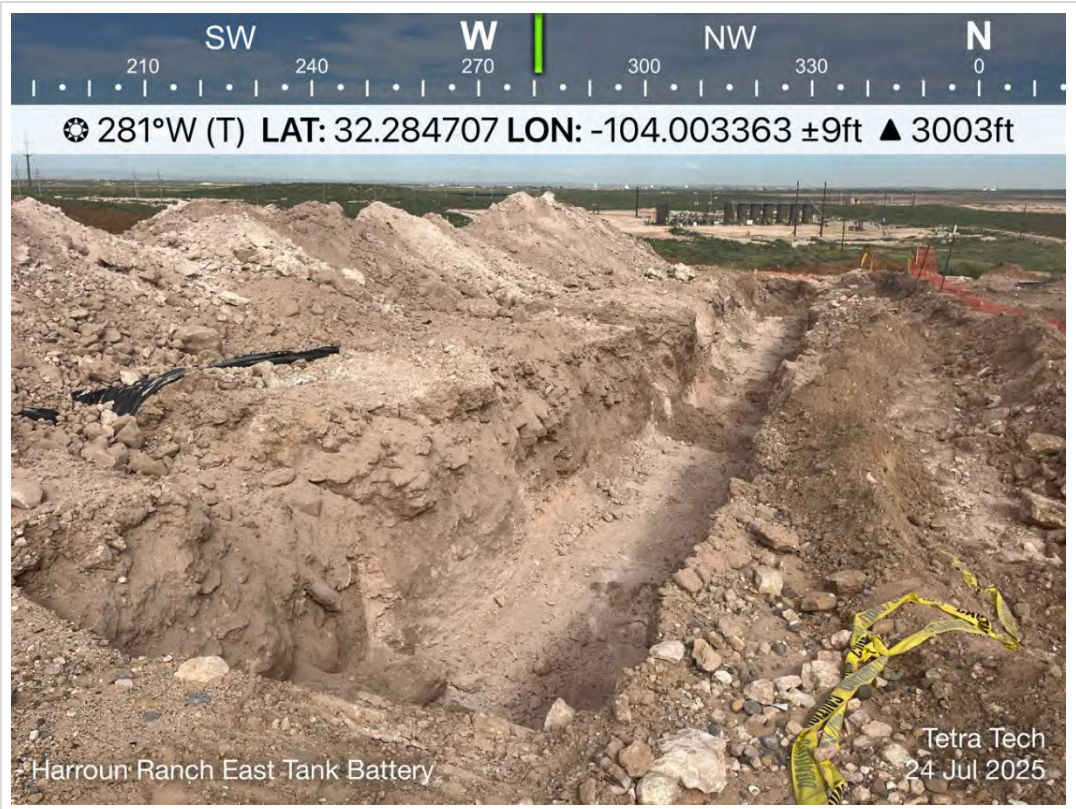
TETRA TECH, INC. PROJECT NO. 212C-MD-03775	DESCRIPTION	View west of additional excavation progress.	17
	SITE NAME	Harroun Ranch East Tank Battery Release	7/24/2025

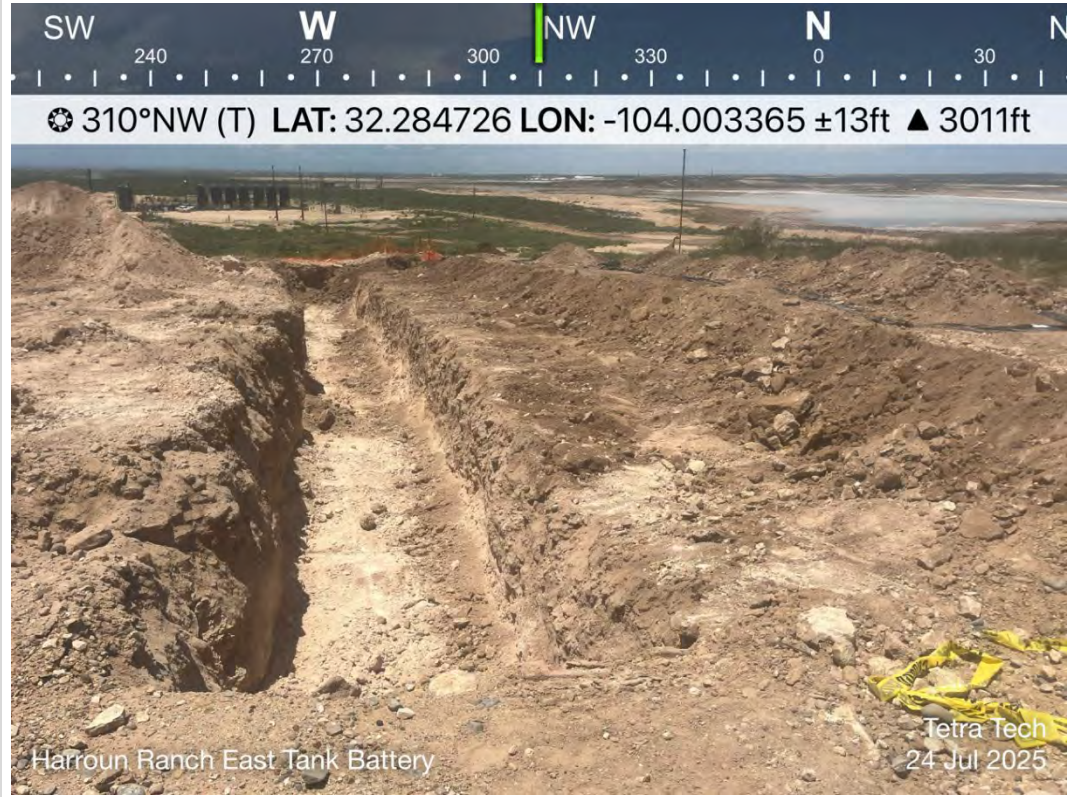
TETRA TECH, INC. PROJECT NO. 212C-MD-03775	DESCRIPTION	View northwest of additional excavation progress.	18
	SITE NAME	Harroun Ranch East Tank Battery Release	7/24/2025

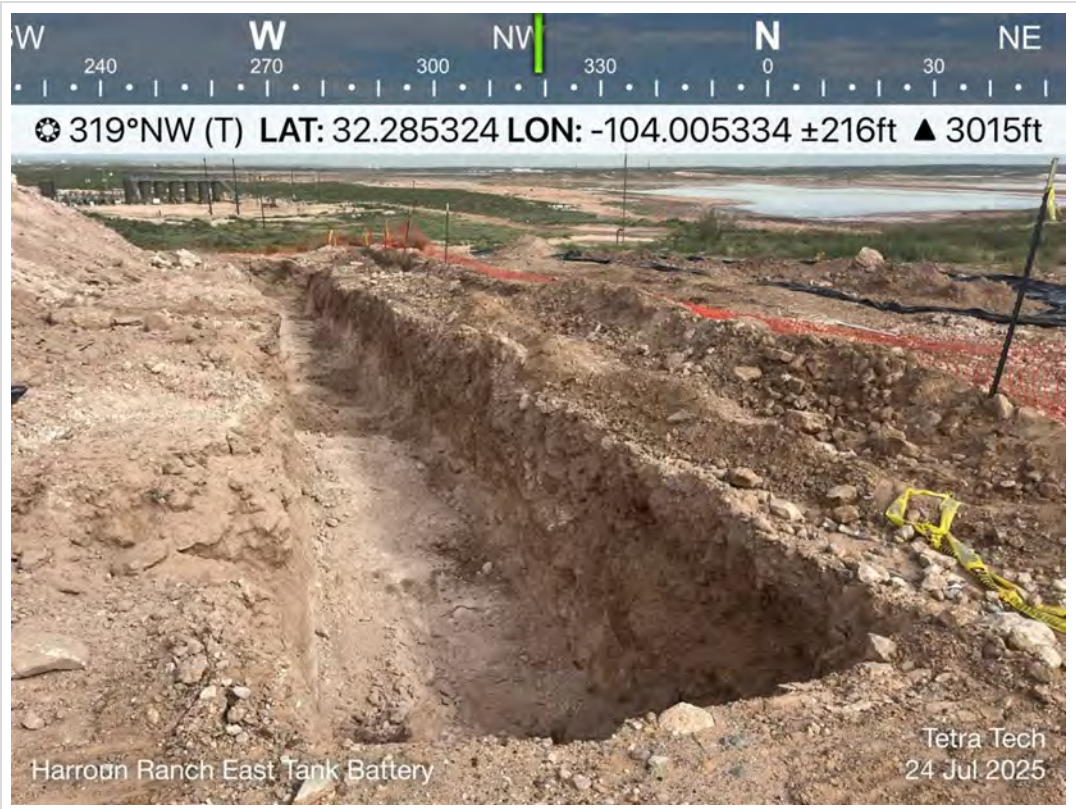
TETRA TECH, INC. PROJECT NO. 212C-MD-03775	DESCRIPTION	View northwest of additional excavation progress.	19
	SITE NAME	Harroon Ranch East Tank Battery Release	7/24/2025

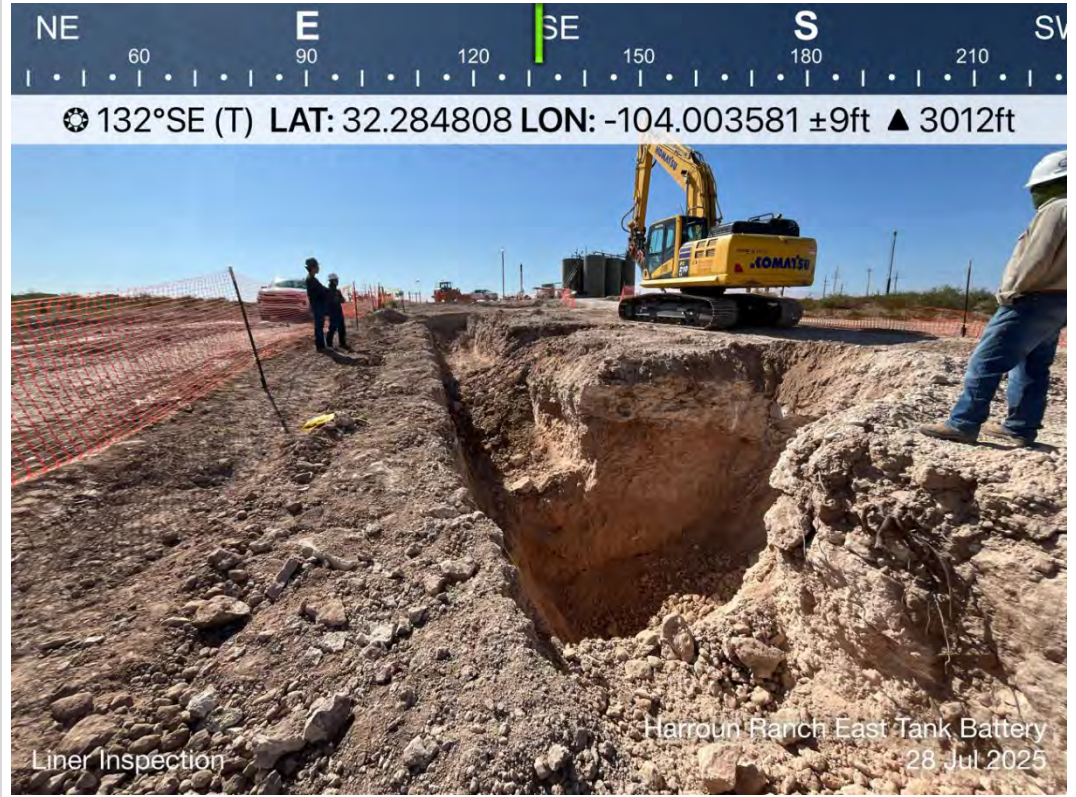
TETRA TECH, INC. PROJECT NO. 212C-MD-03775	DESCRIPTION	View southeast of additional excavation progress.	20
	SITE NAME	Harroon Ranch East Tank Battery Release	7/28/2025

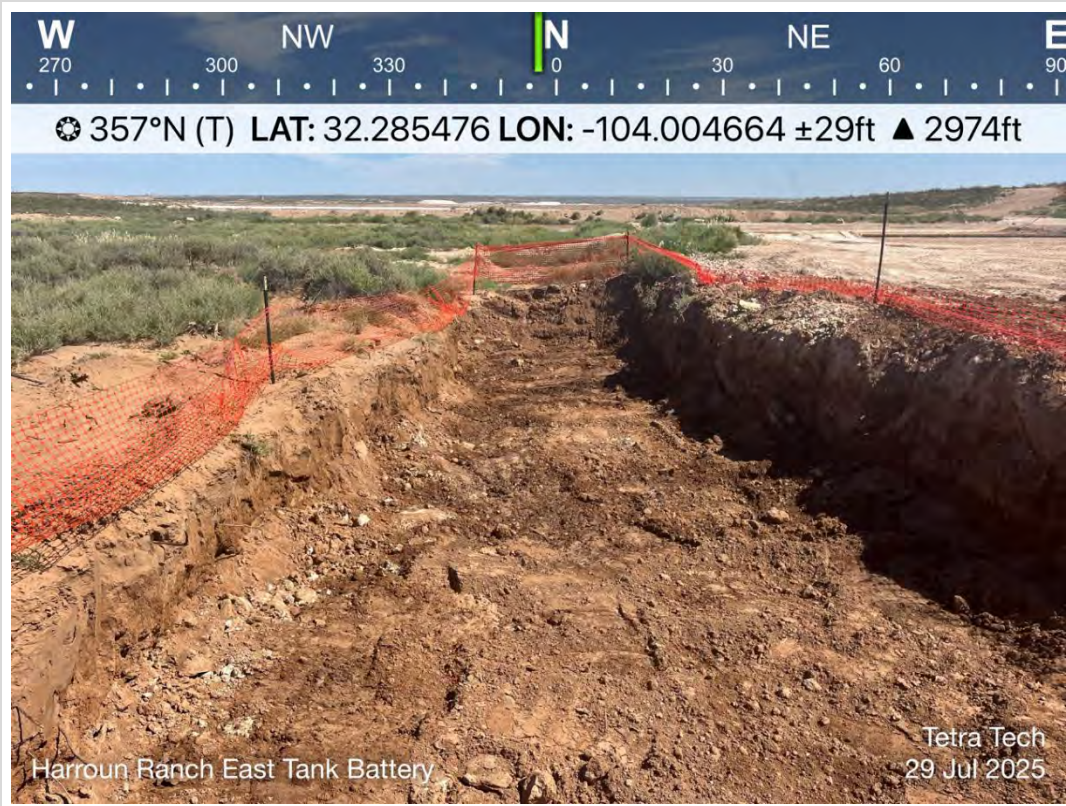
TETRA TECH, INC. PROJECT NO. 212C-MD-03775	DESCRIPTION	View north of additional excavation progress.	21
	SITE NAME	Harroun Ranch East Tank Battery Release	7/29/2025

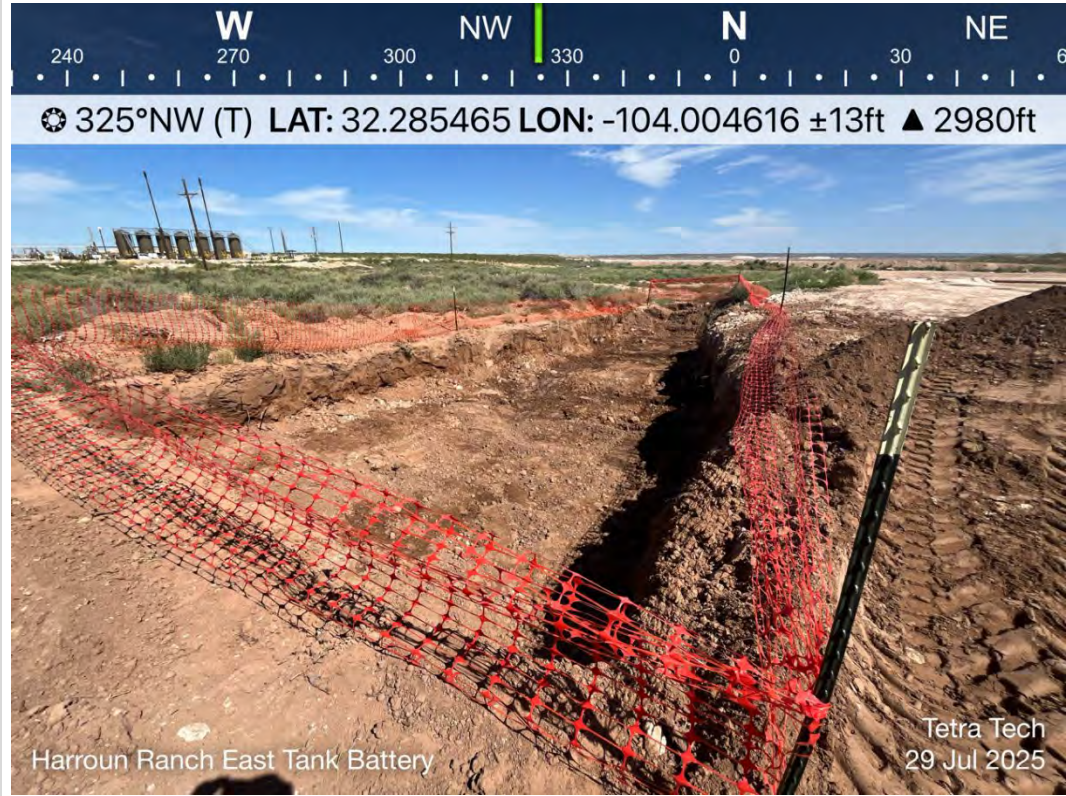
TETRA TECH, INC. PROJECT NO. 212C-MD-03775	DESCRIPTION	View north of additional excavation progress.	22
	SITE NAME	Harroun Ranch East Tank Battery Release	7/29/2025

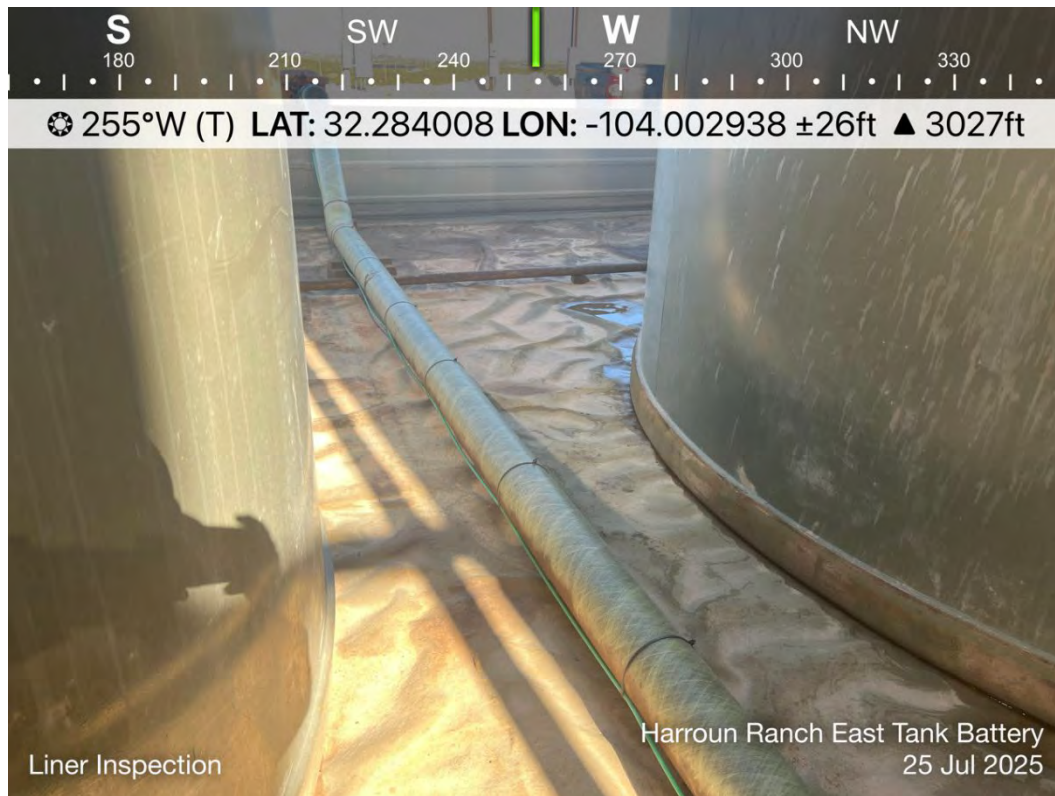
TETRA TECH, INC. PROJECT NO. 212C-MD-03775	DESCRIPTION	View west. Inside tank battery containment post rain event. Current lined containment conditions: no rips, holes, or tears observed.	24
	SITE NAME	Harroun Ranch East Tank Battery Release	7/25/2025
