**Re: Closure Report
BTA Oil Producers, LLC
Harroun Ranch East Tank Battery Release
Unit O, Section 20, Township 23 South, Range 29 East
Eddy County, New Mexico
Incident ID nAPP2202845563**

nAPP2202845563 Closure Report
Harroun Ranch East Tank Battery Release

BTA Oil Producers, LLC
October 6, 2025

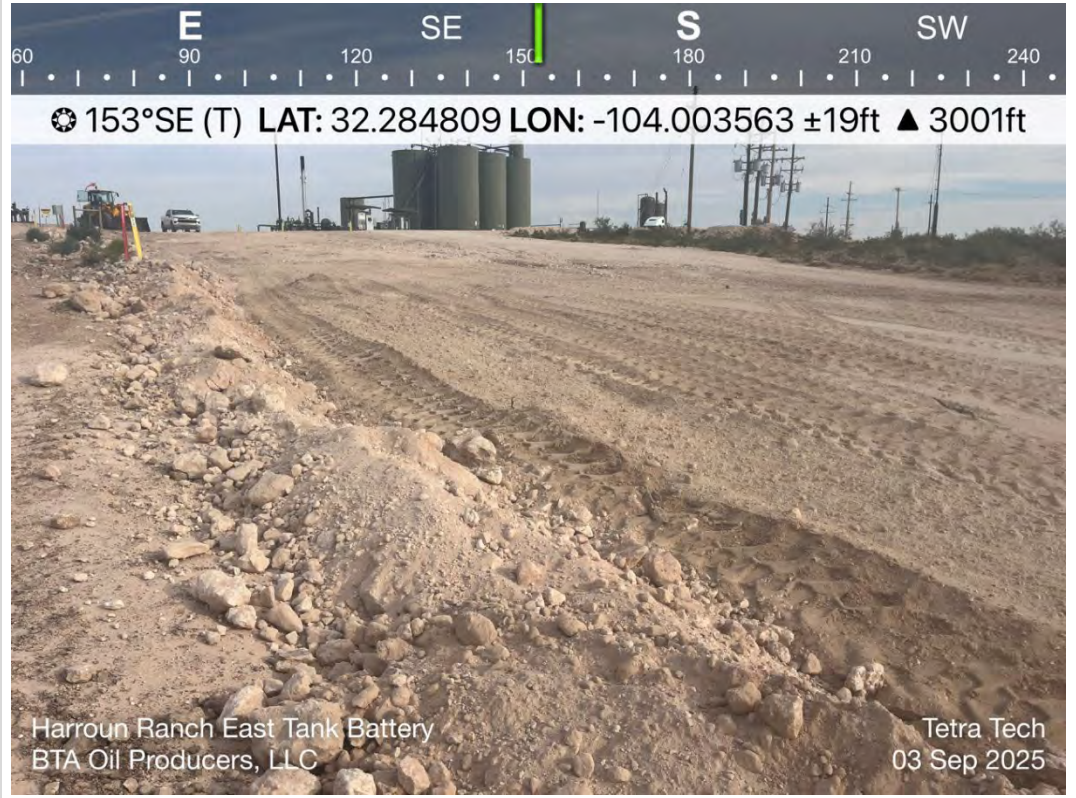
TETRA TECH, INC. PROJECT NO. 212C-MD-03775	DESCRIPTION	View southeast of backfilling activities.	28
	SITE NAME	Harroun Ranch East Tank Battery Release	9/3/2025

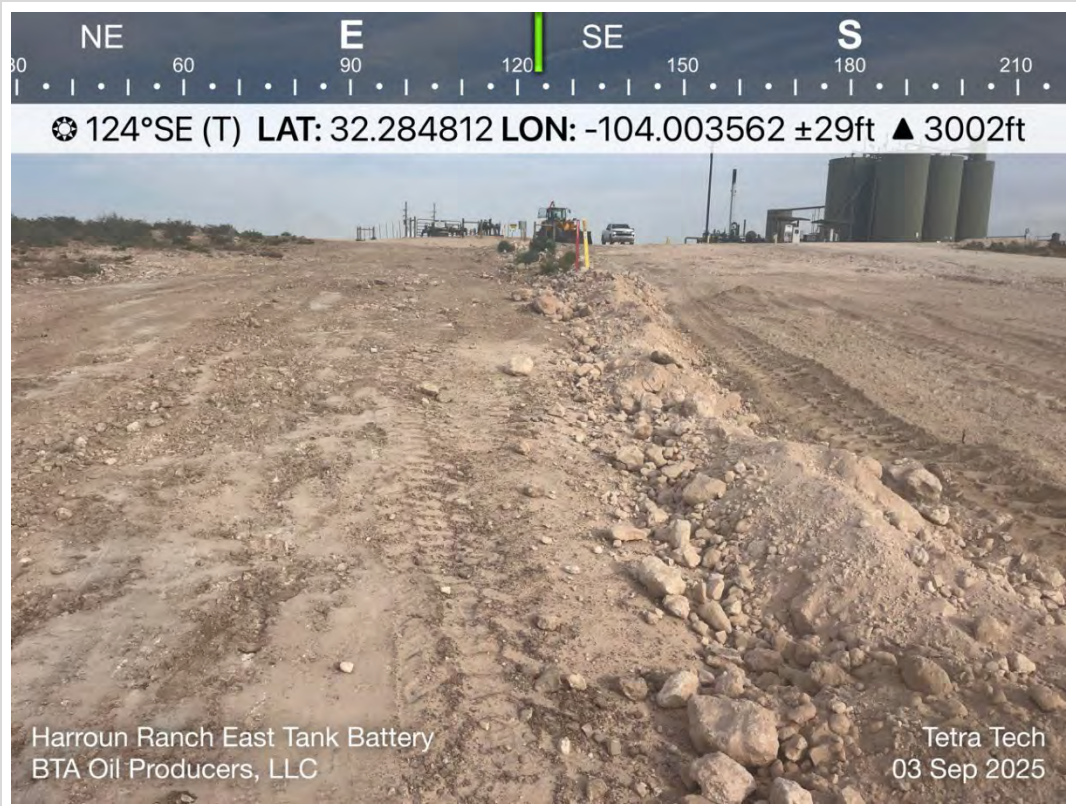
TETRA TECH, INC. PROJECT NO. 212C-MD-03775	DESCRIPTION	View southeast of backfilling activities.	29
	SITE NAME	Harroun Ranch East Tank Battery Release	9/3/2025

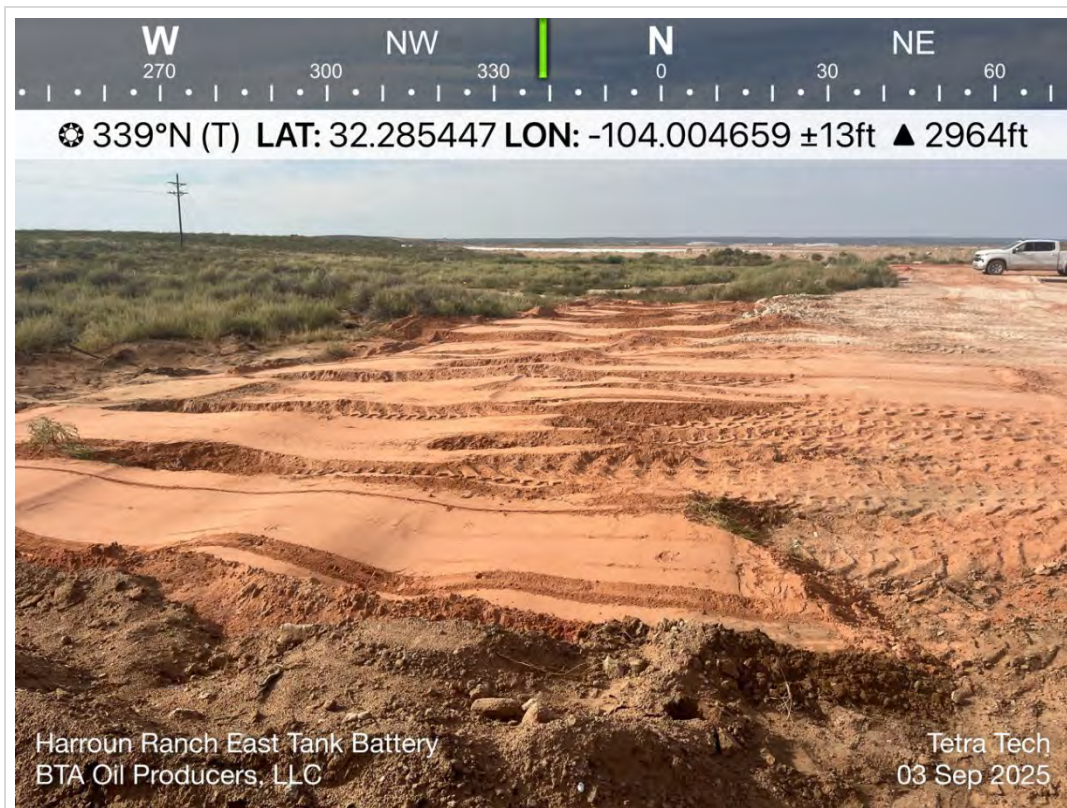
TETRA TECH, INC. PROJECT NO. 212C-MD-03775	DESCRIPTION	View north of backfilling and seeding activities.	31
	SITE NAME	Harroun Ranch East Tank Battery Release	9/3/2025
