Re: Closure Request

PLU Big Sinks 19-24-31 USA Battery

Incident Numbers nAPP2430551104 & nAPP2434134681

Eddy County, New Mexico

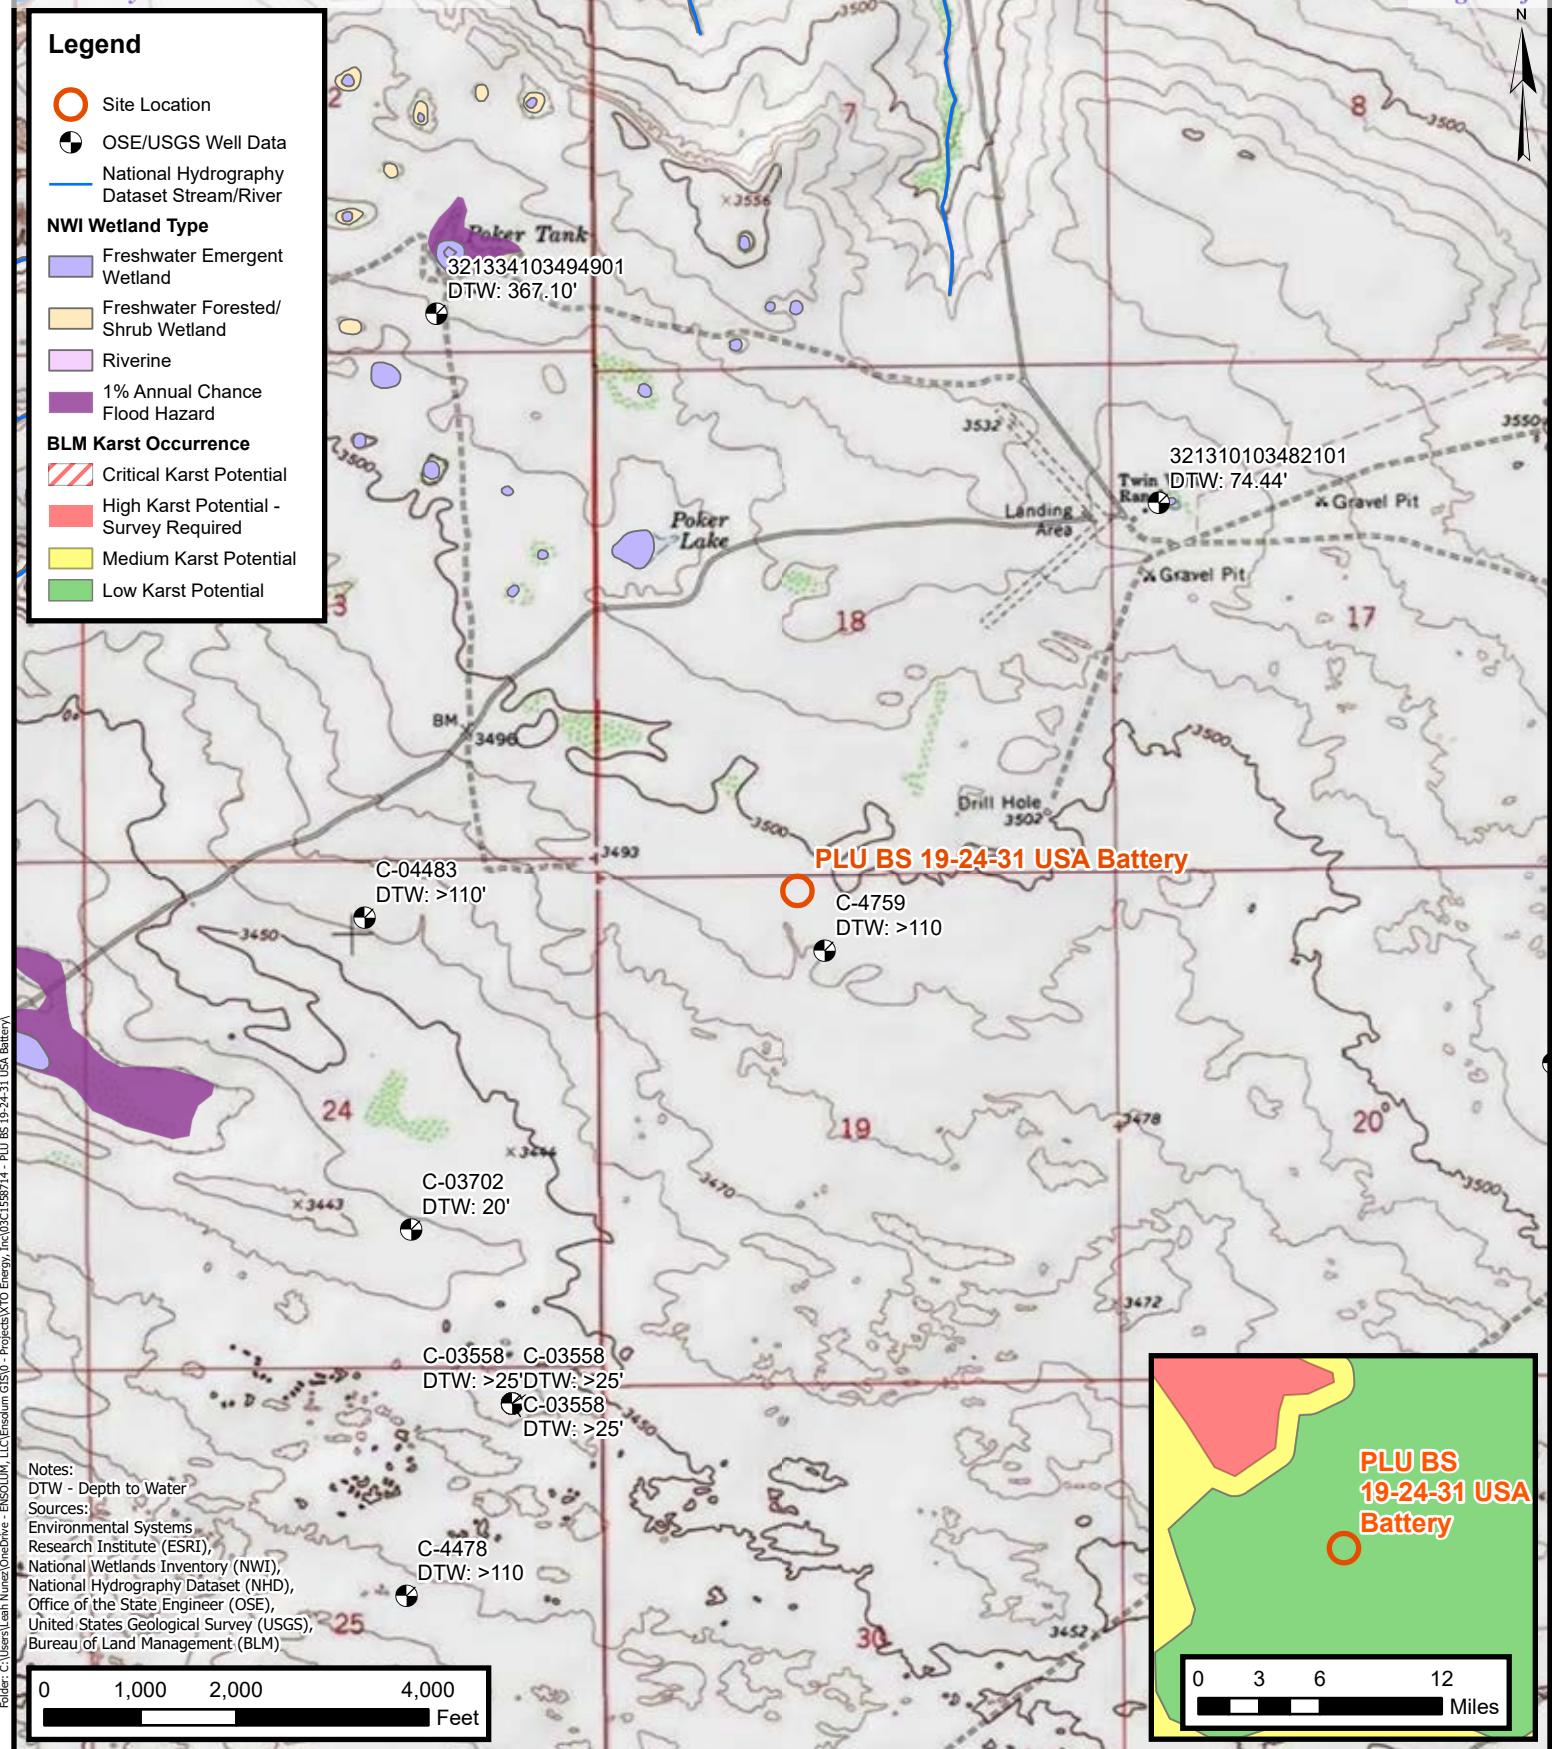
FIGURE

The Site was characterized to assess the applicability of Table I Closure Criteria for Soils Impacted by a Release, of Title 19, Chapter 15, Part 29 (19.15.29) of the New Mexico Administrative Code (NMAC). Results from the characterization desktop review are presented below and potential Site receptors are identified on Figure 1.

Depth to groundwater at the Site is estimated to be greater than 100 feet below ground surface (bgs) based on the nearest groundwater well data. The closest permitted groundwater well with depth to groundwater data is a New Mexico Office of the State Engineer (NMOSE) permitted well (C-4759), located approximately 0.14 miles southeast of the Site. The soil boring was advanced on August 11, 2023, to a total depth of 110 feet bgs. The well was properly plugged and abandoned using hydrated bentonite chips and drill cuttings. All wells used for depth to groundwater determination are presented on Figure 1. The Well Record and Log for C-4759 is included in Appendix A.

The closest continuously flowing or significant watercourse to the Site is a riverine located approximately 6,343 feet northeast of the Site. The Site is greater than 200 feet from a lakebed, sinkhole, or playa lake and greater than 300 feet from an occupied residence, school, hospital, institution, church, or wetland. The Site is greater than 1,000 feet to a freshwater well or spring and is not within a 100-year floodplain or overlying a subsurface mine. The Site is not underlain by potentially unstable geology (low potential karst designation area).

Site Receptor Map

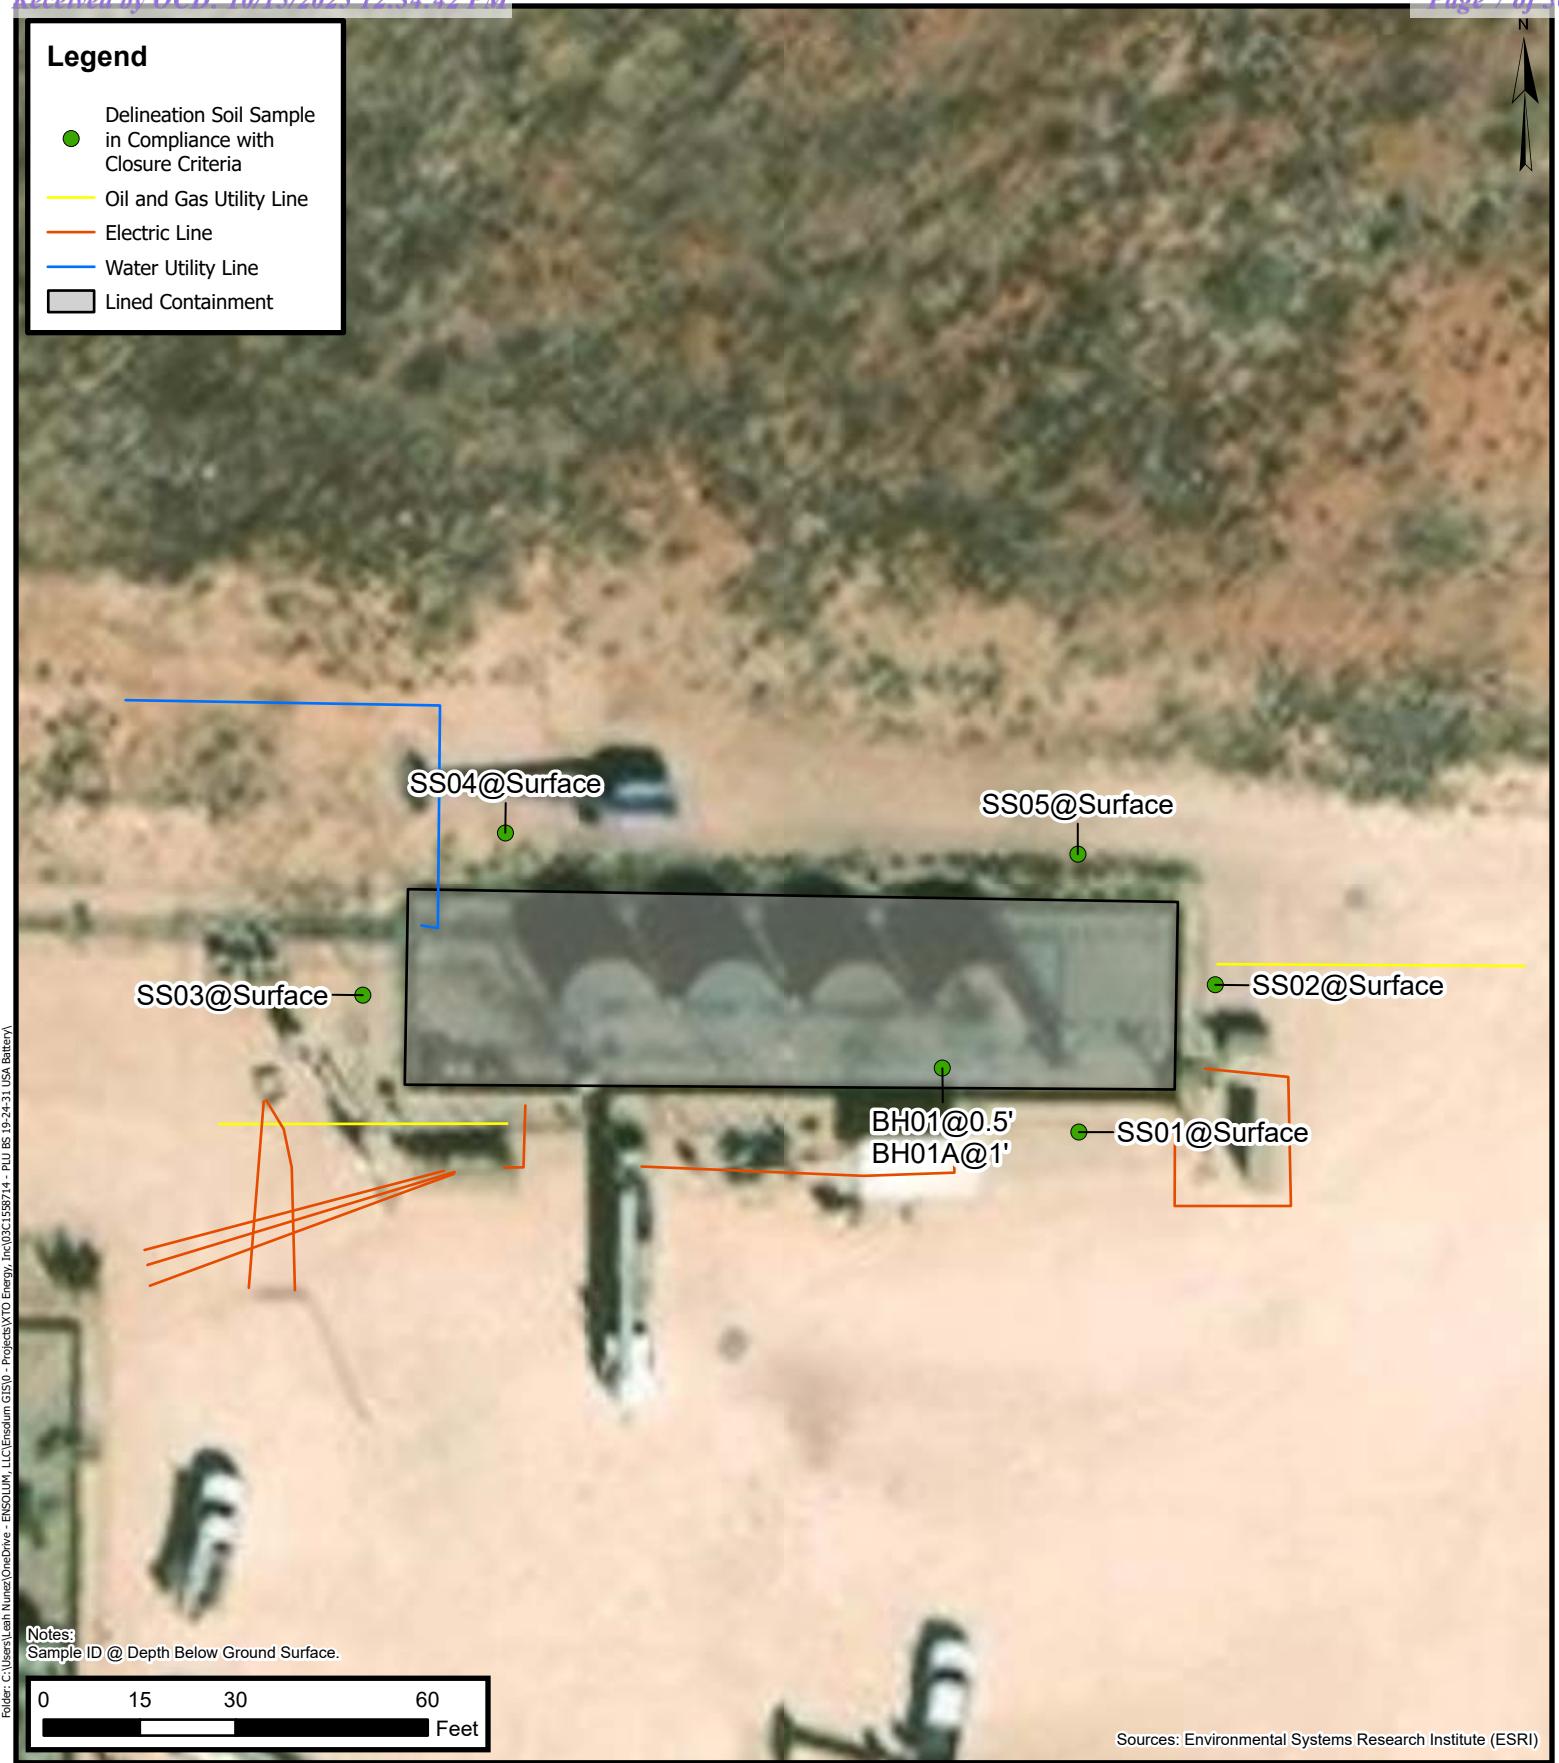
**FIGURE
2**

On August 27, 2025, Ensolum personnel were at the Site to oversee delineation activities. Five delineation soil samples (SS01 through SS05) were collected around the lined containment from ground surface to assess the lateral extent of the release. One borehole (BH01) was advanced via hand auger to a terminal depth of 1-foot bgs in the location of the liner hole. Discrete soil samples were collected from the borehole at depths ranging from 0.5 feet bgs to 1-foot bgs. All delineation soil samples were field screened for volatile organic compounds (VOCs) utilizing a calibrated photoionization detector (PID) and chloride utilizing Hach® chloride QuanTab® test strips. Field screening results and observations of the soil samples from the borehole were logged on a lithologic/soil sampling log, which is included in

Appendix C. The delineation soil sample locations were mapped utilizing a handheld Global Positioning System (GPS) unit and are depicted on Figure 2. Photographic documentation is included in Appendix B.

Laboratory analytical results for delineation soil samples SS01 through SS05 indicated all COCs were in compliance with Site Closure Criteria and reclamation standards, confirming the lateral extent of the release. Delineation soil samples from borehole BH01 at 0.5 feet bgs and 1-foot bgs indicated all COCs were in compliance with Site Closure Criteria. Laboratory analytical results are summarized in Table 1 and the laboratory analytical reports are included in Appendix D.

Delineation Soil Sample Locations

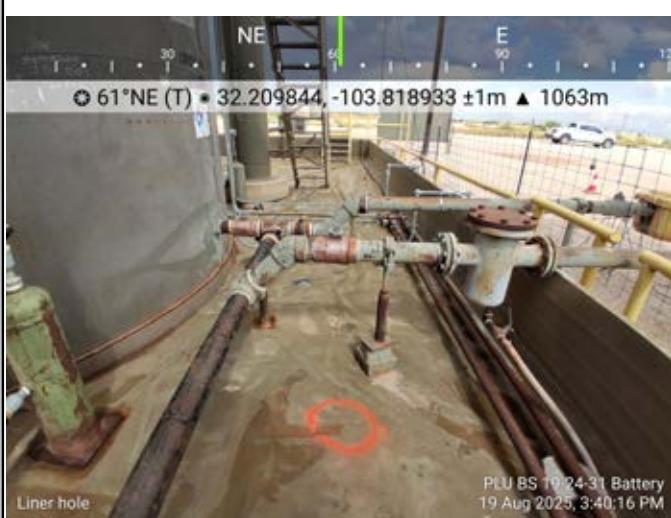
The lined containment was cleaned of all debris and power washed, and a liner integrity inspection was conducted by Ensolum personnel on August 19, 2025. The lined containment was inspected, and it was determined to contain a small hole. Delineation to determine the extent of the release was warranted. A site map of the lined containment is included in Figure 2. Photographic documentation of the inspection is included in Appendix B.

Photograph: 1 Date: 8/19/2025
Description: Hole in Liner before cleaning activities
View: Northeast

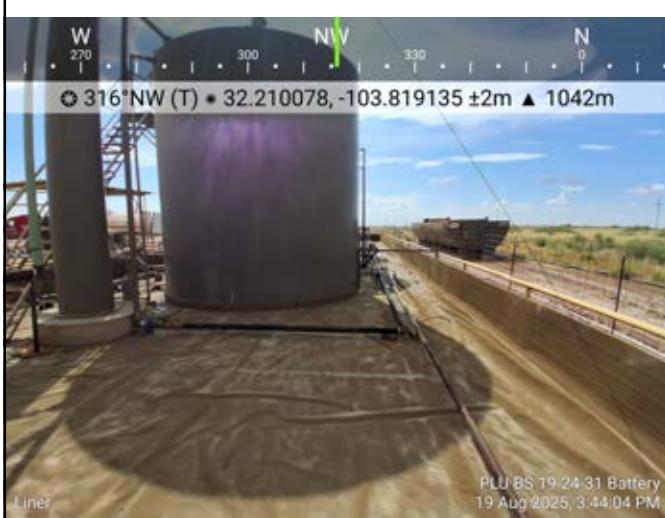
Photograph: 2 Date: 8/19/2025
Description: Liner before cleaning and repairs
View: Northwest

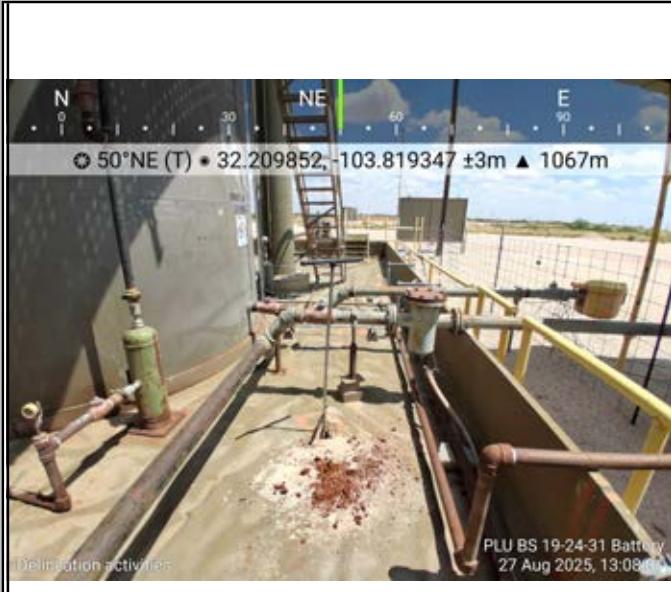
Photograph: 3 Date: 8/27/2025
Description: Delineation activities near BH01
View: Northeast

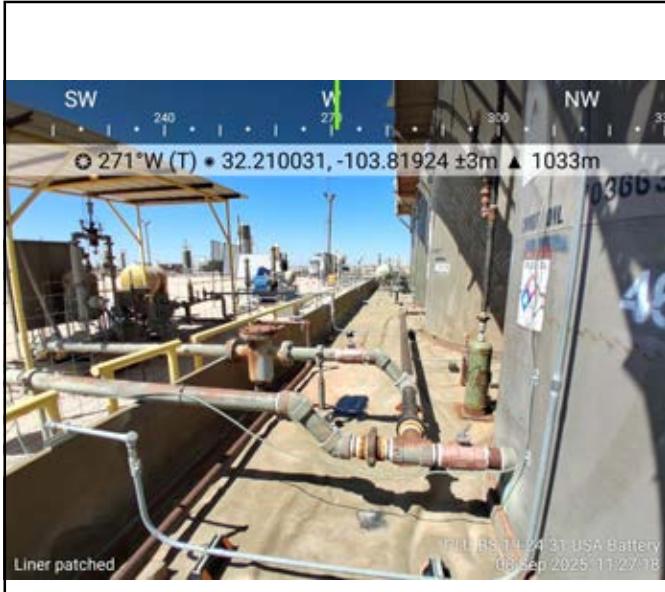
Photograph: 4 Date: 9/8/2025
Description: Liner Patch near BH01
View: West

Liner integrity inspection and delineation activities were conducted at the Site to address the October 2024 and December 2024 releases of produced water. Laboratory analytical results for the soil samples collected indicated that all COC concentrations were compliant with the Site Closure Criteria and/or reclamation standards where applicable. Based on the soil sample analytical results, no impacted soil was identified, and no further remediation was required. XTO patched all holes and tears in the liner following completion of delineation activities.
