**Re: Deferral Request
Corral Canyon 8 Sat
Incident Number nAPP2514157393
Eddy County, New Mexico**

XTO Energy, Inc.
Deferral Request
Corral Canyon 8 Sat

Environmental Karst Study Report

XTO Corral Canyon 8 Satellite

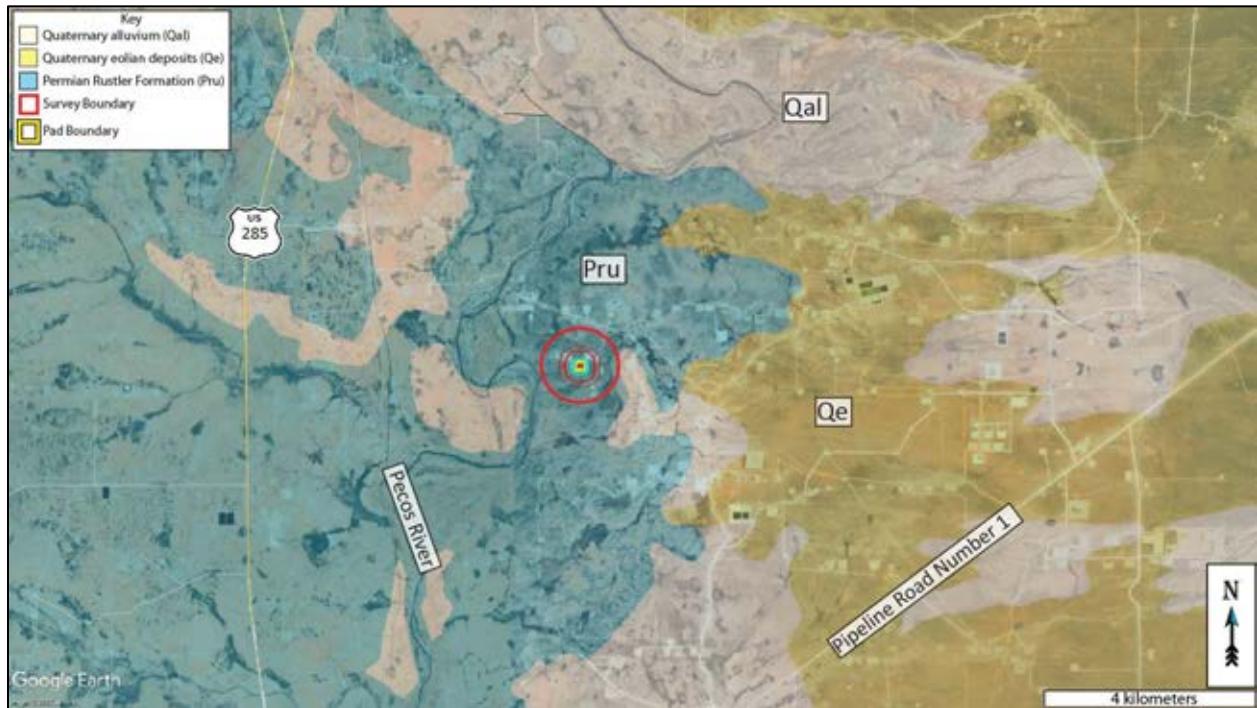
The site for the XCC8 survey is located at an elevation of 903 meters (2,961 feet), \pm 6 meters (19 feet), and is located within a region underlain by the Permian Rustler Formation (Pru). The area is mantled by thin gypsumiferous soils (gypsiter), Quaternary alluvium (Qal), and eolian deposits (Qe)^[11] up to 5 meters in depth (**Figure 3**).

Figure 3: Geology overview. Geology map credit: The Digital Geologic Map of New Mexico in ARC/INFO Format. Background image credit: Google Earth. Image date: March 20, 2023. Image datum: WGS-84.

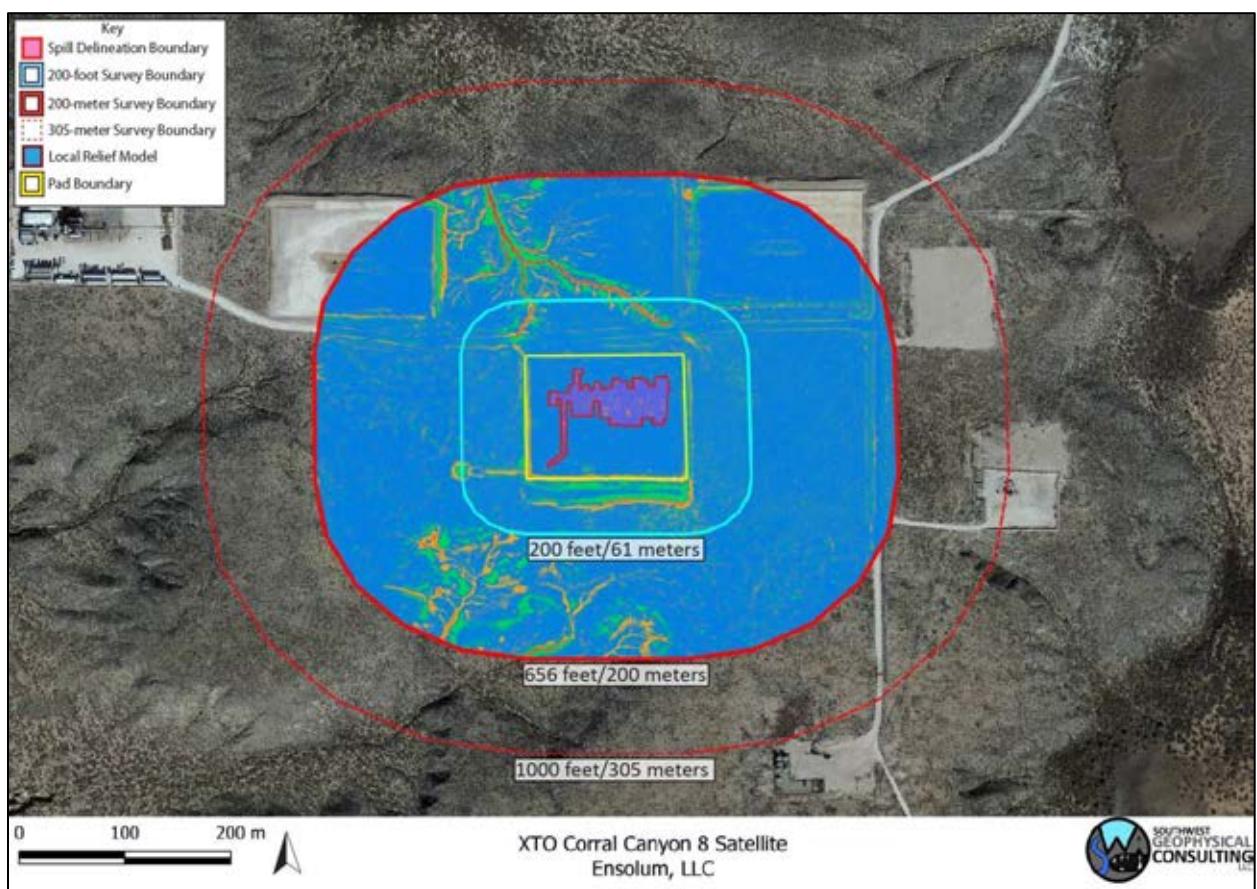
No surface karst features exist within the **200-meter** survey boundary, and no springs exist within the 305-meter (1,000 foot) survey boundary^[1].

Figure 6: UAS-conducted surface karst survey results. Background image credit: Google Earth. Image date: March 20, 2023. Image datum: WGS-84.

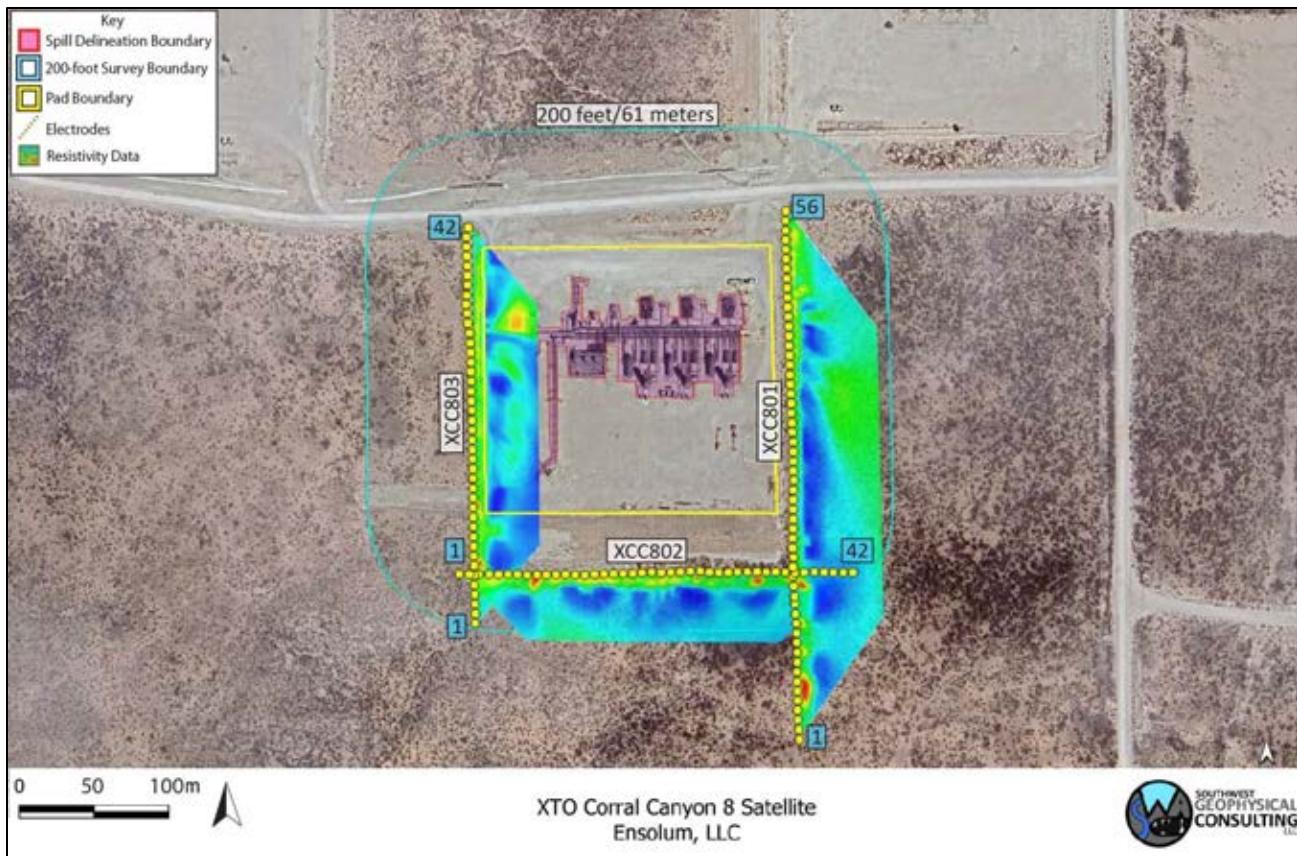
Figure 8: Data overlay. Colored trapezoids are 2D inverted resistivity lines. Background image credit: Google Earth. Image date: January 27, 2023.

Resistivity of the survey area drops below 50 $\Omega\text{-m}$ at approximately 12 - 15 meters (39.4 – 49.2 feet) depth and generally increases to greater than 500 $\Omega\text{-m}$ below these depths throughout the survey area, indicating a change from moist to saturated caliche/gypssite soils or gypsums to the bedrock of the Rustler Formation (**Figure 7** and **Figure 8**).

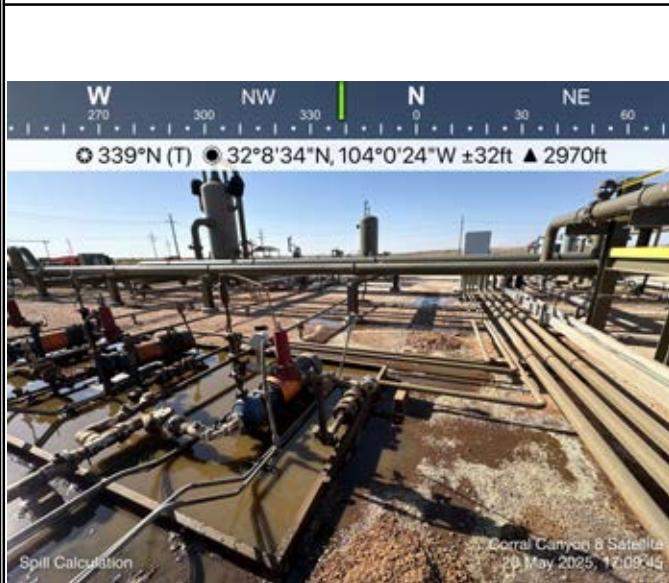
Photograph: 1 Date: 5/20/2025
 Description: Initial release near containment, BH01
 View: Northwest

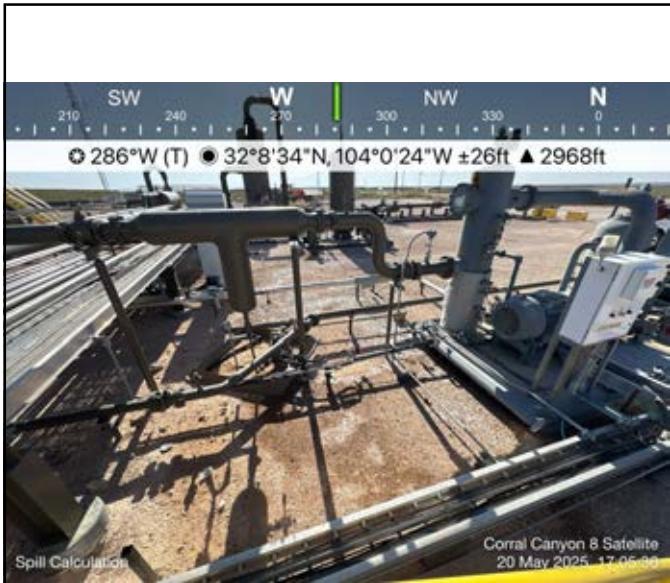
Photograph: 2 Date: 5/20/2025
 Description: Initial release near SS04
 View: West

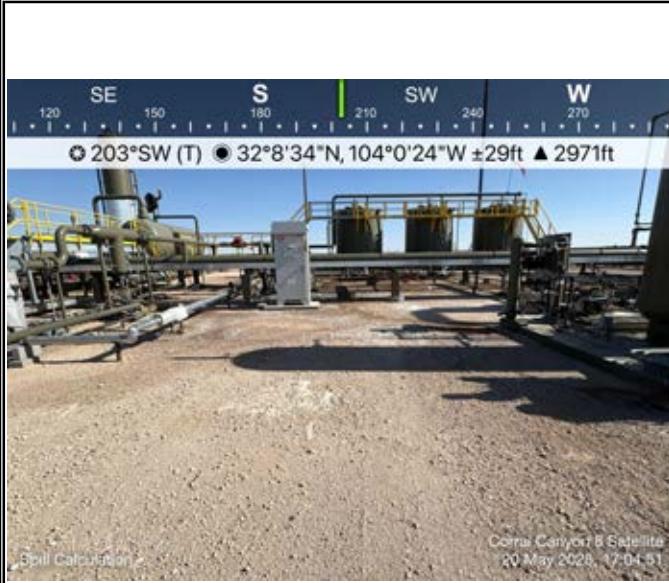
Photograph: 3 Date: 5/20/2025
 Description: Initial release near SS02
 View: South

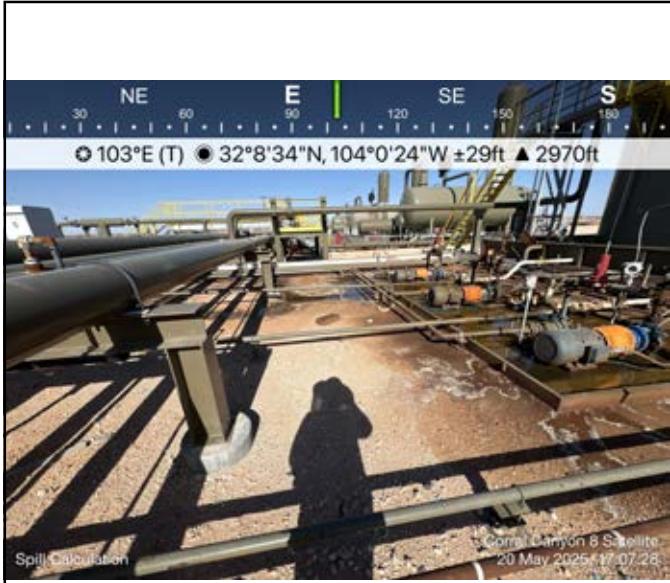
Photograph: 4 Date: 5/20/2025
 Description: Initial release near lined containment
 View: East

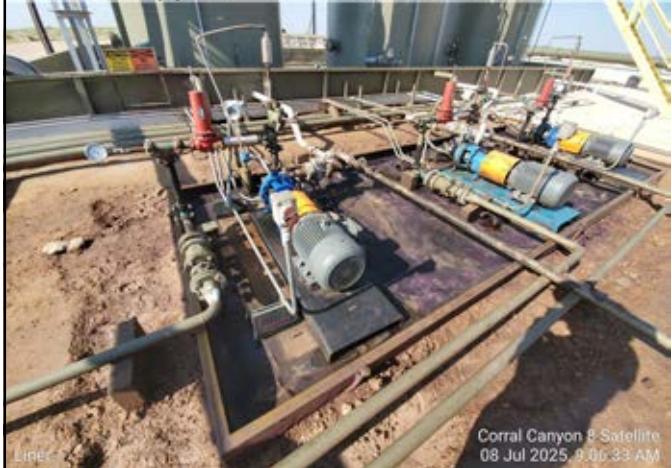
Photograph: 10
Description: Liner competency inspection
View: Southeast

The steel lined containment overflowed as a result of the May 20, 2025, release of produced water. A 48-hour advance notice of the liner inspection was submitted to the NMOCD on July 7, 2025. The liner was cleared of all debris and fluids. A liner integrity inspection was conducted by Ensolum personnel on July 8, 2025. The lined containment was inspected and was determined to be operating as designed. Upon inspection, no rips, tears, holes, or damage was observed. The liner was determined to be sufficient, and all released fluids from the containment were recovered. NMOCD correspondence for approval of the liner inspection notification is included in Appendix C. Photographic documentation of the inspection is included in Appendix D.

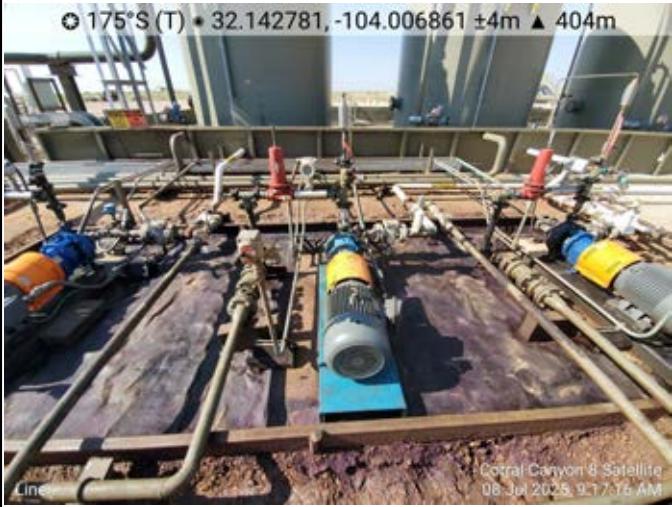
Photograph: 11
Description: Liner competency inspection
View: South

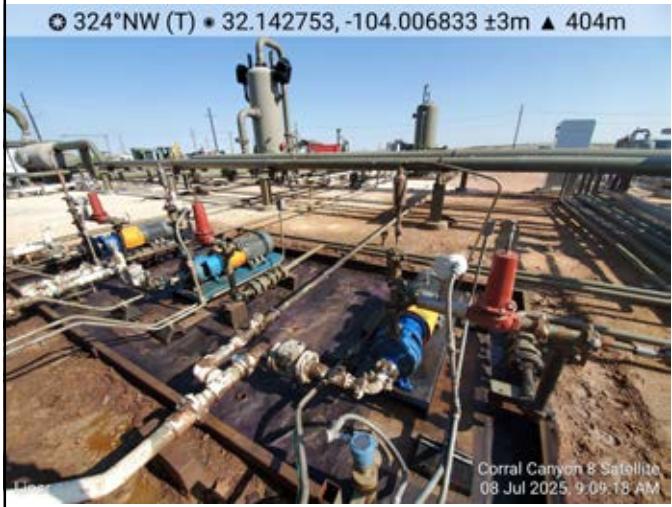
Photograph: 12
Description: Liner competency inspection
View: Northwest

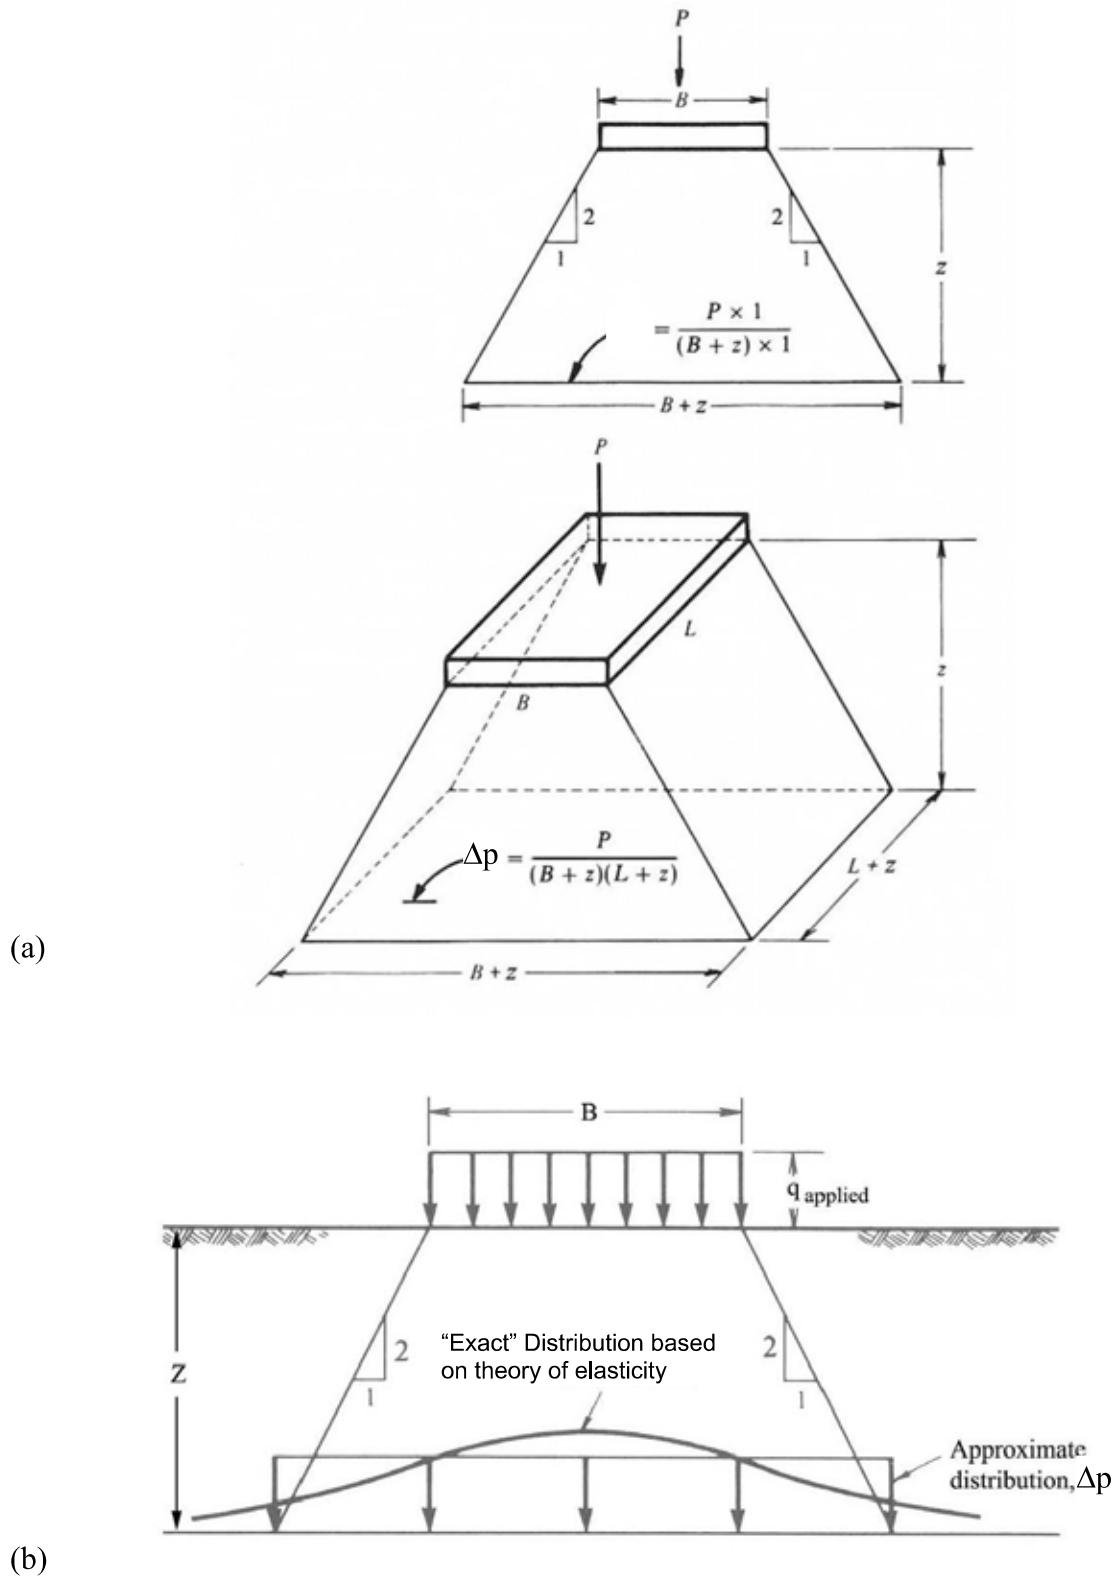
Figure 2-10. Distribution of vertical stress by the 2:1 method (after Perloff and Baron, 1976).

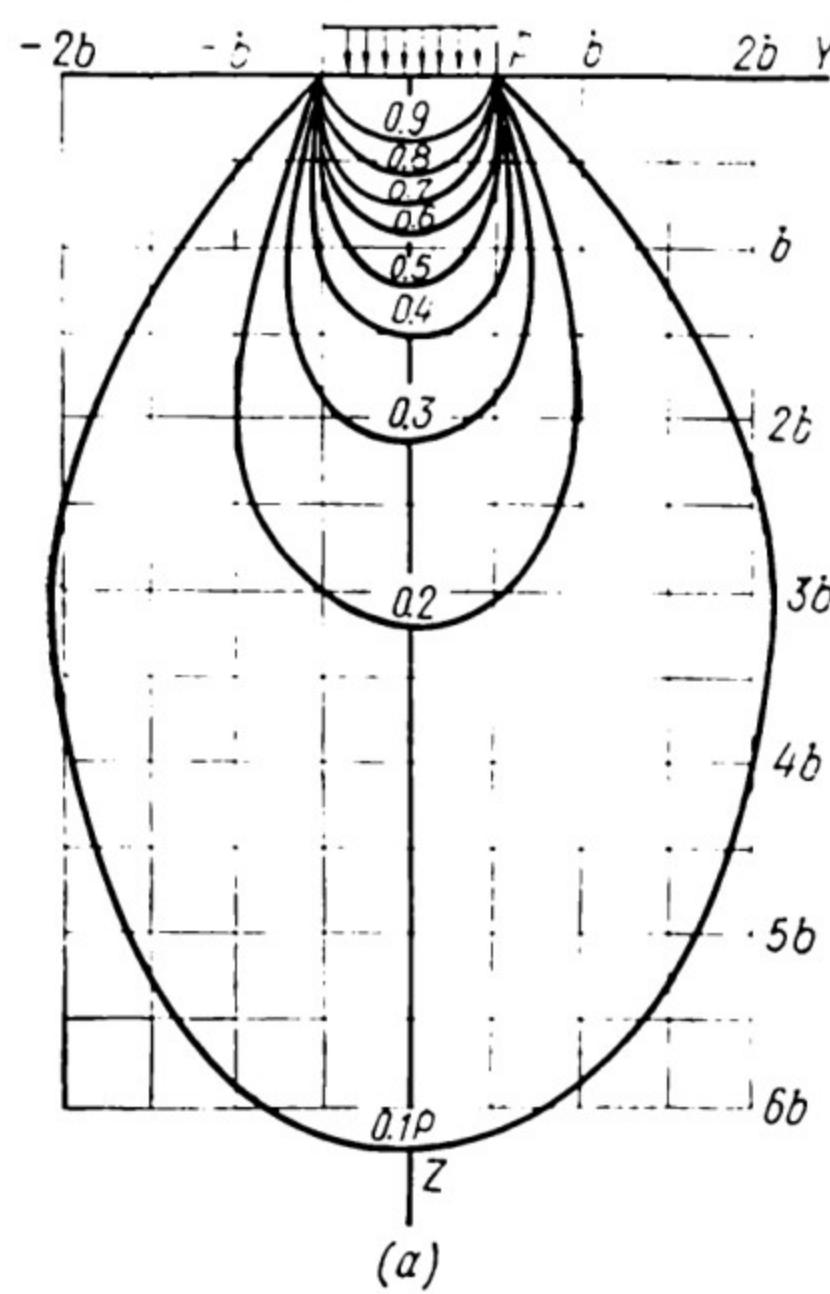
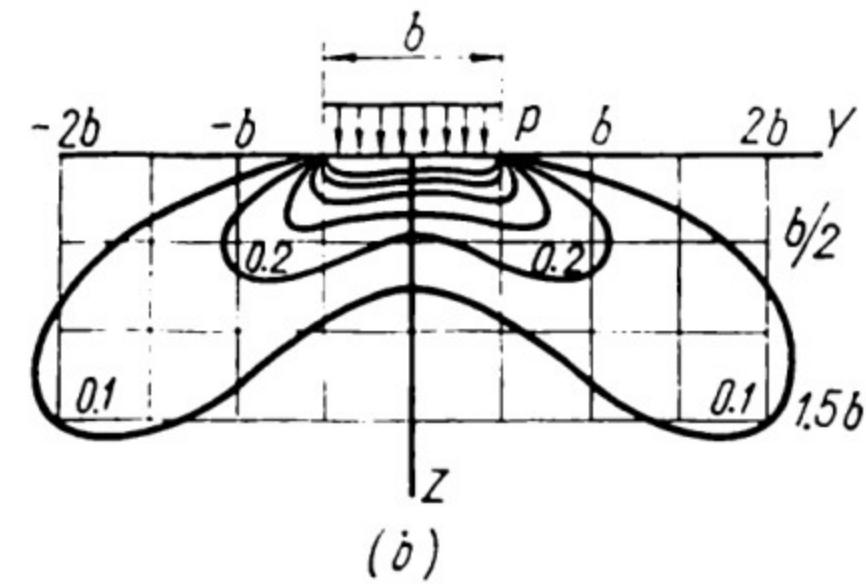
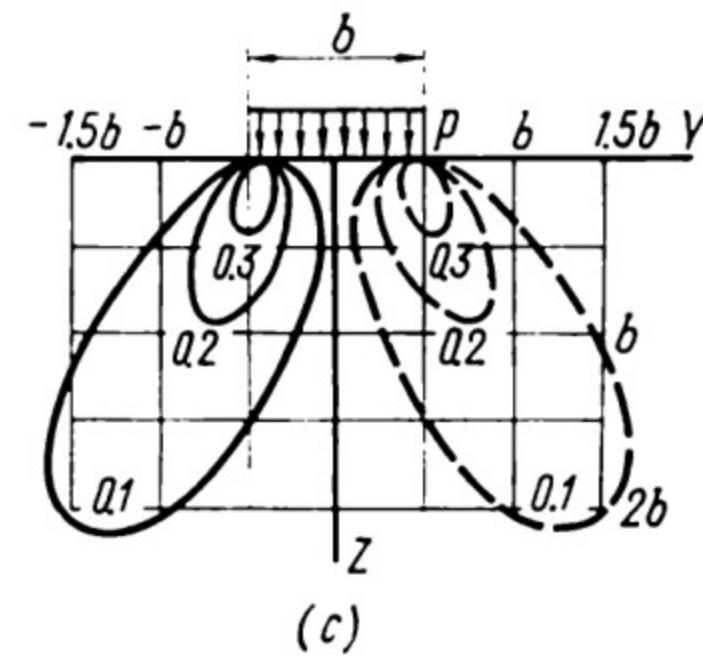
Fig. 49. Lines of equal stresses in a linearly deformable massif for the planar problem

(a) isobars σ_z ; (b) lateral pressure σ_y ; (c) shears τ_{zx}
