Re: Closure Request
James Ranch Unit #124H
Incident Number NAB1517555063
Eddy County, New Mexico

Ensolum, LLC (Ensolum), on behalf of XTO Permian Operating LLC (XTO), has prepared this *Closure Request* to document assessment, excavation, and soil sampling activities at the James Ranch Unit #124H (Site). The purpose of the Site assessment and soil sampling activities was to assess for the presence or absence of impacts to soil following a release of produced water. Based on field observations, field screening activities, and soil sample laboratory analytical results, XTO is submitting this *Closure Request*, describing remedial activities that have occurred and requesting no further remediation for Incident Number NAB1517555063.

Site Receptor Map

Soil Sample Locations

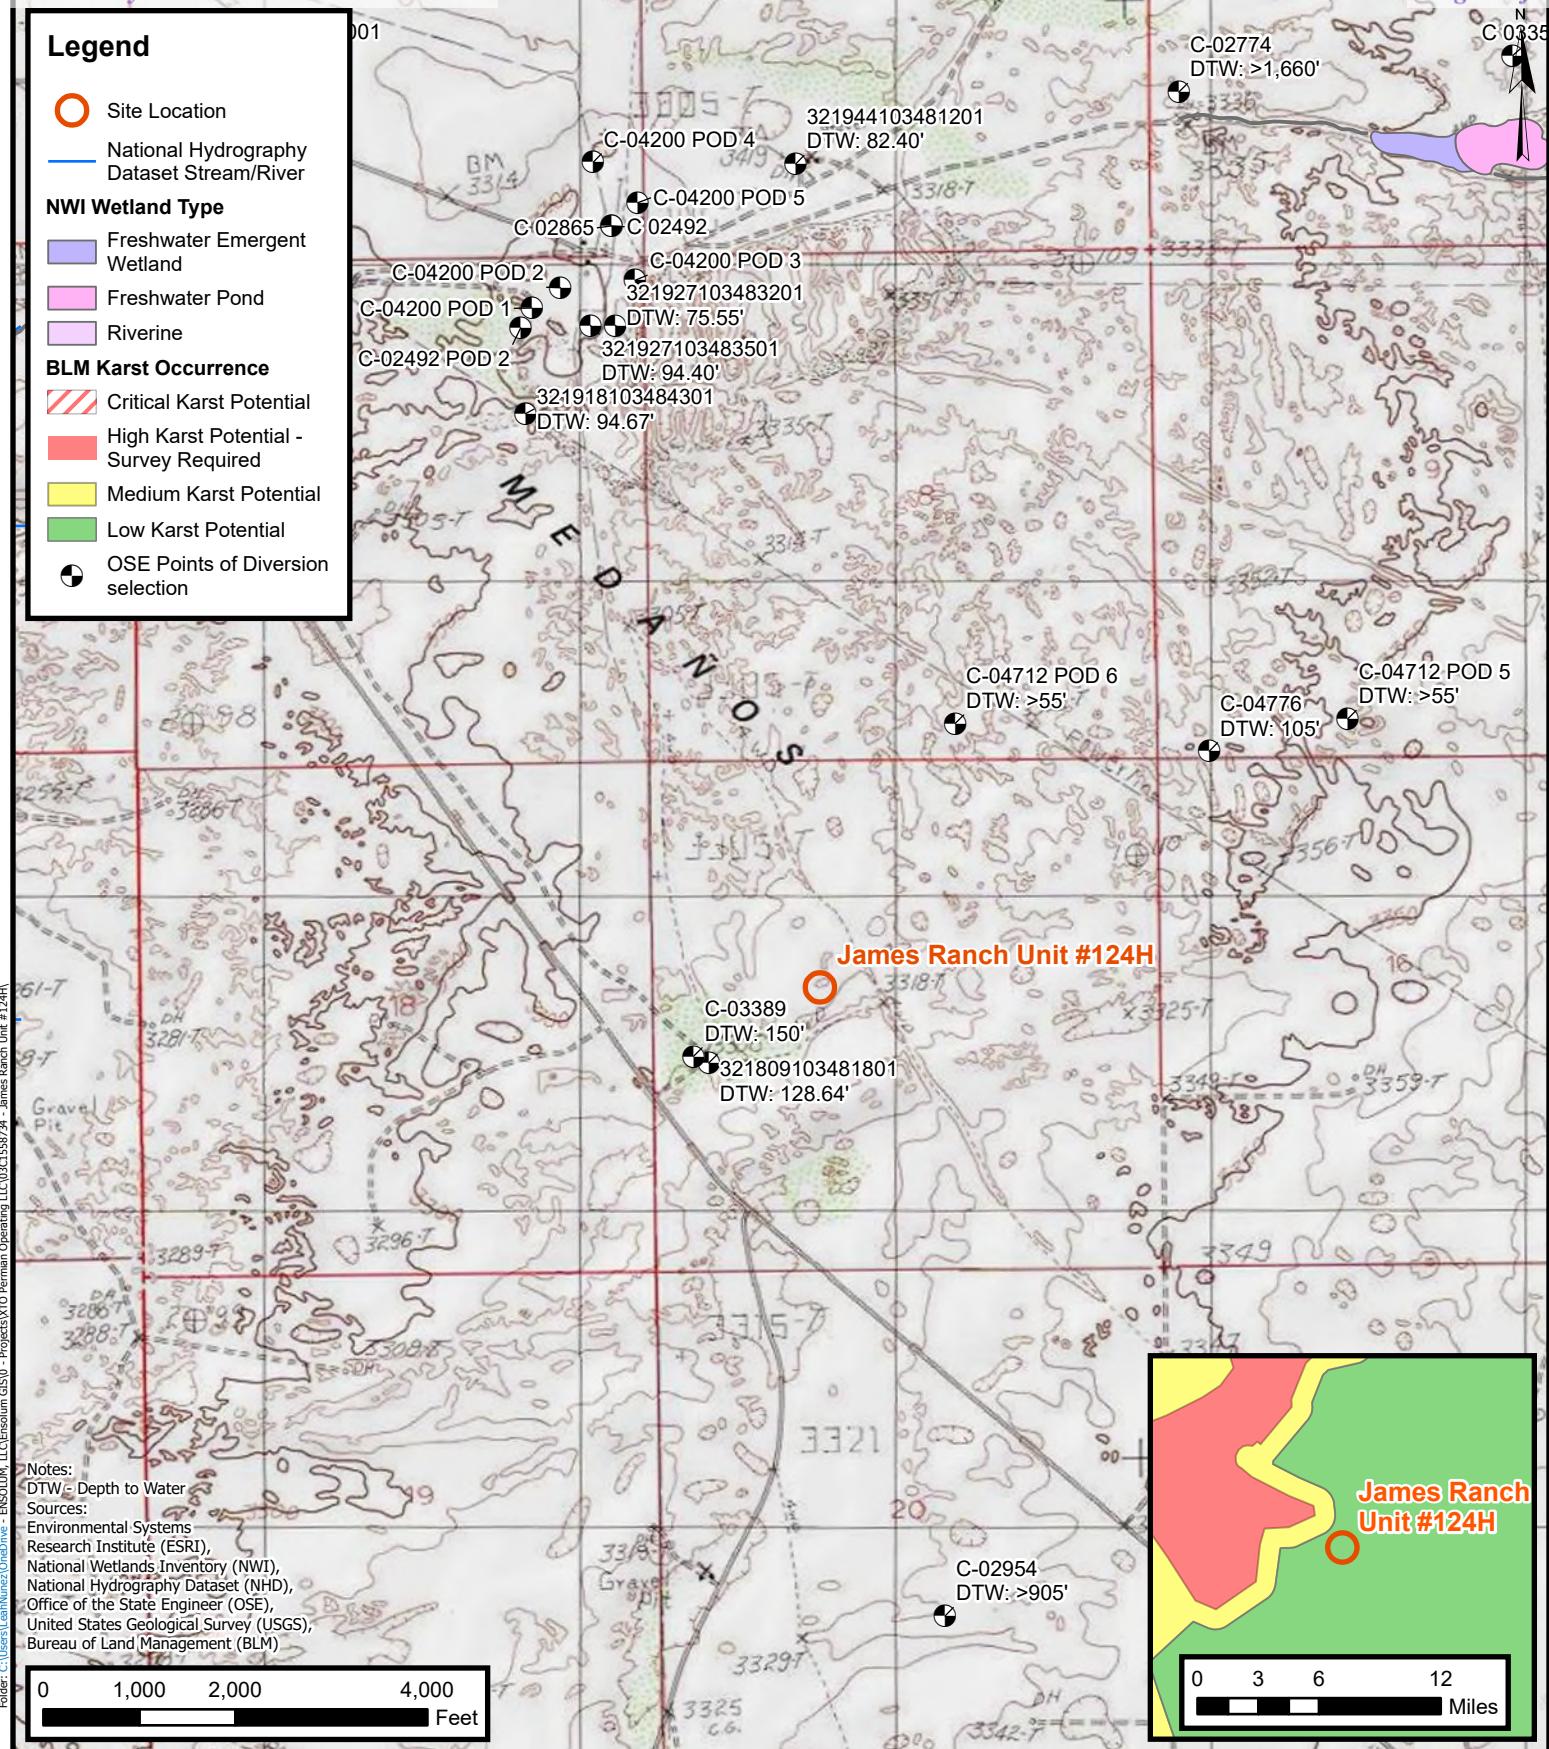
FIGURE
1

Depth to groundwater at the Site is estimated to be greater than 100 feet below ground surface (bgs) based on the nearest groundwater well data. The closest permitted groundwater well is United States Geological Survey (USGS) well 321809103481801, located approximately 1,400 feet southwest of the Site. The well has a reported depth to groundwater of 128.64 feet bgs and was most recently measured in January 2013. The well record is provided in Appendix A. All wells used for depth to groundwater determination are depicted on Figure 1.

The closest continuously flowing or significant watercourse to the Site is an unnamed arroyo located approximately 1.5 miles west of the Site. The Site is greater than 200 feet from a lakebed, sinkhole, or playa lake and greater than 300 feet from an occupied residence, school, hospital, institution, church, or wetland. The Site is greater than 1,000 feet to a freshwater well or spring and is not within a 100-year floodplain or overlying a subsurface mine. The Site is not underlain by unstable geology (low potential karst designation area). Site receptors are identified on Figure 1.

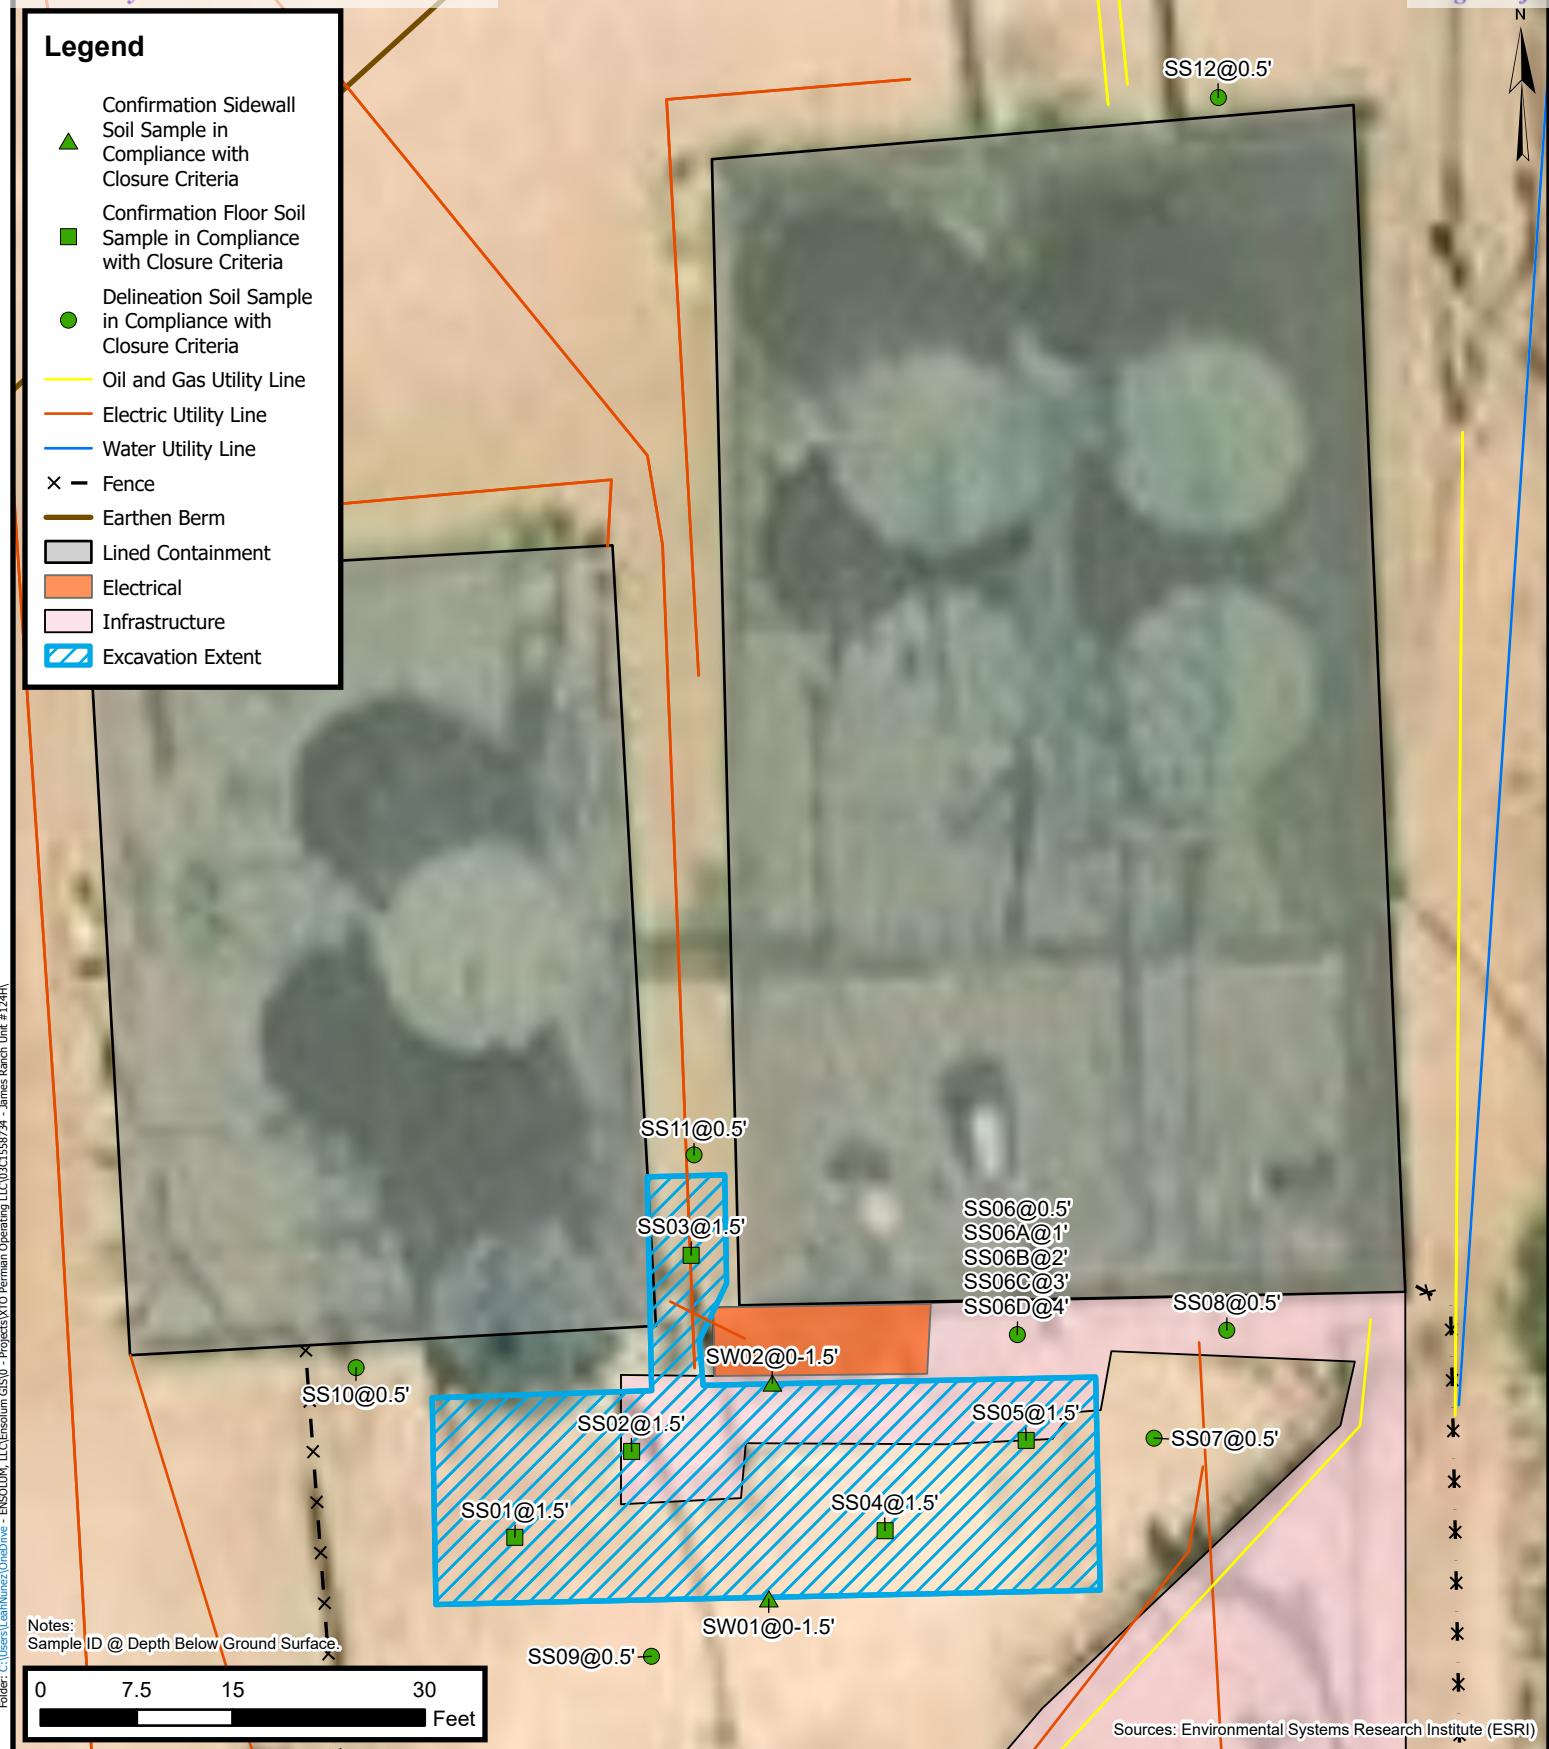
On October 8, 2025, Ensolum personnel were at the Site to conduct delineation and soil sampling activities. Two delineation soil samples, SS11 and SS12, were collected to confirm lateral delineation of the release extent. One delineation borehole was advanced via hand auger in the vicinity of SS06 to a terminal depth of 4 feet bgs. Discrete soil samples were collected from the delineation borehole at depths ranging from 1-foot to 4 feet bgs, and soil was field screened for VOCs utilizing a calibrated PID and chloride utilizing Hach® chloride QuanTab® test strips. Photographic documentation of the sampling activities is included in Appendix B. The soil sampling activities were conducted immediately following a rain event. Slight pooling in adjacent lined containments and saturation on the pad surface can be seen as a result of this rain event, not resulting from a release. Field screening results and observations for the borehole were logged on a lithologic/soil sampling log, which are included in Appendix C. The delineation soil sample locations were mapped utilizing a handheld global positioning system (GPS) unit and are depicted on Figure 2.

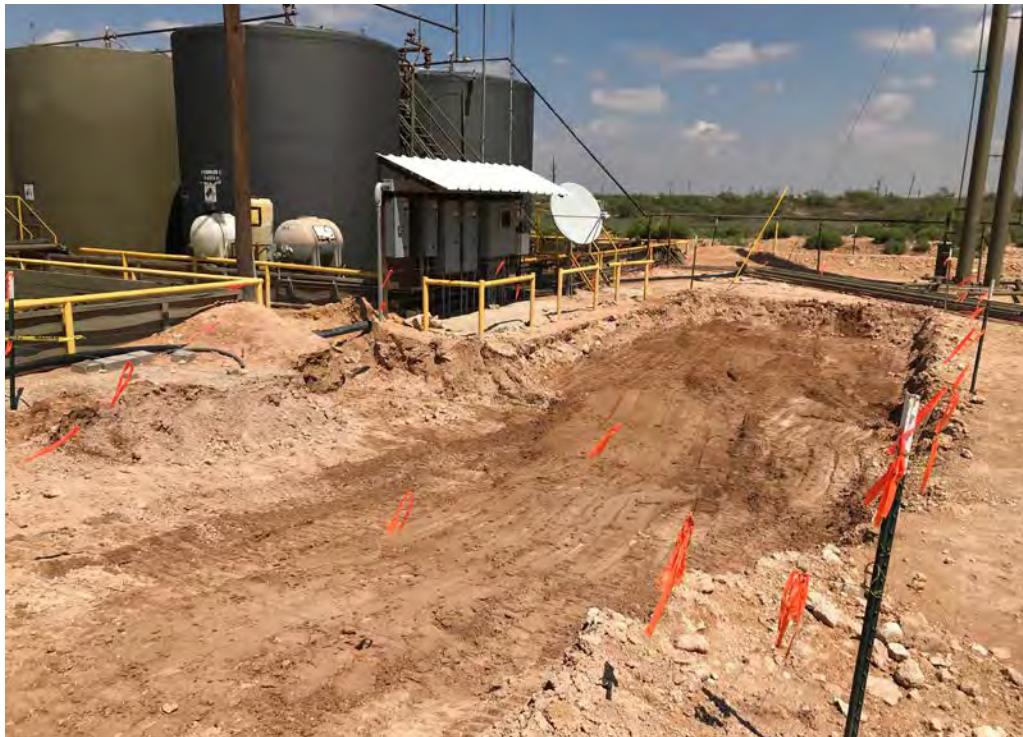
Photograph 1: View east of tank battery and excavation.

The final excavation measured approximately 926 square feet in area with a depth of approximately 1.5 feet bgs throughout the excavation. The horizontal extent of the excavation is illustrated on Figure 2. Approximately 58.7 cubic yards of impacted soil were removed using a skidsteer and hydro-excavator. Impacted soil was transported and properly disposed of at the Lea Land Landfill, in Eunice, New Mexico.

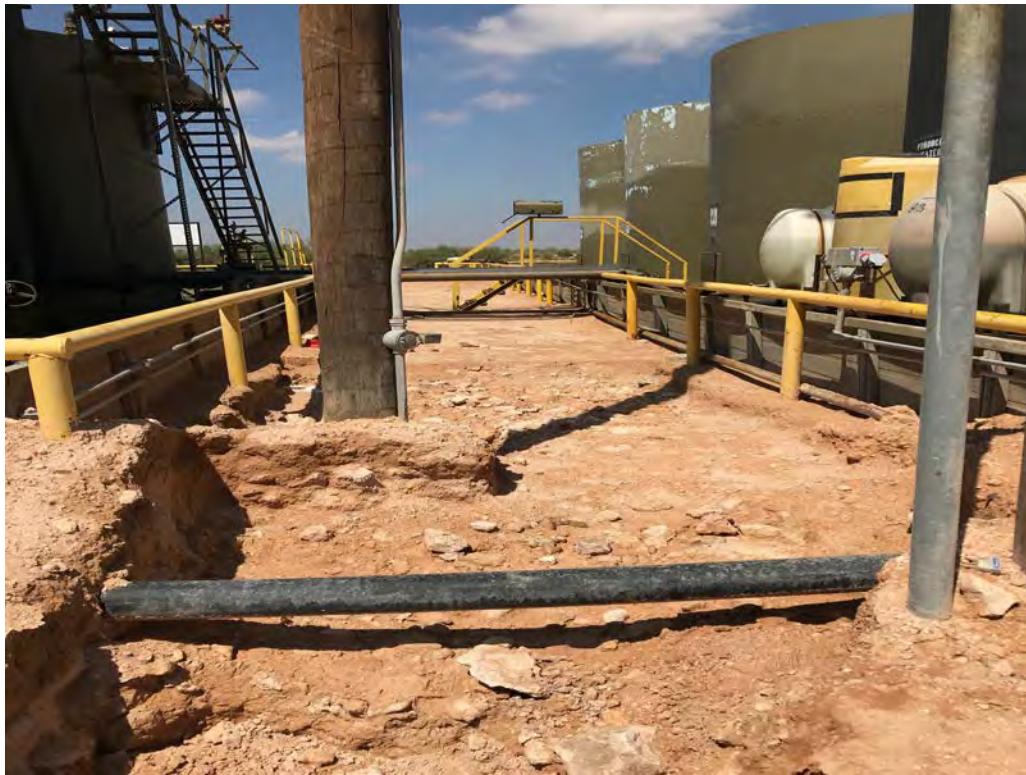
Photograph 2: View north of tank battery and excavation.

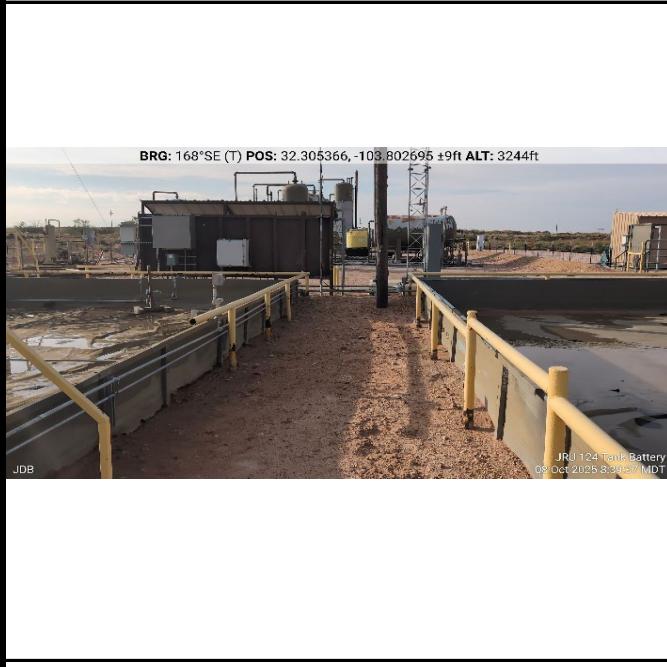
Photograph: 1

Description: Delineation activities; near SS11

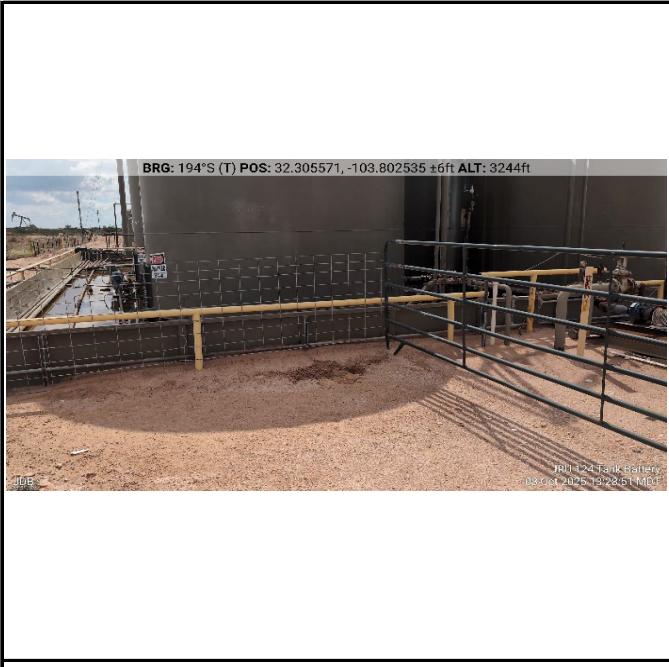
Photograph: 2

Description: Delineation activities; near SS12

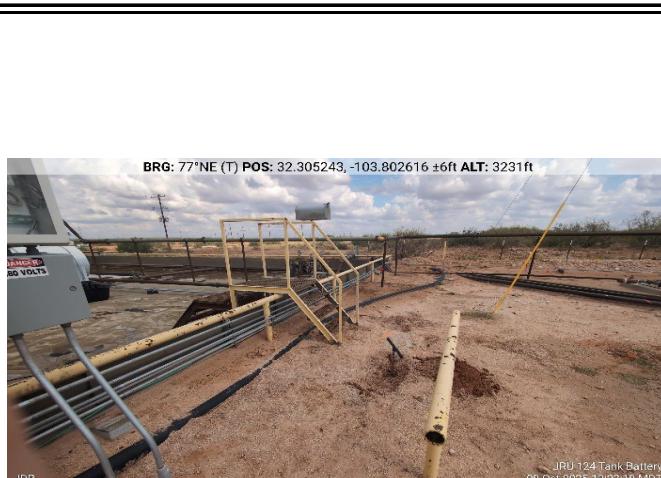
Photograph: 3

Description: Delineation activities; near SS06
