## **Release Assessment and Deferral**

**PLU Big Sinks 25 Federal Battery  
Unit B, Section 36, Township 24 South, Range 30 East  
Facility ID: fAPP2123047138  
County: Eddy  
Vertex File Number: 25A-03510**

**Date:**  
December 2025

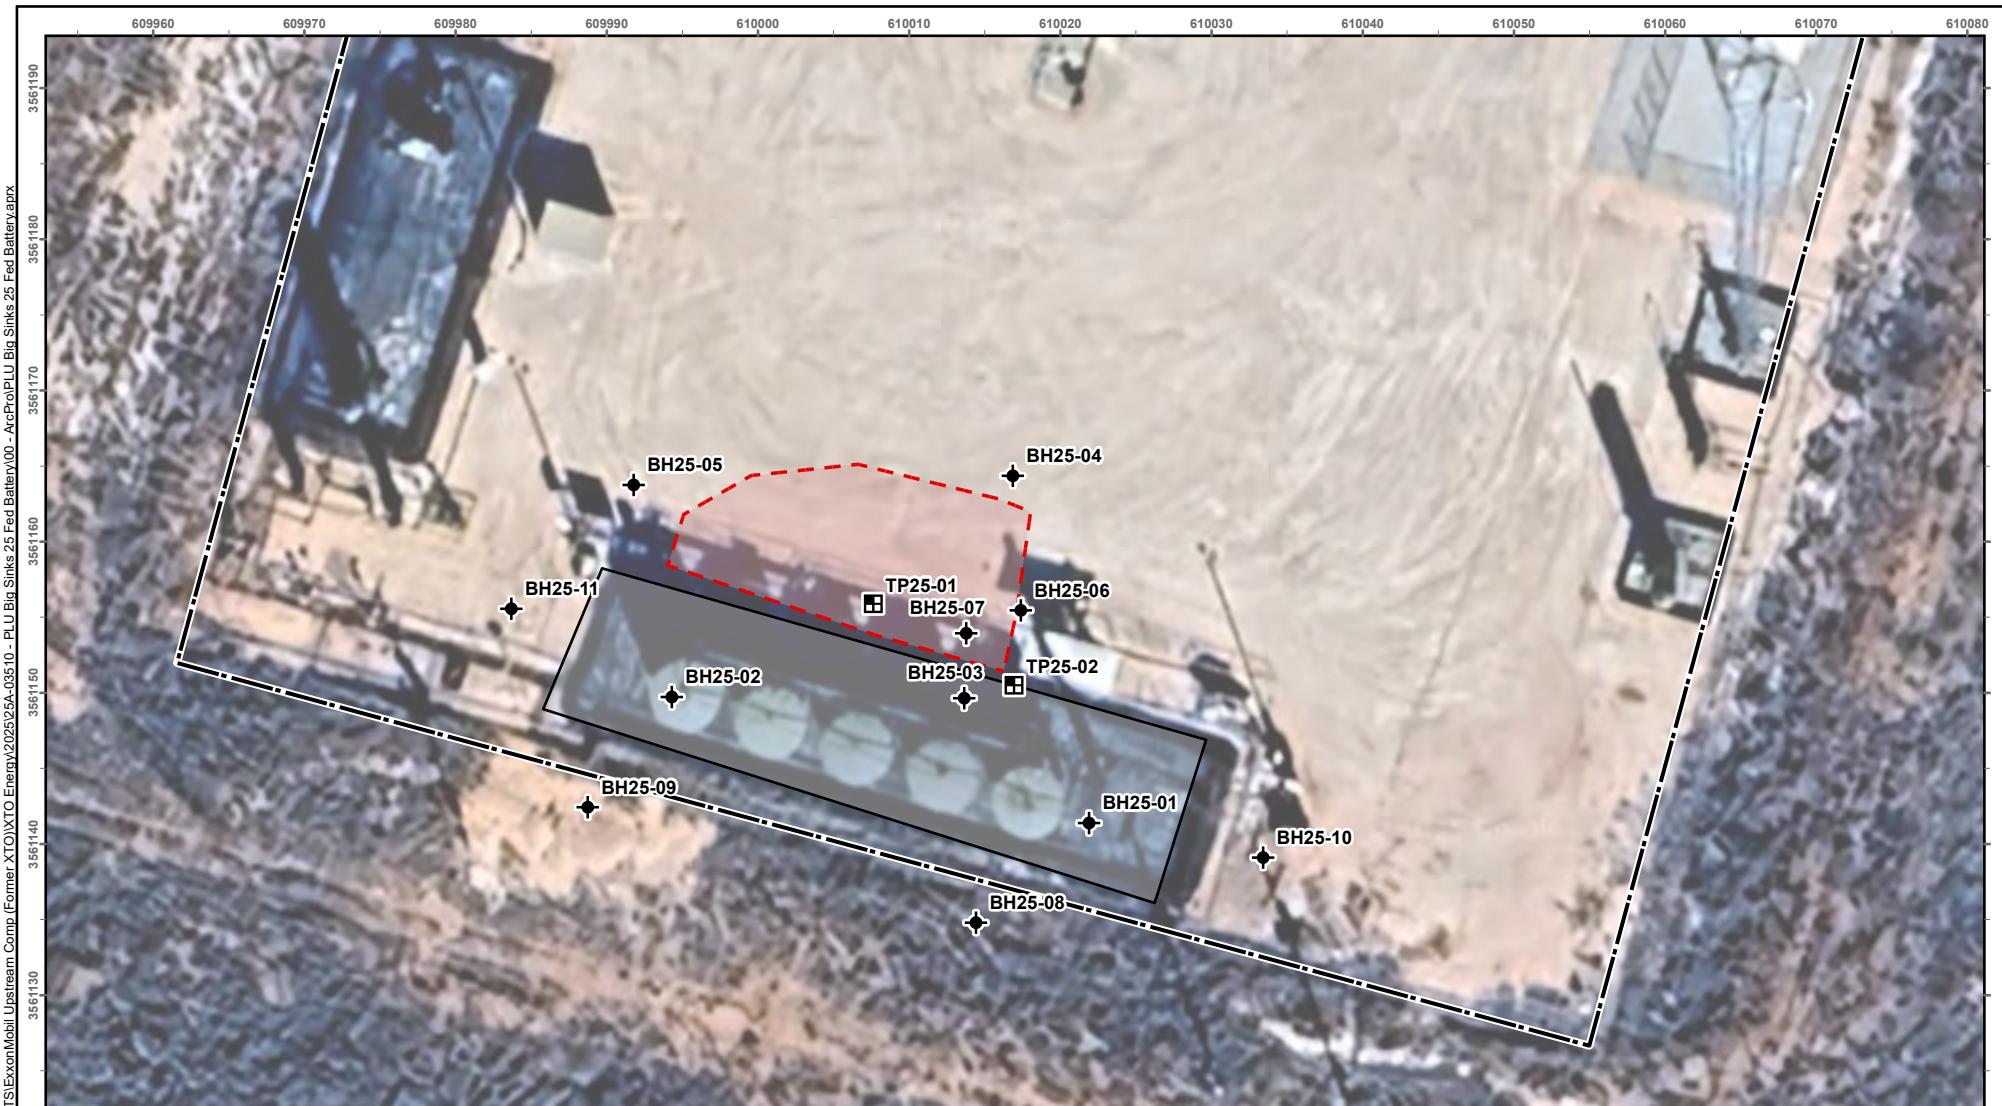
◆ Borehole      ■ Approximate Lease Boundary  
■ Trench Sample      ■ Approximate Release Extent (~212 sq.ft.)

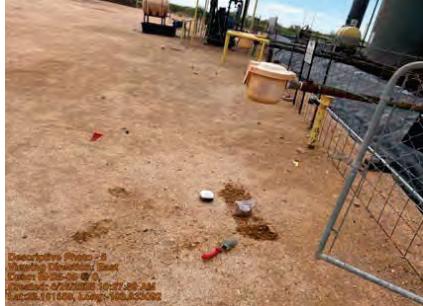
<p><b>Descriptive Photo - 6</b> Viewing Direction: East Date: BH25-05 @ 0' Stepped out 10' Created: 05/07/2019 11:07:54 AM Latitude: 31.1000000000 Longitude: -105.88200000</p> <p><b>BH25-05 @ 0'</b></p>	<p><b>Viewing Direction: East</b></p>

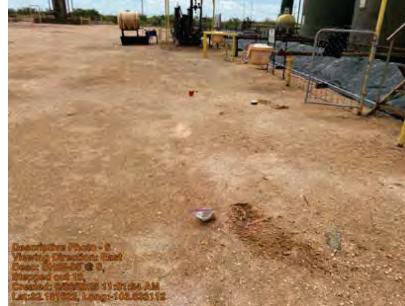
<p><b>Descriptive Photo - 6</b> Viewing Direction: East Date: BH25-05 @ 0' Stepped out 10' Created: 05/07/2019 11:07:54 AM Latitude: 31.1000000000 Longitude: -105.88200000</p> <p><b>BH25-05 @ 0' Stepped out 10'</b></p>
<p><b>Viewing Direction: South</b></p>

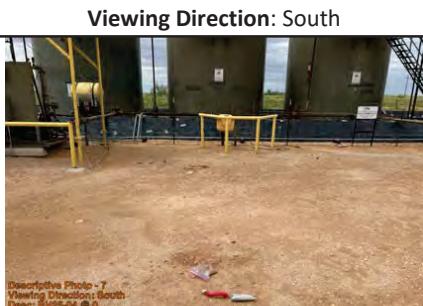
<p><b>Descriptive Photo - 7</b> Viewing Direction: South Date: BH25-04 @ 0' Stepped out 10' Created: 05/07/2019 11:07:54 AM Latitude: 31.1000000000 Longitude: -105.88200000</p> <p><b>BH25-04 @ 0' Stepped out 10'</b></p>	<p><b>Viewing Direction: East</b></p>

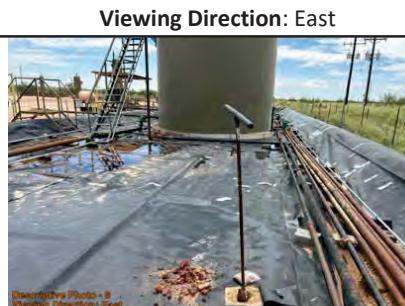
<p><b>Descriptive Photo - 8</b> Viewing Direction: East Date: BH25-02 @ 1' Stepped out 10' Created: 05/07/2019 11:07:54 AM Latitude: 31.1000000000 Longitude: -105.88200000</p> <p><b>BH25-02 @ 1'</b></p>

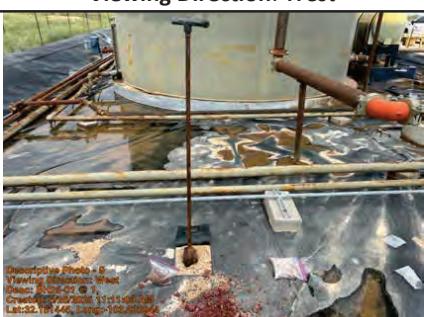
<p>Viewing Direction: West</p>

<p>Descriptive Photo - 0 Viewing Direction: West Date: 06/26/25 @ 11:10 AM Depth: 0' to 10' @ 1' intervals Lat: 32.101444, Long:-103.520244</p>	<p>Viewing Direction: North</p>

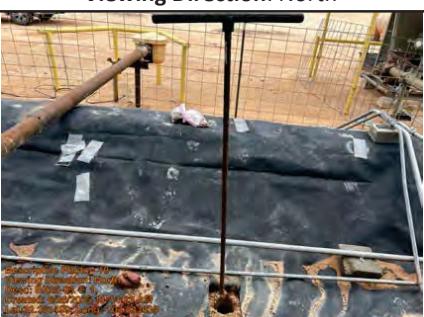
<p>Descriptive Photo - 1 Viewing Direction: North Date: 06/26/25 @ 11:10 AM Depth: 0' to 10' @ 1' intervals Lat: 32.101444, Long:-103.520244</p>
<p>BH25-01 @ 1'</p>	<p>BH25-03 @ 1'</p>
<p>Viewing Direction: South</p>

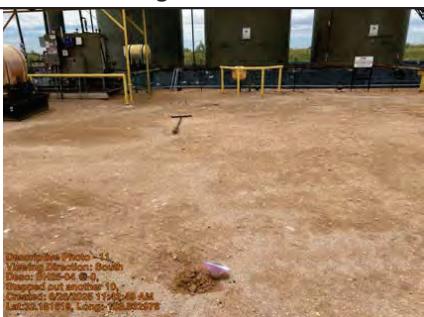
<p>Descriptive Photo - 3 Viewing Direction: South Date: 06/26/25 @ 11:10 AM Depth: 0' to 10' @ 1' intervals Lat: 32.101444, Long:-103.520244</p>	<p>Viewing Direction: East</p>

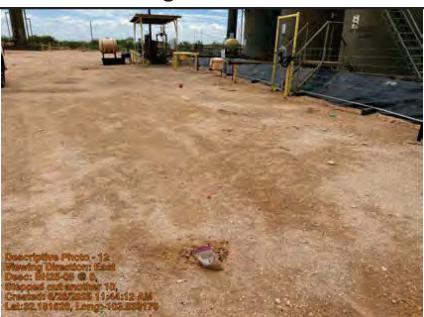
<p>Descriptive Photo - 12 Viewing Direction: East Date: 06/26/25 @ 11:10 AM Depth: 0' to 10' @ 1' intervals Lat: 32.101444, Long:-103.520244</p>
<p>BH25-04 @ 0' Stepped out another 10'</p>	<p>BH25-05 @ 0' Stepped out another 10'</p>

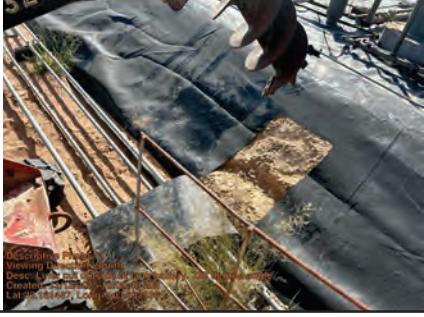
<p><b>Viewing Direction: South</b></p>

<p>Descriptive Photo Viewing Direction: South Date: 11/14/2025 7:27:00 PM UTC Created: 11/14/2025 7:27:00 PM UTC Last Edit: 11/14/2025 7:27:00 PM UTC</p>	<p><b>Viewing Direction: Southeast</b></p>

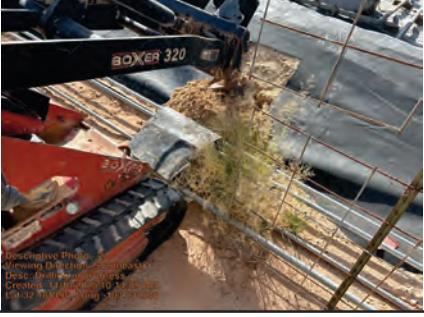
<p>Descriptive Photo Viewing Direction: Southeast Date: 11/14/2025 7:27:00 PM UTC Created: 11/14/2025 7:27:00 PM UTC Last Edit: 11/14/2025 7:27:00 PM UTC</p>
<p>Liner cut outside of tank battery. 195 degree angle</p>	<p>Drilling in progress</p>
<p><b>Viewing Direction: Southeast</b></p>
