## **SITE CHARACTERIZATION, ASSESSMENT, AND CLOSURE REPORT**

**ROSS DRAW LAYFLAT  
NMOCD INCIDENT ID #nAPP2521369867  
32.0060278, -103.7454167  
UNIT B, SECTION 35 T26S-R31E  
EDDY COUNTY, NEW MEXICO**

**EOG RESOURCES, INC.  
5509 CHAMPIONS DR.  
MIDLAND, TEXAS 79706**

**RANGER ENVIRONMENTAL SERVICES, LLC  
P.O. BOX 201179  
AUSTIN, TEXAS 78720**

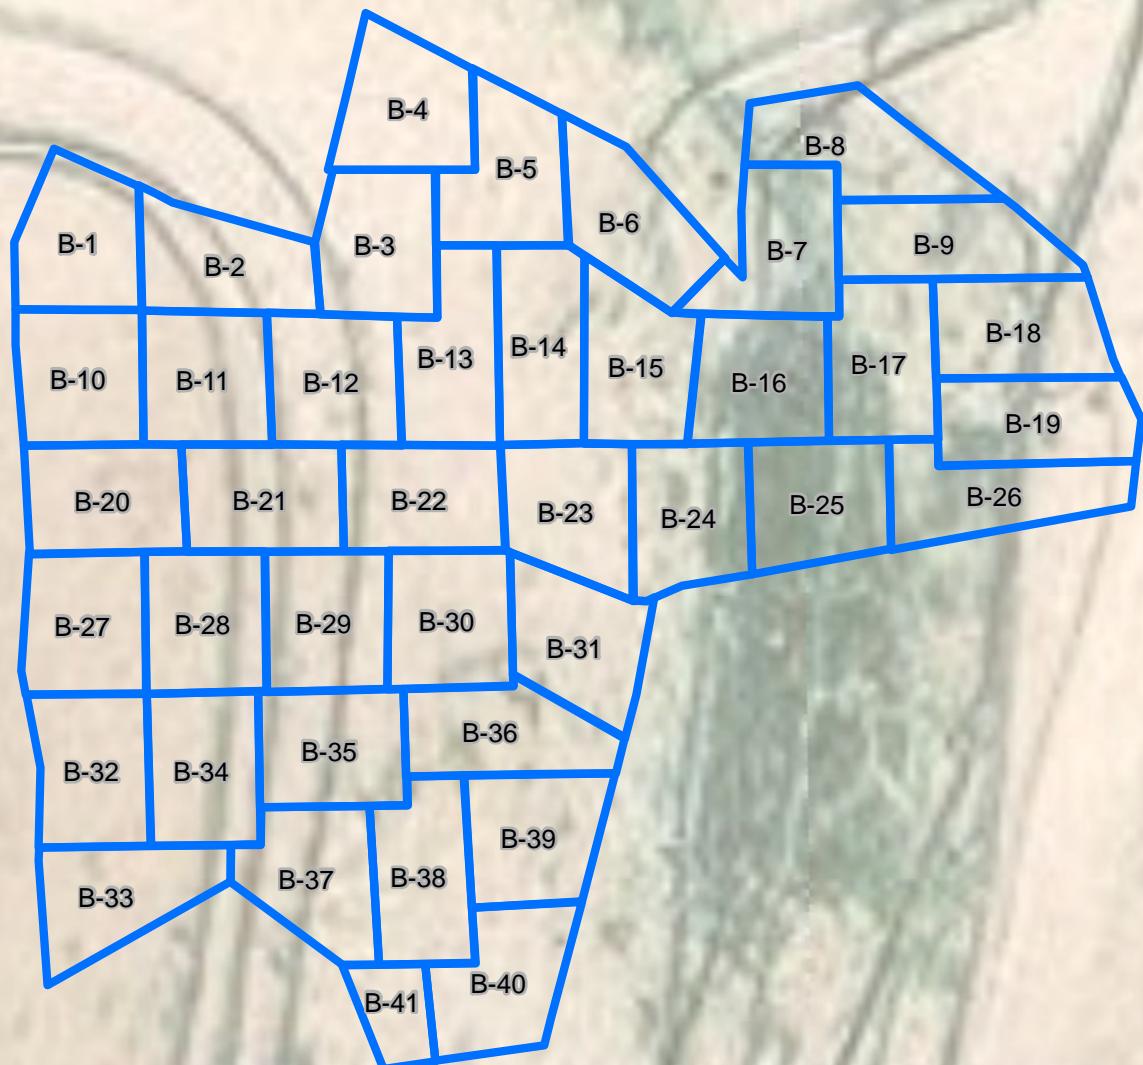
Confirmation Sample Area

Based upon the observed impact area associated with the release, a total of 41 confirmation soil samples were collected from the surface of the impacted area. The cleanup confirmation soil samples were collected in accordance with NMAC 19.15.29.12 Subsection D as representative five-point composite samples with each composite sample representative of no more than 200 square feet. Upon collection, the soil samples were submitted to Cardinal Labs in Hobbs New Mexico for analysis of total petroleum hydrocarbons (TPH) using EPA Method 8015; benzene, toluene, ethylbenzene and xylenes (BTEX) using EPA Method 8021; and, and total chloride using Method SM 4500. A copy of the laboratory analytical reports including chain-of-custody documentation is attached.

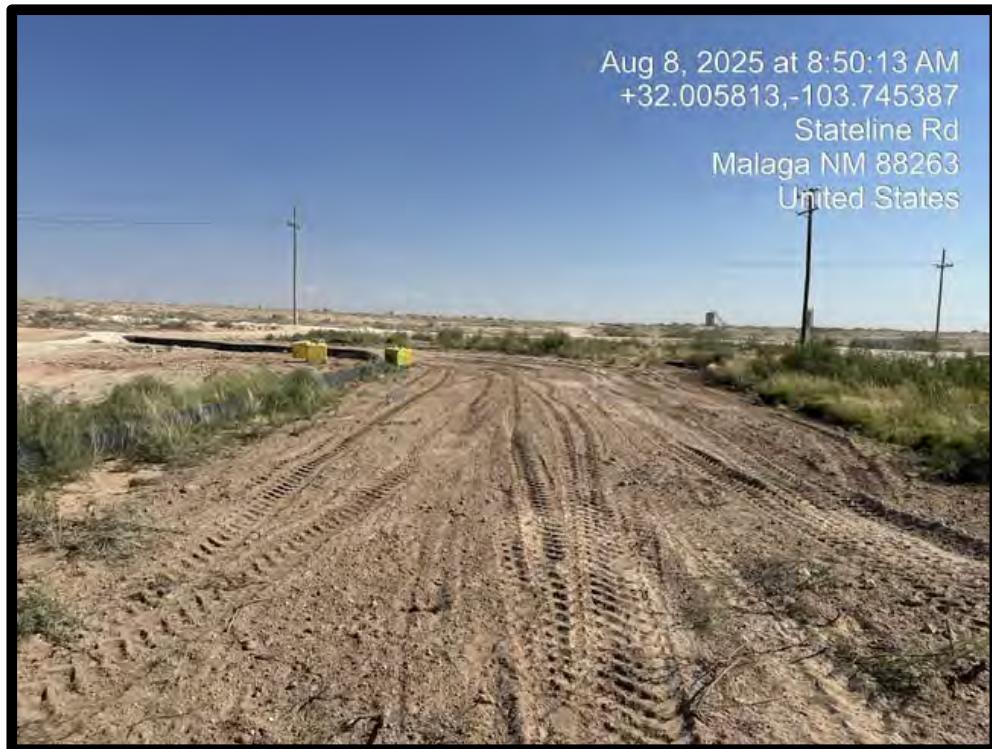
In order to document impacts associated with the release, on August 8, 2025, Ranger personnel mobilized to the Site and completed a preliminary inspection. Upon inspection, no free standing fluids were observed, however, the impacted area was visible due to saturated soils. Vegetation in the area did not show signs of impact and no obvious adverse conditions were observed in the impact area. Using a GPS unit capable of submeter accuracy, Ranger personnel documented the apparent area impacted by the release.

**PHOTOGRAPH NO. 1 – A view of the Site during the initial Ranger site visit on August 8, 2025. The view is towards the north.**

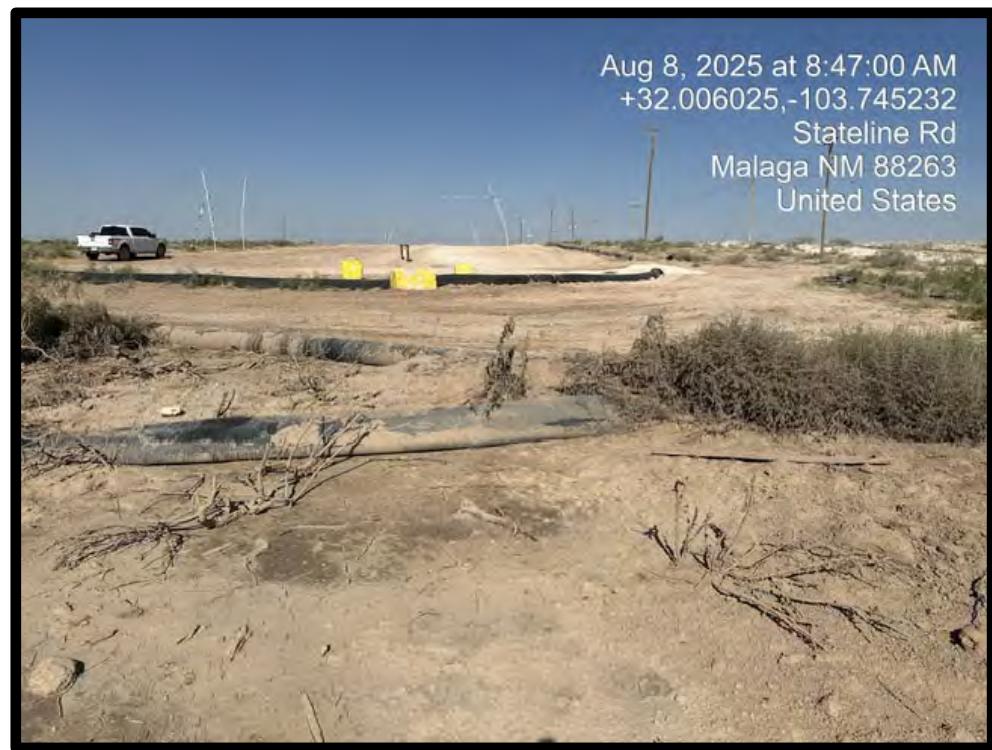
**PHOTOGRAPH NO. 2 – An additional view of the initial Ranger site visit on August 8, 2025. The view is towards the west.**

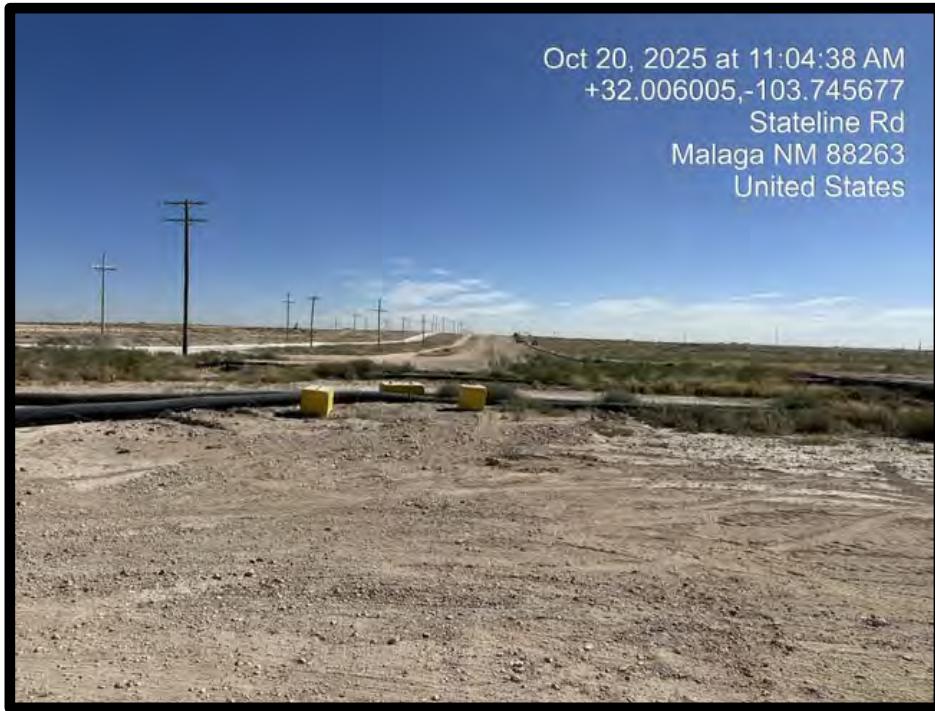
In order to assess soil conditions and determine if remedial efforts were warranted in the area impacted by the release, Ranger personnel returned to the site on October 20, 2025 to complete additional assessment efforts. The assessment included the collection of a total of 13 discrete grab samples for field screening purposes. The assessment samples were collected at ground surface level from various locations within the observed impact area.

**PHOTOGRAPH NO. 3 – A view of the Site during the October 20, 2025 assessment activities. The view is towards the east.**

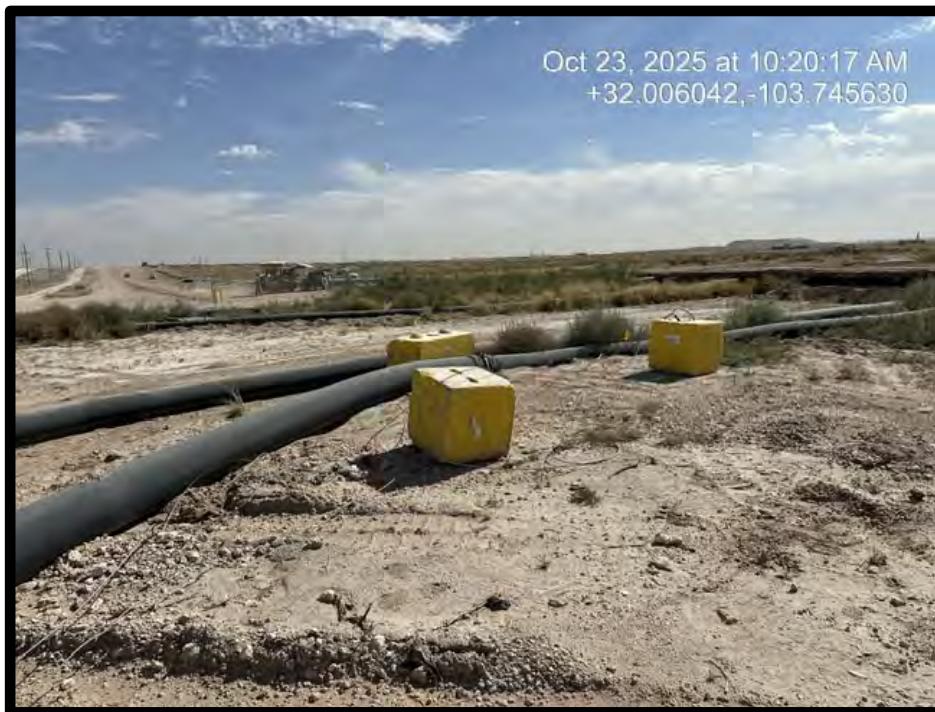
In order to confirm the observed field readings, Ranger personnel returned to the Site on October 23, 2025 to collect confirmation soil samples from the impacted area.

**PHOTOGRAPH NO. 4 – A view of the Site during the October 23, 2025 confirmation sampling activities. The view is towards the southeast.**

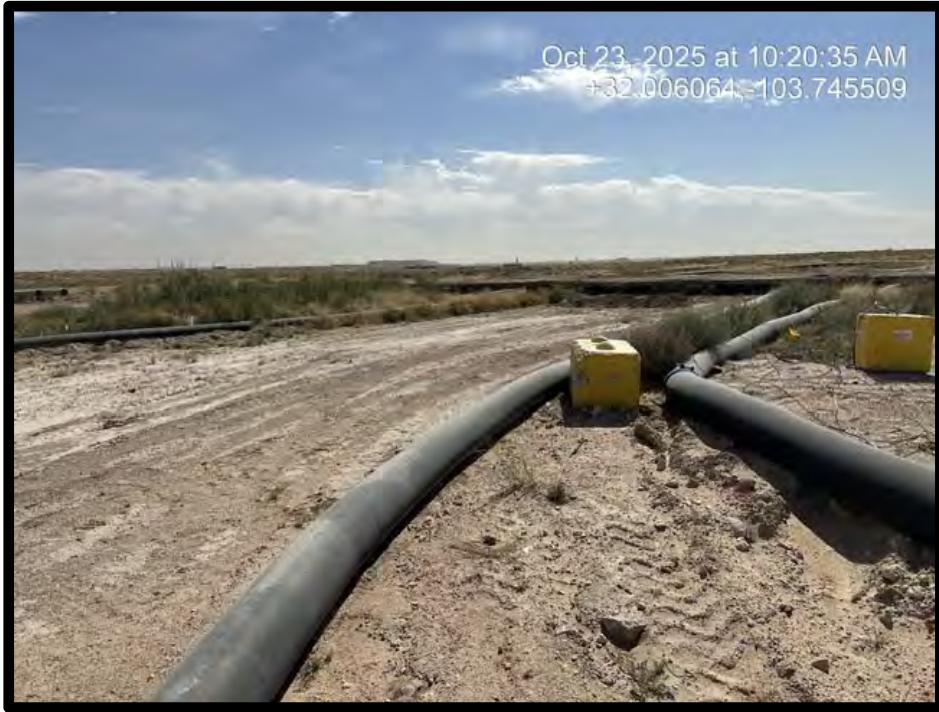
**PHOTOGRAPH NO. 5** – An additional view of the Site during the October 23, 2025 confirmation sampling activities. The view is towards the south-southeast.

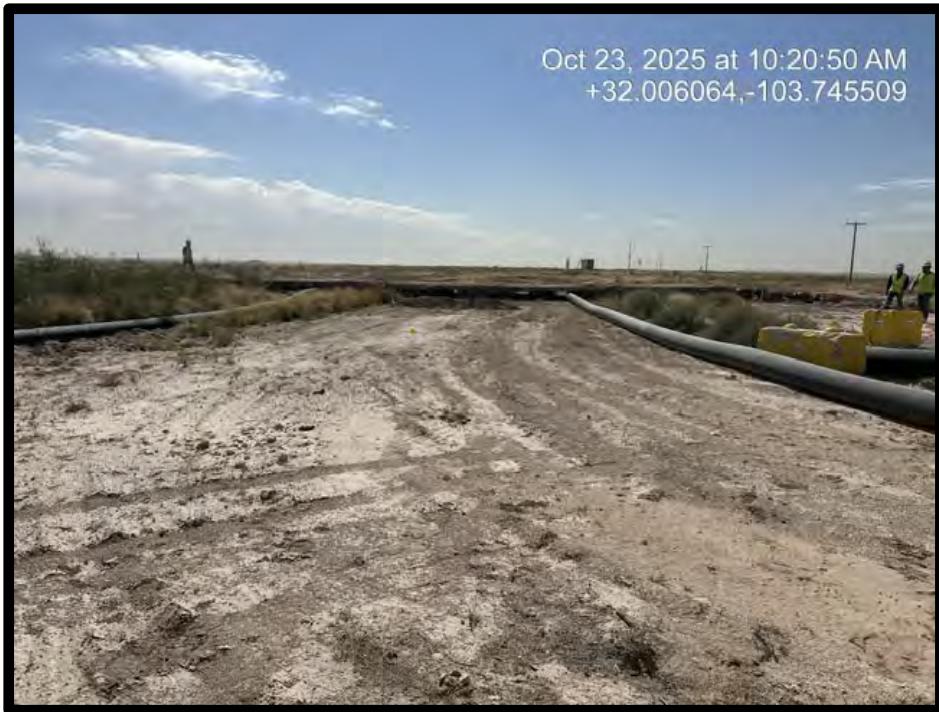
**PHOTOGRAPH NO. 6** – An additional view of the Site during the October 23, 2025 confirmation sampling activities. The view is towards the south.
