**Re: Closure Request
Corral Canyon Expansion
Incident Number nAPP2526633829
Eddy County, New Mexico**

Ensolum, LLC (Ensolum) on behalf of XTO Energy, Inc. (XTO), has prepared this *Closure Request* to document site assessment, excavation, soil sampling activities, and the results of a karst survey at the Corral Canyon Expansion (Site). The purpose of the assessment and soil sampling activities was to assess for the presence or absence of impacts to soil following a release of produced water. Based on field observations, field screening activities, and soil sample laboratory analytical results, XTO is submitting this *Closure Request*, describing remedial activities that have occurred and requesting no further remediation for Incident Number nAPP2526633829.

XTO Energy, Inc
 Corral Canyon Expansion
 Incident Number: nAPP2526633829
 Unit P, Section 05, T 25S, R 29E
 Eddy County, New Mexico

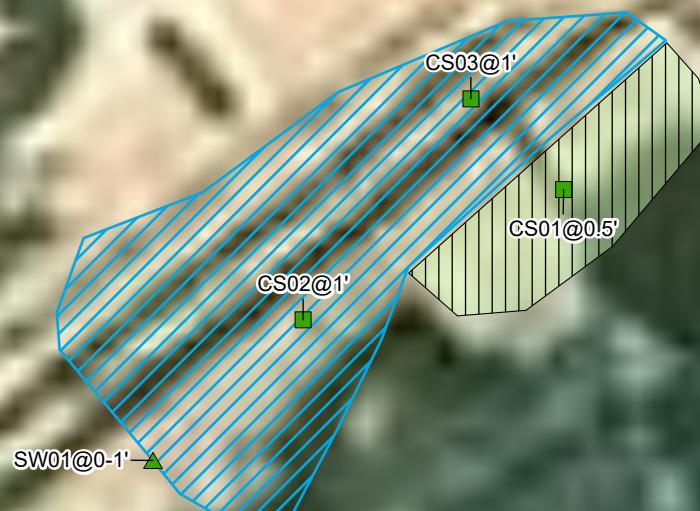
Impacted soil was surface scraped and excavated from the release area as indicated by visible staining. Surface scraping and excavation activities were performed using hand shovels and transport vehicles. The excavation occurred on the well pad, near active production equipment, pipelines, and support structures. To direct excavation activities, Ensolum personnel screened soil for VOCs and chloride as described above. Following the removal of impacted soil, Ensolum personnel collected 5-point composite soil samples representing no more than 200 square feet from the sidewalls and floor of the excavation or surface of the scraped extent. The 5-point composite soil samples were collected by placing five equivalent aliquots of soil into a 1-gallon, resealable plastic bag and homogenizing the samples by thoroughly mixing. Confirmation soil samples CS01 through CS03 were collected from the release extent at depths ranging from 0.5 feet to 1-foot bgs. Confirmation sidewall soil sample SW01 was collected from the sidewall of the excavation at depths ranging from ground surface to 1-foot bgs. The excavation extent and confirmation soil sample locations are presented on Figure 3.
