Re: Deferral Request
Corral Canyon 8 Satellite
Incident Number nAPP2501553916
Eddy County, New Mexico

XTO Energy, Inc.
Deferral Request
Corral Canyon 8 Satellite

Environmental Karst Study Report

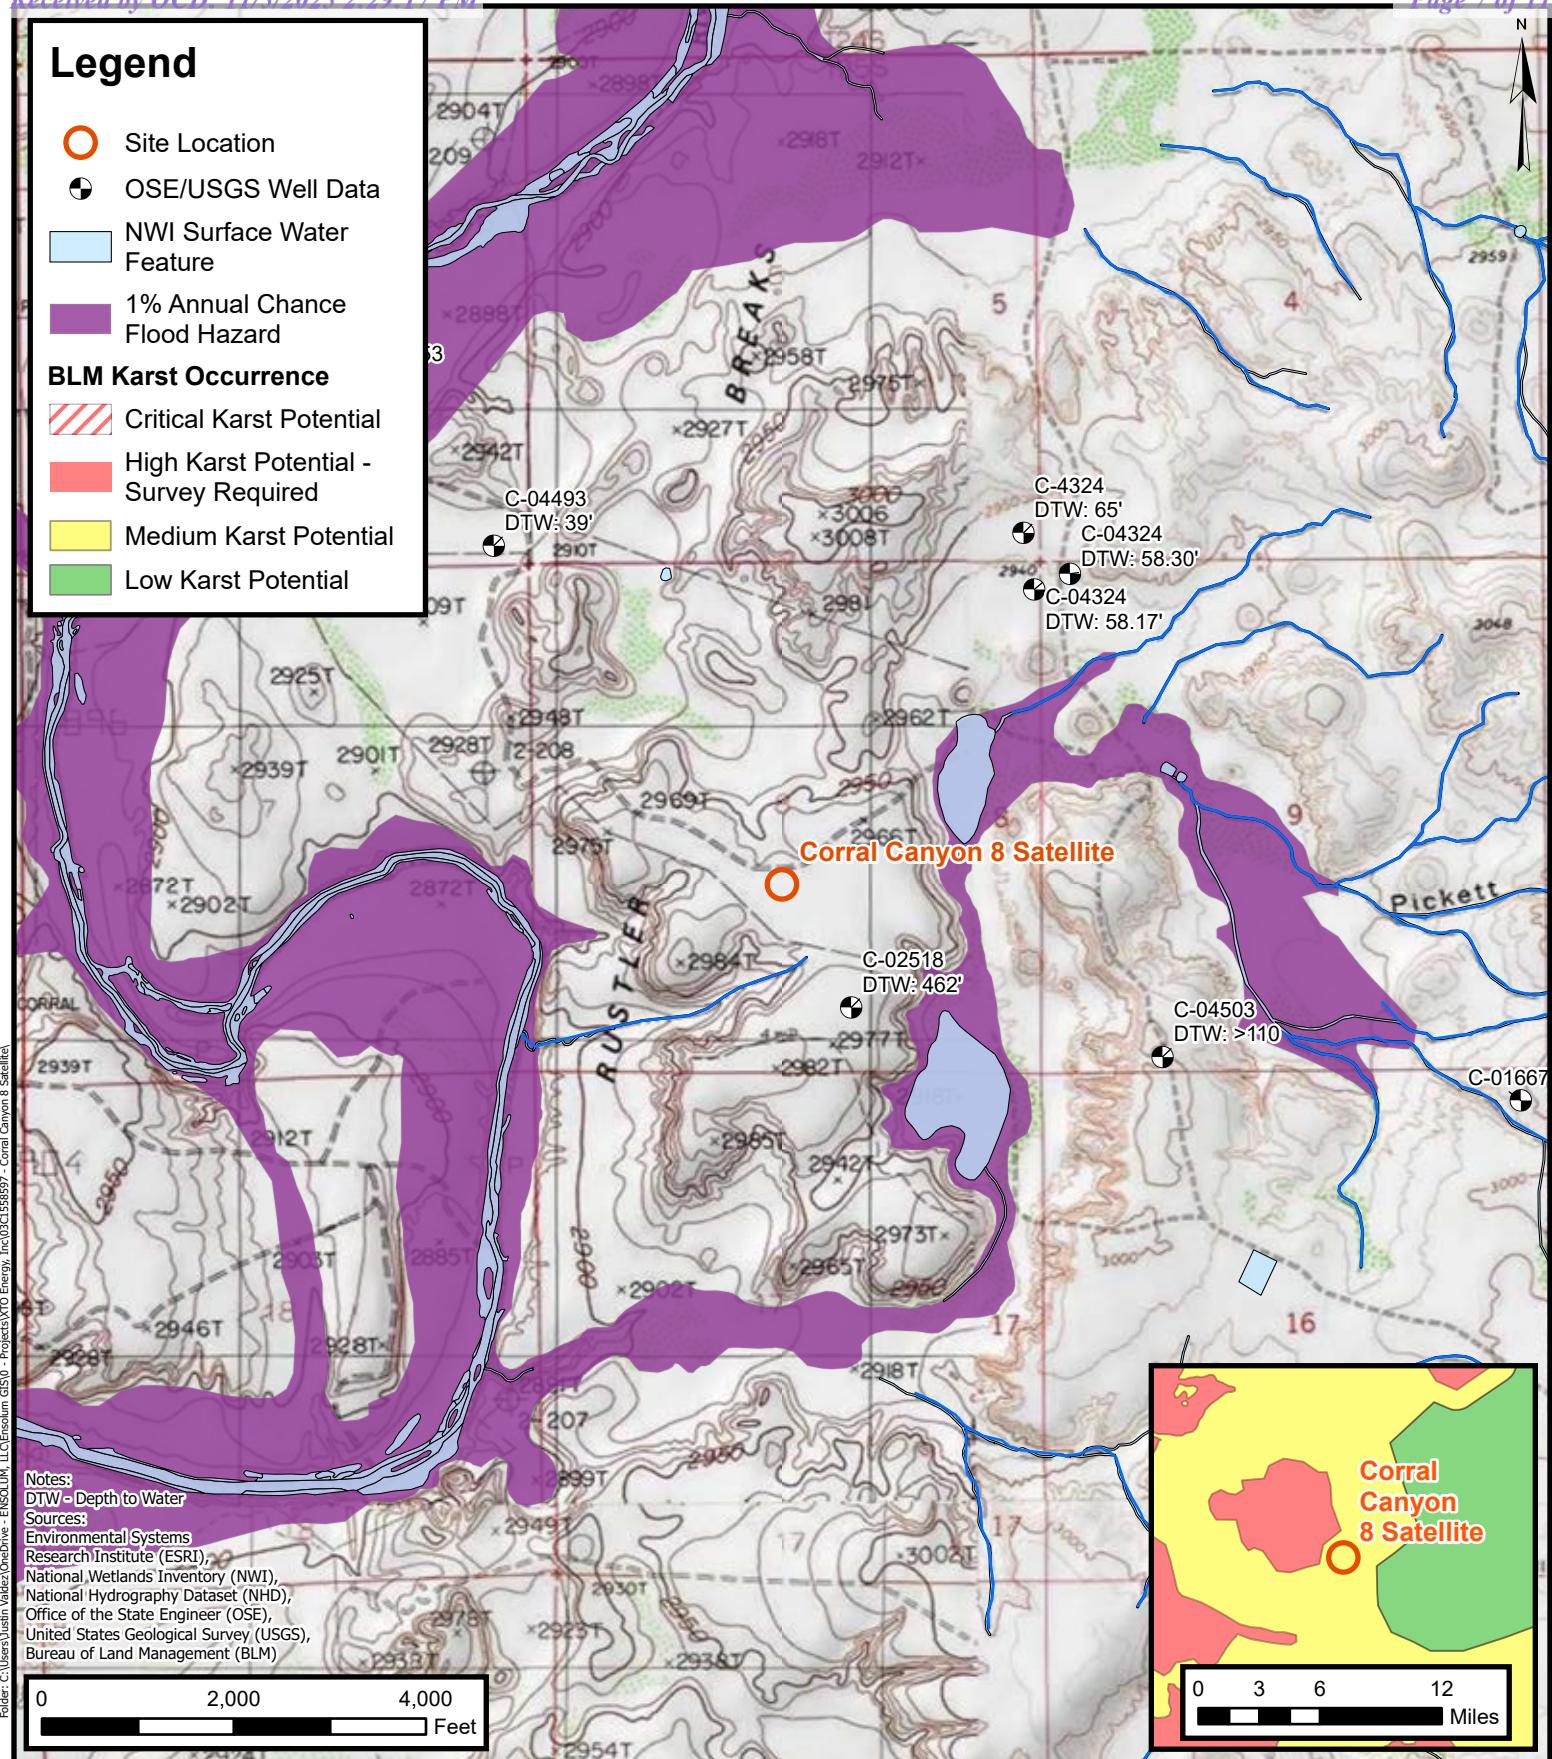
FIGURE
1

The Site was characterized to assess the applicability of Table I, Closure Criteria for Soils Impacted by a Release, of Title 19, Chapter 15, Part 29 (19.15.29) of the New Mexico Administrative Code (NMAC). Results from the characterization desktop review are presented below and potential Site receptors are identified on Figure 1.

Site Receptor Map
XTO Energy, Inc
Corral Canyon 8 Satellite
Incident Number: nAPP2501553916
Unit J & K-08-25S-29E
Eddy County, New Mexico

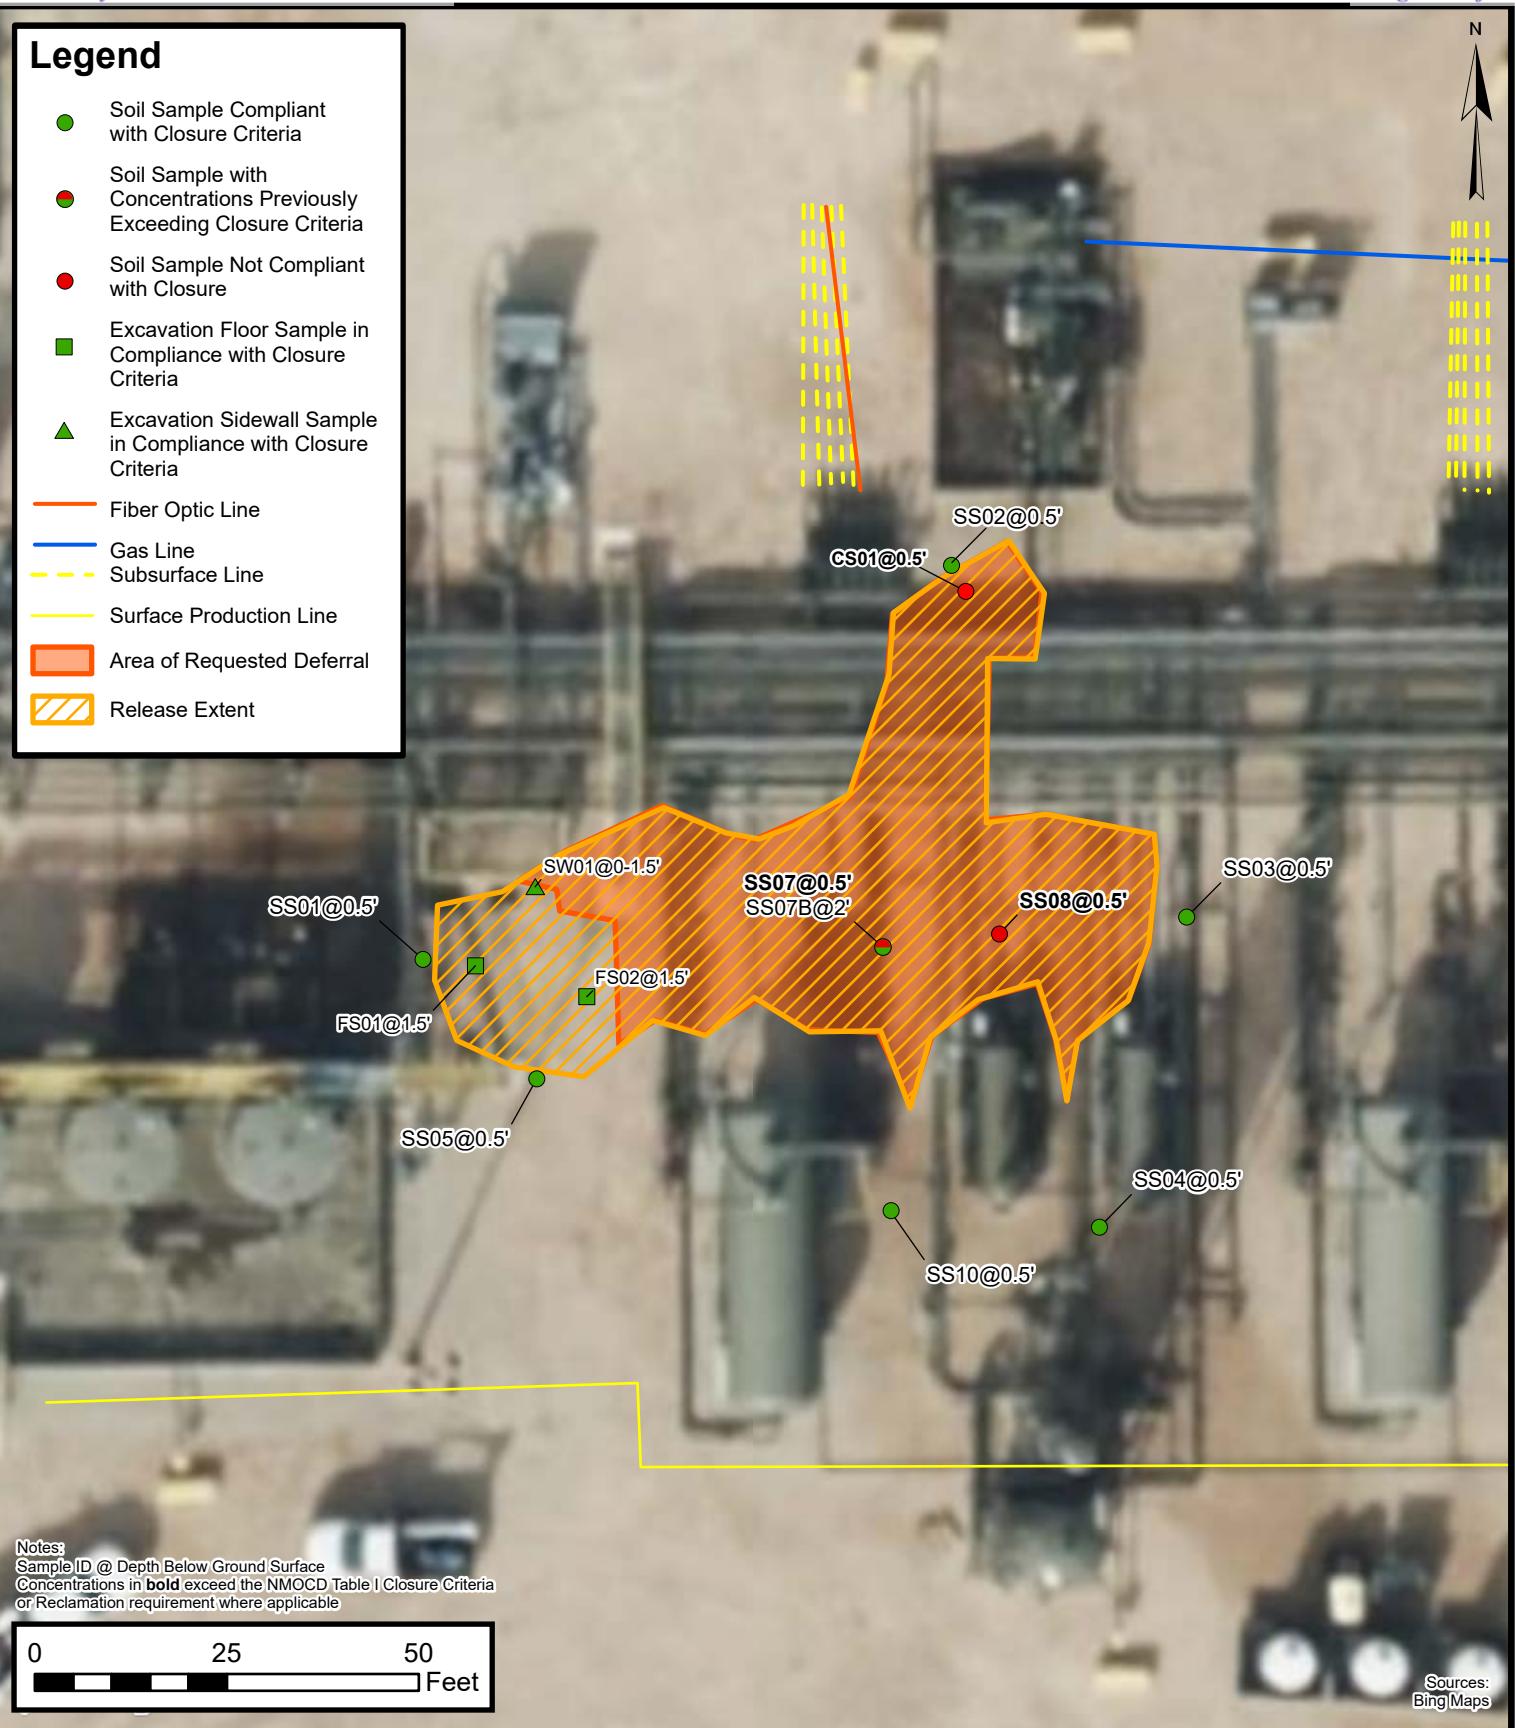
Area of Requested Deferral

XTO Energy, Inc
 Corral Canyon 8 Satellite
 Incident Number: nAPP2501553916
 Unit J & K-08-25S-29E
 Eddy County, New Mexico

Based on the Site conditions and following OSHA Excavation Standards, the RPE recommendation indicates excavation should not be completed within 37 feet from the edge of the Horizontal Separator A footing and no less than 20 feet from the edge of the Horizontal Separators B and C. The RPS recommendation indicates excavation should not be completed within 18 feet 10 inches from the edge of the pipe rack footing to prevent disruption of the stability of underlain soil. The RPE recommendation indicates that excavation should not be completed within 37 feet from the edge of the LACT structure footing. Based on the dimensions of the requested excavation and presence of adjacent structures, there is inadequate structure support to conduct excavation of the identified impacted soil in a manner that protects both personnel health and equipment stability.

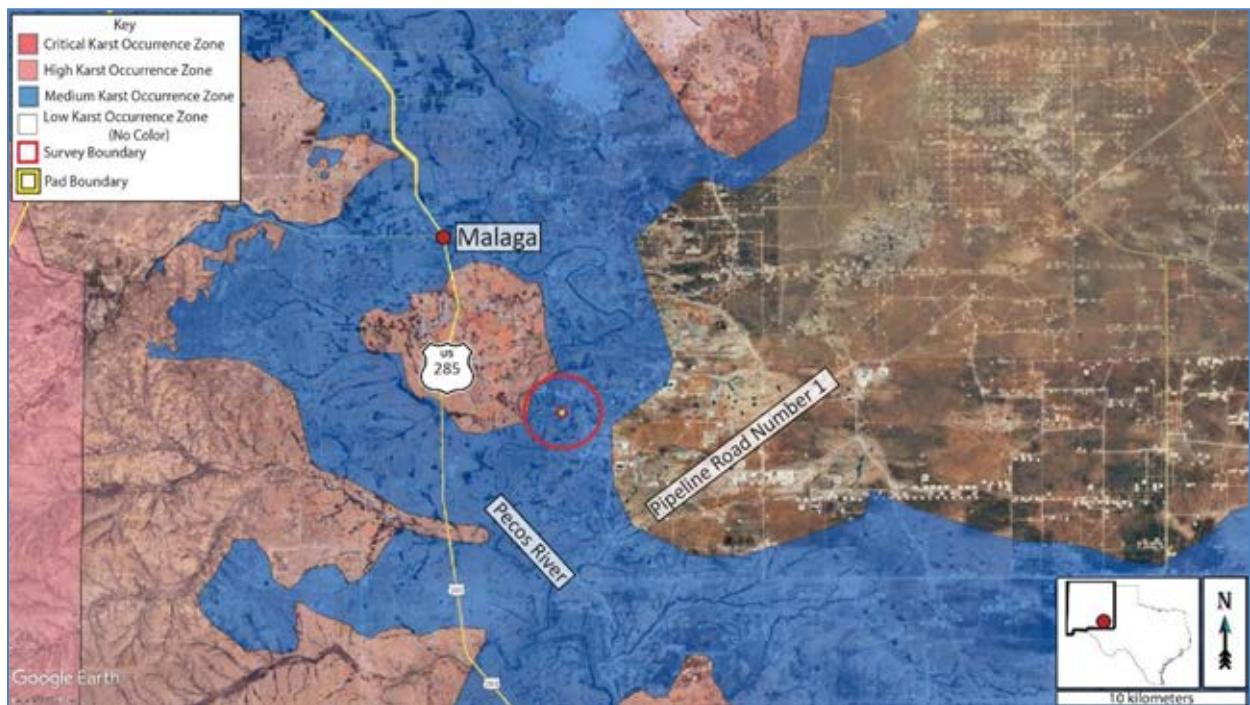
The Bureau of Land Management (BLM) categorizes all areas within the Carlsbad Field Office (CFO) zone of responsibility as having either low, medium, high, or critical cave potential based on geology, occurrence of known caves, density of karst features, and potential impacts to freshwater aquifers^[4]. These designations are also recognized by the New Mexico State Land Office (NMSLO). This project occurs within a **MEDIUM** karst occurrence zone (MKOZ)^[5] (**Figure 1**).

Figure 1: Karst occurrence zone overview. Background image credit: Google Earth. Image date: August 21, 2024. Image datum: WGS-84.

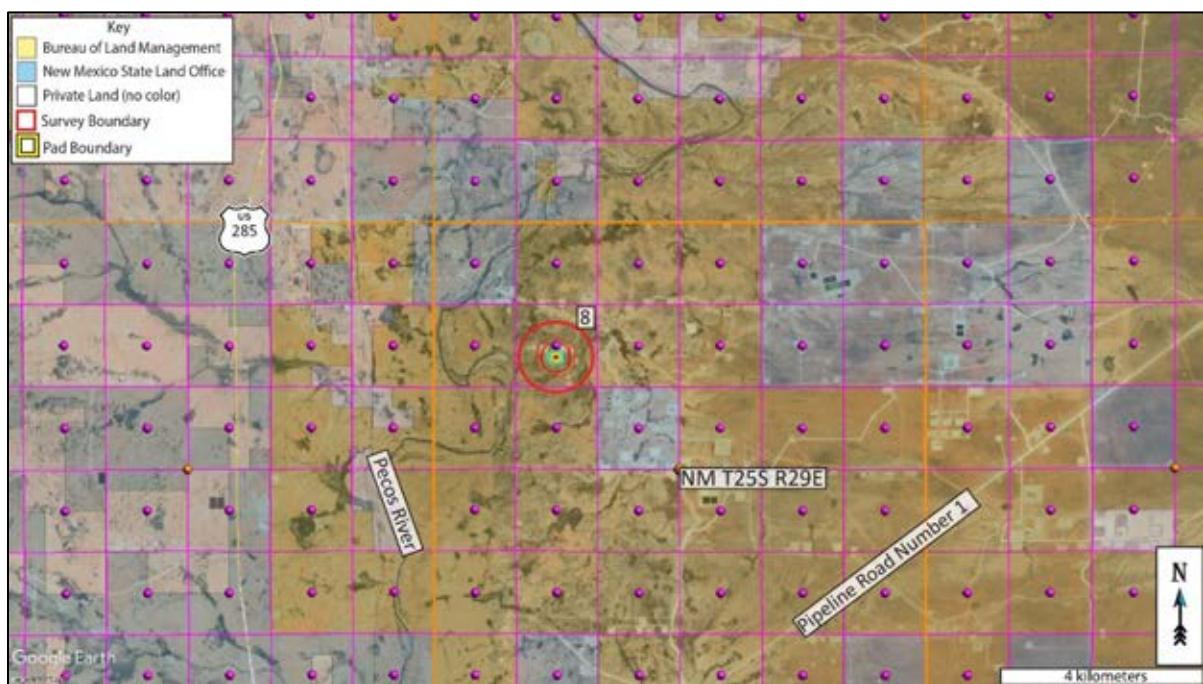
Figure 2: Land ownership and PLSS overview. Background image credit: Google Earth. Image date: March 20, 2023. Image datum: WGS-84.

The site is located 11.1 kilometers (6.9 miles) southeast of Malaga, New Mexico, east of US Highway 285 and northwest of Pipeline Road Number 1. The release site is located within section 8, NM T25S R29E^[6] (**Figure 1** and **Figure 2**). The region has flat-lying terrain with karstification occurring in the gypssite soils and underlying gypsum and dolomite bedrock^[7] (see section **2.2 Local Geology Summary** for further information). The climate in this area of southeast New Mexico is semi-arid with an average annual precipitation of approximately 13 inches, of which about two-thirds falls as rain during summer thunderstorms from June to October. Summers are hot and sunny while winters are generally mild, with an average maximum temperature of 96°F in July and an average minimum temperature of 28°F in January^[8]. This area is within the Chihuahuan Desert Thornscrub as defined by the Southwestern Regional ReGAP Vegetation map^[9] and the vegetation consists mostly of areas of blue grama, nine-awned pappus grass, burro grass and low scrub including yucca. The spill delineation boundary is located within an MKOZ^[5] (**Figure 1**) and within BLM-CFO managed land^[10] (**Figure 2**).

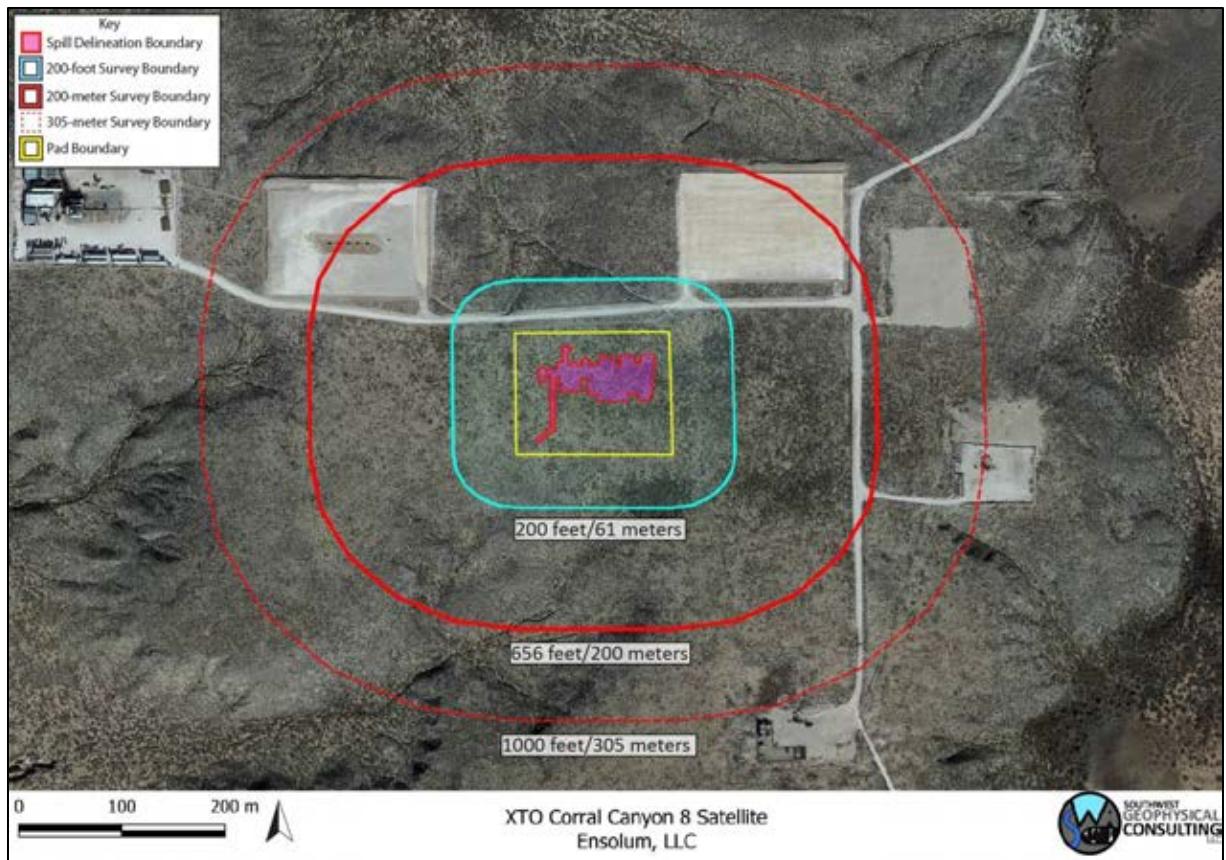
Surface karst surveys are conducted by sUAS at low elevation within 200 meters of the spill delineation boundary^[3] (**Figure 4**) following a preplanned raster pattern flightpath designed for the purpose of generating at least 75% imagery overlap. The collected high-resolution, georeferenced imagery is stitched together to develop orthomosaic imagery which is further developed into a digital elevation model (DEM); the DEM is then processed into a local relief model (LRM) (**Figure 6**). This LRM is color coded to enhance differences in elevation of as little as five centimeters. The orthoimagery, DEM, and LRM are uploaded to a server where they are analyzed by an experienced karst geologist. Finally, the data is reviewed by a senior karst geologist for quality assurance and downloaded into a table for inclusion in a written report^[16].

Figure 4: Surface survey overview. Background image credit: Google Earth. Image date: January 27, 2023. Datum: WGS-84.

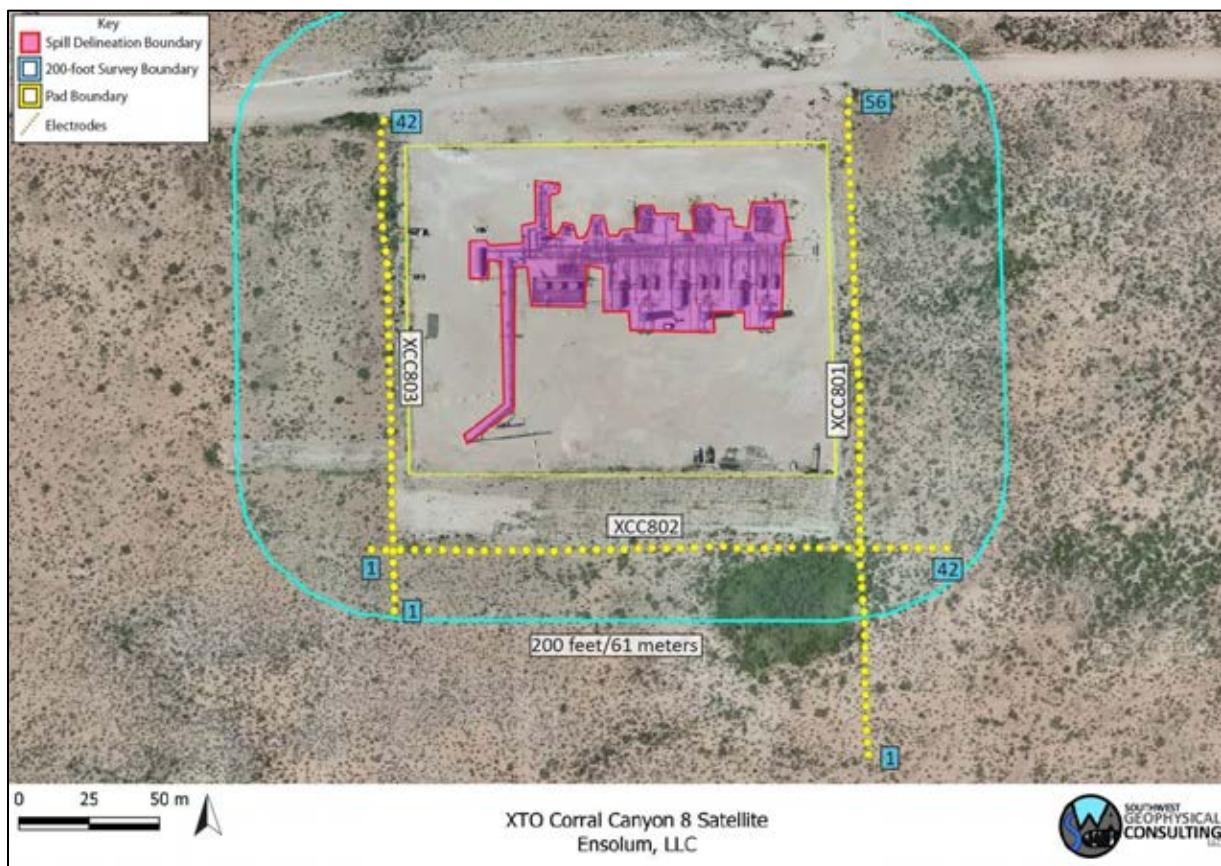
For this survey, an ABEM Terrameter LS 2, two 42-electrode, and one 56-electrode array of 40-centimeter-long electrodes were used to image the subsurface. This survey consisted of three resistivity lines in a dipole-dipole configuration: line XCC801 was laid out south to north, line XCC802 was laid out west to east, and XCC803 was laid out south to north. Line XCC801 consisted of 56 electrodes at 5-meter spacing resulting in a 275-meter-long array and lines XCC802 and XCC803 both consisted of 42 electrodes at 5-meter spacing resulting in 205-meter long arrays (**Figure 5, Table 1**). A preconfigured command file was used to run the data collection (DipoleDipole4x14). The 56-electrode configuration provided a depth of investigation of 55 meters (180 feet) with a resolution of 2.0 to 2.5 meters (6.6 to 8.2 feet). The 42-electrode configuration provided a depth of investigation of 33 meters (108 feet) with a resolution of 2.0 to 2.5 meters (6.6 to 8.2 feet) within the first 5 to 8 meters (16 to 26 feet) from the surface. A Leica GS18 GPS was used to record electrode locations and elevations.

Figure 5: Geophysical survey overview. XCC801 was conducted with 56 electrodes at 5-meter spacing, and both XCC802 and XCC803 were conducted with 42 electrodes at 5-meter spacing (yellow dots denoted with blue numbers). Background image credit: Google Earth. Image date: January 27, 2023. Image datum: WGS-84.

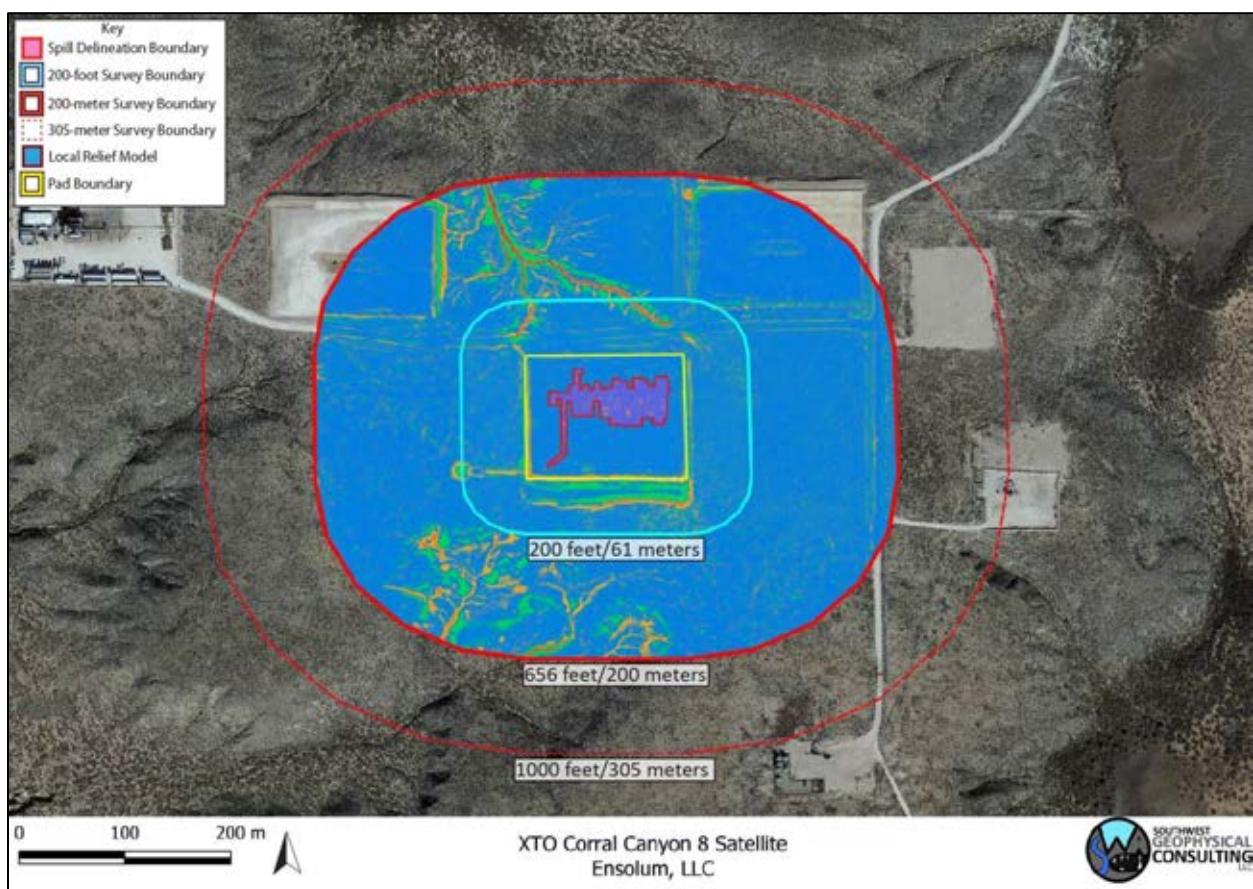
No surface karst features exist within the **200-meter** survey boundary, and no springs exist within the 305-meter (1,000 foot) survey boundary^[1].

The lack of surface karst features does not mean the area is not karstified and the survey area may still contain buried karst features. Caution should be exercised while clearing brush and during any excavation, trenching, or construction operations. Employing a Bureau of Land Management approved karst monitor on site during these operations should be considered.

Figure 6: UAS-conducted surface karst survey results. Background image credit: Google Earth. Image date: March 20, 2023. Image datum: WGS-84.

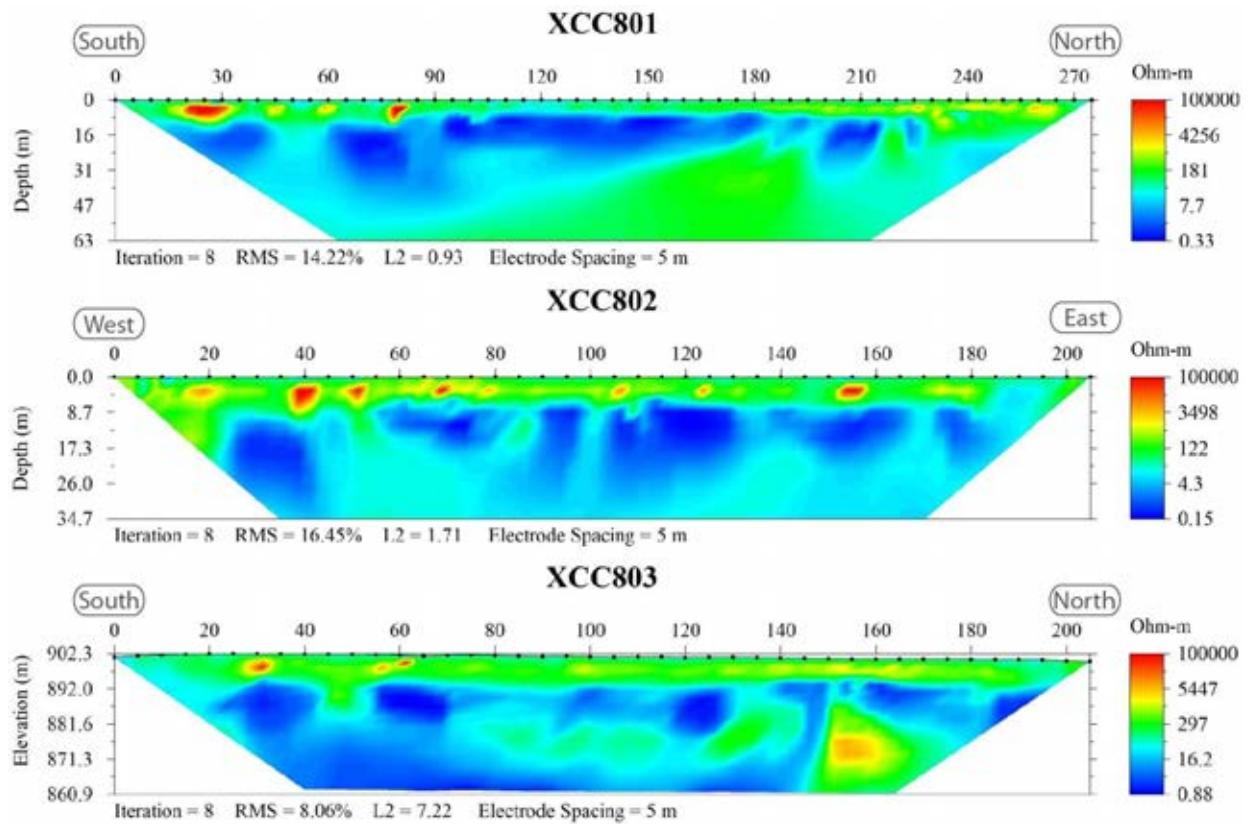
The results of this study indicate a moderately stable geologic system with resistivities between 0.33 and 5,447 Ohm-m with occasional resistivities to 100,000 Ohm-m (**Figure 7**). These high-resistivity anomalies are interpreted to be noise associated with nearby infrastructure. **No anomalies interpreted as underground voids were found in the XCC8 survey area.** Please keep in mind when viewing the 2D inverted resistivity sections that color maps can be widely different for each view. Always check the color map located on the right side of the image when viewing the 2D images to ensure you understand the range of resistivities presented. Distances along the top and depths along the left side are in meters. The color map along the right side is in Ohm-m. Due to the nature of the survey, shallower zones have higher resolution between electrodes than deeper zones; therefore, small features at depth will not be visible.

Figure 7: 2D inverted resistivity sections. Reds and oranges indicate higher resistivity values. Yellows and greens are medium-resistivity values. Blues are low-resistivity values. Please note that the color scale is relative.

Resistivity of the survey area drops below 50 $\Omega\text{-m}$ at approximately 12 - 15 meters (39.4 – 49.2 feet) depth and generally increases to greater than 500 $\Omega\text{-m}$ below these depths throughout the survey area, indicating a change from moist to saturated caliche/gypssite soils or gypsums to the bedrock of the Rustler Formation (**Figure 7** and **Figure 8**).

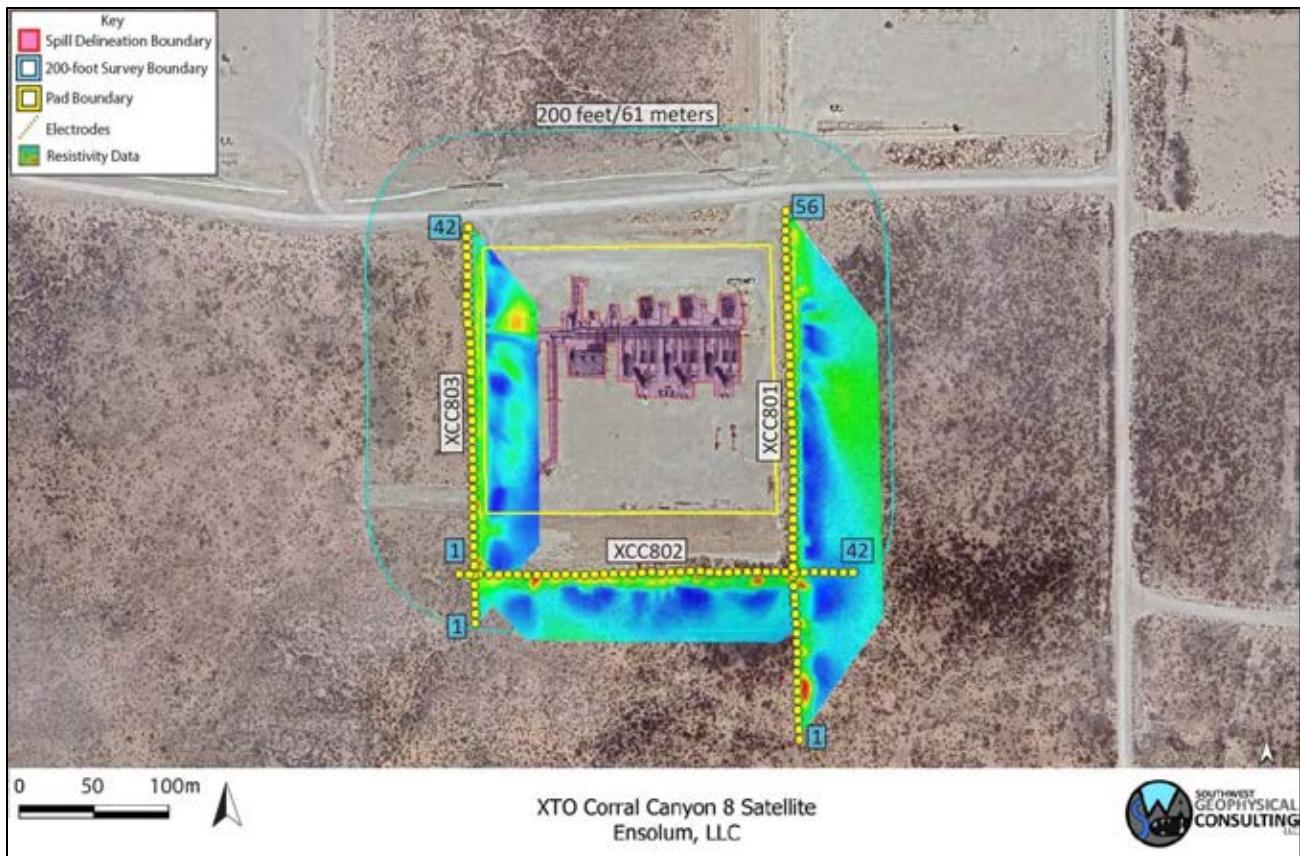
Figure 8: Data overlay. Colored trapezoids are 2D inverted resistivity lines. Background image credit: Google Earth. Image date: January 27, 2023.

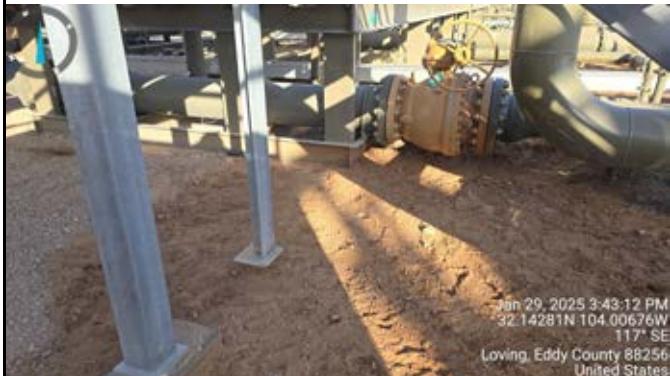
Photograph: 2

Description: Hand excavation activities east of FS02

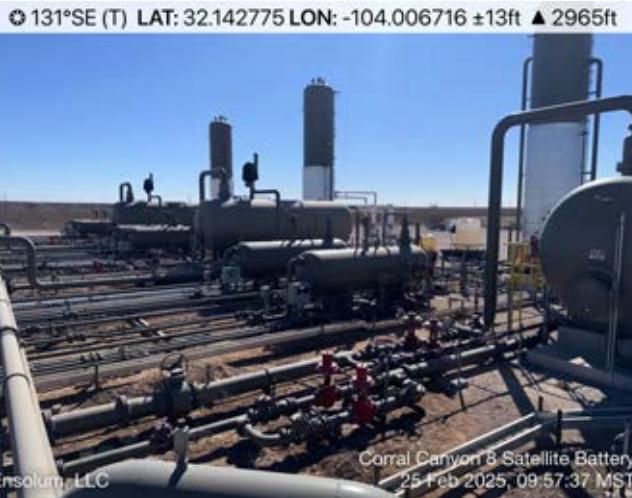
Photograph: 5 Date: 2/25/2025
Description: Hand excavation activities near SS07, SS08
View: Southeast

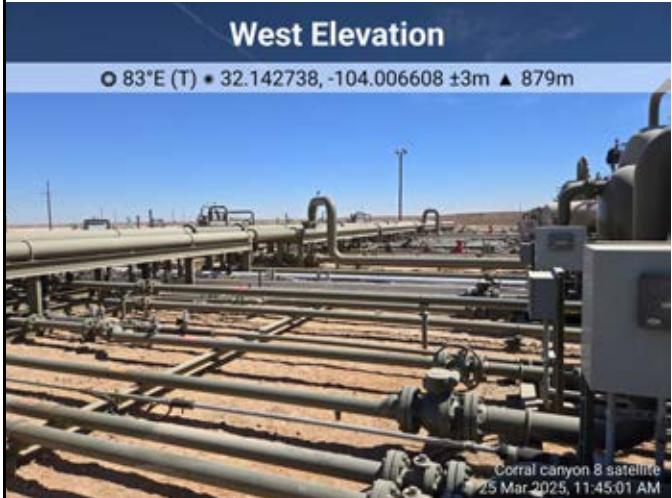
Photograph: 6 Date: 3/25/2025
Description: Delineation activities near SS07B
View: Northeast

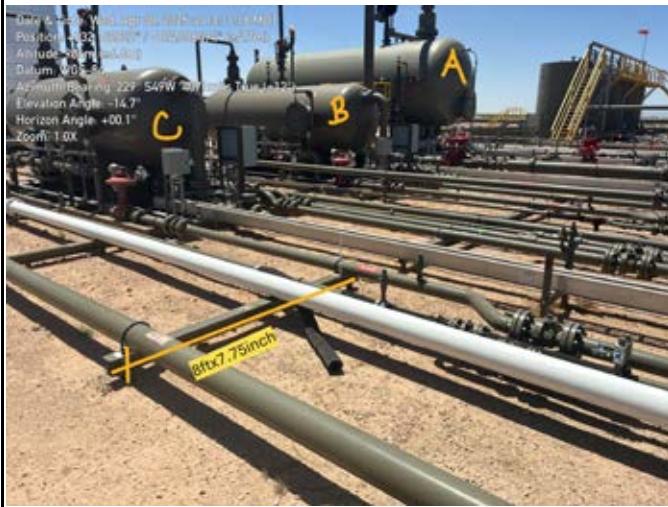
Photograph: 7 Date: 4/30/2025
Description: Engineering measurement activities near separators A, B, C
View: Southwest

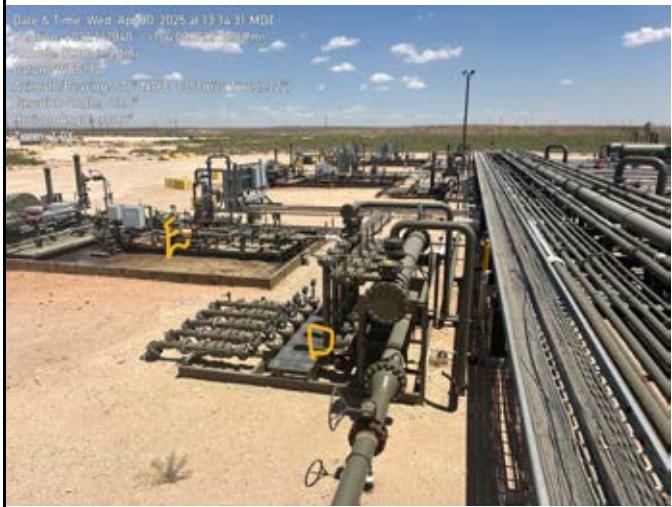
Photograph: 8 Date: 4/30/2025
Description: Engineering measurement activities near pipe array D and LACT unit E
View: Northeast

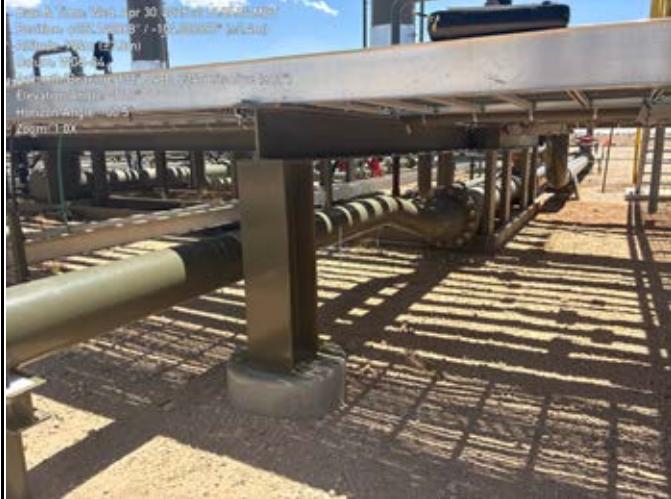
Photograph: 9

Description: Pipe array supports near SS02

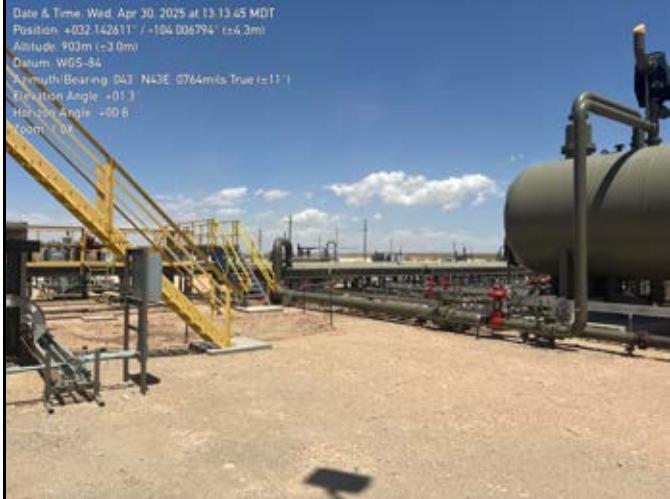
Photograph: 10

Description: Engineering measurement activities near separator A, FS01, FS02, SW01

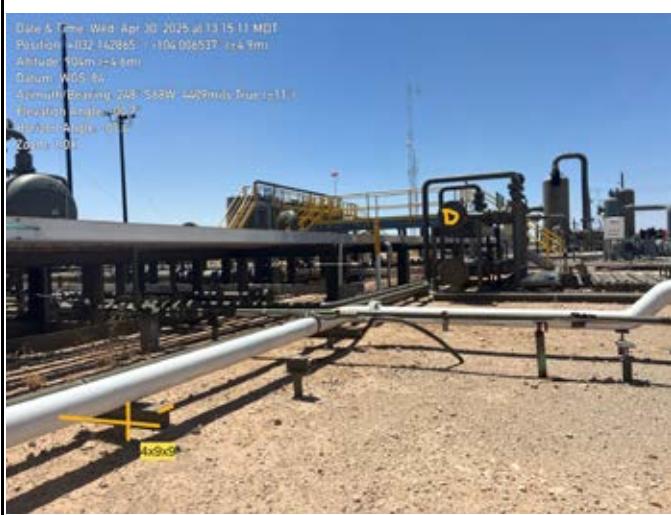
Photograph: 11

Description: Engineering measurements near CS01

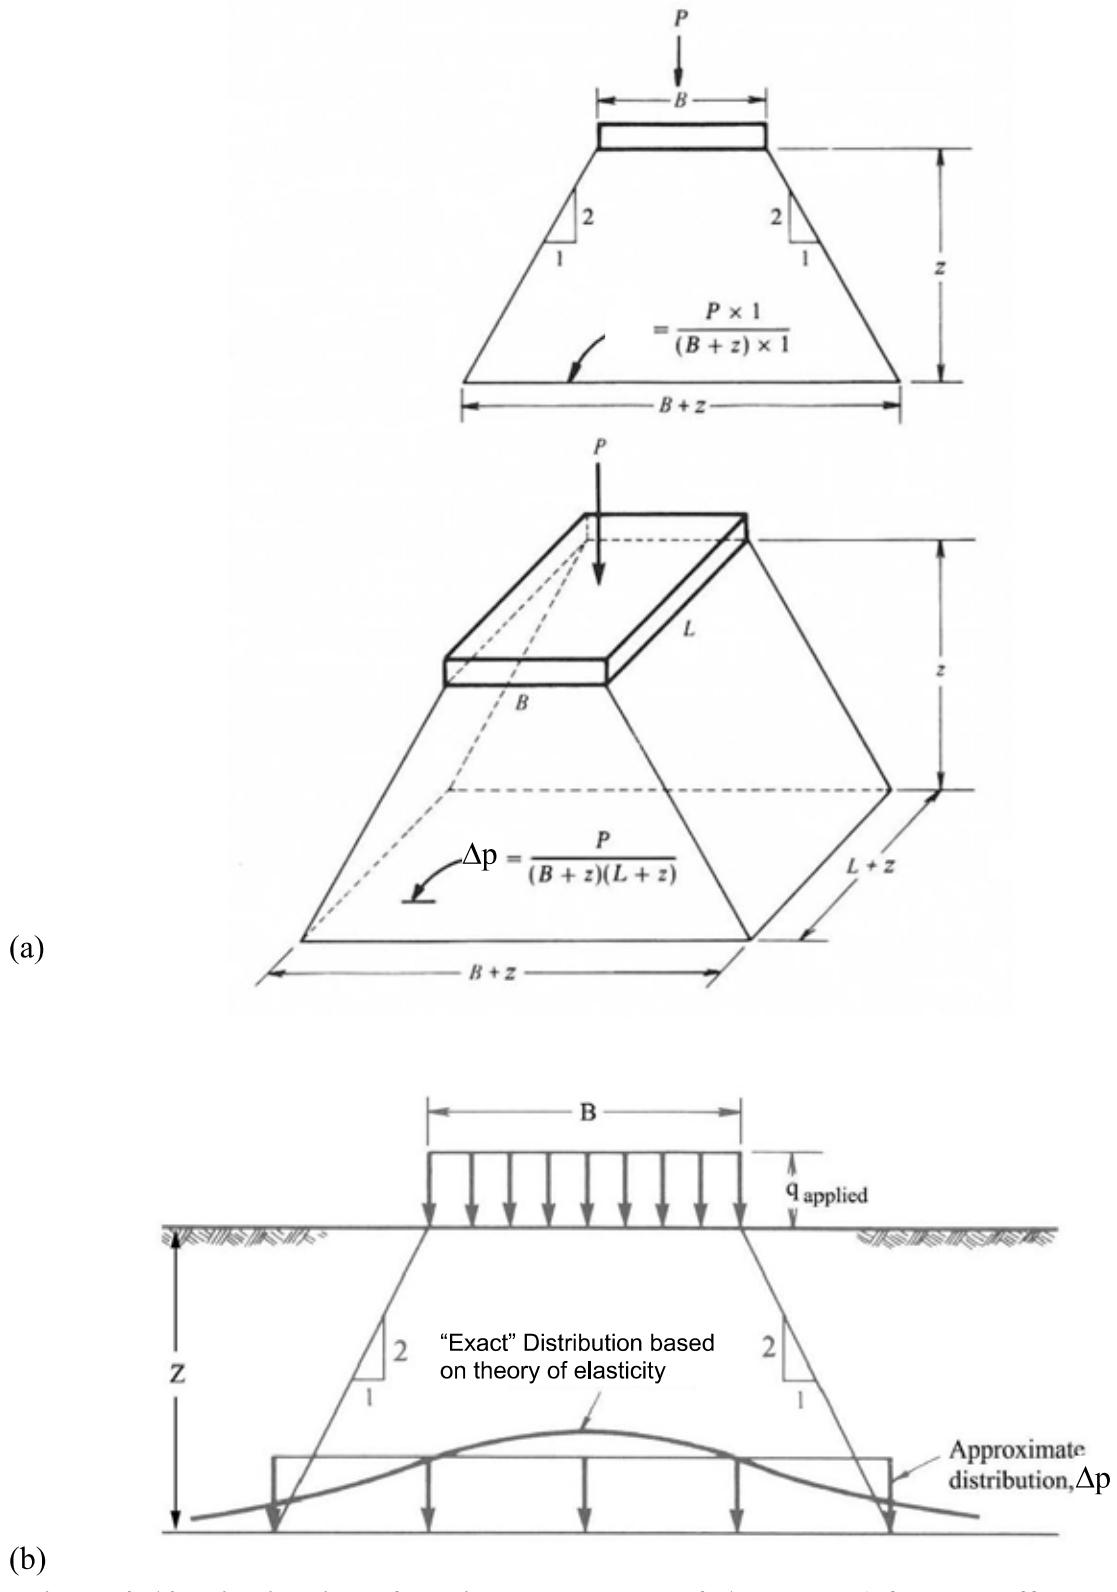
Figure 2-10. Distribution of vertical stress by the 2:1 method (after Perloff and Baron, 1976).

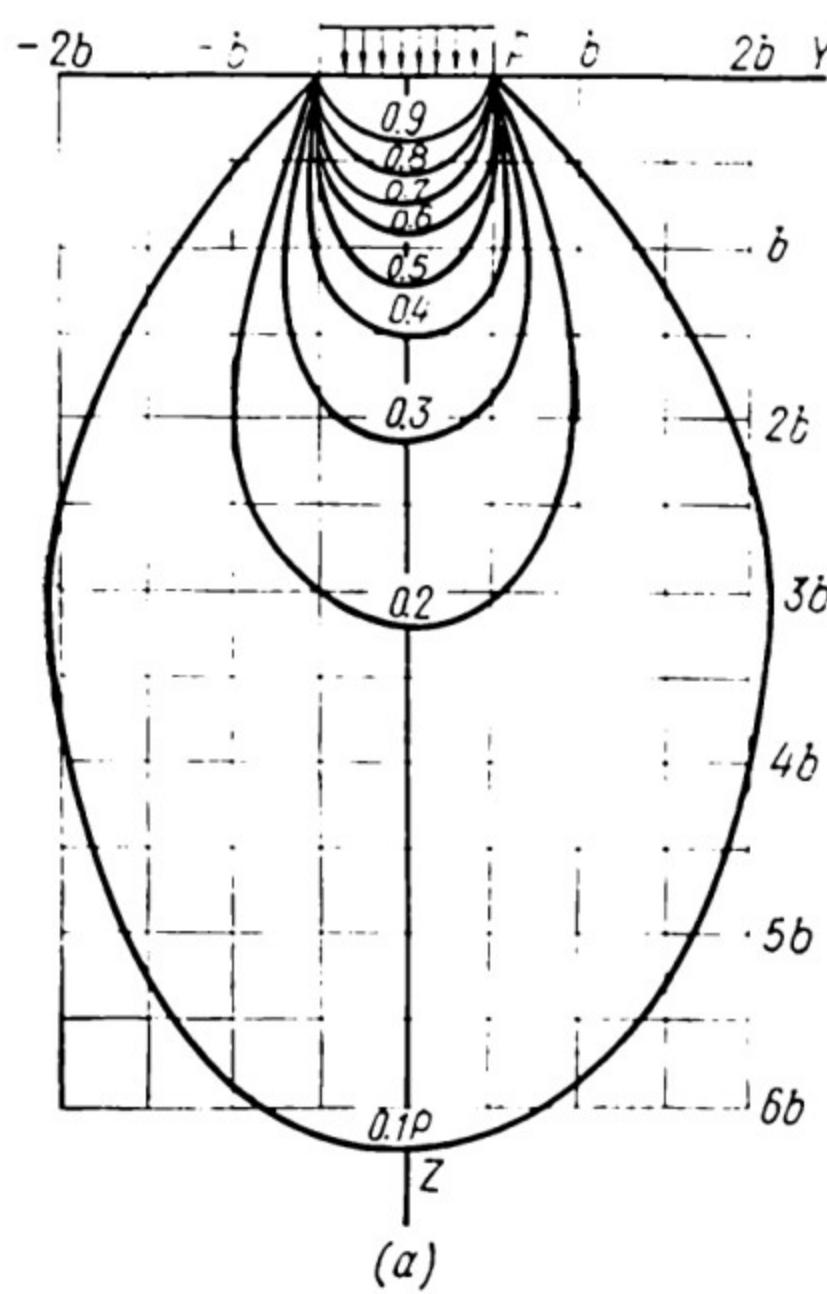
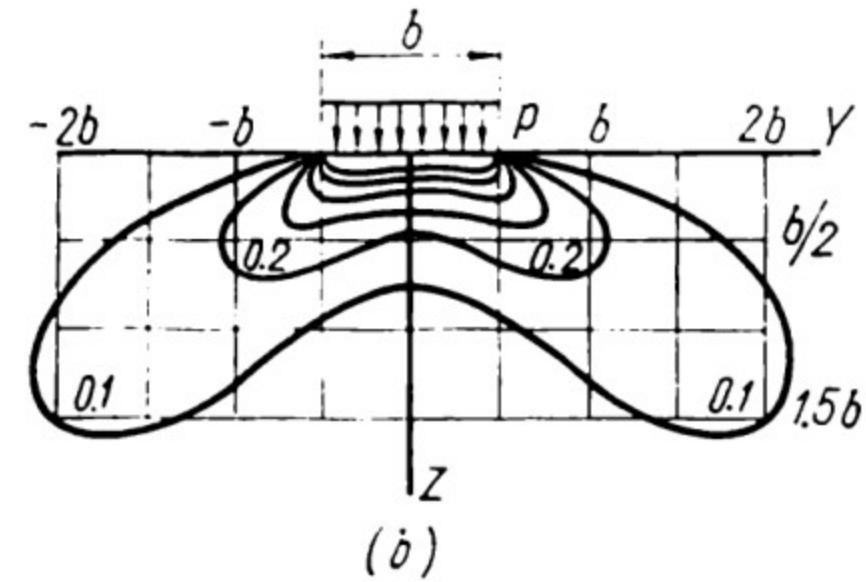
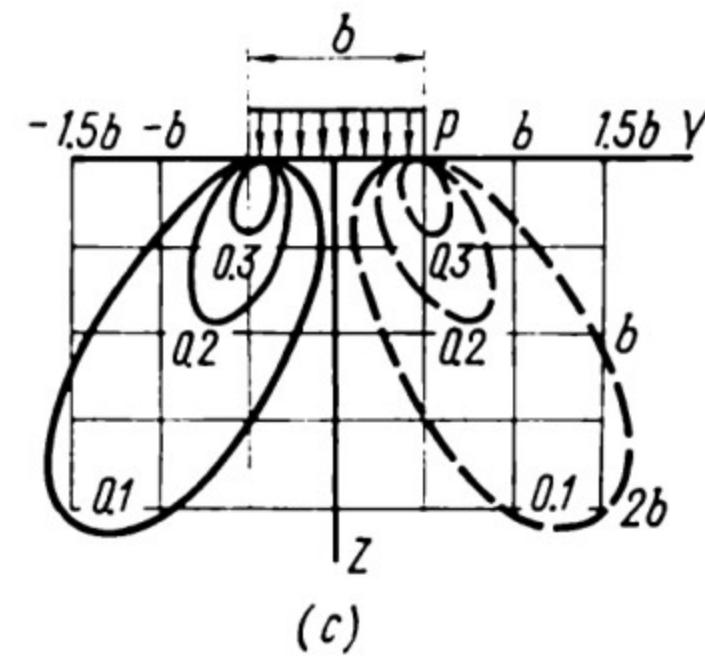
Fig. 49. Lines of equal stresses in a linearly deformable massif for the planar problem

(a) isobars σ_z ; (b) lateral pressure σ_y ; (c) shears τ_{zx}
