## Release Assessment and Closure

**Perla Verde 31 State Com #003H**

**Section 31, Township 19 South, Range 35 East**

**Vertex File Number: 25A-05222**

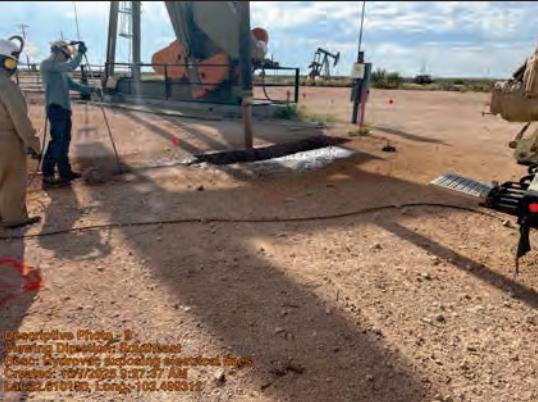
<p>Descriptive Photo: B Viewing Direction: Southeast Photo: Hydrovac exposing electrical lines Created: 10/7/2025 10:27:37 AM Lat: 32.610360, Long: -103.493312</p> <p>Hydrovac exposing electrical lines</p>	<p style="text-align: center;"><b>Viewing Direction: North</b></p>

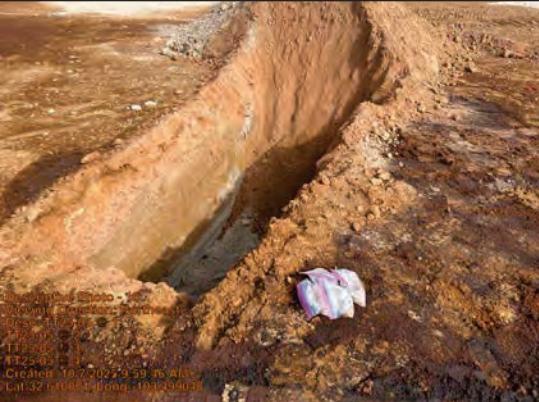
<p>Descriptive Photo: C Viewing Direction: North Photo: Trench with safety glasses Created: 10/7/2025 10:27:37 AM Lat: 32.610360, Long: -103.493312</p> <p>TT25-05 @ 1' TT25-05 @ 2' TT25-05 @ 3' TT25-05 @ 4'</p>
<p style="text-align: center;"><b>Viewing Direction: North</b></p>

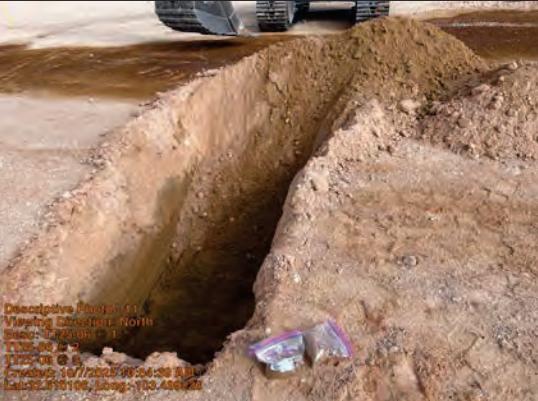
<p>Descriptive Photo: C Viewing Direction: North Photo: Trench with safety glasses Created: 10/7/2025 10:27:37 AM Lat: 32.610360, Long: -103.493312</p> <p>TT25-06 @ 1' TT25-06 @ 2' TT25-06 @ 3'</p>	<p style="text-align: center;"><b>Viewing Direction: South</b></p>

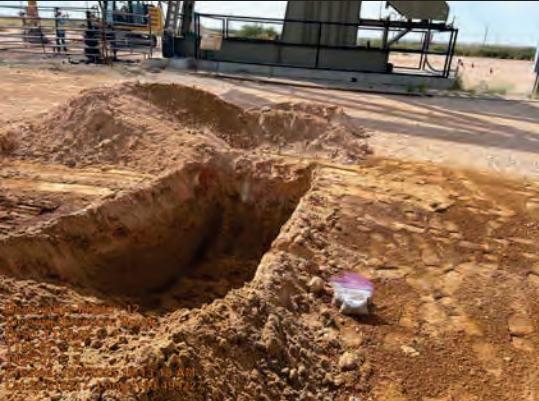
<p>Descriptive Photo: D Viewing Direction: South Photo: Trench with safety glasses Created: 10/7/2025 10:27:37 AM Lat: 32.610360, Long: -103.493312</p> <p>TT25-07 @ 1' TT25-07 @ 2' TT25-07 @ 3'</p>

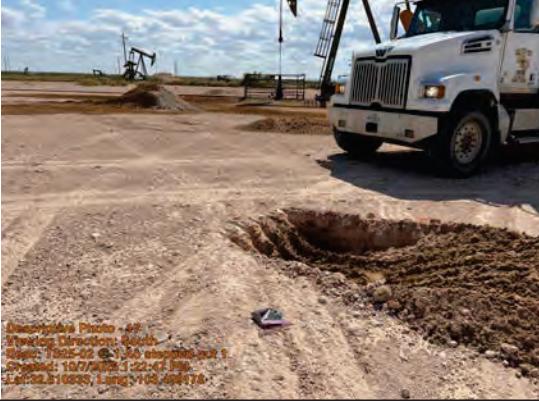
<p>Descriptive Photo - 17 Viewing Direction: South Date: TS25-02 @ 1' stepped out 15' Created: 10/7/2025 1:22:47 PM Lat:32.810382, Long:-103.488745</p>	<p>Viewing Direction: Southeast</p>

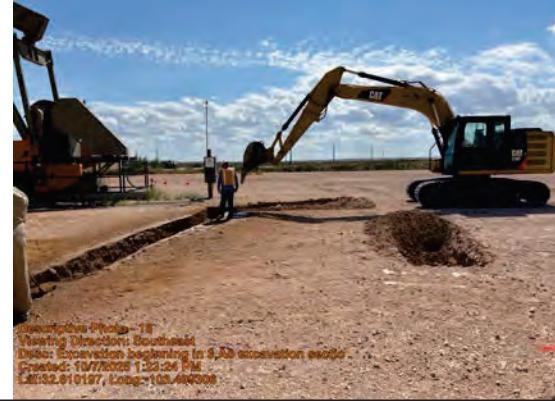
<p>Descriptive Photo - 18 Viewing Direction: Southeast Date: Excavation beginning in 3' excavation section Created: 10/7/2025 1:23:26 PM Lat:32.810157, Long:-103.484706</p>
<p>TS25-02 @ 1' stepped out 15'</p> <p>Viewing Direction: East</p>

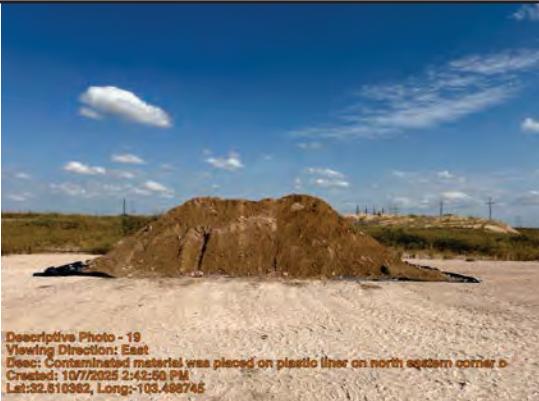
<p>Descriptive Photo - 19 Viewing Direction: East Date: Contaminated material was placed on plastic liner on north eastern corner Created: 10/7/2025 2:42:56 PM Lat:32.810382, Long:-103.488745</p>	<p>Excavation beginning in 3' excavation section</p>

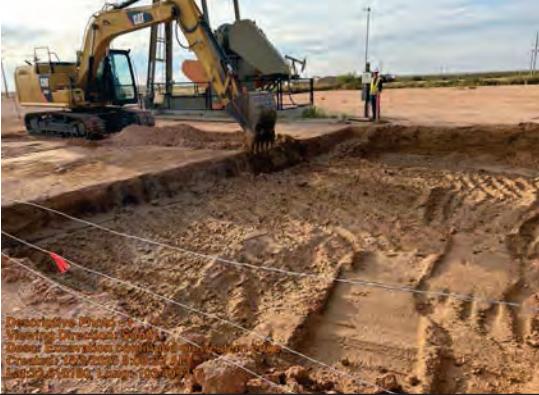
<p>Descriptive Photo - 1 Viewing Direction: South Date: Excavation continued exposing electrical lines Location: 100' from production equipment Lat: 32.509356 Long: -102.499470</p>	<p><b>Viewing Direction: East</b></p>

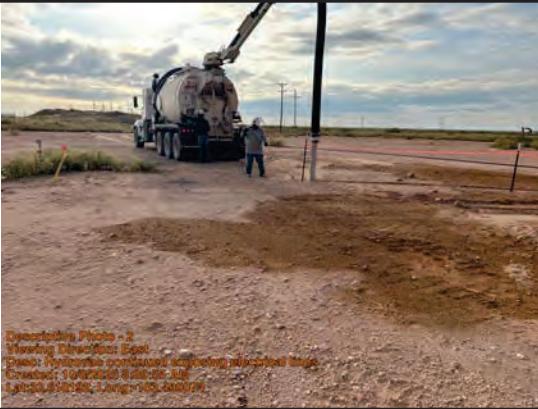
<p>Descriptive Photo - 2 Viewing Direction: East Date: Hydrovac continued exposing electrical lines Location: 100' from production equipment Lat: 32.509356 Long: -102.499470</p>
<p>Excavation continued on western edge</p>	<p>Hydrovac continued exposing electrical lines</p>
<p><b>Viewing Direction: East</b></p>

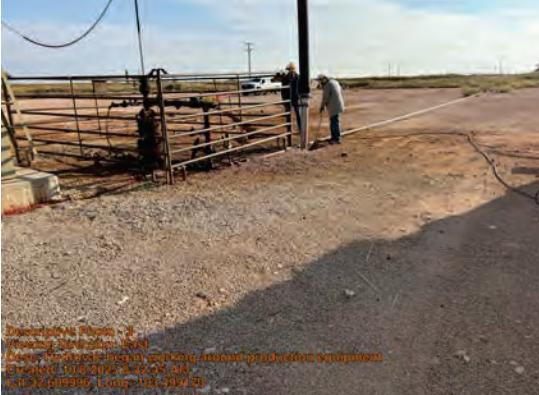
<p>Descriptive Photo - 3 Viewing Direction: East Date: Hydrovac began working around production equipment Location: 100' from production equipment Lat: 32.509356 Long: -102.499470</p>	<p><b>Viewing Direction: North</b></p>

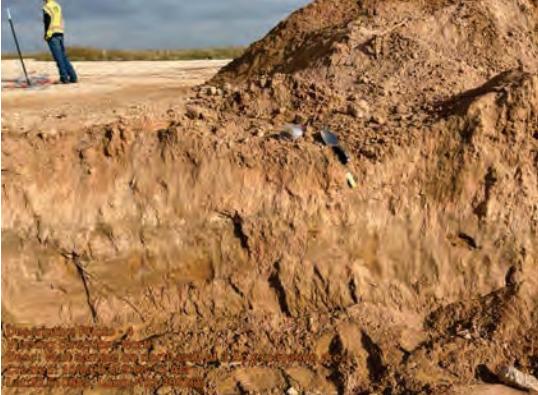
<p>Wall sample on north wall of 3' excavation area</p>
<p>Hydrovac began working around production equipment</p>

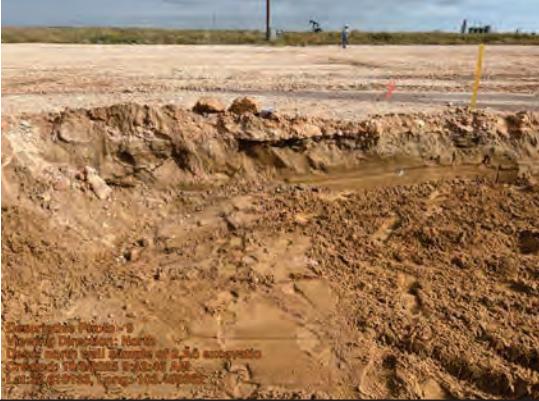
<p>Descriptive Photo - 11 Viewing Direction: North Date: BS25-12 @ 1' A Proximity: 20' from camera, 4:10 AM Latitude: 33.377777, Longitude: -102.400773</p> <p>north wall sample of 2' excavation</p>	<p>Viewing Direction: East</p>

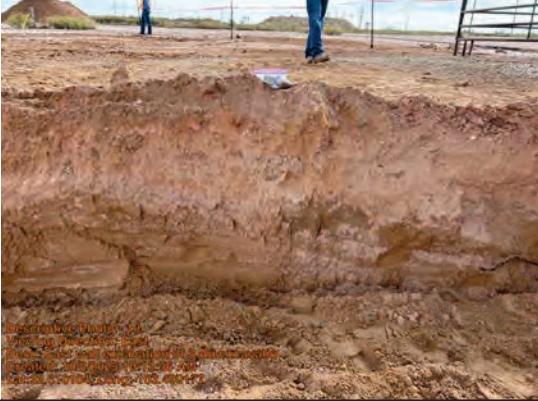
<p>Descriptive Photo - 12 Viewing Direction: East Date: BS25-12 @ 1' A Proximity: 20' from camera, 4:10 AM Latitude: 33.377777, Longitude: -102.400773</p> <p>East wall excavation of 3' excavation</p>
<p>Viewing Direction: North</p>

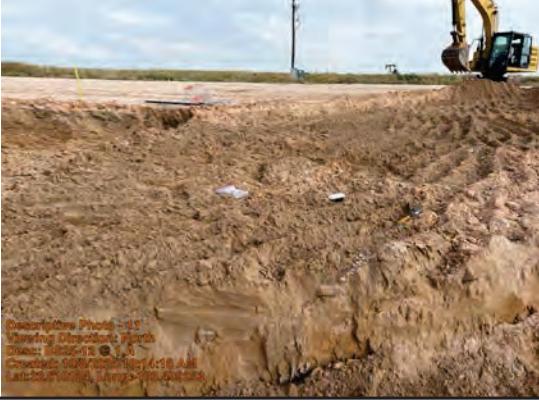
<p>Descriptive Photo - 13 Viewing Direction: North Date: BS25-12 @ 1' A Proximity: 20' from camera, 4:10 AM Latitude: 33.377777, Longitude: -102.400773</p> <p>BS25-12 @ 1'</p>	<p>Viewing Direction: Northeast</p>

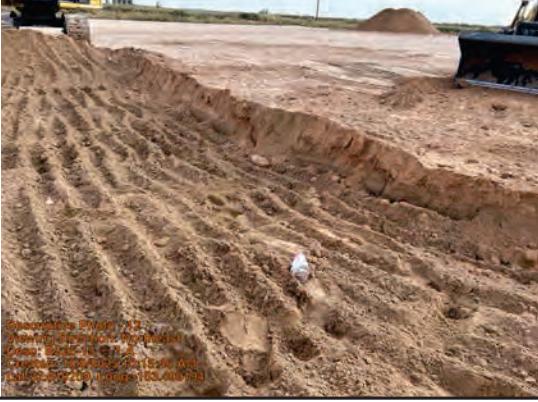
<p>Descriptive Photo - 14 Viewing Direction: Northeast Date: BS25-12 @ 1' A Proximity: 20' from camera, 4:10 AM Latitude: 33.377777, Longitude: -102.400773</p> <p>BS25-15 @ 1'</p>

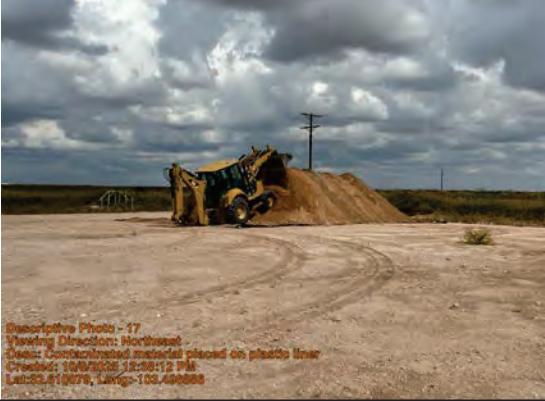
<p>Descriptive Photo - 17 Viewing Direction: Northeast Date: Contaminated material placed on plastic liner Created: 10/8/2025 12:53:12 PM Lat: 32.810079, Long: -103.436682</p>	<p><b>Viewing Direction: North</b></p>

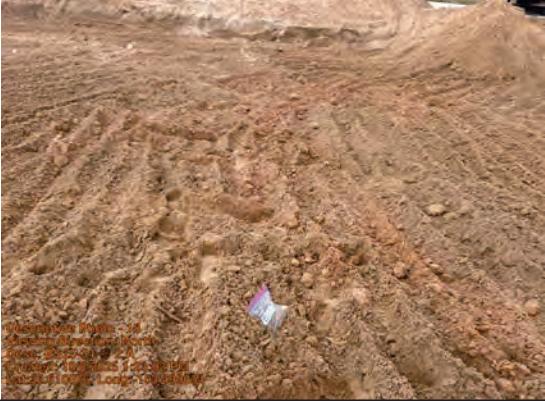
<p>Descriptive Photo - 18 Viewing Direction: North Date: Contaminated material placed on plastic liner Created: 10/8/2025 12:53:20 PM Lat: 32.810079, Long: -103.436682</p>
Contaminated material placed on plastic liner	BS25-31 @ 2'
<p><b>Viewing Direction: Northwest</b></p>

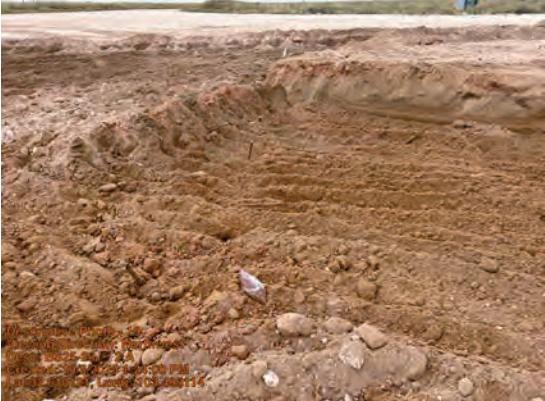
<p>Descriptive Photo - 19 Viewing Direction: Northwest Date: Contaminated material placed on plastic liner Created: 10/8/2025 12:53:20 PM Lat: 32.810079, Long: -103.436682</p>	BS25-26 @ 2'

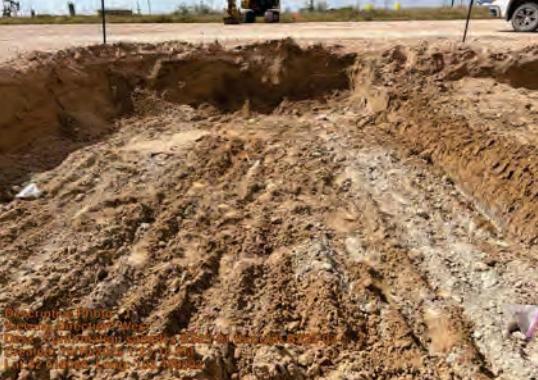
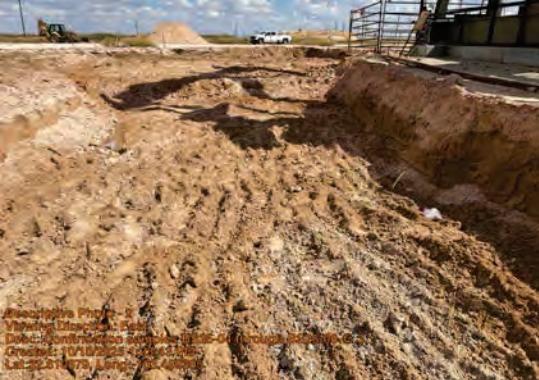
Confirmation samples BS25-01 through BS25-03 @ 3'	Confirmation samples BS25-04 through BS25-06 @ 3'

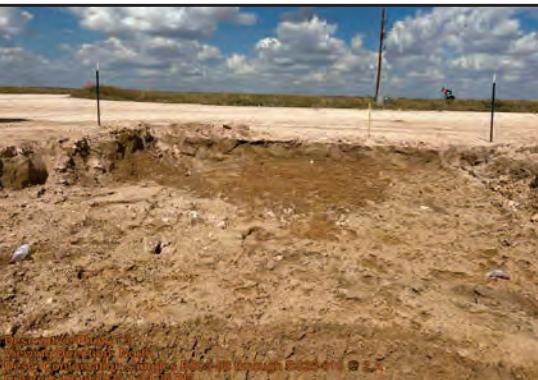
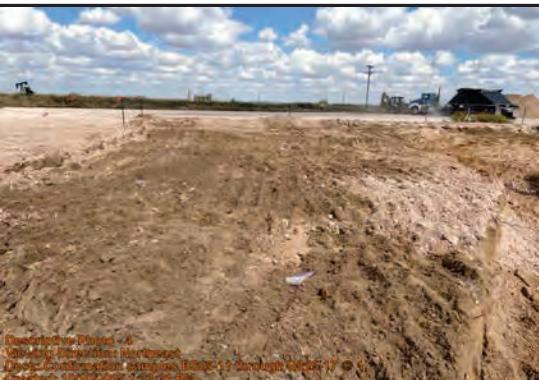
Confirmation samples BS25-08 through BS25-10 @ 2'	Confirmation samples BS25-11 through BS25-17 @ 1'

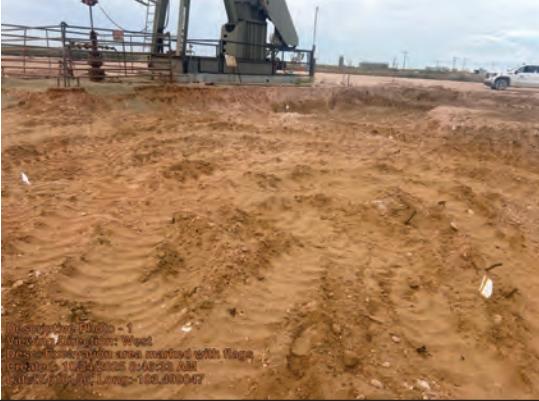
<p>Description Photo - 1 Viewing Direction: West Excavation area marked with flags Captured: 10/24/2022 0:00:20 AM Lat: 33.810135, Long:-103.403579</p>

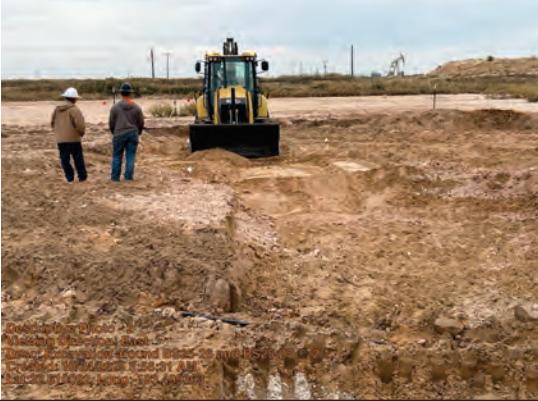
<p>Description Photo - 2 Viewing Direction: East Excavation around BS25-26 and BS25-27 @ 2.1' Captured: 10/24/2022 0:05:51 AM Lat: 33.810122, Long:-103.403579</p>
Excavation area marked with flags	Excavation around BS25-26 and BS25-27 @ 2.1'

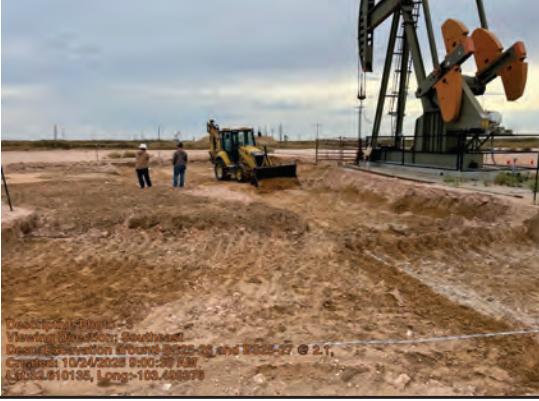
<p>Description Photo - 3 Viewing Direction: Southeast Excavation around BS25-26 and BS25-27 @ 2.1' Captured: 10/24/2022 0:00:20 AM Lat: 33.810135, Long:-103.403579</p>

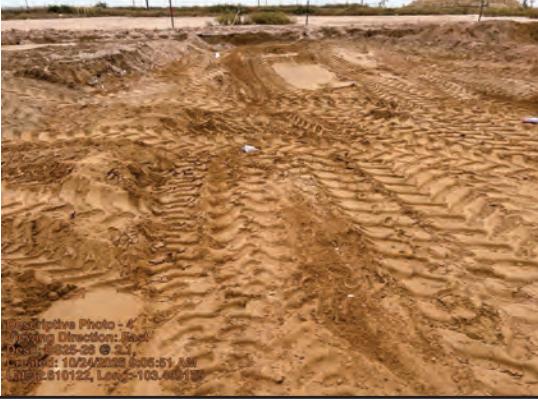
<p>Description Photo - 4 Viewing Direction: East BS25-26 @ 2.1' Captured: 10/24/2022 0:05:51 AM Lat: 33.810122, Long:-103.403579</p>
Excavation around BS25-26 and BS25-27 @ 2.1'	BS25-26 @ 2.1'

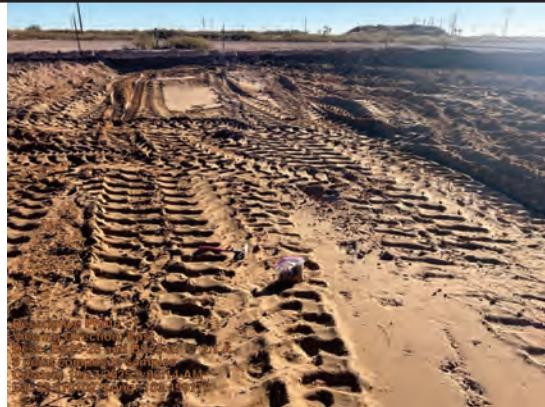
BS25-26 and BS25-27 @ 2.1'  
5 point composite samples

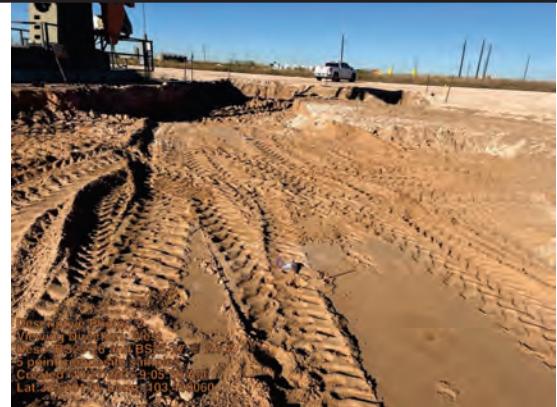
BS25-26 and BS25-27 @ 2.1'  
5 point composite samples

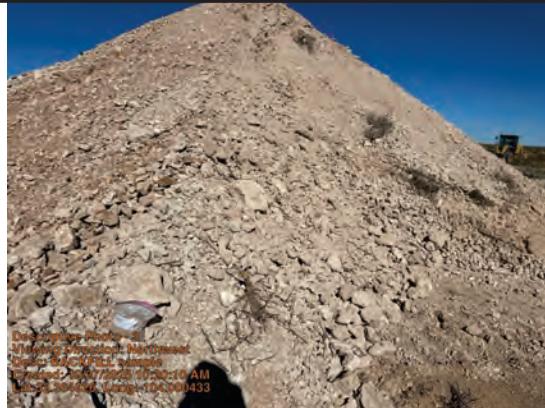
BACKFILL sample
