Re: Closure Request
PLU Ross Ranch 33-25-30 USA Battery
Incident Number nAPP2527230287
Eddy County, New Mexico

Ensolum, LLC (Ensolum), on behalf of XTO Energy, Inc. (XTO), has prepared this *Closure Request* to document the findings of a liner integrity inspection and delineation completed at the PLU Ross Ranch 33-25-30 USA Battery (Site) following a release of crude oil and produced water within a lined containment. Based on the liner integrity inspection activities and laboratory analytical results, XTO is submitting this *Closure Request*, describing the inspection results and requesting closure for Incident Number nAPP2527230287.

XTO Energy, Inc.
Closure Request
PLU Ross Ranch 33-25-30 USA Battery

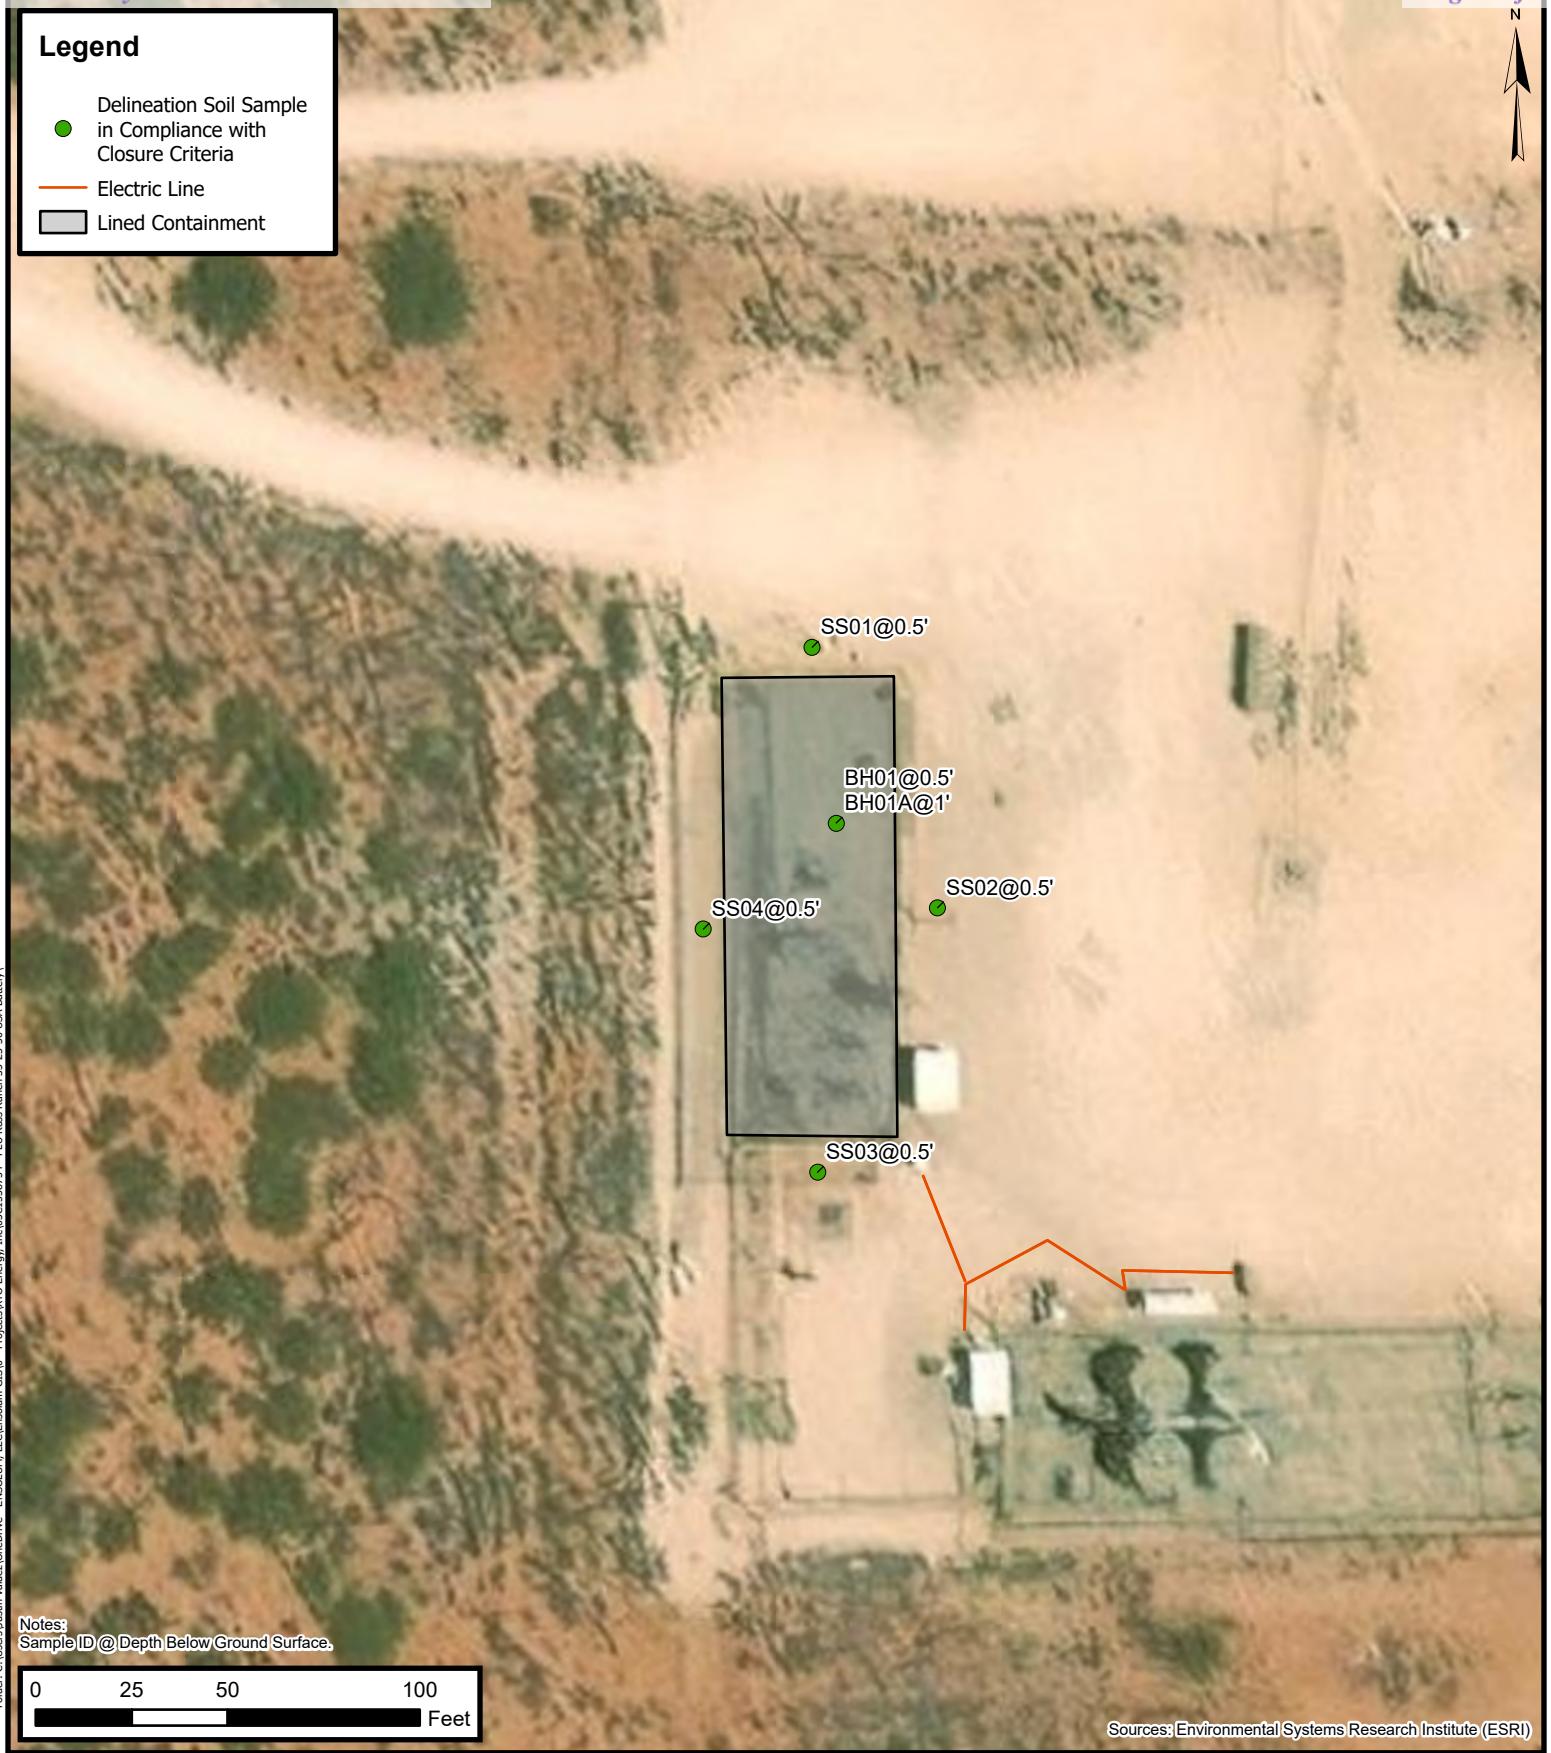
**FIGURE
2**

On October 23, 2025, Ensolum personnel were at the Site to complete delineation activities. Four delineation soil samples (SS01 through SS04) were collected around the lined containment at a depth of 0.5 feet bgs to assess the lateral extent of the release. One borehole (BH01) was advanced via hand auger to a terminal depth of 1-foot bgs in the location of the liner hole. Discrete soil samples were collected from the borehole at depths ranging from 0.5 feet bgs to 1-foot bgs. All delineation soil samples were field screened for volatile organic compounds (VOCs) utilizing a calibrated photoionization detector (PID) and chloride utilizing Hach® chloride QuanTab® test strips. Field screening results and observations of the soil samples from the borehole were logged on a lithologic soil sampling log, which is included in Appendix C. The delineation soil sample locations were mapped utilizing a handheld Global Positioning System (GPS) unit and are depicted on Figure 2. Photographic documentation is included in Appendix B.

Delineation Soil Sample Locations

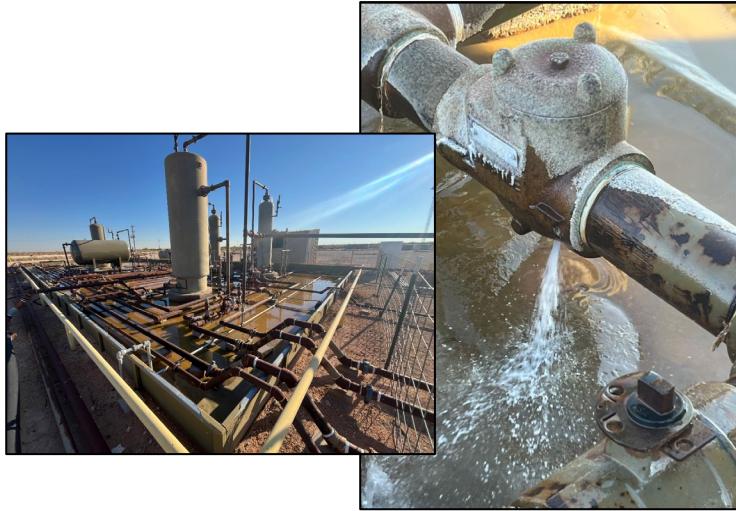
Photograph: 1 Date: 09/27/2025
 Description: Initial release observed for Incident Number nAPP2527230287
 POR located at approximately 32.09331°, -103.89309°

On September 27, 2025, corrosion of the collar of the inlet created a pin hole that resulted in the release of approximately 2 barrels (bbls) of crude oil and approximately 8 bbls of produced water into a lined secondary containment. A vacuum truck was dispatched to the Site to recover free-standing fluids, and all fluids were recovered. The lined containment was power washed to remove any residual fluids. XTO reported the release to the New Mexico Oil Conservation Division (NMOCD) via a Notification of Release (NOR) on September 29, 2025, and submitted an Initial C-141 Application (C-141) on September 29, 2025. The release was assigned Incident Number nAPP2527230287.

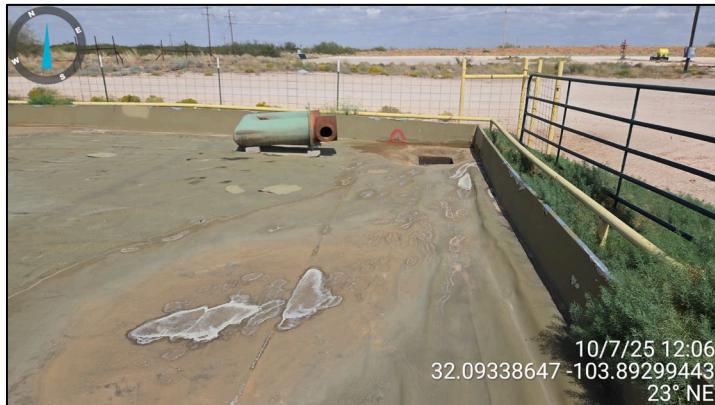
Photograph: 3 Date: 10/07/2025
 Description: Liner inspection activities
 View: Northeast

The lined containment was cleaned of all debris and power washed, and a liner integrity inspection was conducted by Ensolum personnel on October 7, 2025. The lined containment was inspected, and it was determined to contain a small hole. Delineation to determine the extent of the release was warranted. A Site map of the lined containment is included in Figure 2. Photographic documentation of the inspection is included in Appendix B.

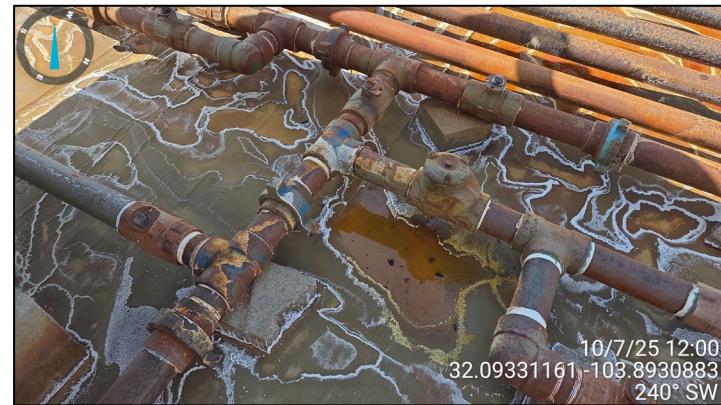
Photograph: 4 Date: 10/07/2025
 Description: POR for Incident Number nAPP2527230287 observed during liner inspection activities.
 View: Southwest

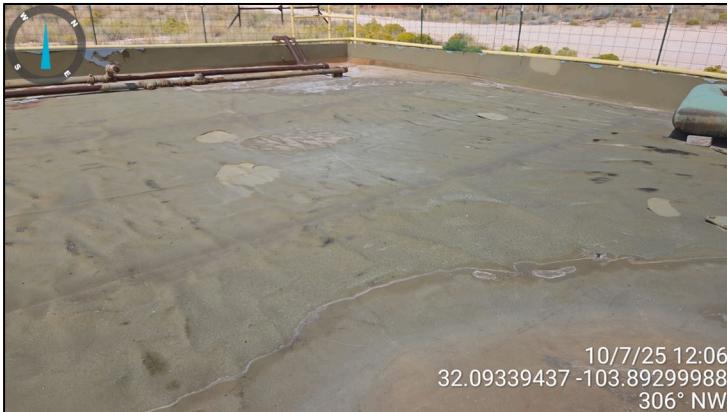
Photograph: 5
Description: Liner inspection activities
View: Northwest

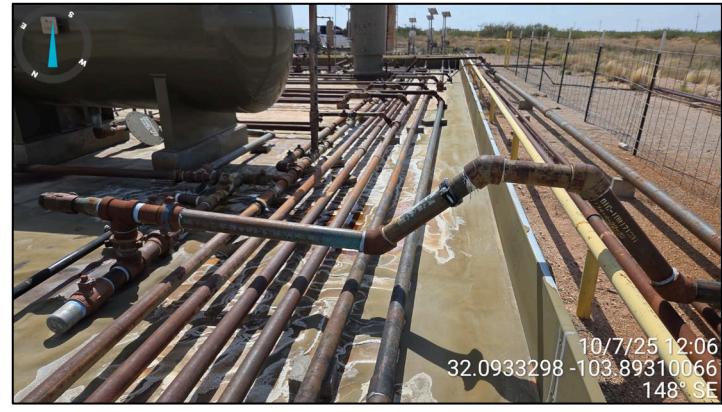
Photograph: 6
Description: Liner inspection activities
View: Southeast

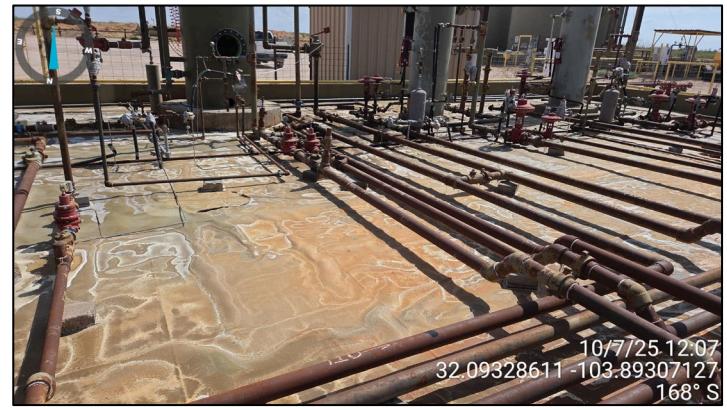
Photograph: 7
Description: Liner inspection activities
View: South

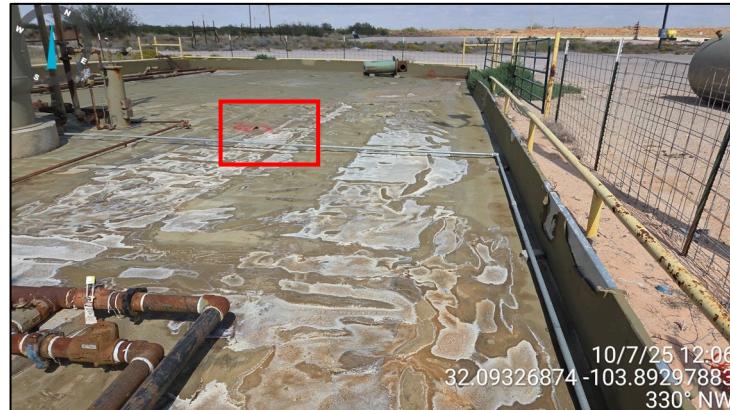
Photograph: 8
Description: Damage and breach in the liner observed
View: Northwest

Liner integrity inspection and delineation activities were conducted at the Site to address the September 2025 release of crude oil and produced water. Laboratory analytical results for the soil samples collected indicated that all COC concentrations were compliant with the most stringent Table I Closure Criteria. Based on the soil sample analytical results, no impacted soil was identified, and no further remediation was required. Ensolum patched the holes and tears in the liner following completion of delineation activities.

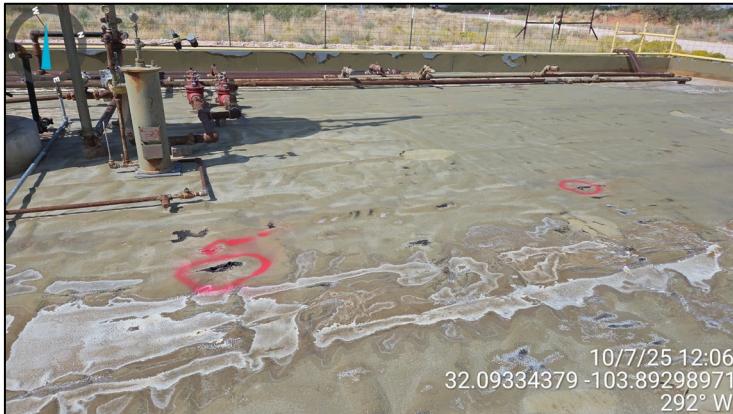
Photograph: 9

Description: Damage and breach in the liner observed

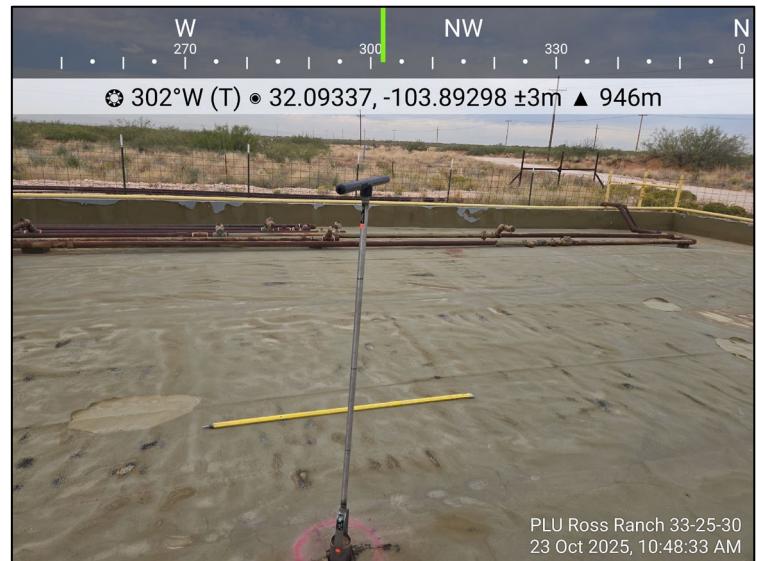
Photograph: 10

Description: Delineation activities, BH01, at breach in the liner

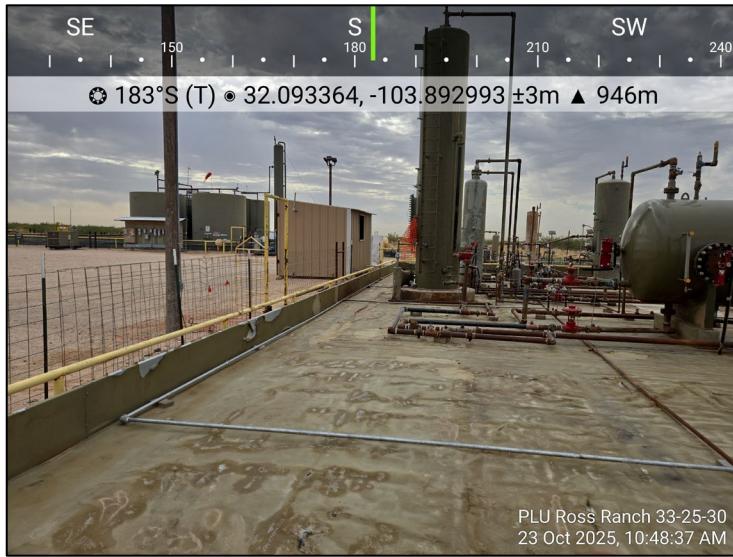
Photograph: 11

Description: Observation of line following cleaning and delineation activities
