**Re: Closure Request**  
**Deer Stalker Federal 5C CTB**  
**Incident Number nAPP2531953879**  
**Lea County, New Mexico**

COG Operating, LLC, (COG), has prepared this *Closure Request* to document the findings of a liner integrity inspection conducted at the Deer Stalker Federal 5C CTB (Site) following the release of an oil/produced water mixture within a lined containment. Based on the liner integrity inspection activities, COG is submitting this Closure Request, describing assessment activities that have occurred and requesting no further action and closure for Incident Number nAPP2531953879.

## Photographic Log

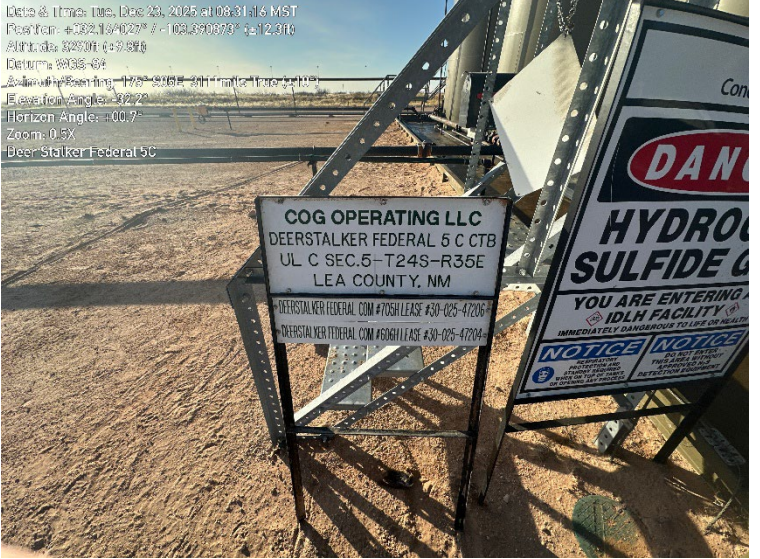
<p><b>Facility:</b> Deer Stalker Federal 5C CTB</p> <p><b>County:</b> Lea County, New Mexico</p> <p><b>Description:</b> Facility Sign</p>	<p>Date &amp; Time: Tue, Dec 23, 2025 at 08:31:16 MST Position: 4382.13°N 109.890093°W 12.916 Altitude: 8930ft 6-958ft Camera: 3038-69 Zoom: 0.5X Elevation Angle: 32.72° Horizon Angle: 100.7° Zoom: 0.5X Deer Stalker Federal 5C</p>

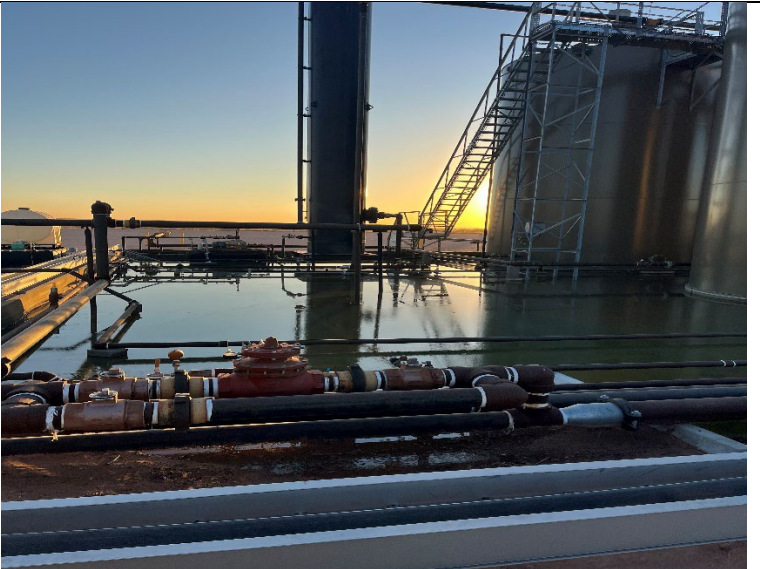
On November 15, 2025, field personnel discovered a leak on a produced water tank causing fifty-nine point seven eight eight four (59.7884) barrels of an oil/produced water mixture to be released into a lined containment. A vacuum truck was dispatched to the site to recover free-standing fluids and approximately fifty-nine (59) barrels of fluid were recovered. The tank was isolated to prevent fluid being further released. COG reported the release to the New Mexico Oil Conservation Division (NMOCD) on a *Release Notification Form C-141* (Form C-141) on November 17, 2025. The release was assigned Incident Number nAPP2531953879.

<p><b>Facility:</b> Deer Stalker Federal 5C CTB</p> <p><b>County:</b> Lea County, New Mexico</p> <p><b>Description:</b> Original release photo from 11/15/2025</p>

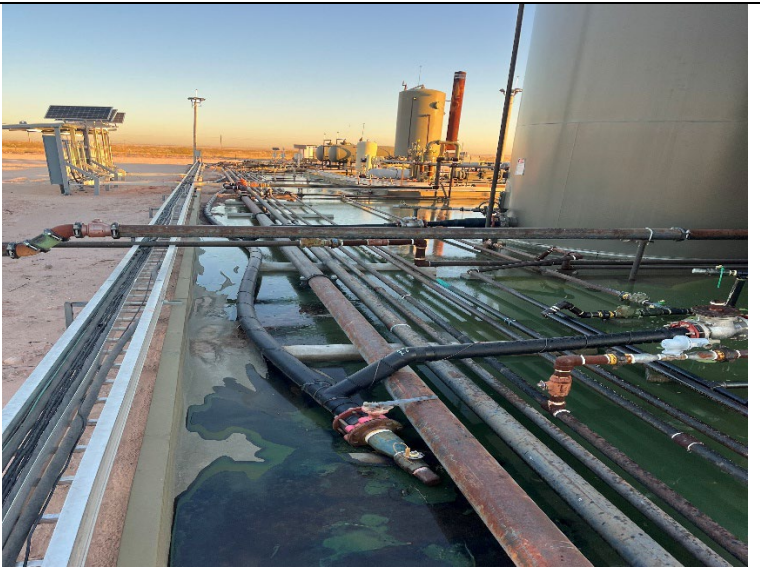
<p><b>Facility:</b> Deer Stalker Federal 5C CTB</p> <p><b>County:</b> Lea County, New Mexico</p> <p><b>Description:</b> Original release photo from 11/15/2025</p>

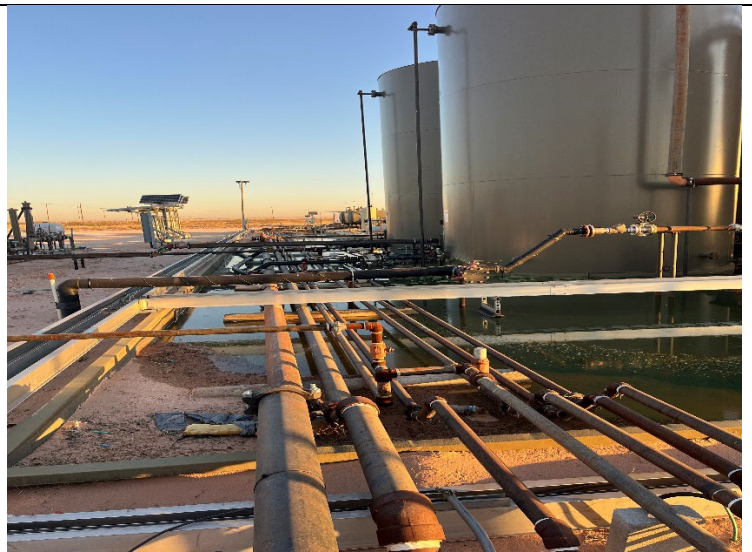
**Description:** Original release photo from 11/15/2025

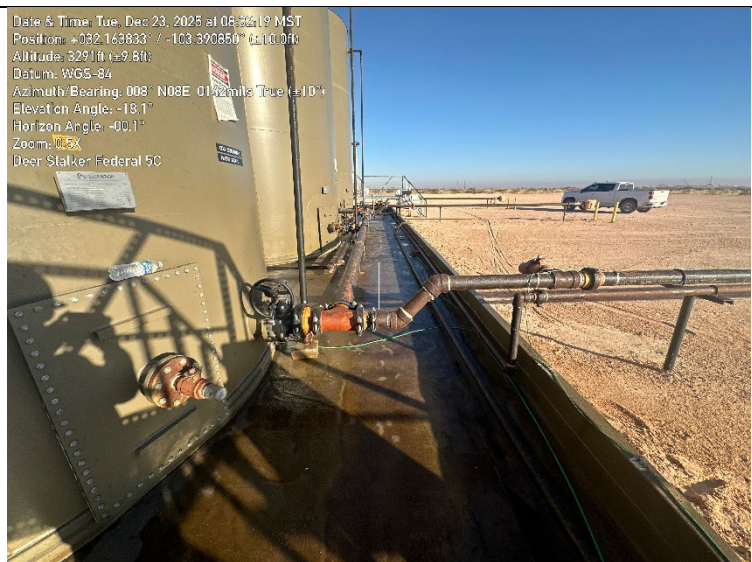
A 48-hour advance notice of the liner inspection was submitted to the NMOCD on December 17, 2025. Prior to conducting the liner integrity inspection, COG operations power washed the liner to remove dirt and debris and recover any residual produced water. A liner integrity inspection was conducted by Jacob Laird on December 23, 2025. Upon inspection, no rips, tears, holes, or damage was observed. The liner was determined to be sufficient, and all released fluids have been removed. Refer to photolog for details.

**Description:** View facing North. Lined area East of production tanks. (Fluid in containment is residual from pressure washing activities.)

Based on the liner inspection throughout the facility, the liner was determined to be sufficient. The release was contained laterally by the lined containment and the liner was performing as designed. No further actions are required at the site. COG, LLC respectfully requests that the New Mexico Oil Conservation Division grant closure approval for Incident Number nAPP2531953879.

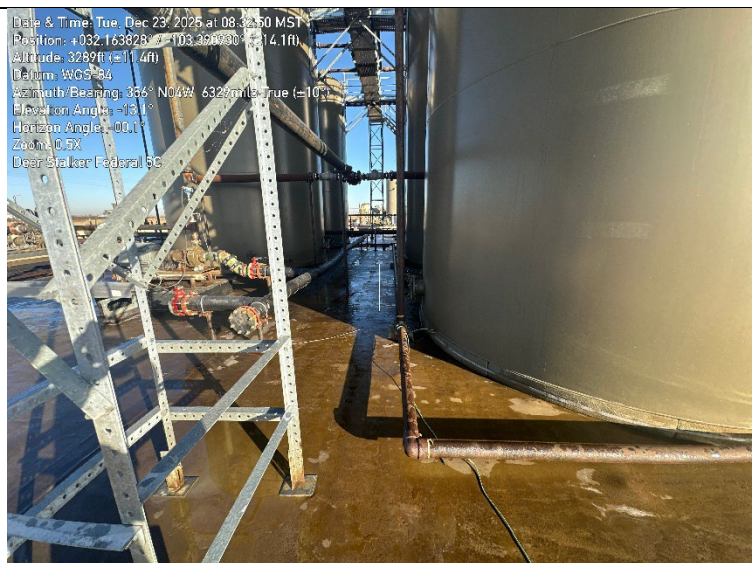
**Description:** View facing North. Lined area between production tanks. (Fluid in containment is residual from pressure washing activities.)

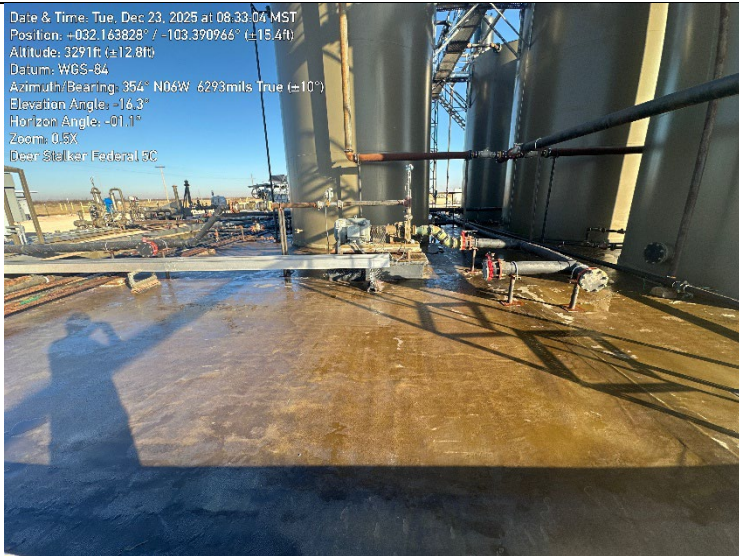
**Description:** View facing North. Lined area South of production tanks. (Fluid in containment is residual from pressure washing activities.)

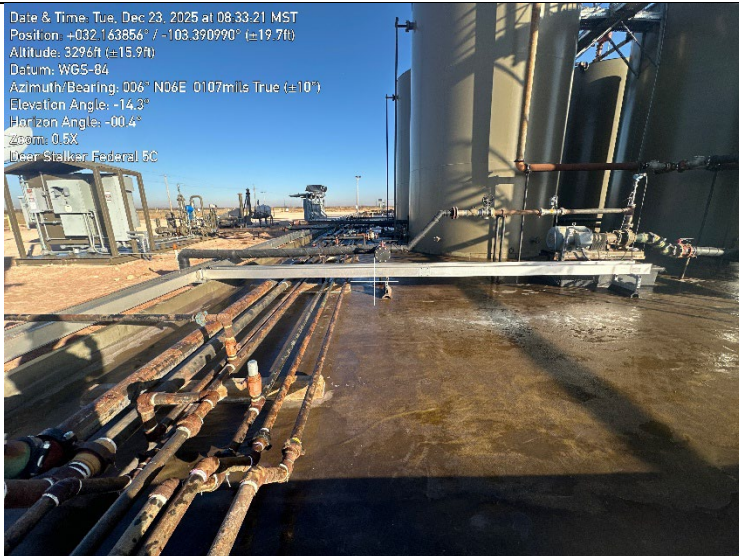
**Description:** View facing North. Lined area West of production tanks and production piping. (Fluid in containment is residual from pressure washing activities.)

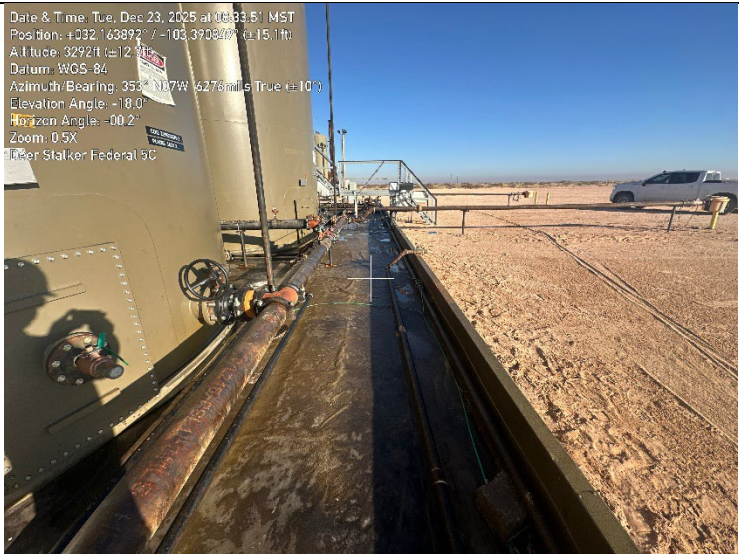
**Description:** View facing North. Lined area East of production tanks. (Fluid in containment is residual from pressure washing activities.)

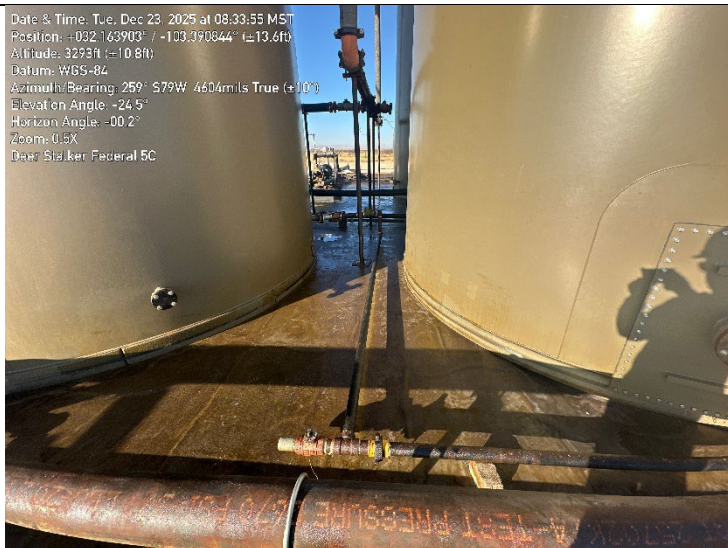
**Description:** View facing West. Lined area between production tanks. (Fluid in containment is residual from pressure washing activities.)

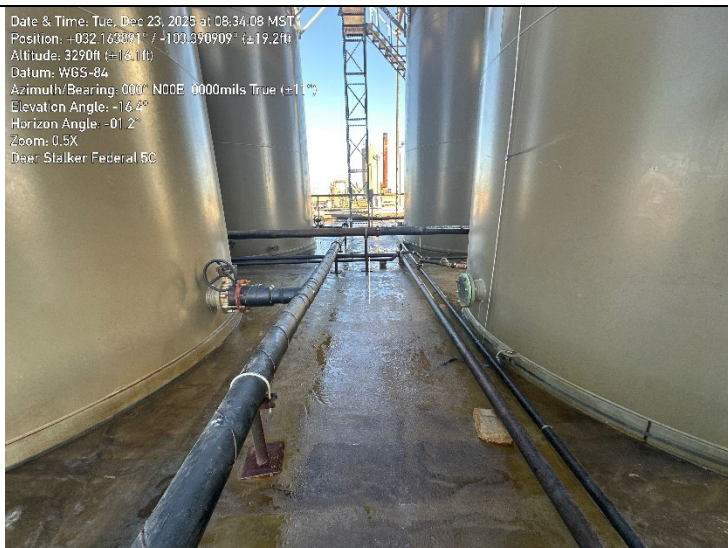
**Description:** View facing North. Lined area between production tanks. (Fluid in containment is residual from pressure washing activities.)

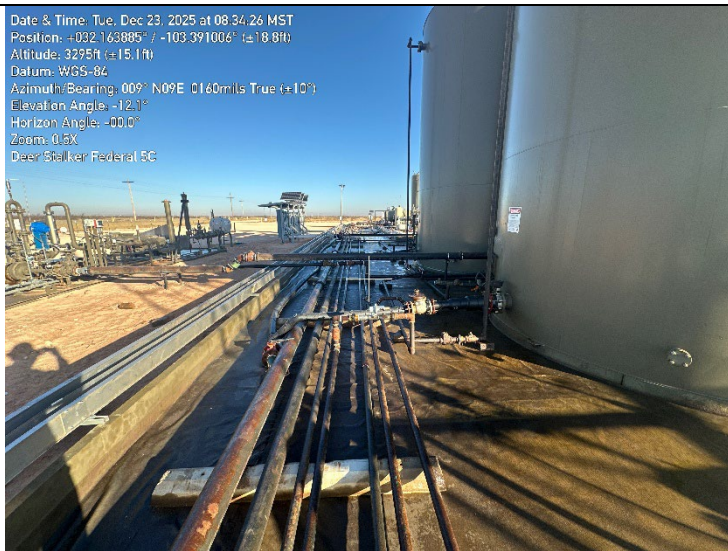
**Description:** View facing North. Lined area West of production tanks and production piping. (Fluid in containment is residual from pressure washing activities.)

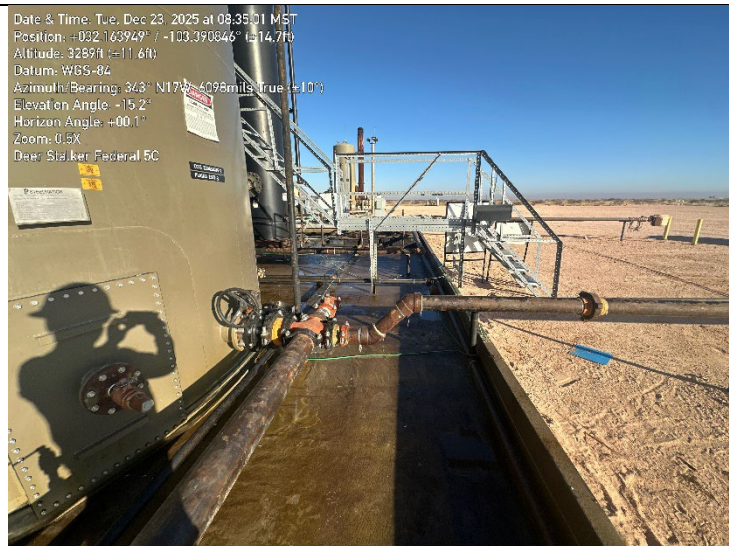
**Description:** View facing North. Lined area East of production tanks. (Fluid in containment is residual from pressure washing activities.)

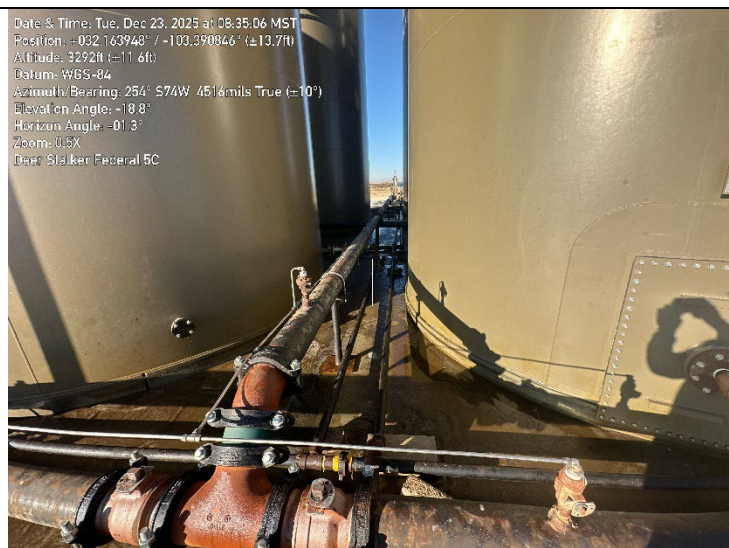
**Description:** View facing North. Lined area between production tanks. (Fluid in containment is residual from pressure washing activities.)

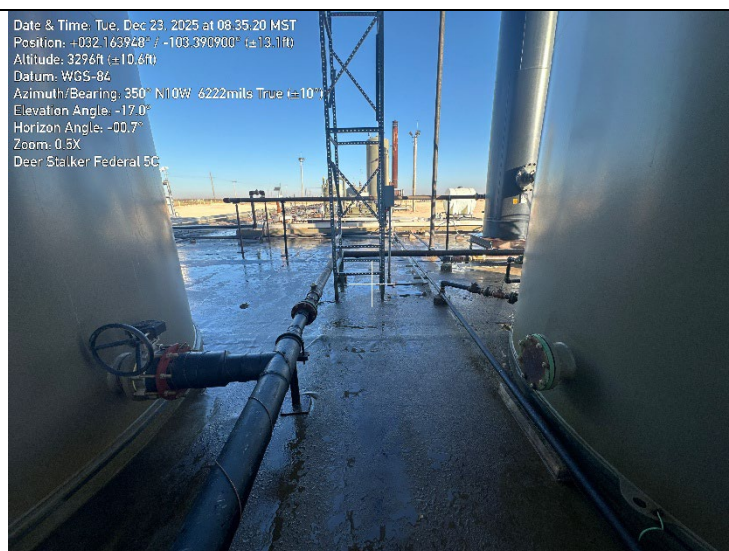
**Description:** View facing North. Lined area between production tanks. (Fluid in containment is residual from pressure washing activities.)

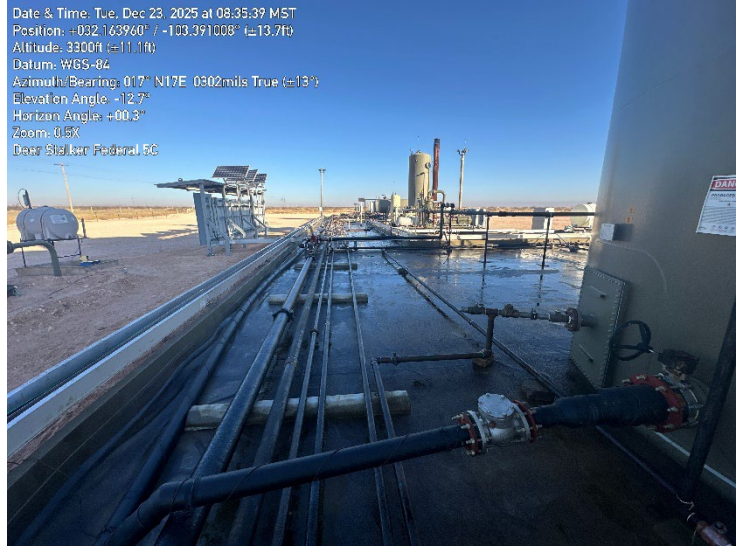
**Description:** View facing North. Lined area West of production tanks and production piping. (Fluid in containment is residual from pressure washing activities.)

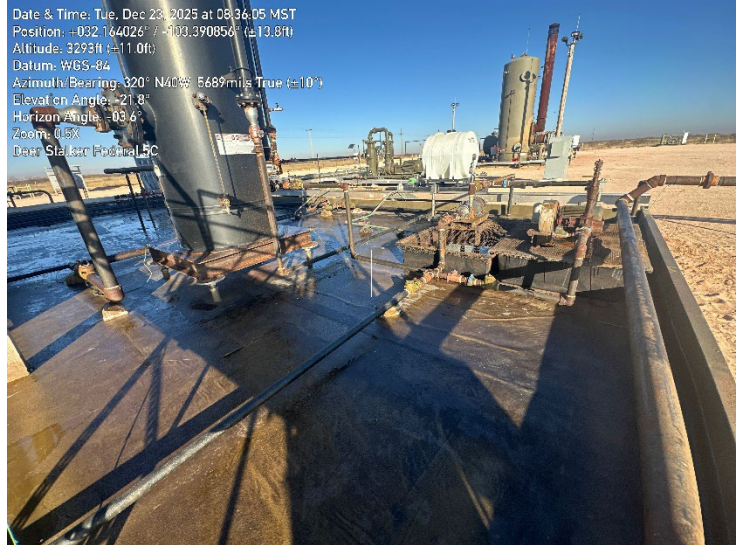
**Description:** View facing Northwest. Lined area near production equipment. (Fluid in containment is residual from pressure washing activities.)

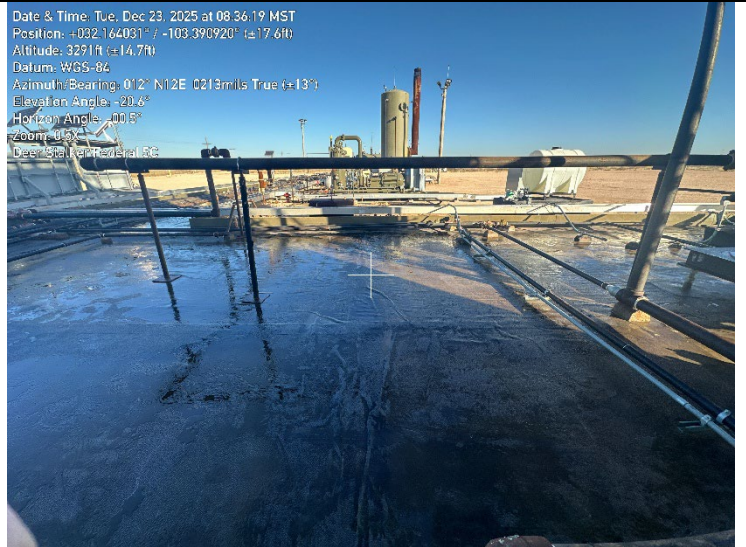
**Description:** View facing North. Lined area North of production tanks. (Fluid in containment is residual from pressure washing activities.)

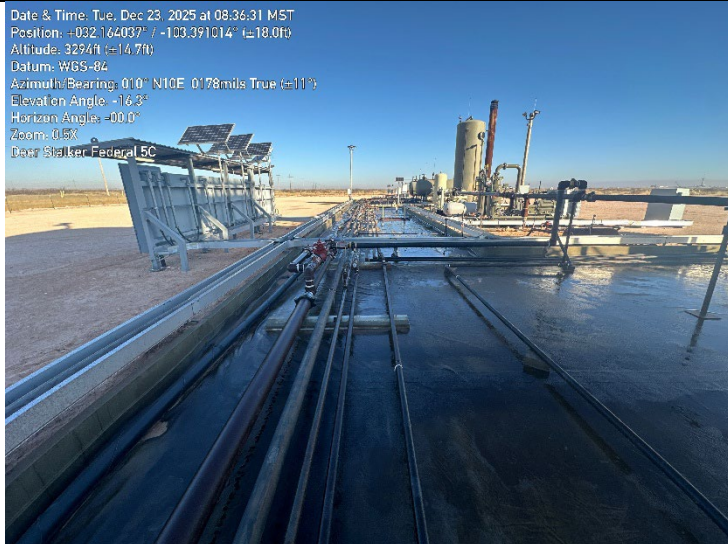
**Description:** View facing North. Lined area near production piping. (Fluid in containment is residual from pressure washing activities.)

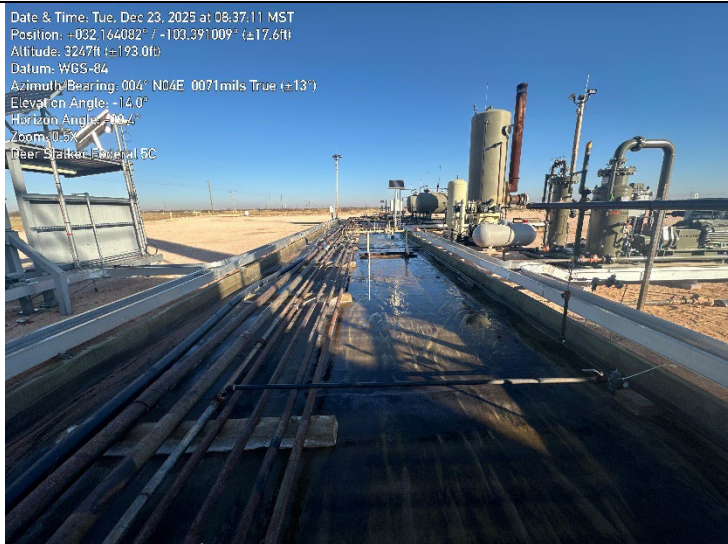
**Description:** View facing North. Lined area near production piping. (Fluid in containment is residual from pressure washing activities.)

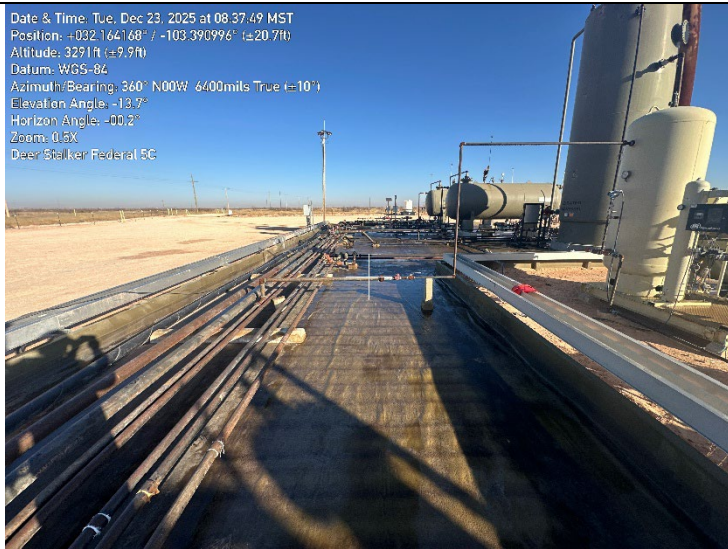
**Description:** View facing North. Lined area near of production piping. (Fluid in containment is residual from pressure washing activities.)

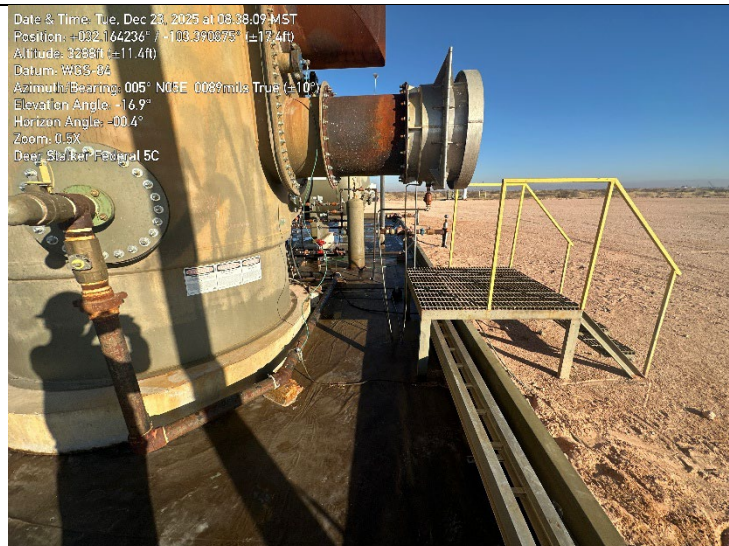
**Description:** View facing North. Lined area near production equipment. (Fluid in containment is residual from pressure washing activities.)

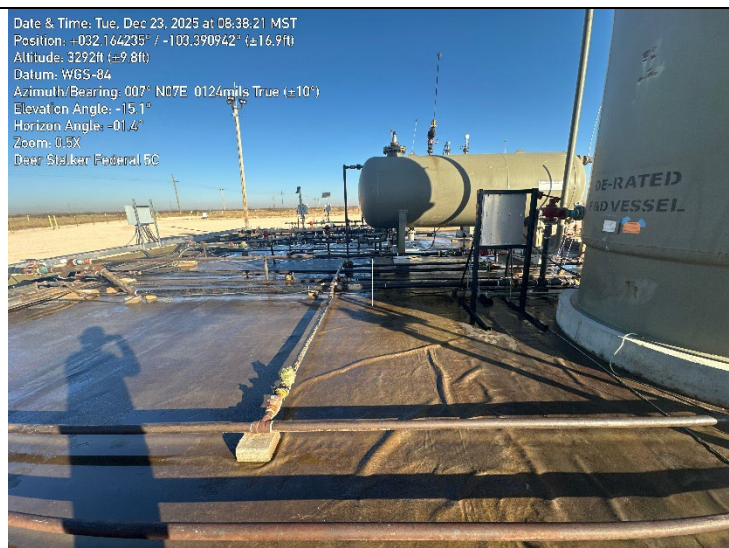
**Description:** View facing North. Lined area near production equipment and piping. (Fluid in containment is residual from pressure washing activities.)

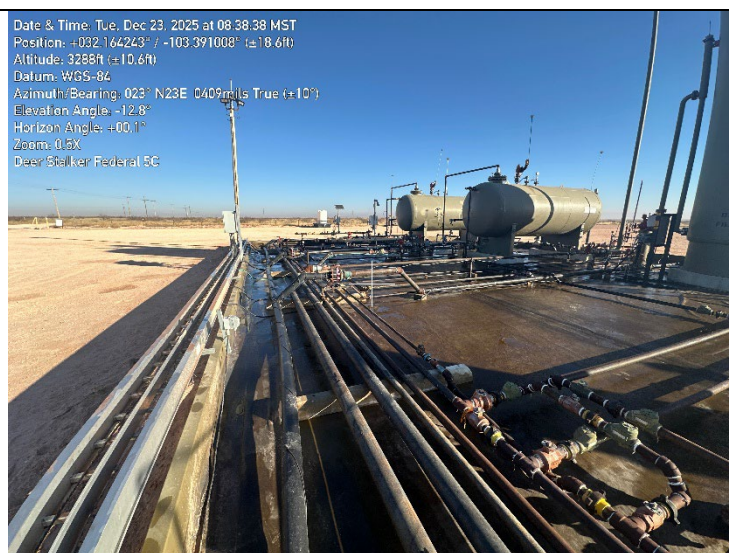
**Description:** View facing North/Northwest. Lined area near production equipment. (Fluid in containment is residual from pressure washing activities.)

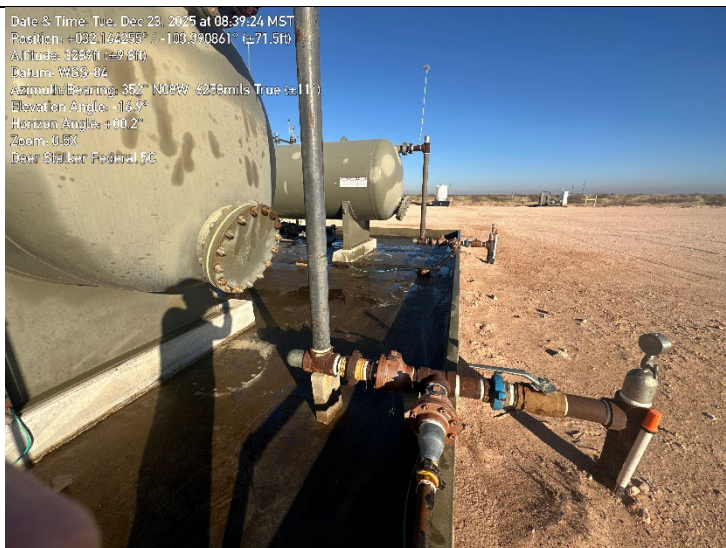
**Description:** View facing North. Lined area near production equipment. (Fluid in containment is residual from pressure washing activities.)

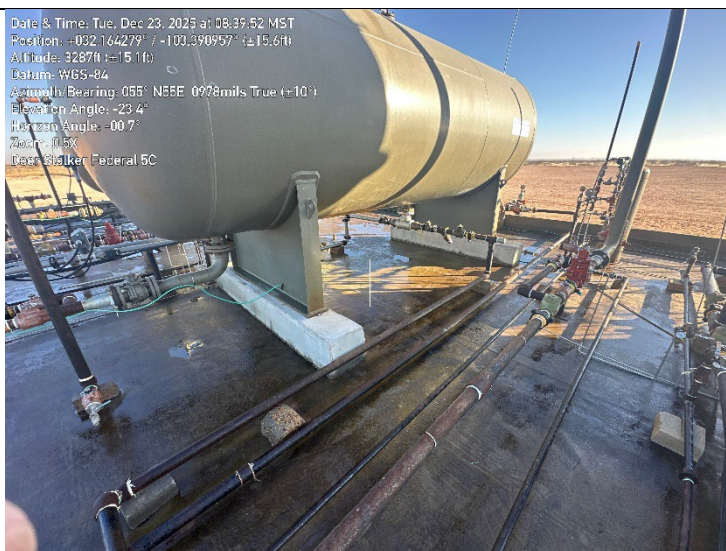
**Description:** View facing Northeast. Lined area near production equipment. (Fluid in containment is residual from pressure washing activities.)

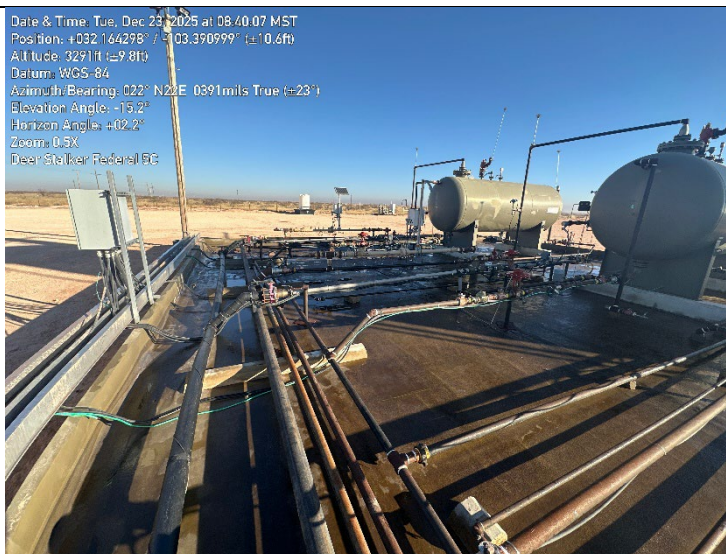
**Description:** View facing North/Northeast. Lined area near production equipment. (Fluid in containment is residual from pressure washing activities.)

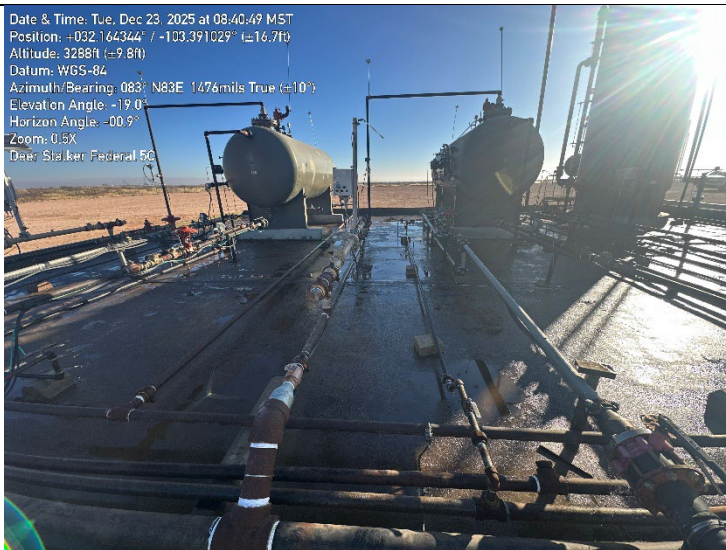
**Description:** View facing East. Lined area near production equipment and piping. (Fluid in containment is residual from pressure washing activities.)

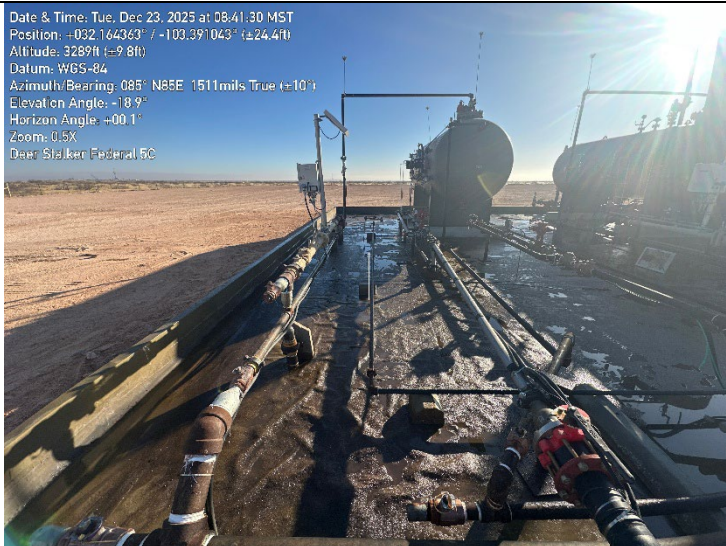
**Description:** View facing East. Lined area near production equipment and piping. (Fluid in containment is residual from pressure washing activities.)

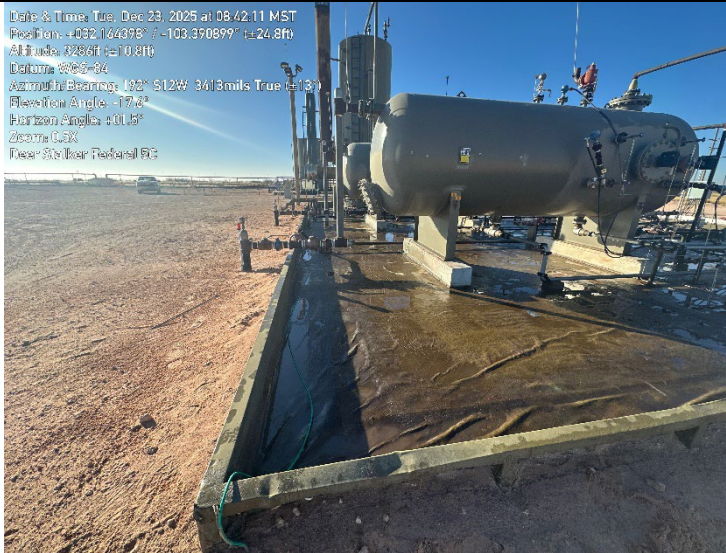
**Description:** View facing South. Lined area near production equipment. (Fluid in containment is residual from pressure washing activities.)
