**Closure Report
Riverwalk Federal 29C CTB
Incident ID: nAPP2532355881
Eddy County, New Mexico
Unit C Sec 29 T26S R29E
32.019557, -104.008166**

**Produced Water Release
Point of Release: Corrosion
Release Date: 11/09/2025
Volume Released: 10 Barrels of Produced Water
Volume Recovered: 8 Barrels of Produced Water**

**Re: Closure Report
Riverwalk Federal 29C CTB
Concho Operating, LLC
Incident Number: nAPP2532355881
Site Location: Unit C, S29, T26S, R29E
(Lat 32.019557°, Long -104.008166°)
Eddy County, New Mexico**

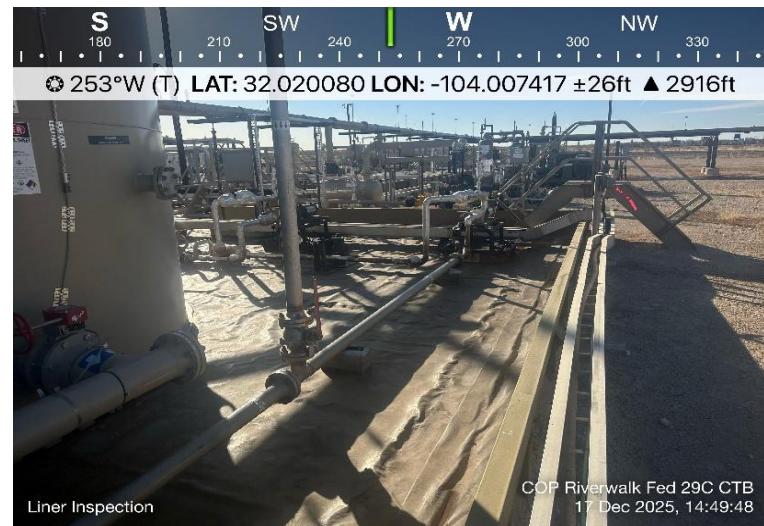
**Photograph No. 3****Facility:** Riverwalk FED 29C CTB**County:** Eddy County, New Mexico**Description:**

View West of cleaned Liner.

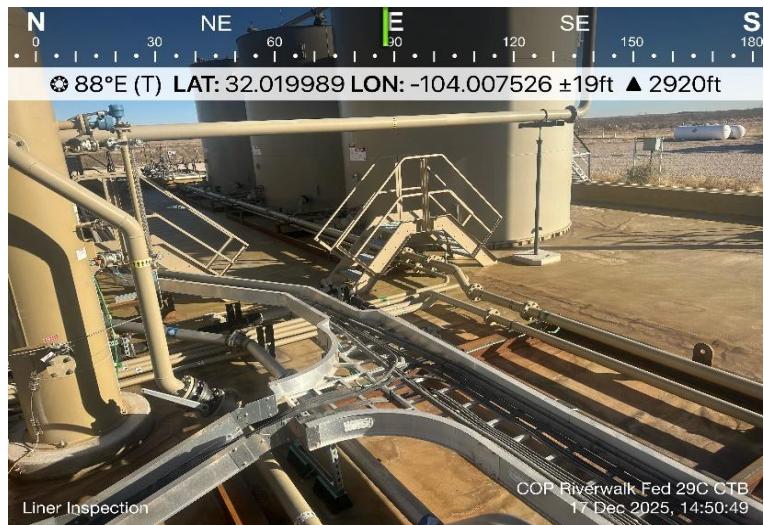
Photograph No. 4**Facility:** Riverwalk FED 29C CTB**County:** Eddy County, New Mexico**Description:**

View East of cleaned Liner.

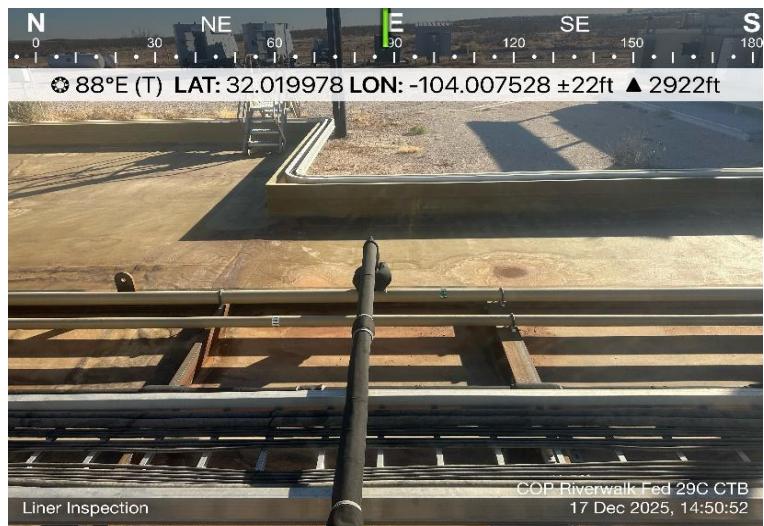
**Photograph No. 5****Facility:** Riverwalk FED 29C CTB**County:** Eddy County, New Mexico**Description:**

View East of cleaned Liner.

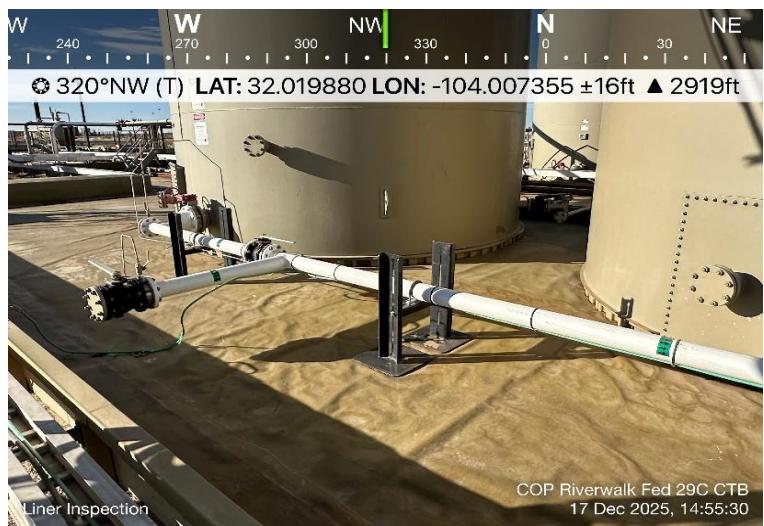
**Photograph No. 6****Facility:** Riverwalk FED 29C CTB**County:** Eddy County, New Mexico**Description:**

View Northwest of cleaned Liner.

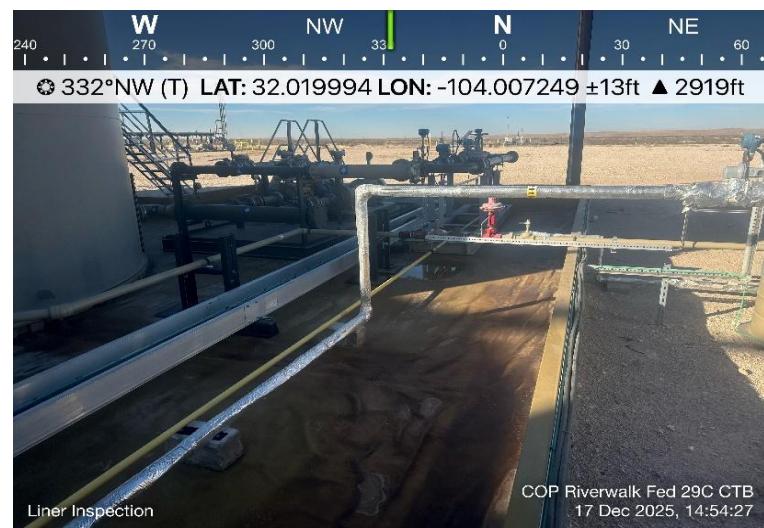
Photograph No. 7**Facility:** Riverwalk FED 29C CTB**County:** Eddy County, New Mexico**Description:**

View Northwest of cleaned Liner.

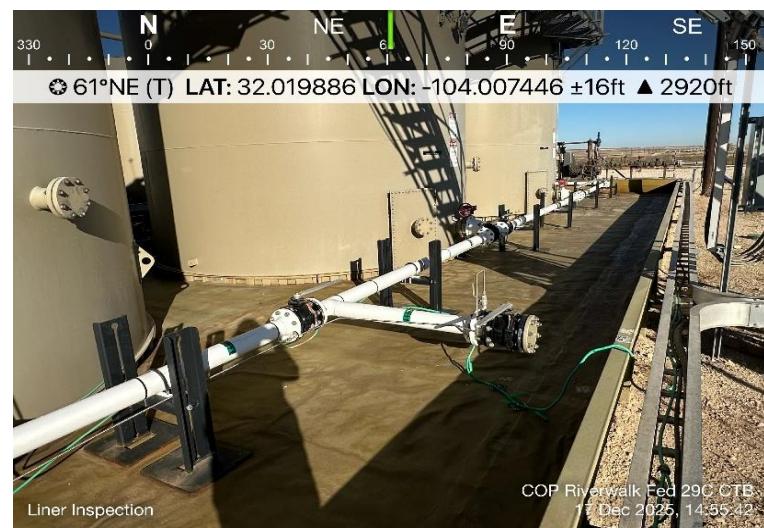
**Photograph No. 8****Facility:** Riverwalk FED 29C CTB**County:** Eddy County, New Mexico**Description:**

View Northeast of cleaned Liner.

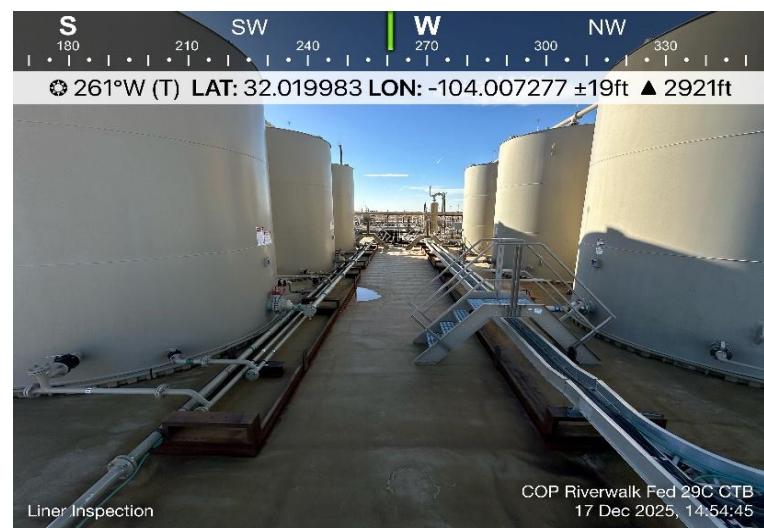
**Photograph No. 9****Facility:** Riverwalk FED 29C CTB**County:** Eddy County, New Mexico**Description:**

View West of cleaned Liner.

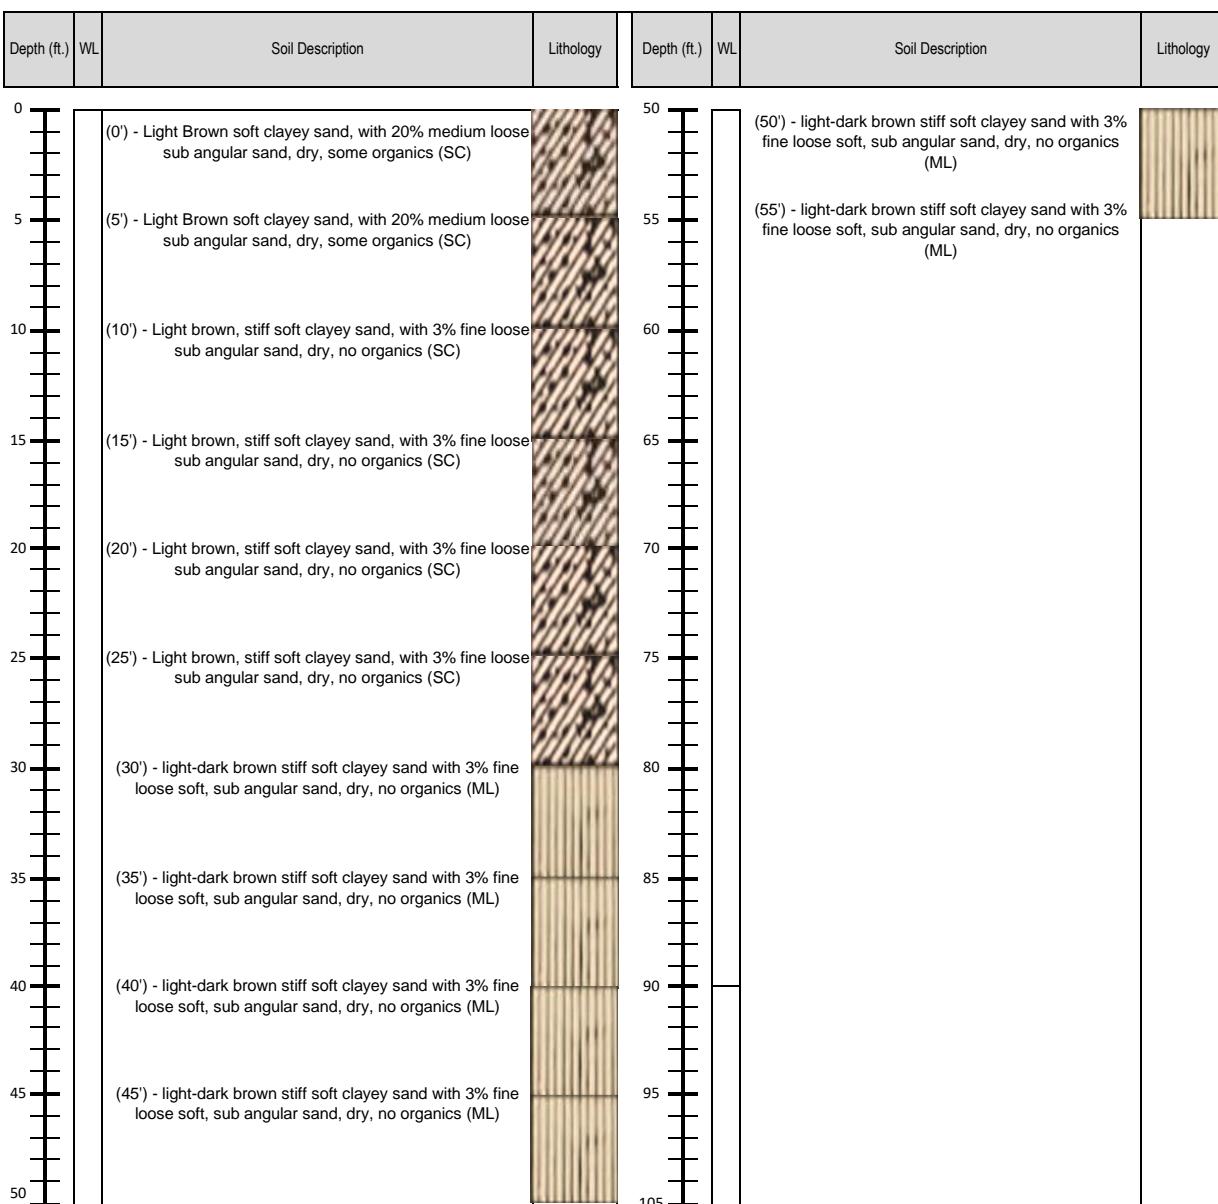
Project Name : COG - Copperhead Fee A 3H (02.08.22)
 Project No. : 1023
 Location : Eddy County, New Mexico
 Coordinates : 32.016146, -104.021411
 Elevation : 2,935'

Comments : Boring terminated at 55' at 10:00 AM Central Time with no presence of groundwater or moisture.

Well gauged on 4/29/22 at 11:00 AM Central Time with no detection of groundwater or moisture

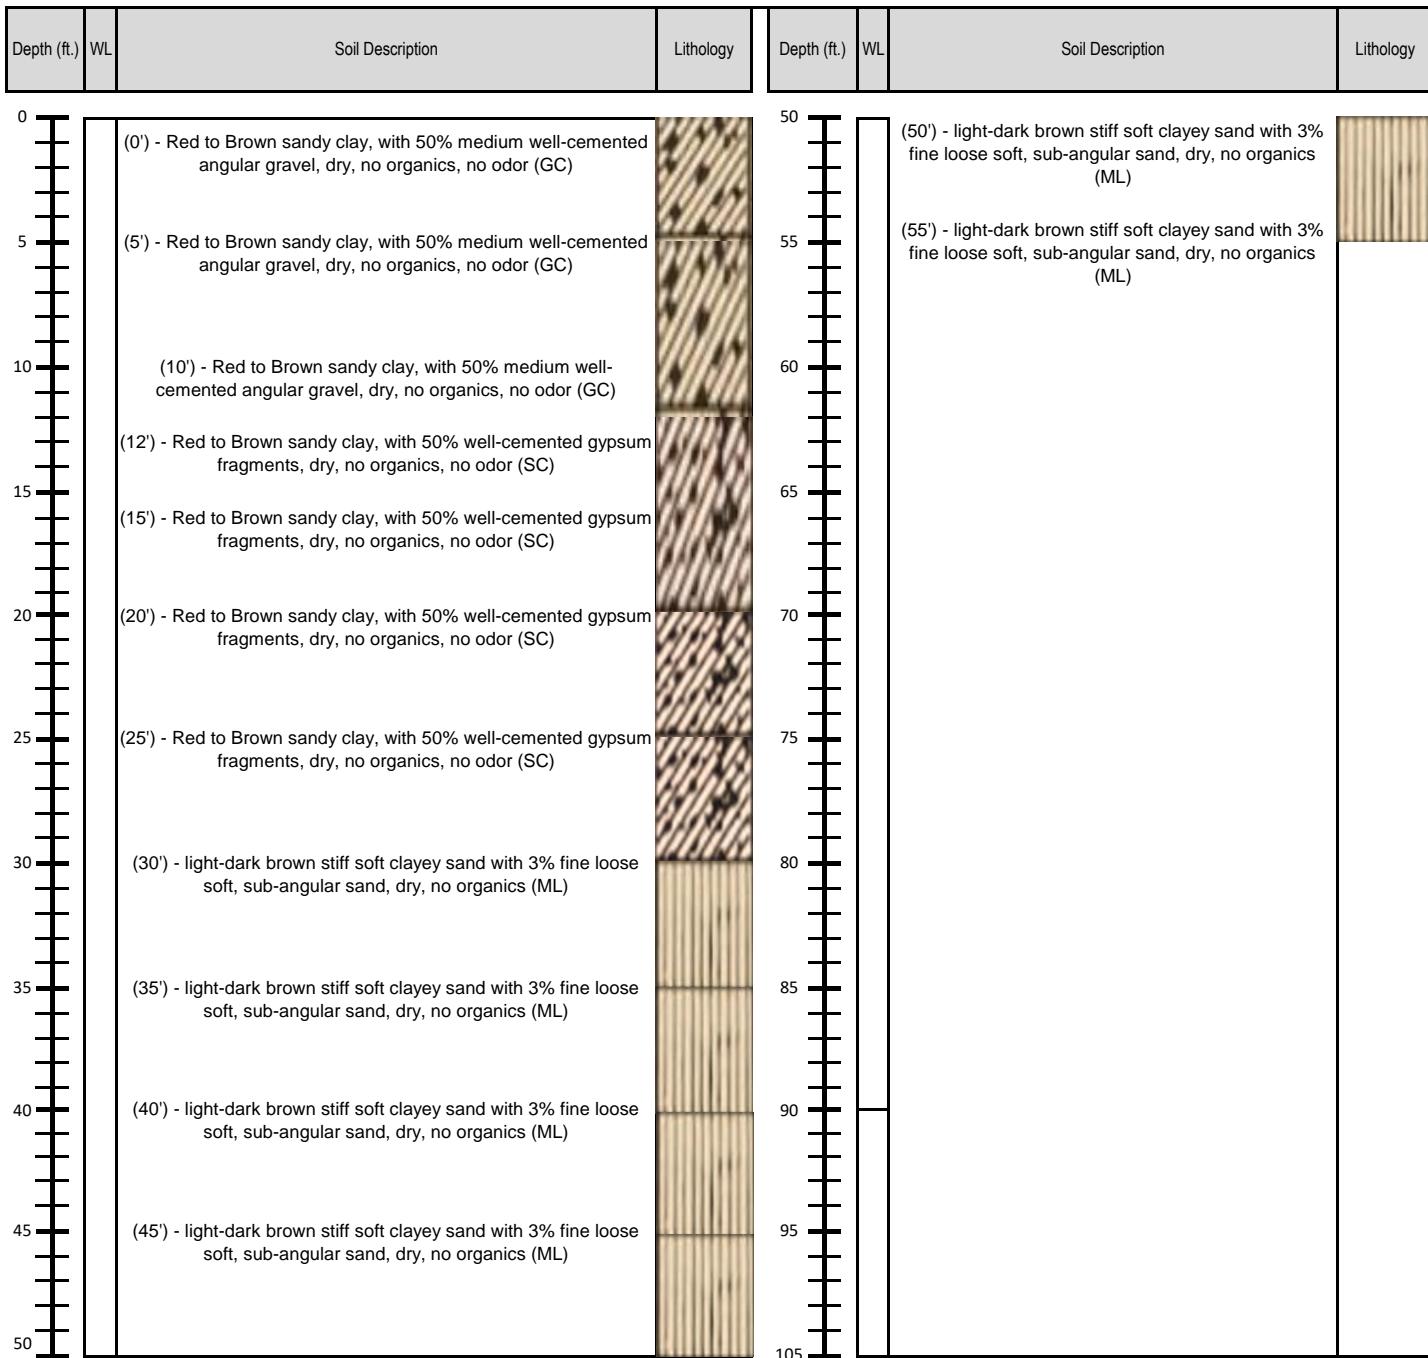
Project Name :	COG - Copperhead Fee 31E CTB (01.14.22)	Date :	Monday, May 9, 2022
Project No. :	1002	Sampler :	Lane Scarborough
Location :	Eddy County, New Mexico	Driller :	Scarborough Drilling
Coordinates :	32.002359, -104.031693	Method :	Air Rotary
Elevation :	2,930'

Comments : Boring terminated at 55' at 10:00 AM Central Time with no presence of groundwater or moisture.

Well gauged on 5/13/22 at 11:00 AM Central Time with no detection of groundwater or moisture
