Land Reclamation Report

Dolores AIL Federal #3

Incident ID: nAPP2513446761

September 2025

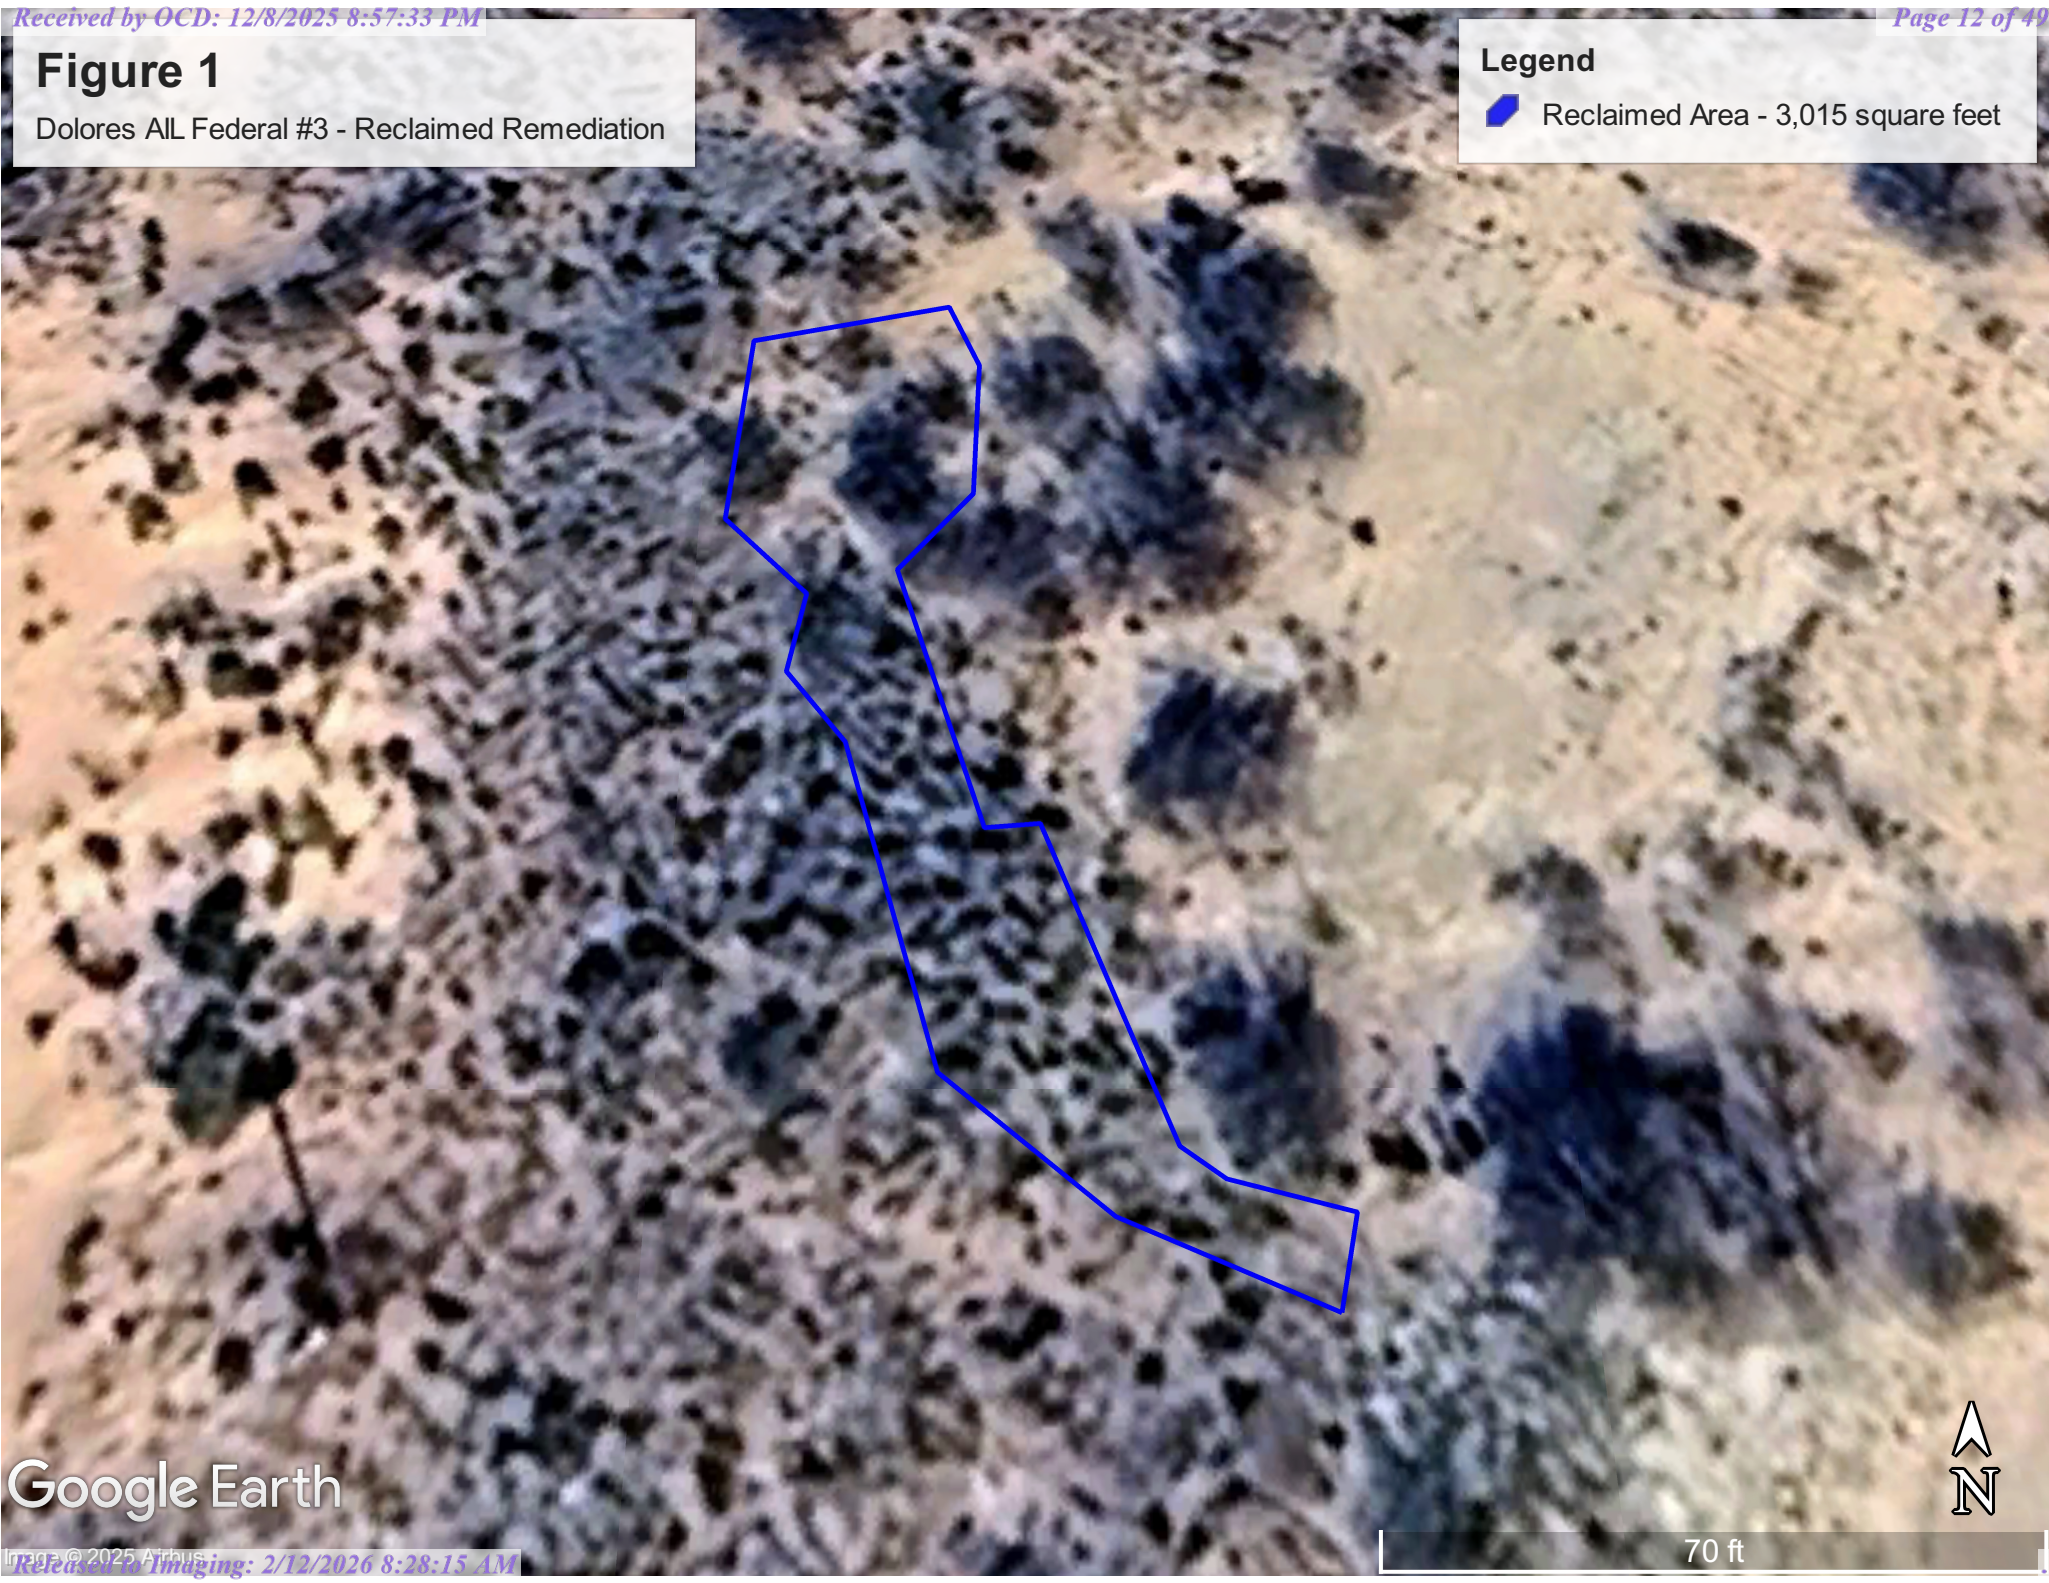
Figure 1

Dolores AIL Federal #3 - Reclaimed Remediation

Reclaimed Area - 3,015 square feet

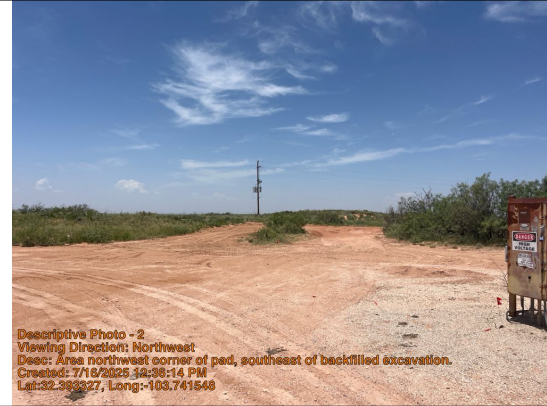
Descriptive Photo - 2
Viewing Direction: Northwest
Desc: Area northwest corner of pad, southeast of backfilled excavation.
Created: 7/18/2025 12:38:14 PM
Lat:32.993327, Long:-103.741548

Area northwest corner of pad, southeast of backfilled excavation.

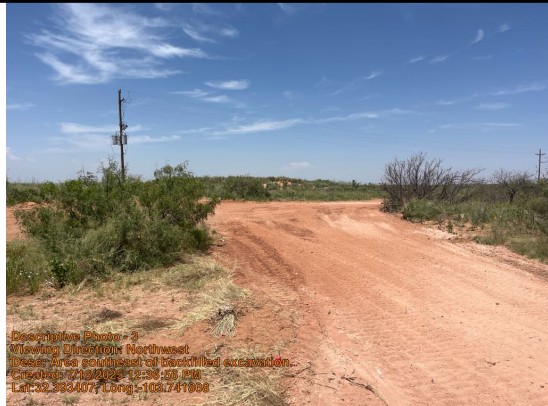
Descriptive Photo - 3
Viewing Direction: Northwest
Desc: Area southeast of backfilled excavation.
Created: 7/18/2025 12:38:29 PM
Lat:32.993407, Long:-103.741894

Area southeast of backfilled excavation.

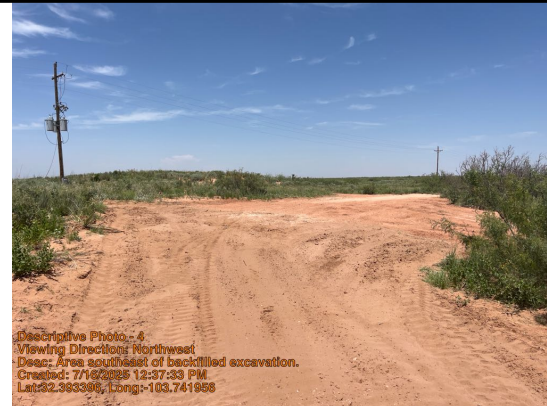
Descriptive Photo - 4
Viewing Direction: Northwest
Desc: Area southeast of backfilled excavation.
Created: 7/18/2025 12:37:33 PM
Lat:32.993396, Long:-103.741958

Area southeast of backfilled excavation.

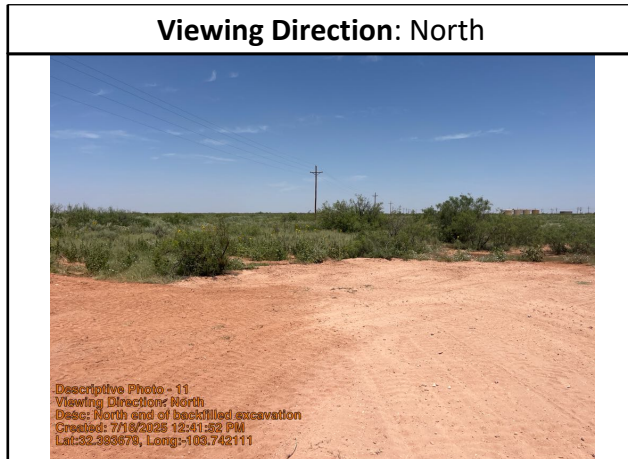
North end of backfilled excavation

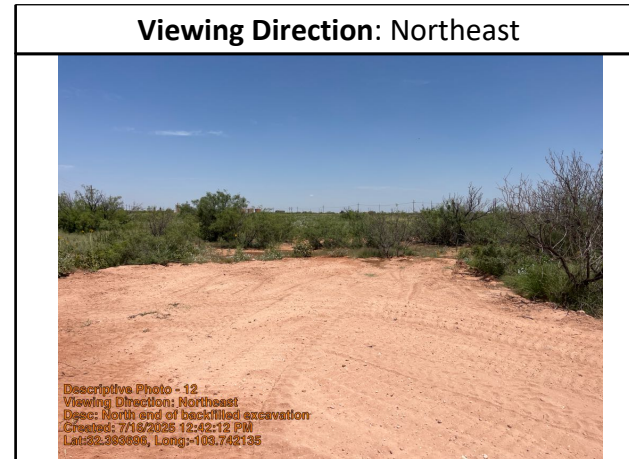
North end of backfilled excavation

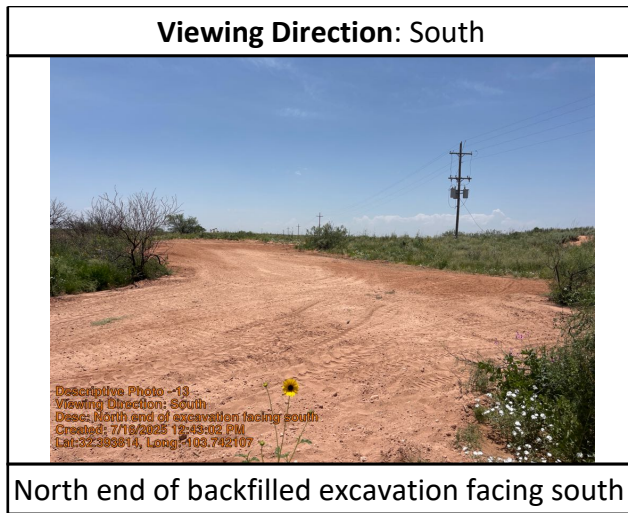
North end of backfilled excavation facing south

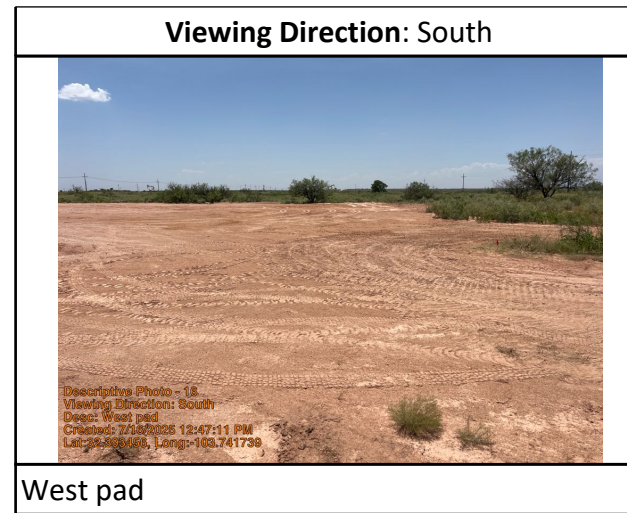
West pad
