**Re: 2026 Q1 Groundwater Monitoring Report
Historic Dickinson Tank Battery Release
Unit Letter M, Sec 1, T15S, R37E
GPS Coodinates: 33.042588°N, -103.158438°W
Lea County, New Mexico
NMOCD Release Number: NAUTOFLWP00122 (Formerly 1R-432)**

New Tech Global Environmental, LLC (NTGE) on behalf of Devon Energy (Devon), has prepared this 2026 Q1 Groundwater Monitoring Report for submittal to the New Mexico Oil Conservation Division (NMOCD) in Albuquerque, New Mexico. This report presents the 2026 first (1th) quarter laboratory analysis of groundwater samples collected from three (3) monitor wells (MW-6A, MW-South-A, and MW-North-A) at the former Dickinson Tank Battery (Site) located in Unit Letter M, Section 1, Township 15 South, Range 37 East, in Lea County, New Mexico. The geodetic position is latitude 33.042588° N, longitude -103.158438° W. See Figures 1 and 2 for Site Location and Topographic Maps.

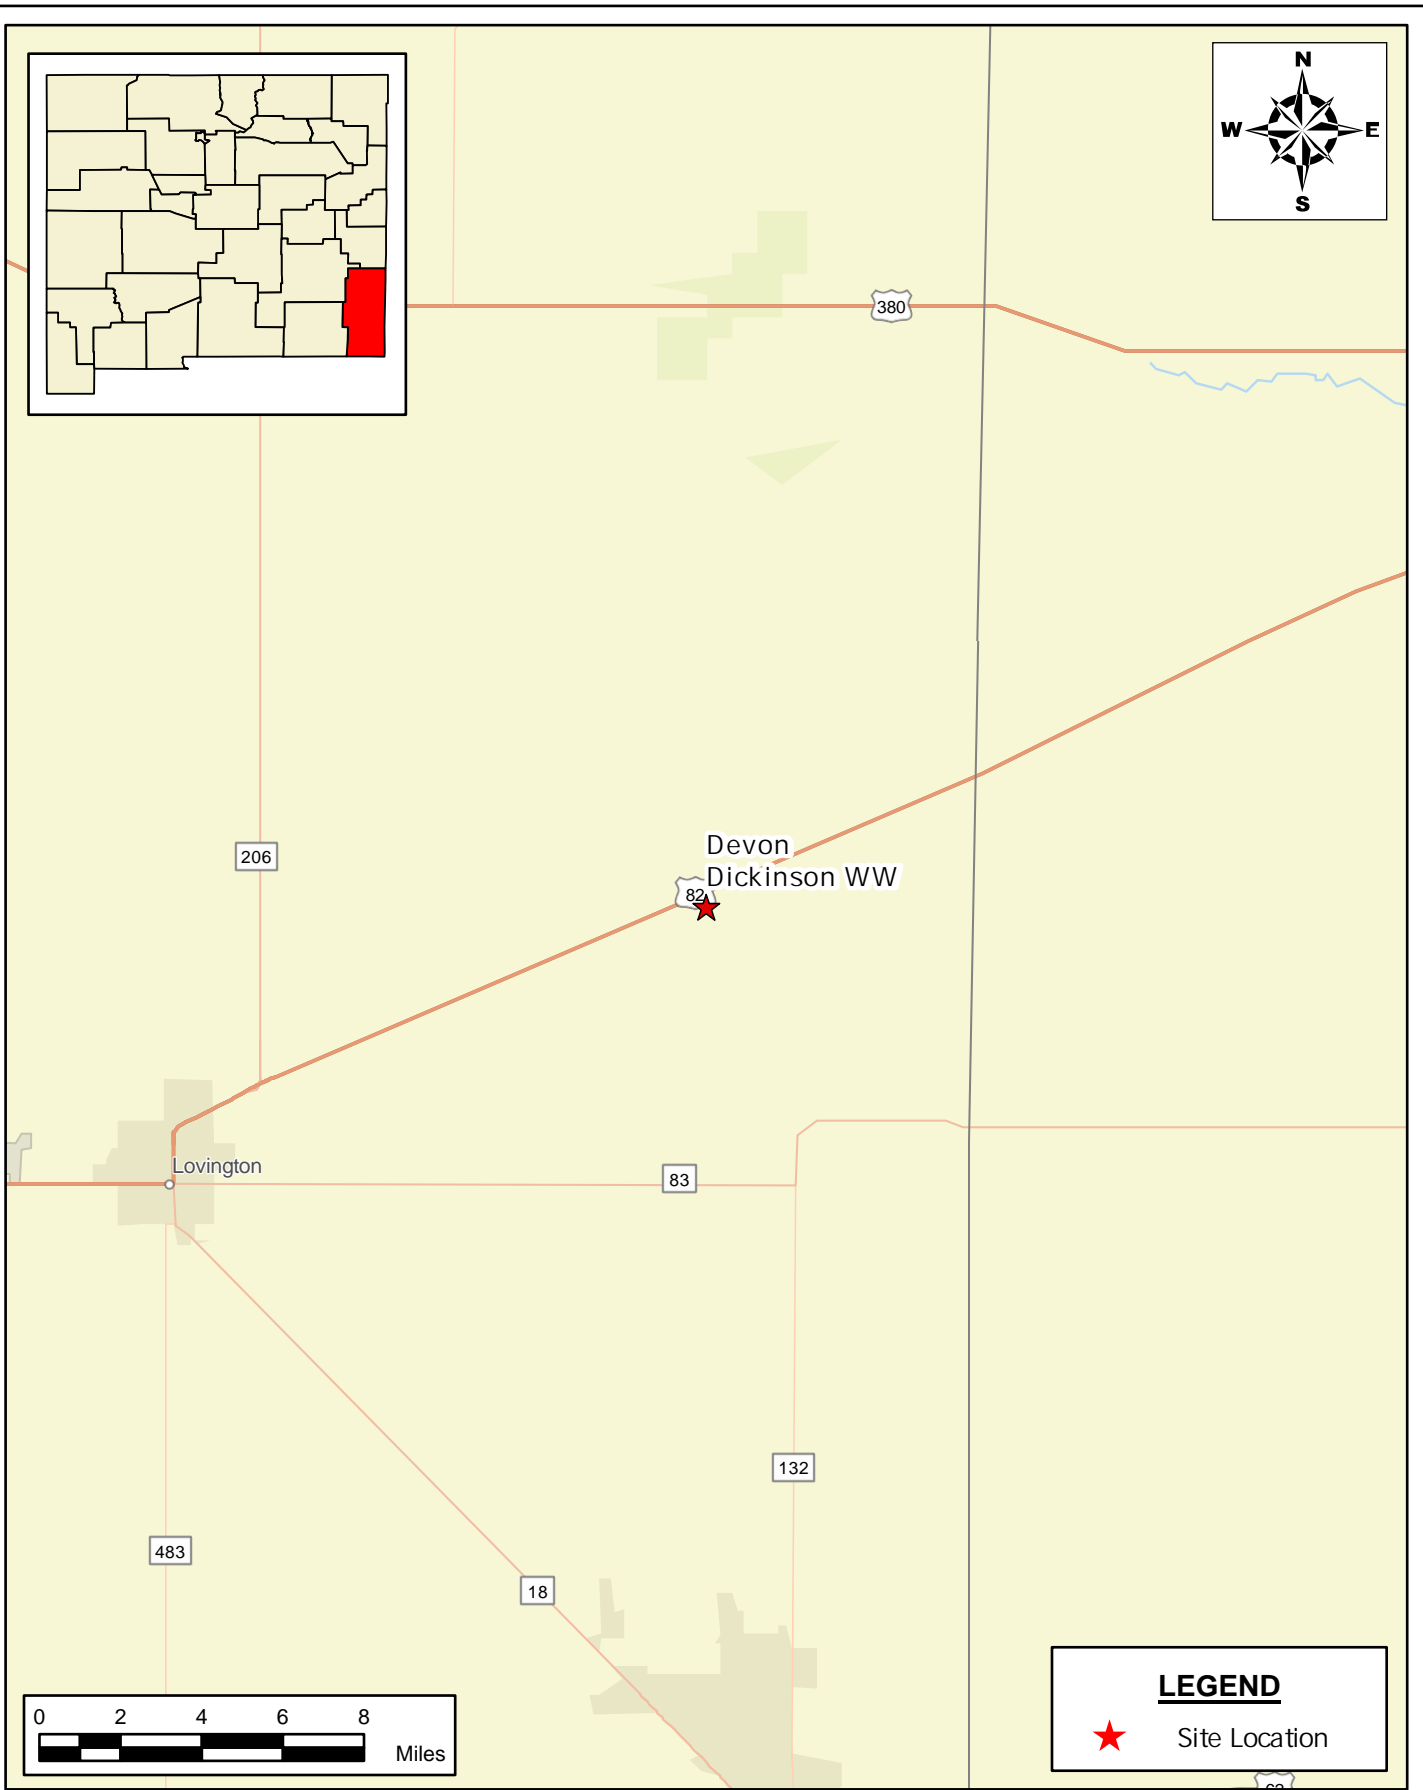
FIGURE 1

SITE LOCATION MAP
DEVON ENERGY
 DEVON DICKINSON WW
 LEA COUNTY, NEW MEXICO
 33.042724, -103.158525

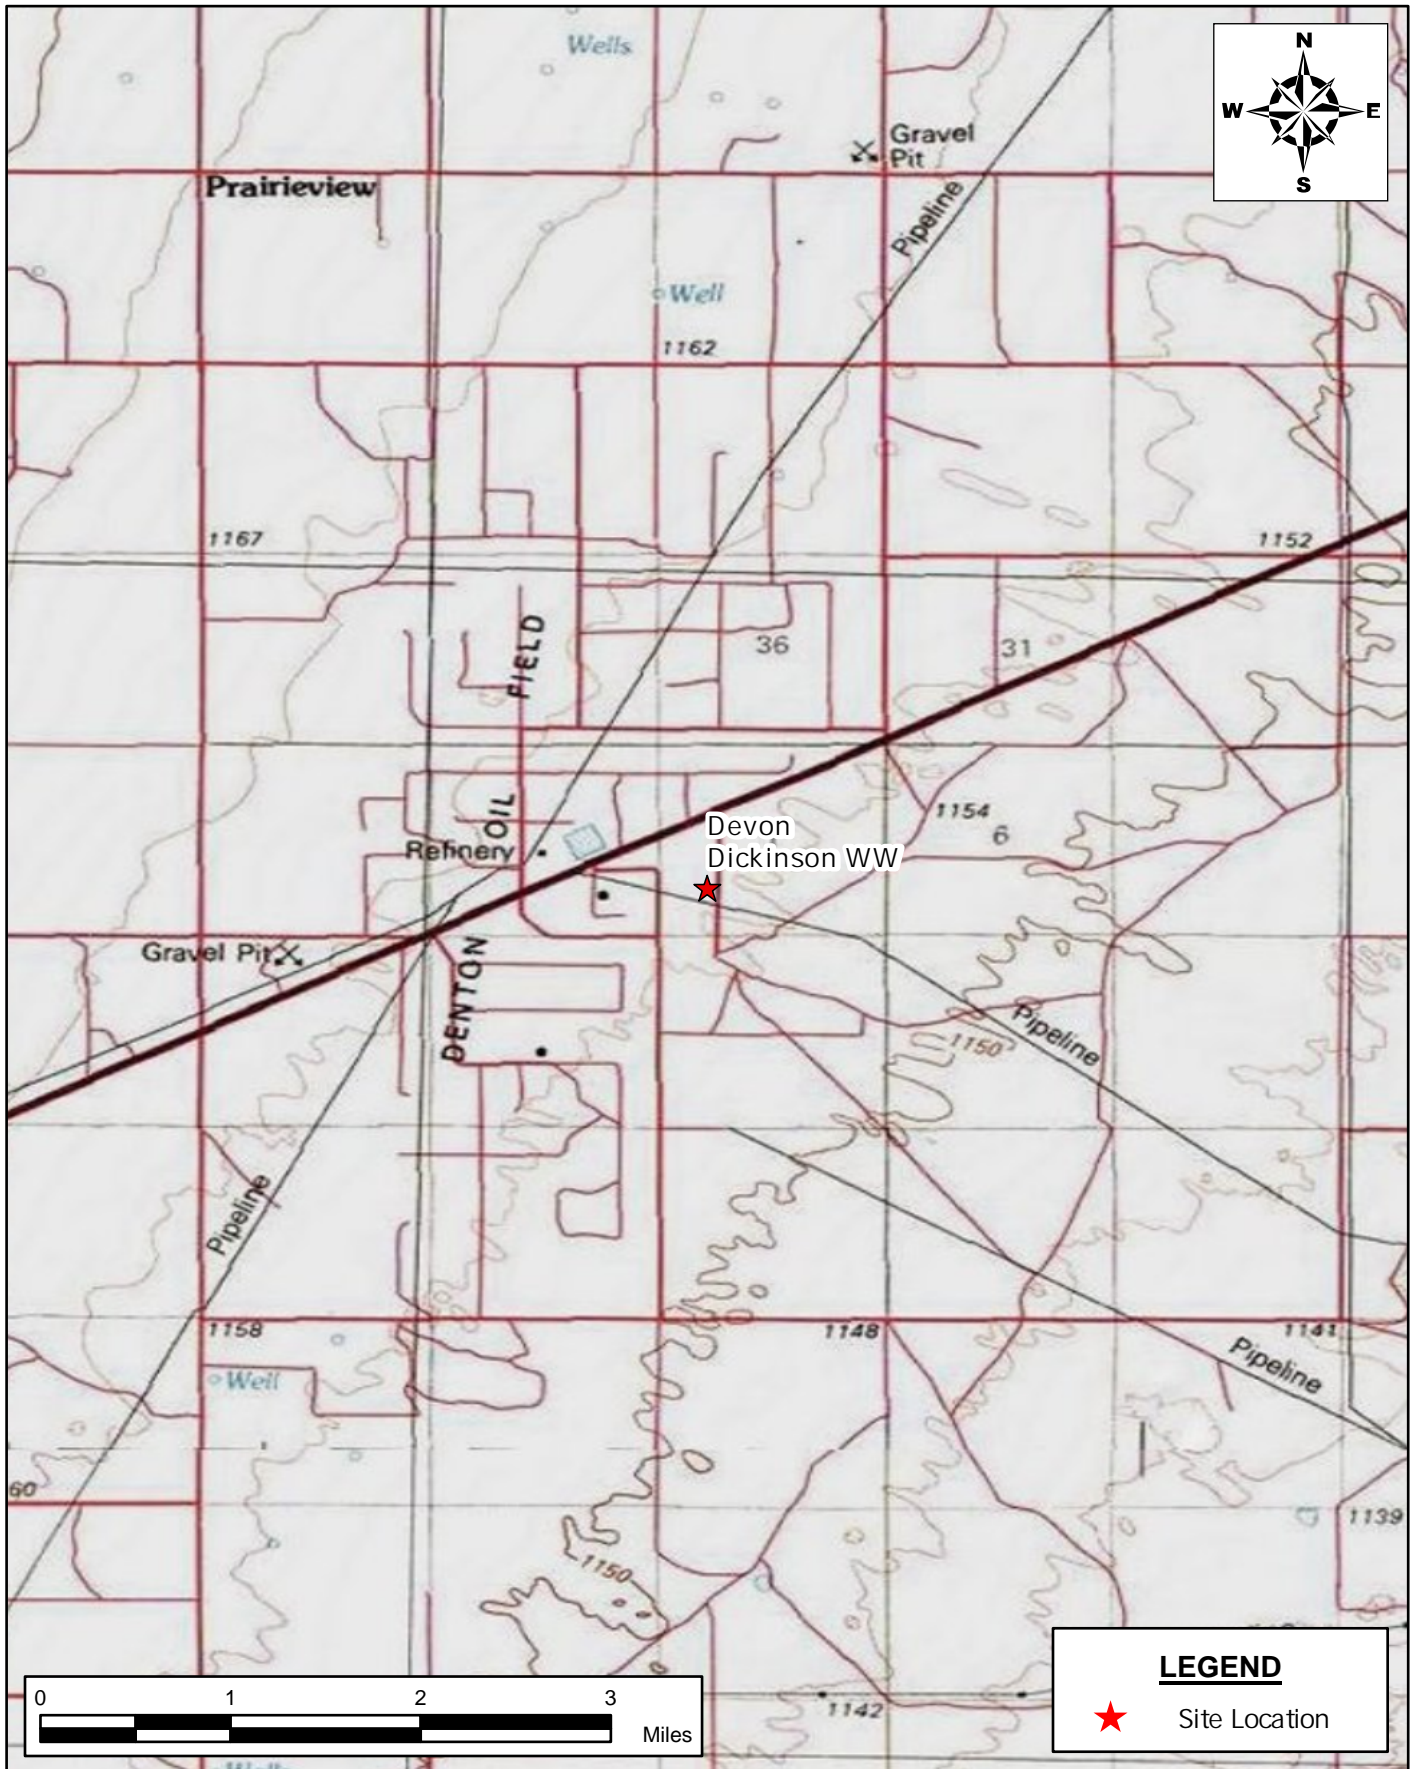
DRAWING NUMBER:
FIGURE 2
 SHEET NUMBER:
1 of 1

TOPOGRAPHIC MAP
DEVON ENERGY
 DEVON DICKINSON WW
 LEA COUNTY, NEW MEXICO
 33.042724, -103.158525

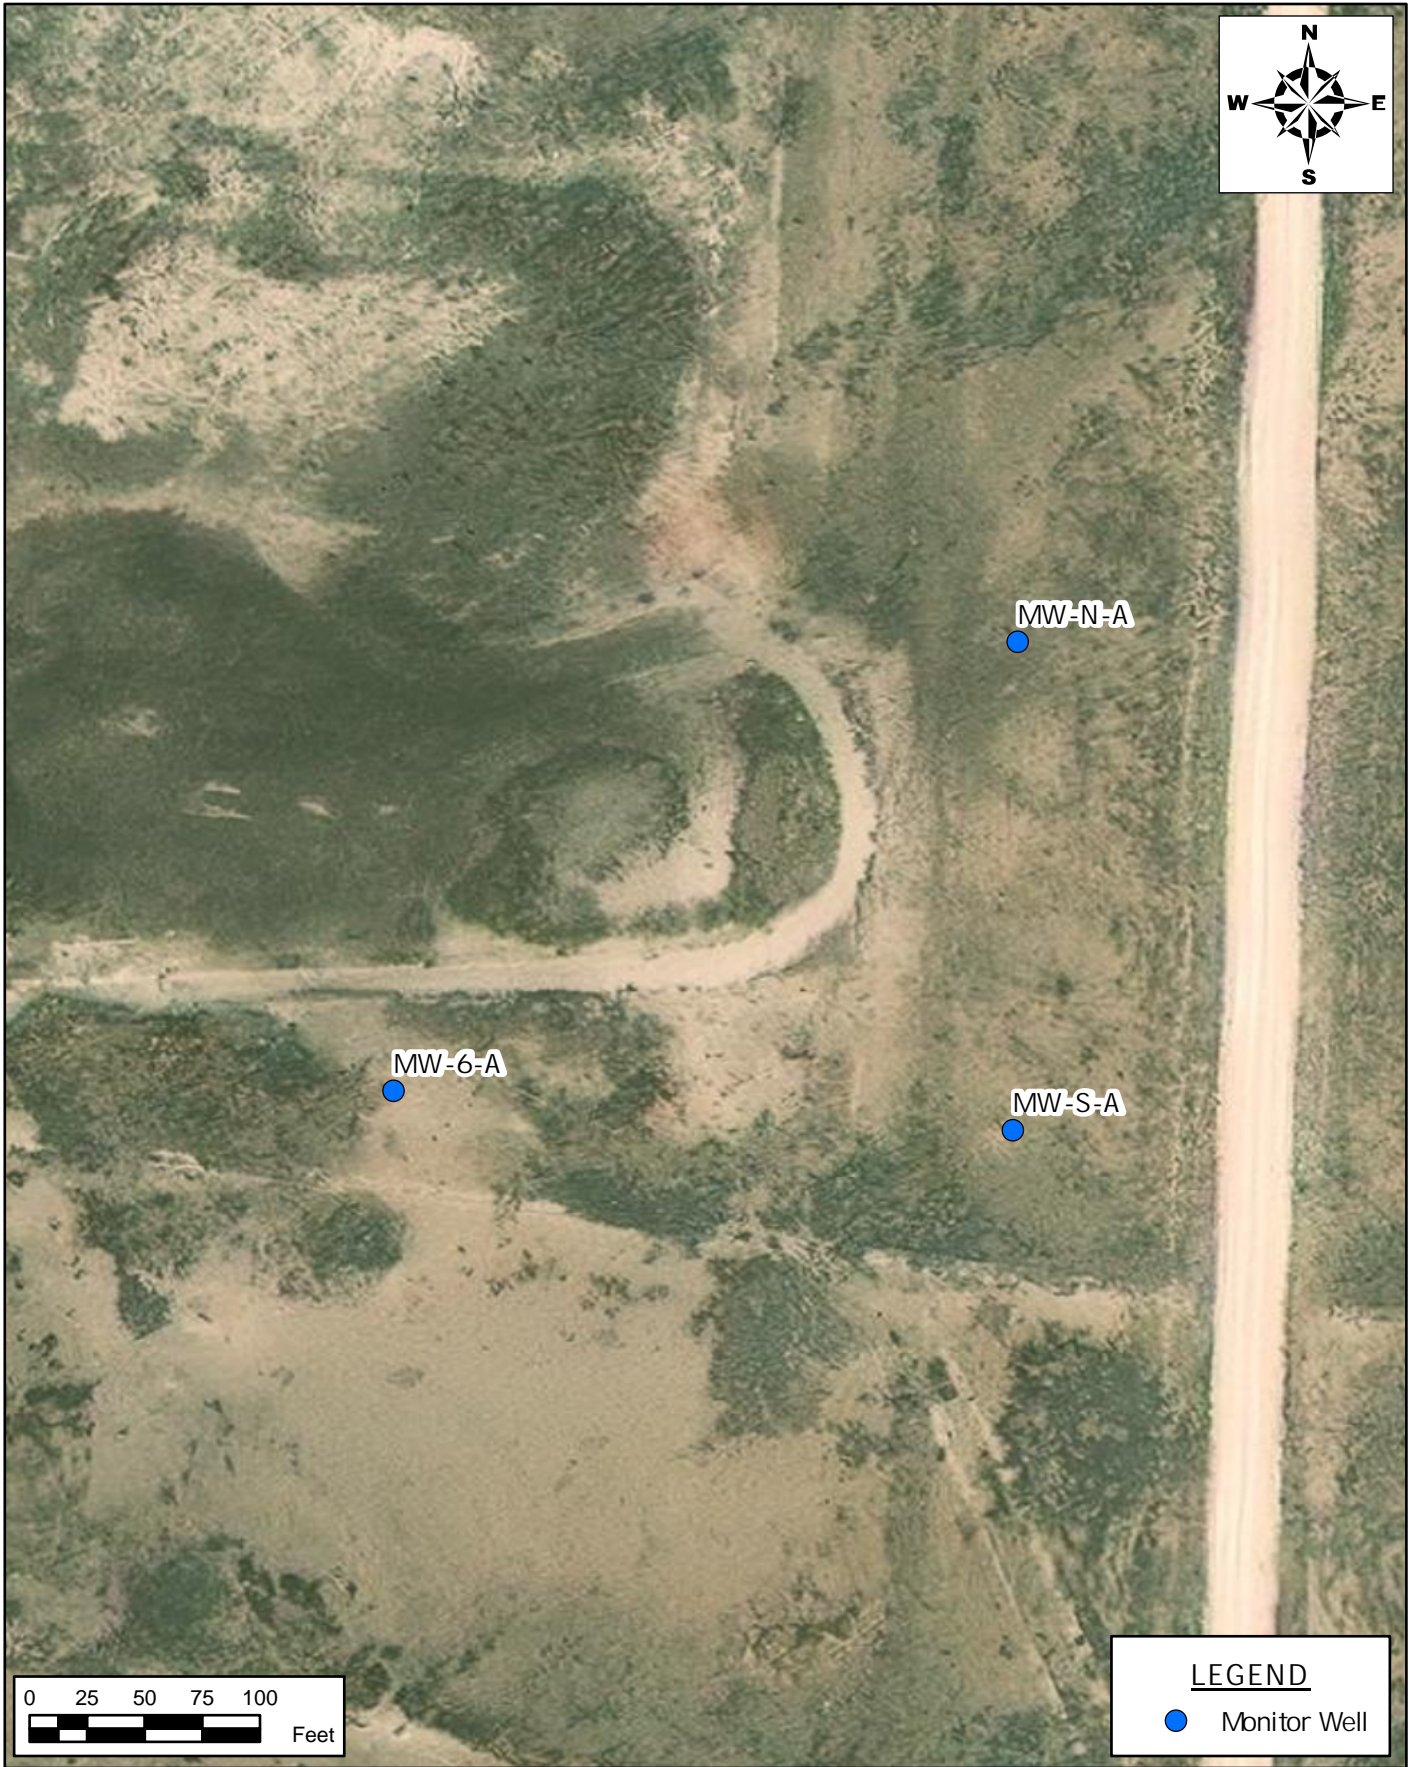
FIGURE 3

MONITOR WELL LOCATION MAP
DEVON ENERGY
 DEVON DICKINSON WW
 LEA COUNTY, NEW MEXICO
 33.042724, -103.158525

On February 6, 2026, NTGE was onsite to gauge each of the three (3) monitor wells. See Figure 3 for site monitoring well locations. Utilizing a water level indicator each of the wells were gauged from a mark on the north side of the well casing to first depth of encountered groundwater and the bottom of the well. The corrected groundwater depth was then calculated, and a gradient map developed. Figure 4 indicates the groundwater gradient at the site is to the northeast towards monitor well MW-North-A. See Table 1 for gauging data with corrected groundwater elevations.

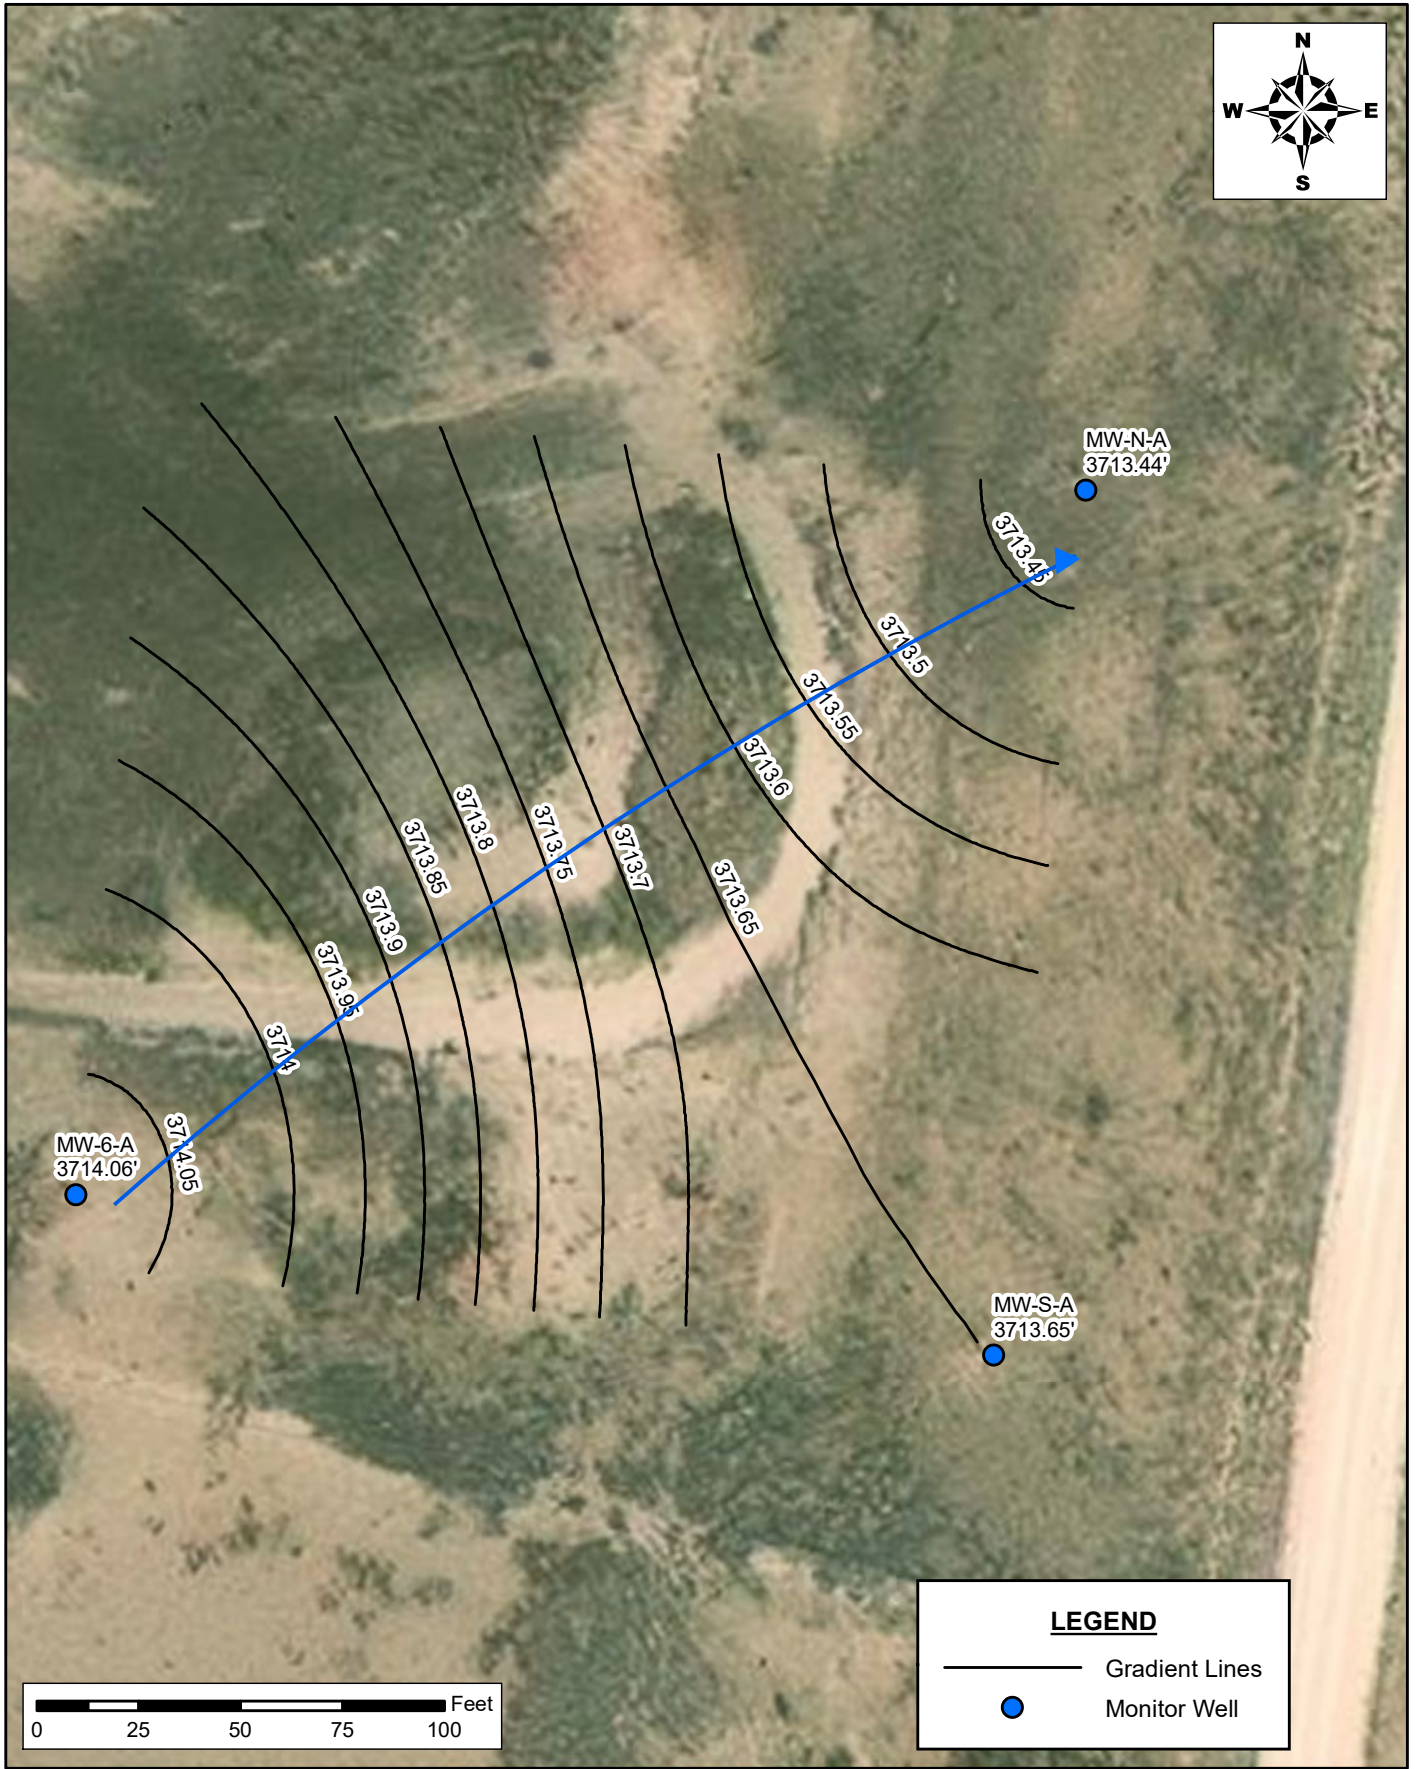
FIGURE 4

GROUNDWATER GRADIENT MAP
 DEVON ENERGY
 DEVON DICKINSON WW
 LEA COUNTY, NEW MEXICO
 32.042724° -103.158525°

1. Base Image: ESRI Maps & Data 2017
2. Map Projection: NAD 1983
3. Contour Intervals= 0.25 Ft
4. Elevation in feet
5. Gauged 02/06/2026

Based on the current groundwater results, the site gradient appears to be northeast towards monitor well MW-North-A with analytical results below the NMWQCC standards. NTGE suggests the site should remain on quarterly sampling and if the site is below NMWQCC standards for eight (8) consecutive quarters (through December 2026), Devon should pursue closure of the site.

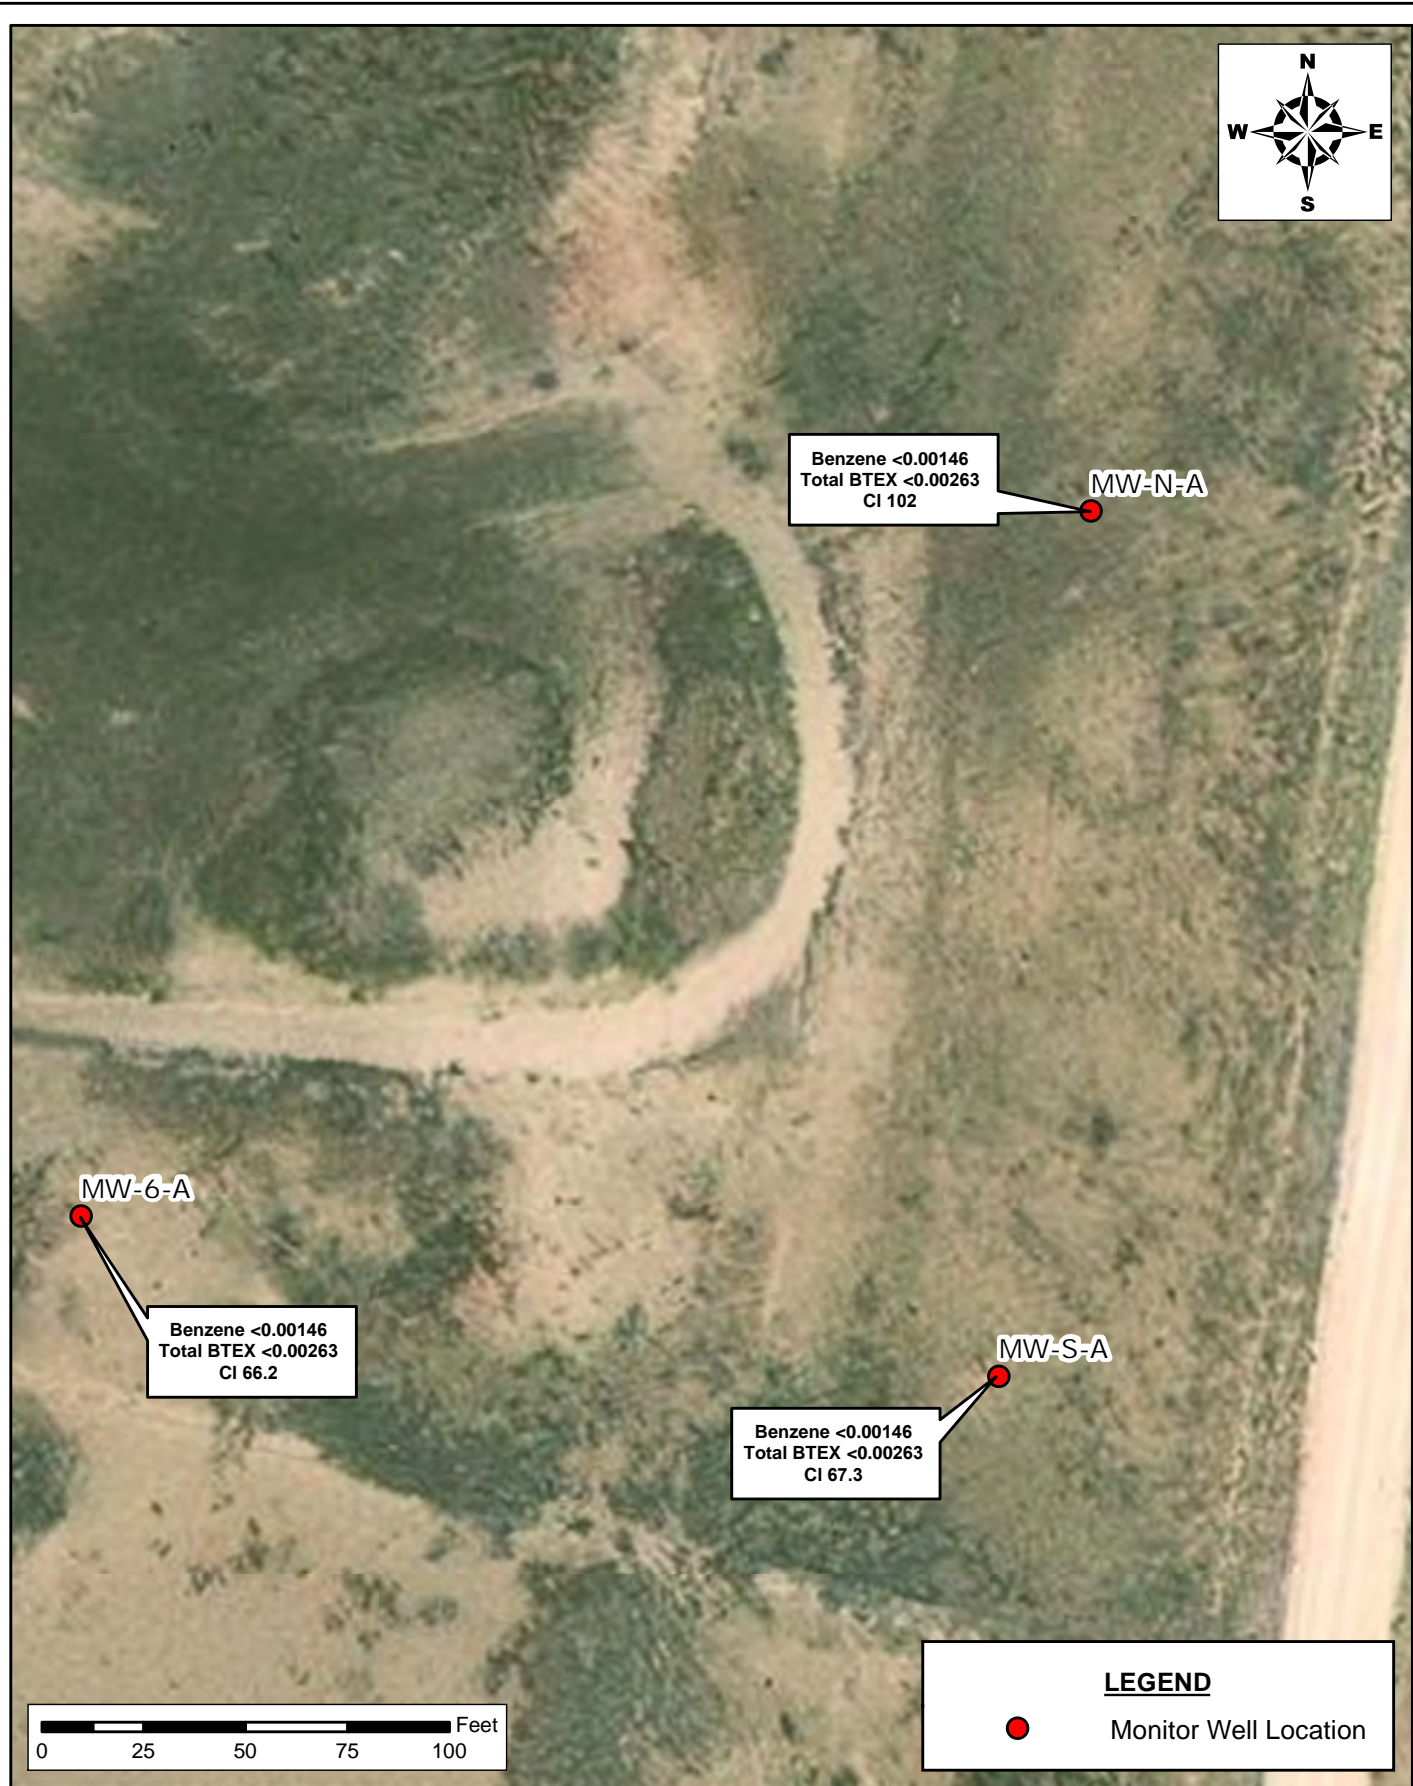
DRAWING NUMBER:
FIGURE 5
 SHEET NUMBER:
1 of 1

GROUNDWATER CONCENTRATION MAP
 DEVON ENERGY
 DEVON DICKINSON WW
 LEA COUNTY, NEW MEXICO
 32.042724° -103.158525°

1. Base Image: ESRI Maps & Data 2017
2. Map Projection: NAD 1983
3. Results in mg/L
4. .Sampled on 02/06/26

Analytical results indicated all samples were below the NMWQCC standards for BTEX and chlorides. Chlorides in the groundwater ranged from 66.2 milligrams per Liter (mg/L) in MW-6-A to 102 mg/L in MW-North-A. The BTEX concentrations were all below laboratory method detection limits. See Table 2 for groundwater analytical results along with Figure 5 Groundwater Hydrocarbon Concentration Map. See Appendix A for laboratory analytical results.
