February 5, 2026

New Mexico Oil Conservation Division

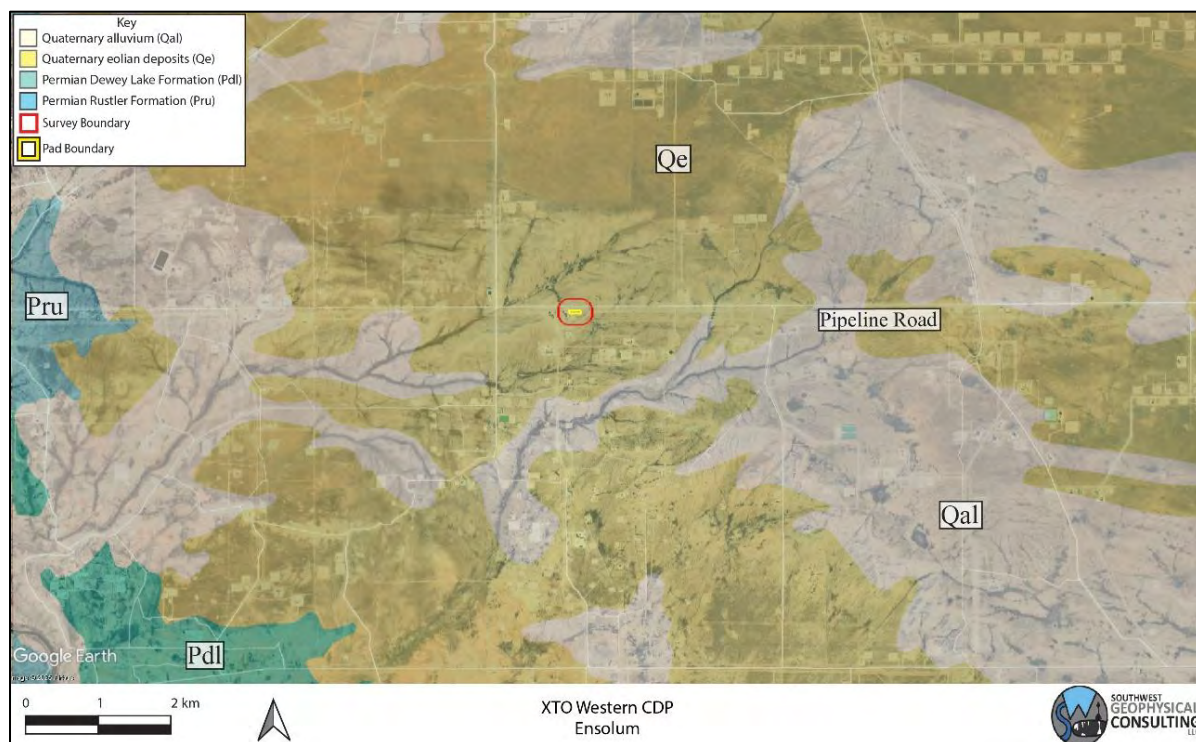
Figure 3: Geology overview. Geology map credit: The Digital Geologic Map of New Mexico in ARC/INFO Format. Background image credit: Google Earth. Image date: December 31, 2023. Image datum: WGS-84.

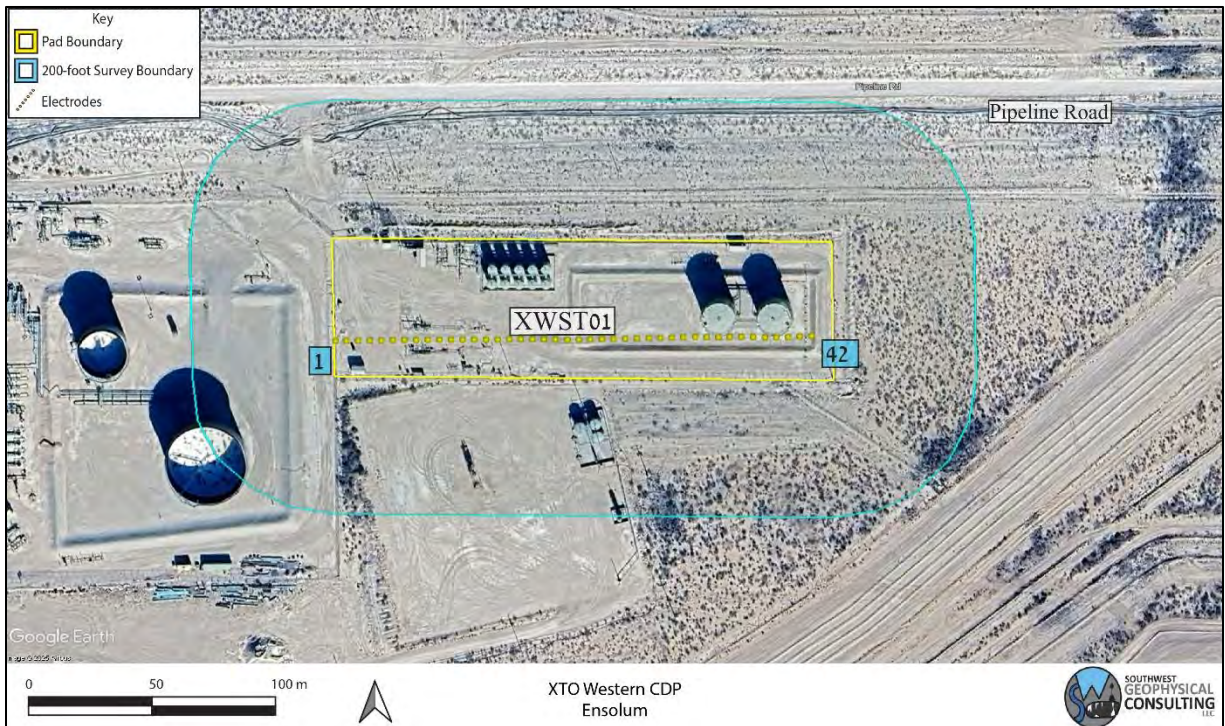
Figure 5: Geophysical survey overview. One survey line was conducted with 42 electrodes (yellow dots denoted with blue numbers). Background image credit: Google Earth. Image date: December 31, 2023. Datum: WGS-84.

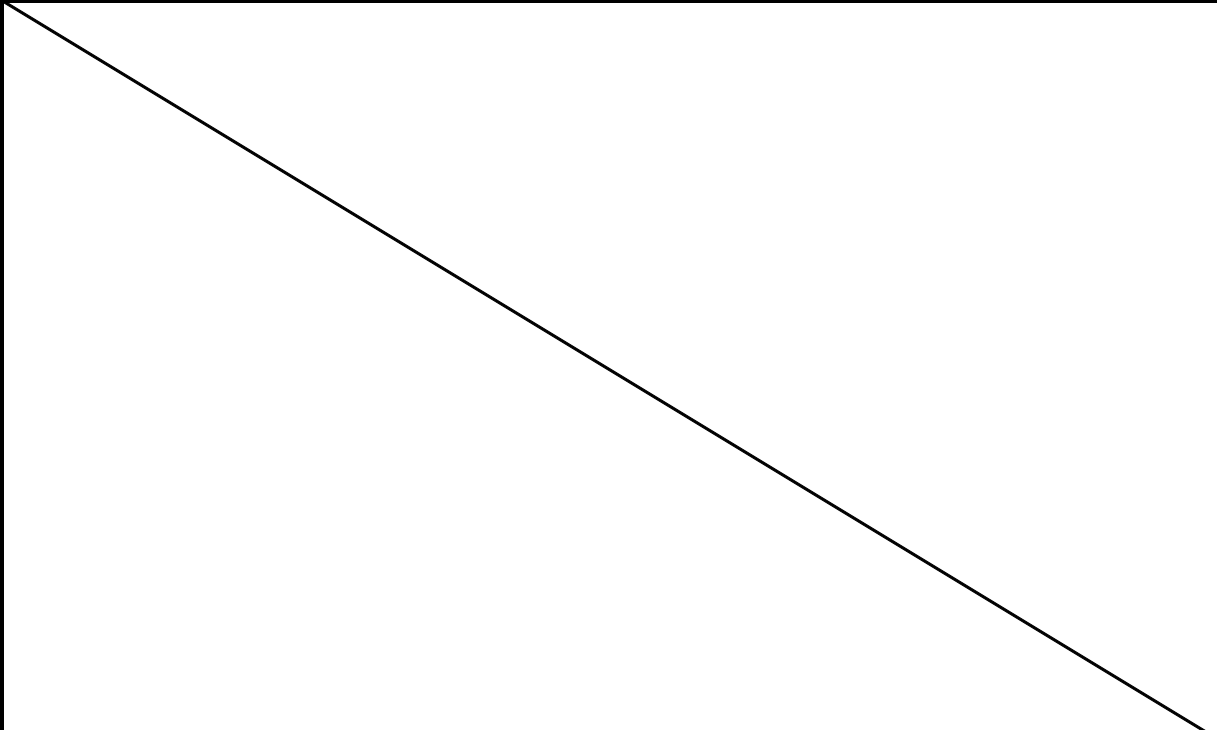
D	<168	1,805	Y	PH02A	2	2		Strong odor at 2 feet bgs	
D	<168	115	N	PH02B	3	3		Weak odor at 3 feet bgs	
D	<168	27.4	N	PH02C	4	4		Weak odor at 4 feet bgs	
Total Depth @ 4 feet bgs
