CLOSURE REPORT

Maddox B Fed Com #1
Unit Letter N, S13 T30N R13W
San Juan County, New Mexico

New Mexico EMNRD OCD Incident ID No. NAPP2531853923

February 5, 2026

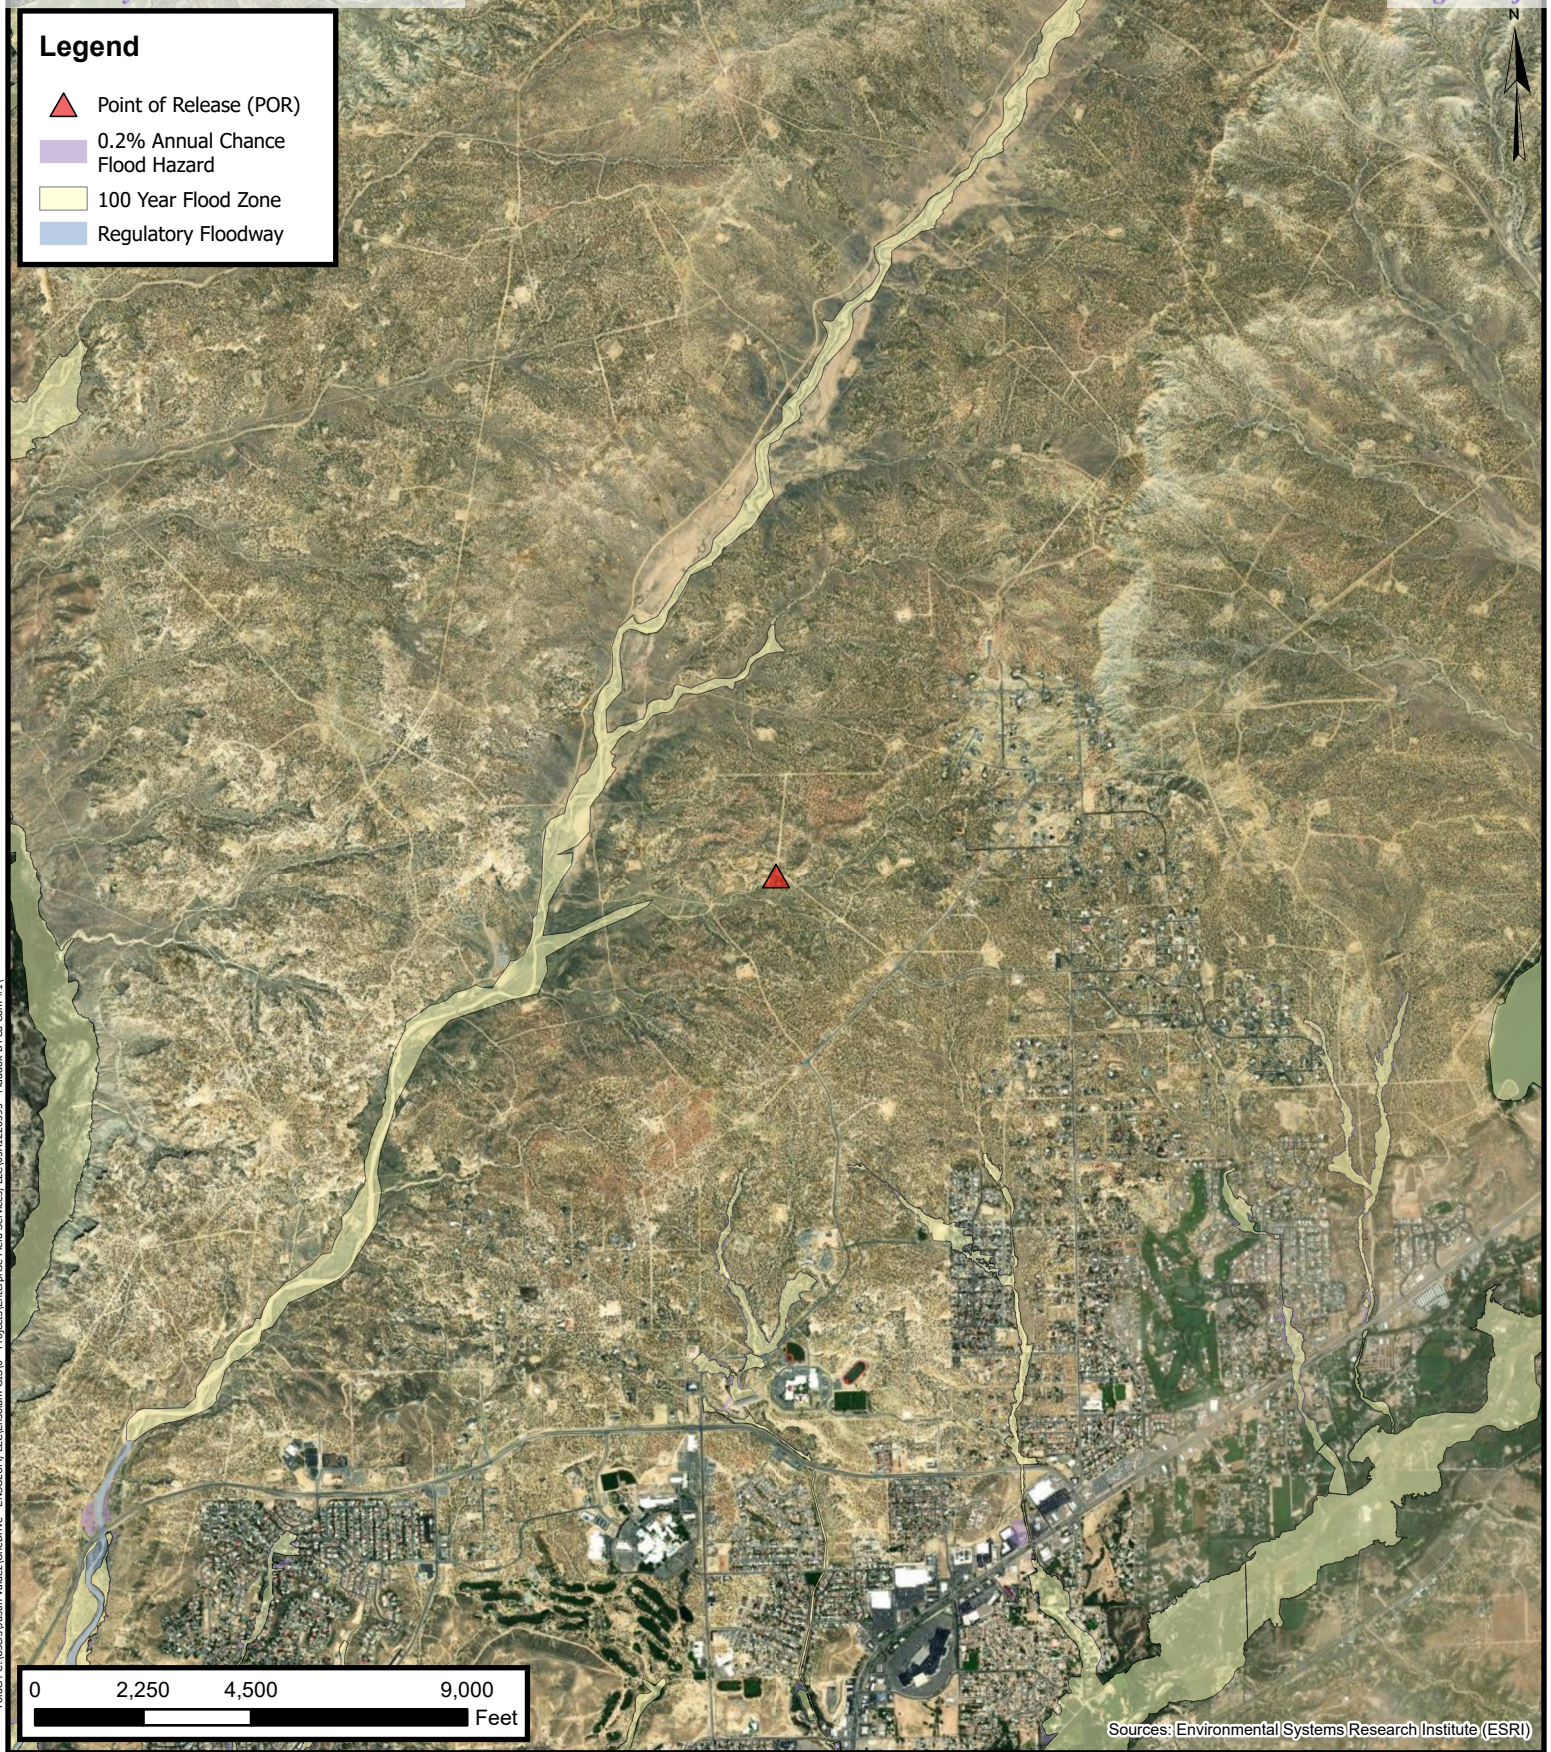
**FIGURE
G**

Mines, Mills, and Quarries
Enterprise Field Services, LLC
Maddox B Fed Com #1
Project Number: 05A1226395
Unit N, Section 13, T 30N, R 13W, San Juan County, New Mexico
36.808348, -108.159644

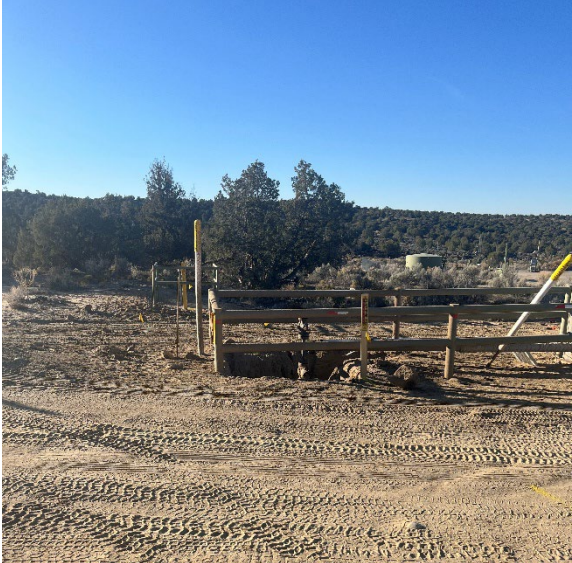
A wide-angle photograph of a dirt area with tire tracks, a wooden fence, and trees in the background under a clear blue sky.
<p>Photograph 2</p> <p>Photograph Description: View of the in process excavation activities.</p>

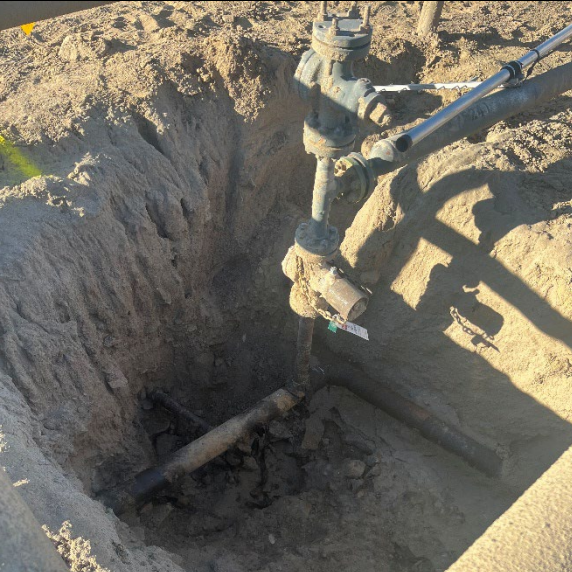
A close-up view of a metal valve assembly being worked on in a deep, narrow excavation pit.
<p>Photograph 3</p> <p>Photograph Description: View of the in process excavation activities.</p>

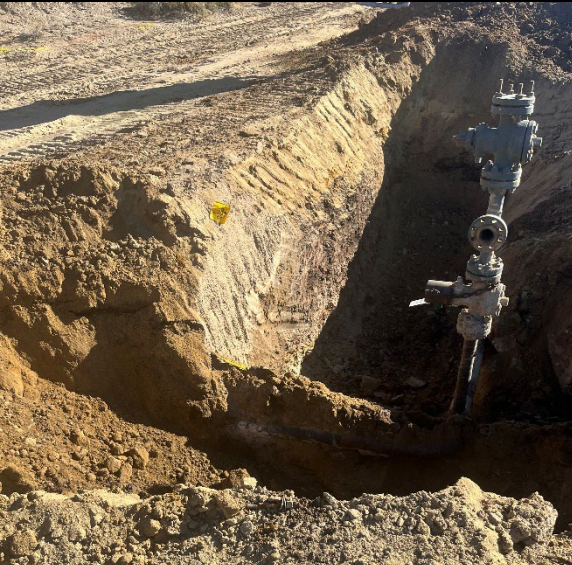
A view of the excavation pit from a different angle, showing the metal valve assembly and the surrounding earthen walls.

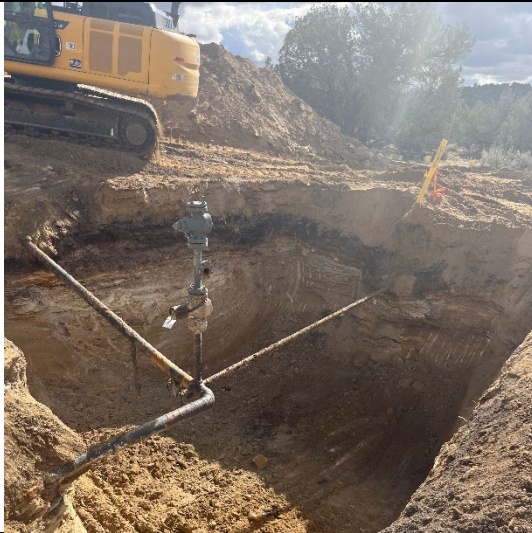
Photograph 7

Photograph Description: View of the final excavation.

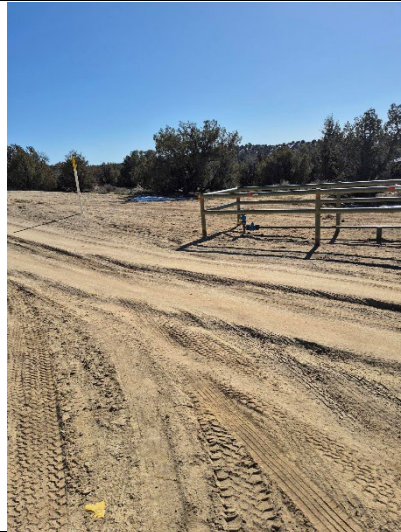
Photograph 8

Photograph Description: View of the final excavation after initial restoration.

The excavation was backfilled with imported fill and then contoured to the surrounding grade. The backfill and the upper four feet of the excavation have been analytically verified to be below the Tier I soil standards of 50 mg/kg BTEX, 10 mg/kg benzene, 100 mg/kg total combined TPH, and 600 mg/kg Chloride. See **Appendix D** and **Appendix F** for further documentation.
