Remediation Work Plan

JRU DI 7 CVB

Remediation Work Plan
JRU DI 7 CVB

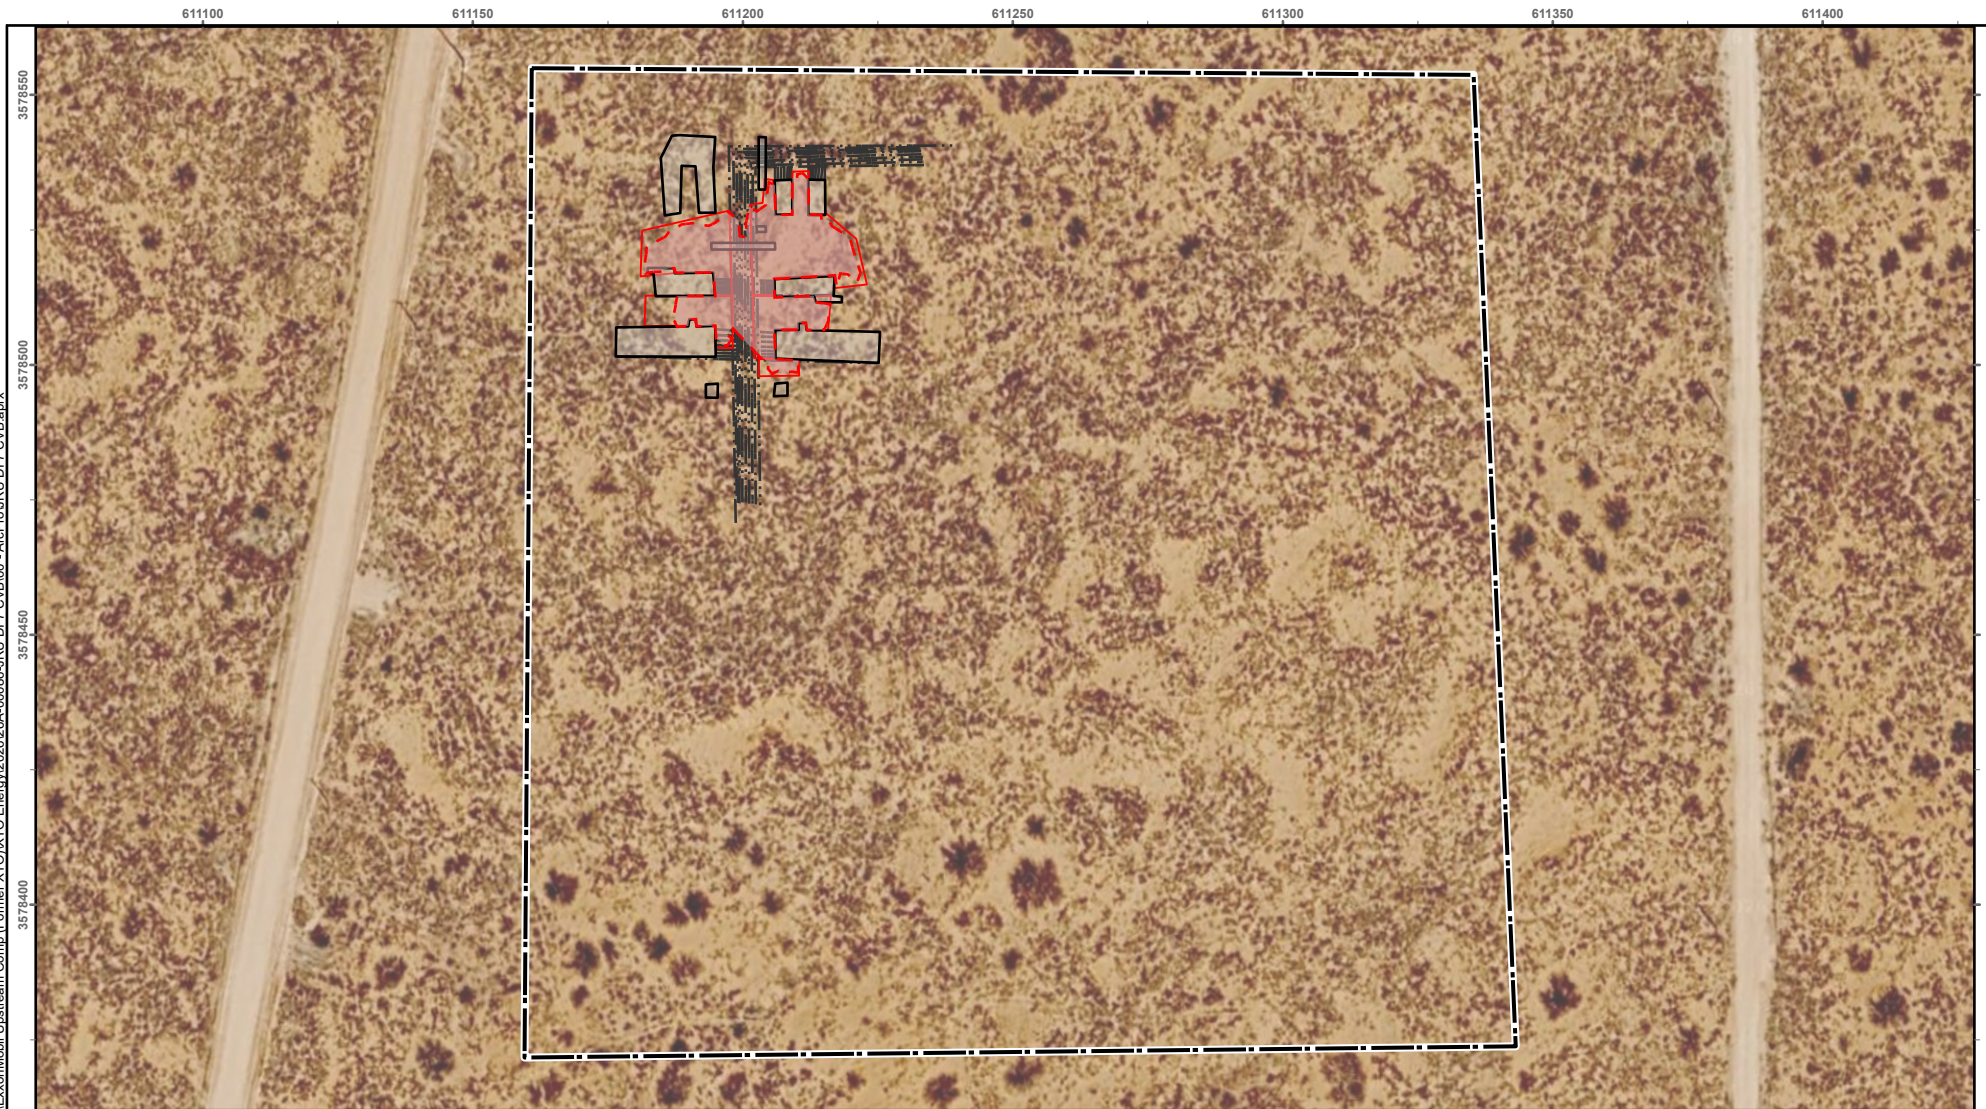
- Utilities
- Approximate Lease Boundary
- Release Extent (~7,088 sq.ft.)
- Proposed Remediation Extent
- Production Equipment

The proposed plan is to remediate site to allowable closure criteria through excavation and removal of impacted soils. The base and walls of excavation will be sampled under NMOCD confirmation sampling event. Samples will be sent to Cardinal laboratory for analysis. Final remediation will be completed per Bureau of Land Management guidelines once production is complete.

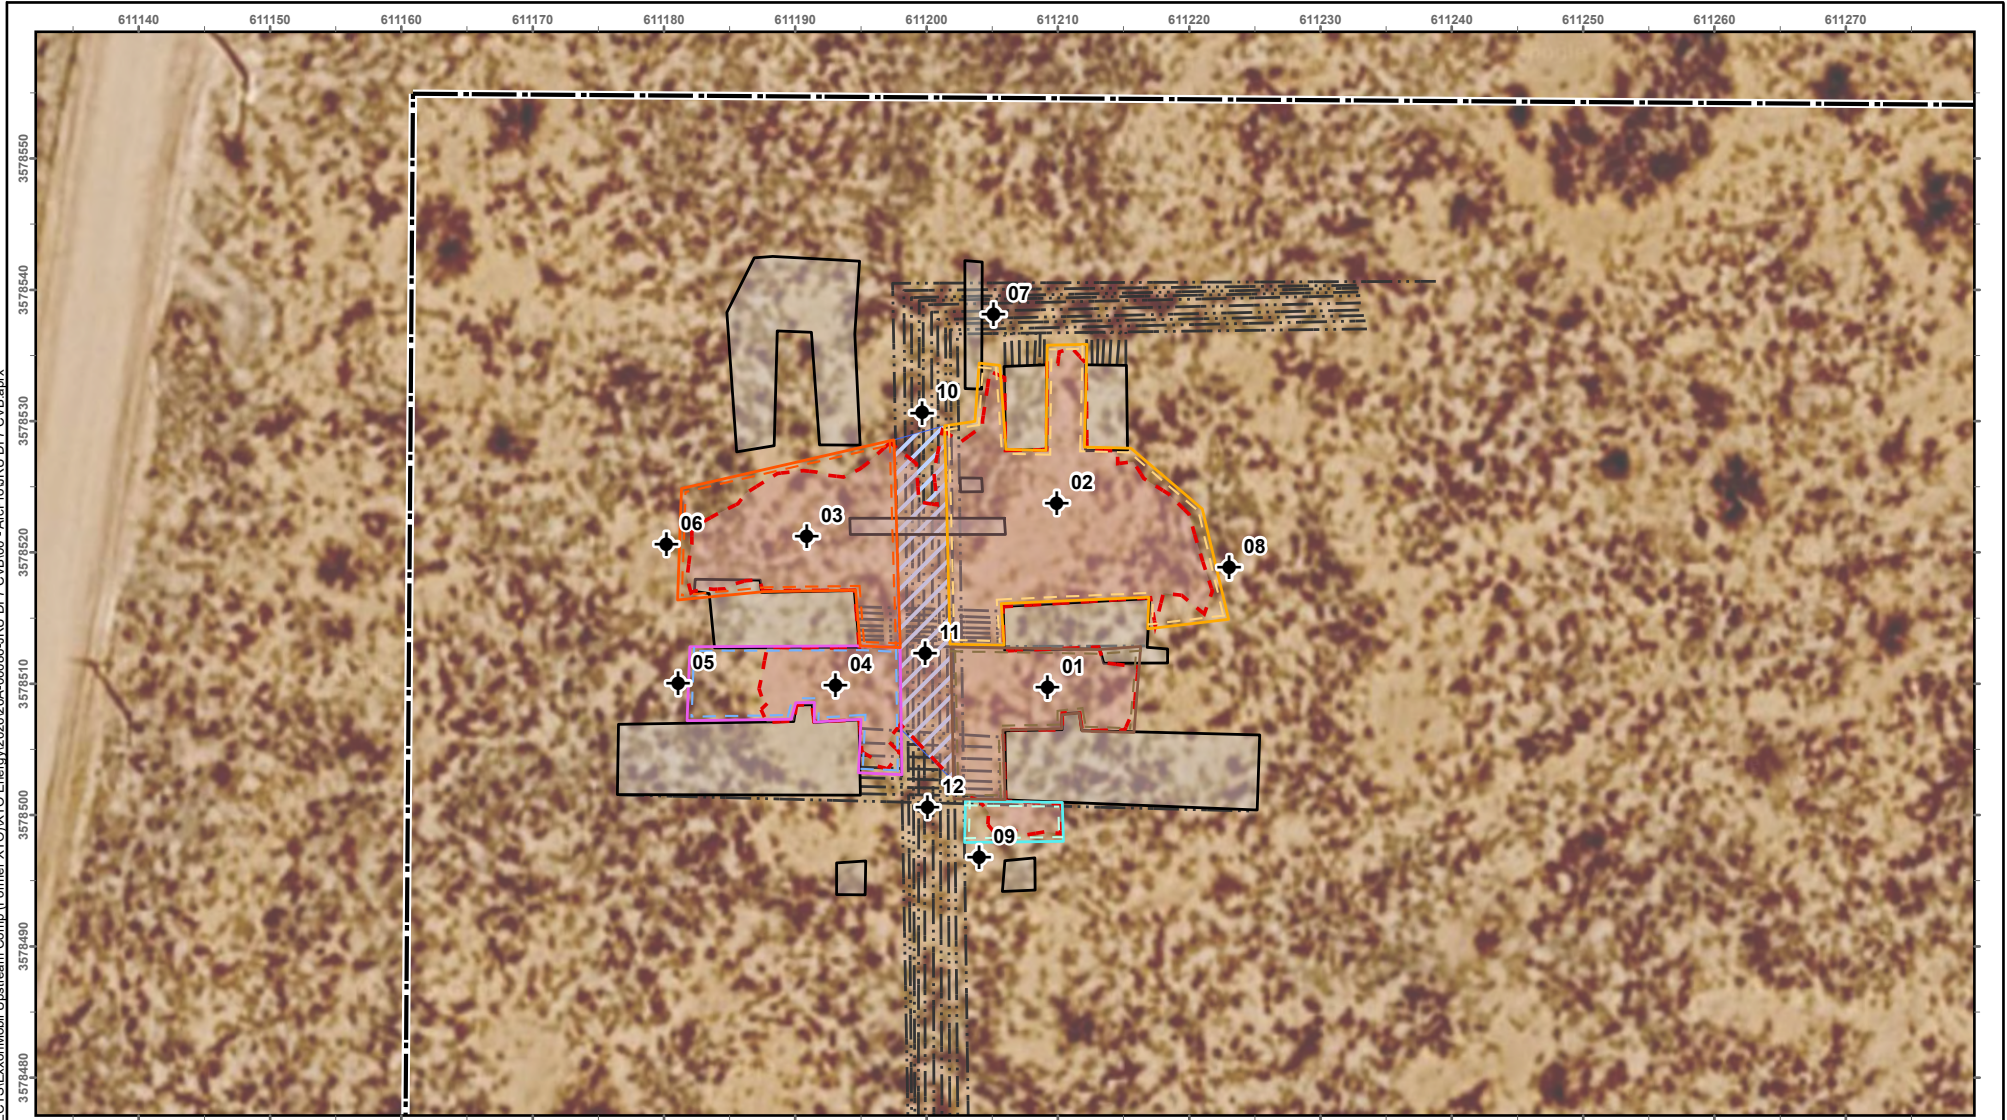
- ◆ Borehole (Prefixed by "BH26-")
- Utilities
- ▭ Approximate Lease Boundary
- ▭ Production Equipment
- ▭ Deferral Area (~1,047 sq.ft.)
- ▭ Release Extent (~7,088 sq.ft.)
- ▭ Proposed South Excavation to 1' bgs (~244 sq.ft.)
- ▭ Proposed South West Excavation to 1' bgs (~1,095 sq.ft.)
- ▭ Proposed North Excavation to 1' bgs (~3,049 sq.ft.)
- ▭ Proposed Central Excavation to 2' bgs (~1,150 sq.ft.)
- ▭ Proposed North West Excavation to 2' bgs (~1,885 sq.ft.)

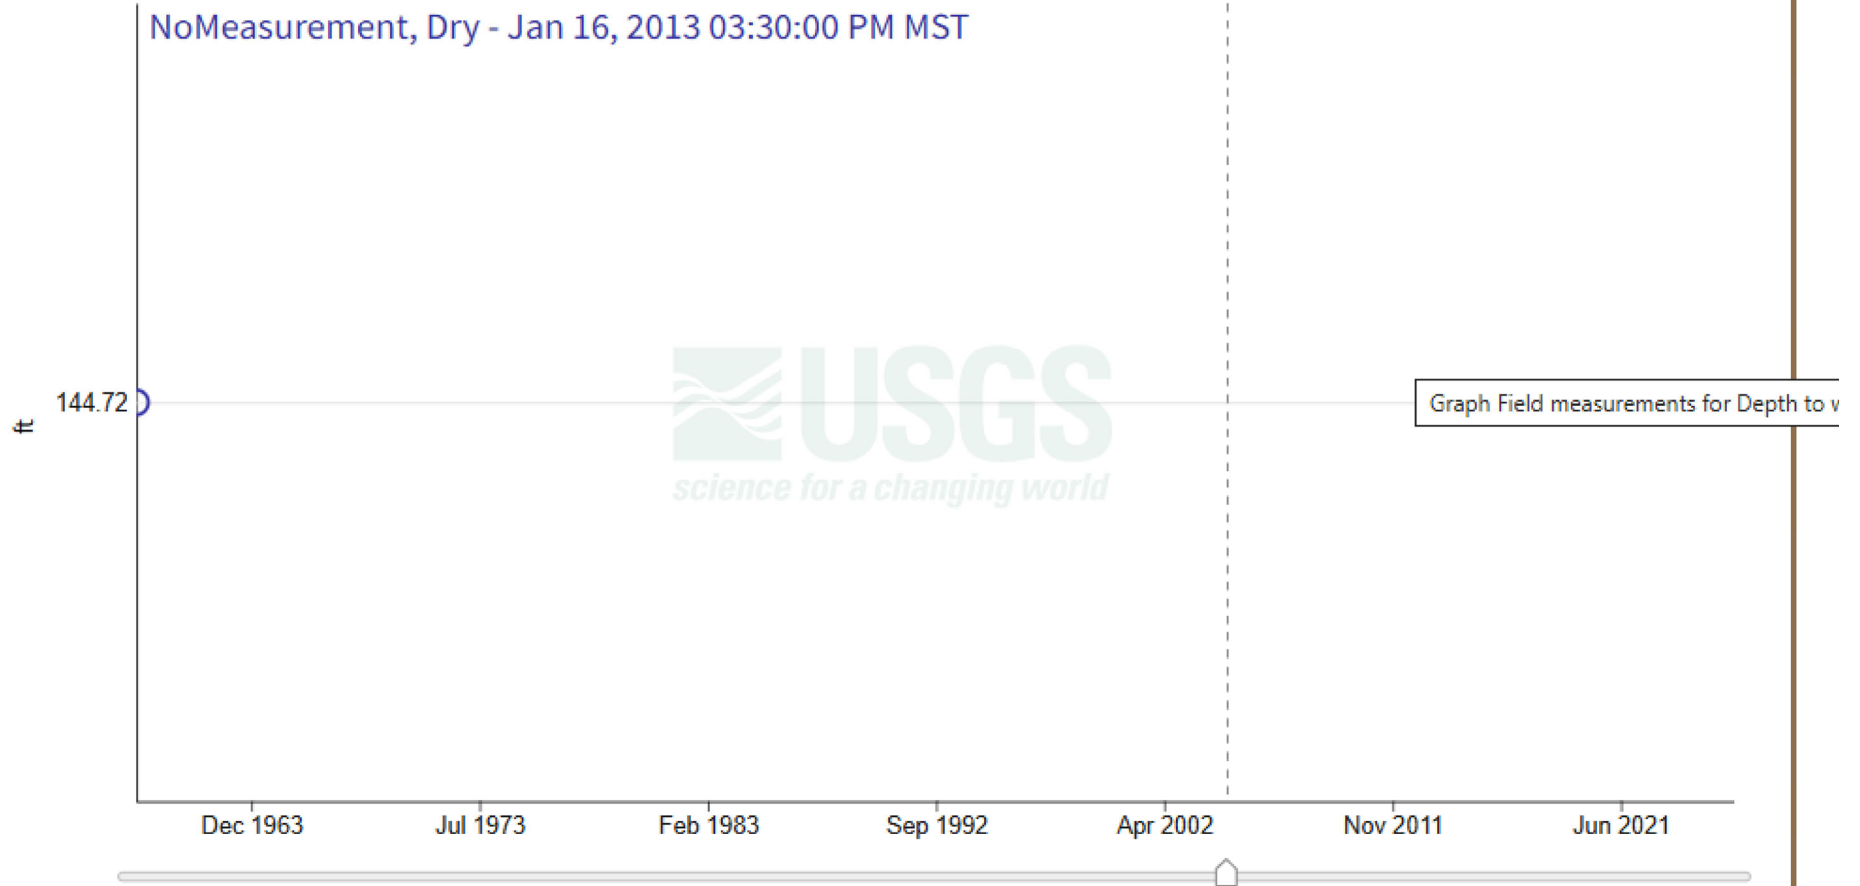
23S.31E.06.312333 - USGS-321946103492001

February 4, 1959 - February 16, 2026
Depth to water level, feet below land surface

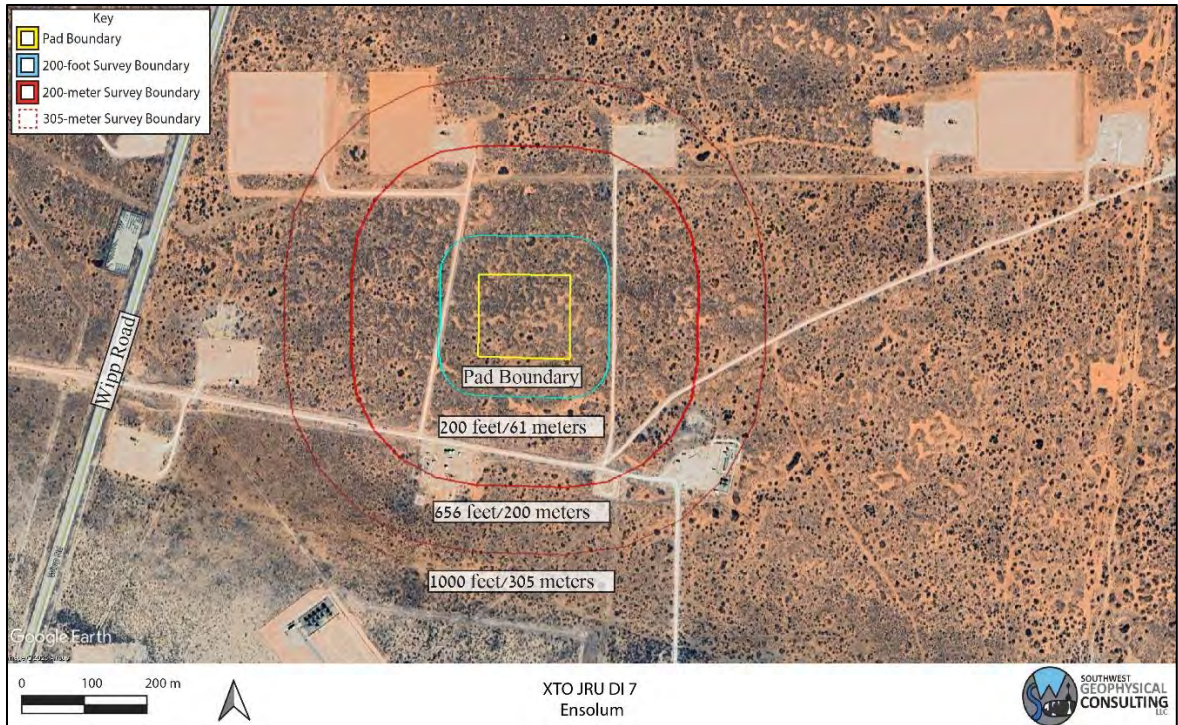
Figure 4: Surface survey overview. Please note the pad boundary is the approximate location provided by the client. Background image credit: Google Earth. Image date: April 2, 2023. Datum: WGS-84.

Surface karst surveys are conducted by sUAS at low elevation within 200 meters of the spill delineation boundary^[4] (**Figure 4**) following a preplanned raster pattern flightpath designed for the purpose of generating at least 75% imagery overlap. The collected high-resolution, georeferenced imagery is stitched together to develop orthomosaic imagery which is further developed into a digital elevation model (DEM); the DEM is then processed into a local relief model (LRM) (**Figure 6**). This LRM is color coded to enhance differences in elevation of as little as five centimeters. The orthoimagery, DEM, and LRM are uploaded to a server where they are analyzed by an experienced karst geologist. Finally, the data is reviewed by a senior karst geologist for quality assurance and downloaded into a table for inclusion in a written report^[16].

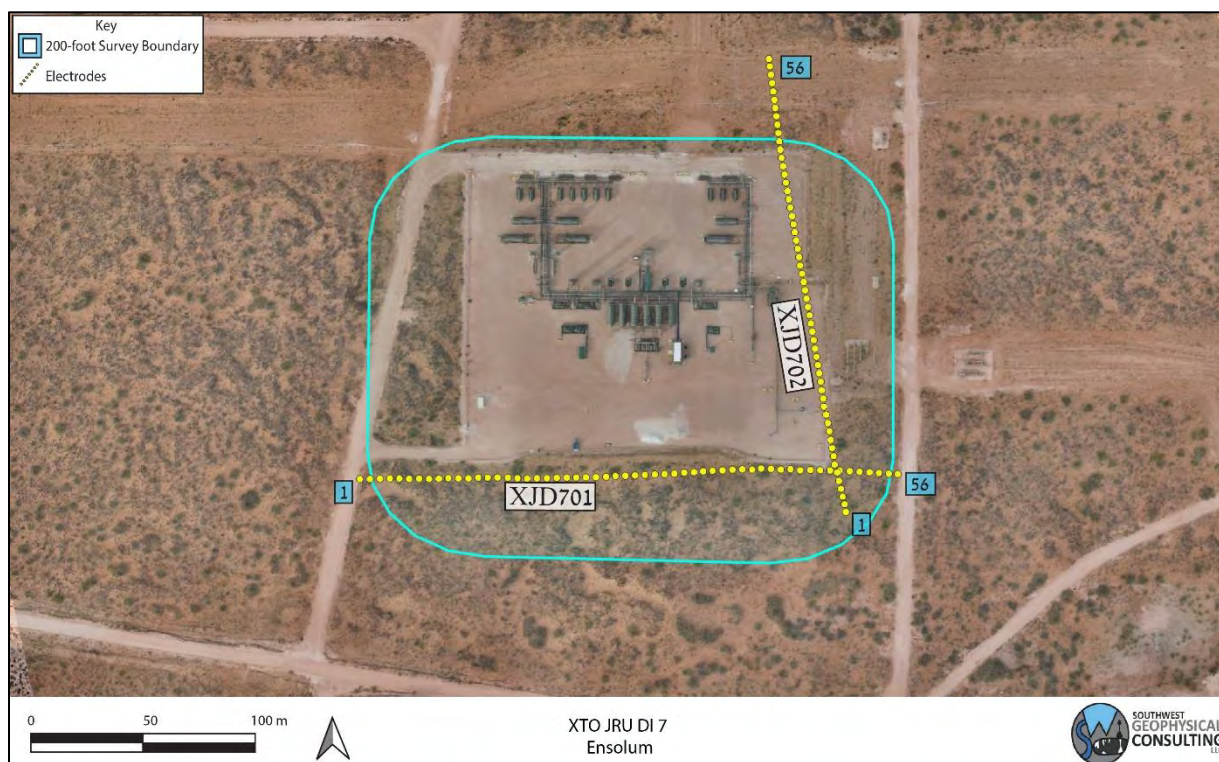
Figure 5: Geophysical survey overview. Two survey lines were conducted with 56 electrodes each at 5-meter spacing (yellow dots denoted with blue numbers). Please note that orthographic imagery is shown as the pad does not yet appear on Google satellite/aerial imagery. The approximate pad boundaries provided by the client were omitted because they do not match the actual pad location. Background image datum: WGS-84.

For this survey, an Advanced Geosciences Inc. (AGI) SuperSting™ Wifi R8 with an 8-channel switchbox, a 56-electrode array of 40-centimeter-long (1.3 feet) stainless-steel electrodes, and a tablet controller were used to image the subsurface. This survey consisted of two resistivity lines consisting of 56 electrodes at 5-meter spacing in a dipole-dipole configuration, resulting in 275-meter-long arrays. Line XJD701 is laid out west to east, while line XJD702 is laid out south to north. (Figure 5, Table 1).

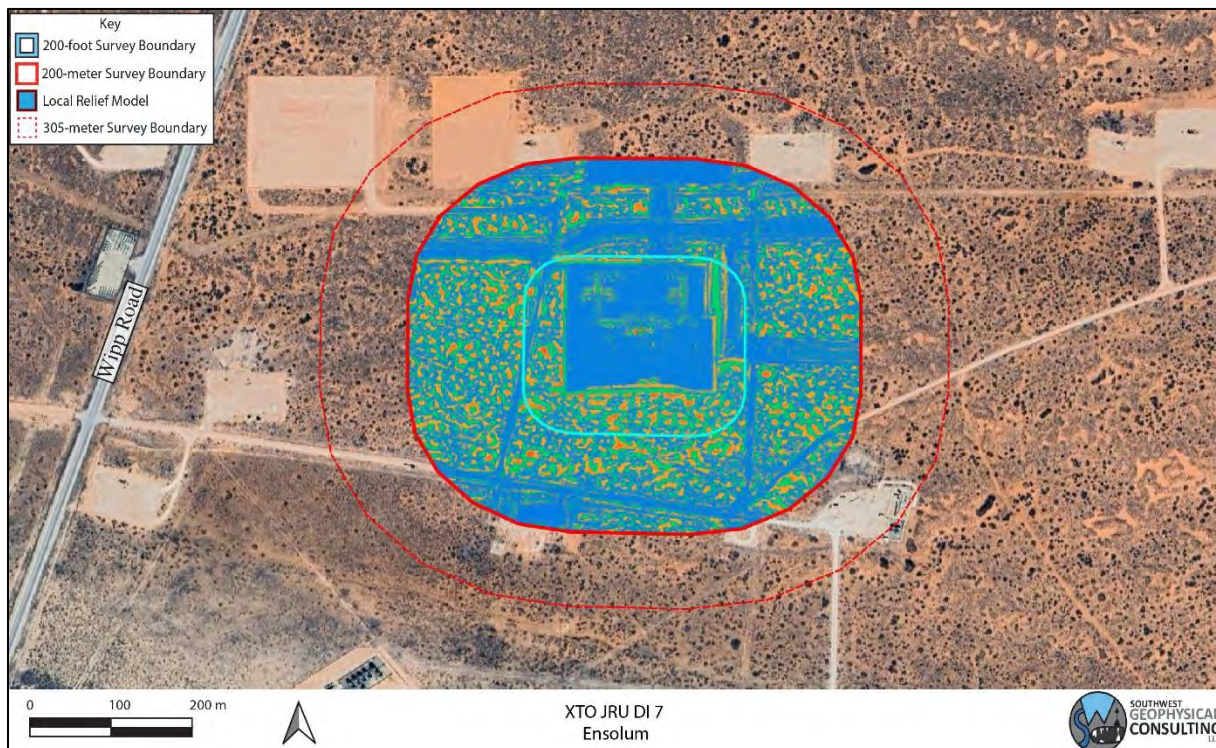
Figure 6: Surface karst survey results. Background image credit: Please note that orthographic imagery is shown as the pad does not yet appear on Google satellite/aerial imagery. The approximate pad boundaries provided by the client were omitted because they do not match the actual pad location. Background image datum: WGS-84.

No springs exist within the 305-meter (1,000-foot)^[1] survey boundary (Figure 6).

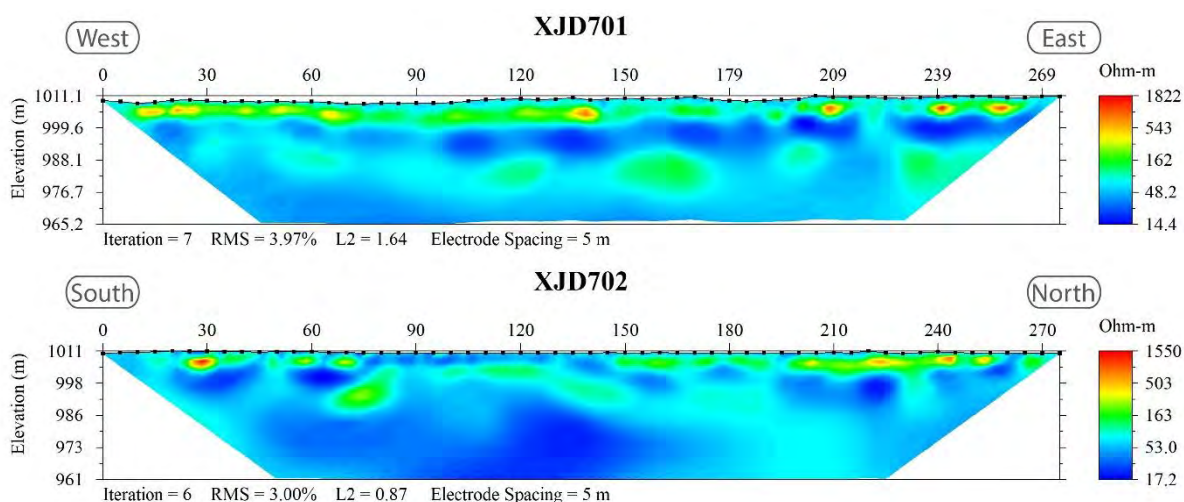
Figure 7: 2D inverted resistivity section. Reds and oranges indicate higher resistivity values. Yellows and greens are medium-resistivity values. Blues are low-resistivity values. Please note that the color scale is relative.

The results of this study indicate a well-layered geologic system with resistivities between 14.4 and 300 Ohm-m with occasional areas up to 1,822 Ohm-m (**Figure 7**). Please keep in mind when viewing the 2D inverted resistivity sections that color maps can be widely different for each view. Always check the color map located on the right side of the image when viewing the 2D images to ensure you understand the range of resistivities presented. Distances along the top and depths along the left side are in meters. The color map along the right side is in Ohm-m. Due to the nature of the survey, shallower zones have higher resolution between electrodes than deeper zones; therefore, small features at depth will not be visible.

No surface karst features and no anomalies consistent with air-filled subsurface voids are found within the XJD7 survey area. However, small solutionally enlarged voids or fractures at or near the resolution limit of the survey (2.5 – 3.0 meters) may be present. Areas of higher resistivity (reds, yellows, and greens) near the surface are interpreted as dry gypsite soils and gypsum or dolomite bedrock of the Rustler Formation^[17] (**Figure 7** and **Figure 8**).

Low-resistivity areas between 14.4 – 25 Ohm-m may fluid from a brine release, surface-to-subsurface hydrologic pathways, or a layer of either clays or halite lenses, or moist to saturated layers within the Rustler Formation (**Figure 7**).

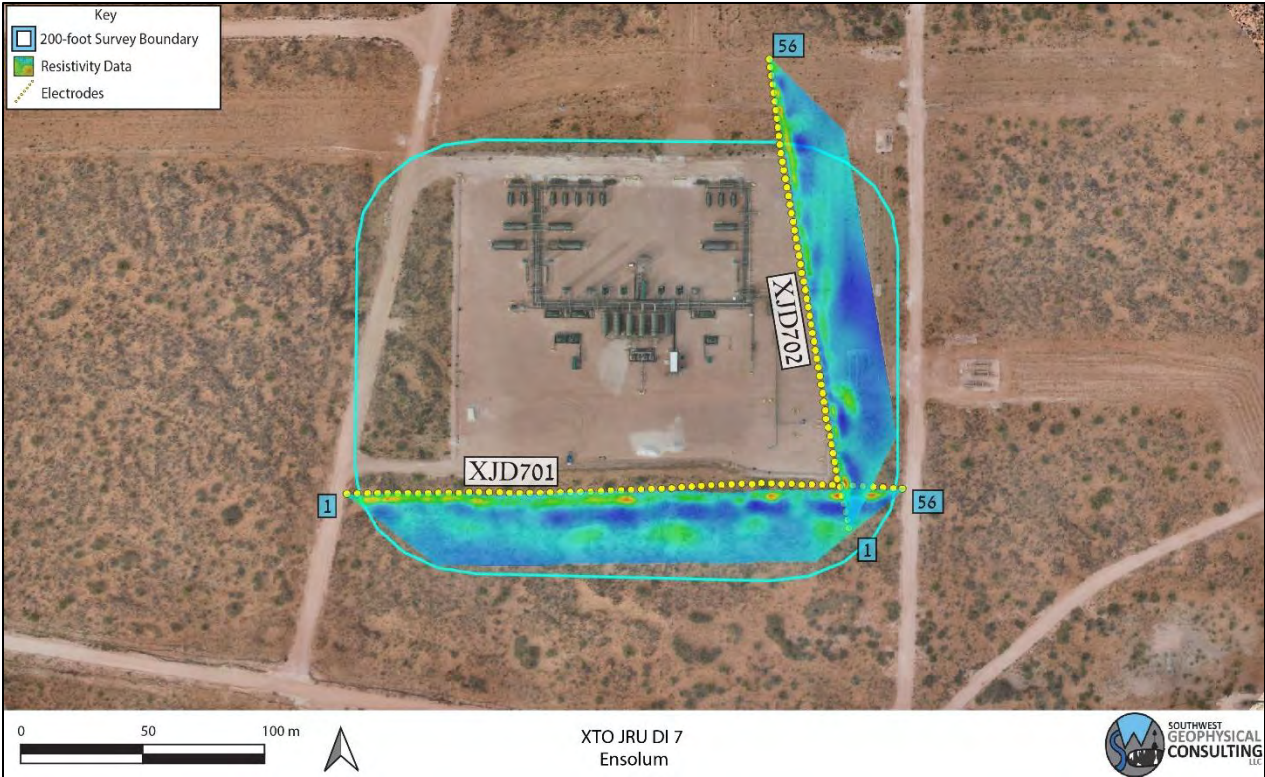
Figure 8: Data overlay. Colored trapezoids are the 2D inverted resistivity lines. Please note that orthographic imagery is shown as the pad does not yet appear on Google satellite/aerial imagery. The approximate pad boundaries provided by the client were omitted because they do not match the actual pad location. Background image datum: WGS-84.

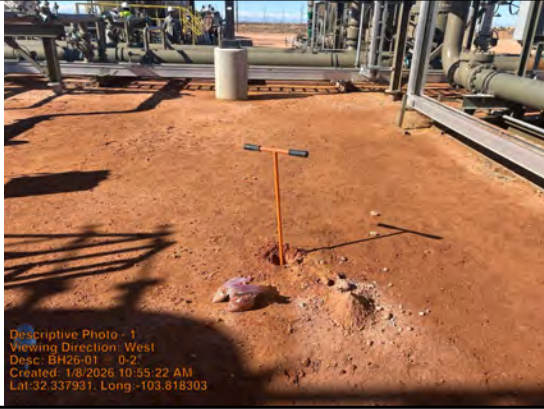
Descriptive Photo - 1
Viewing Direction: West
Desc: BH26-01 @ 0-2'
Created: 1/8/2026 10:55:22 AM
Lat:32.337931, Long:-103.818303

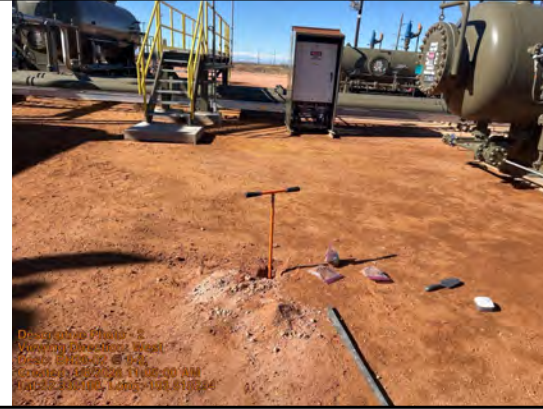
Descriptive Photo - 2
Viewing Direction: West
Desc: BH26-02 @ 0-2'
Created: 1/8/2026 11:02:00 AM
Lat:32.338026, Long:-103.818304

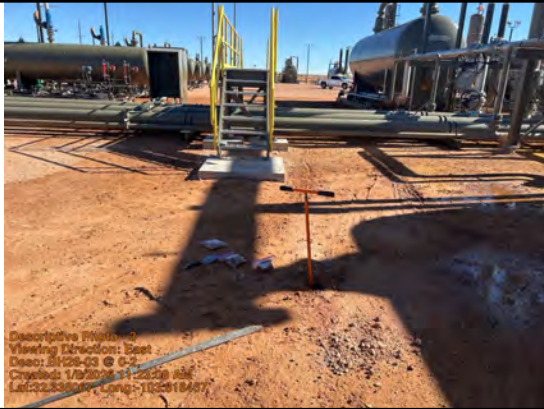
Descriptive Photo - 3
Viewing Direction: East
Desc: BH26-03 @ 0-2'
Created: 1/8/2026 11:23:08 AM
Lat:32.338027, Long:-103.818487

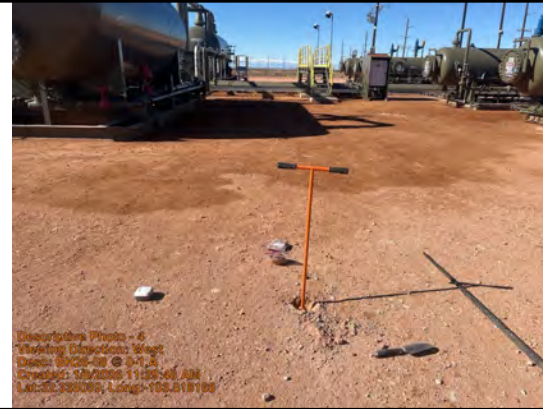
Descriptive Photo - 4
Viewing Direction: West
Desc: BH26-08 @ 0-1'
Created: 1/8/2026 11:03:01 AM
Lat:32.338026, Long:-103.818129

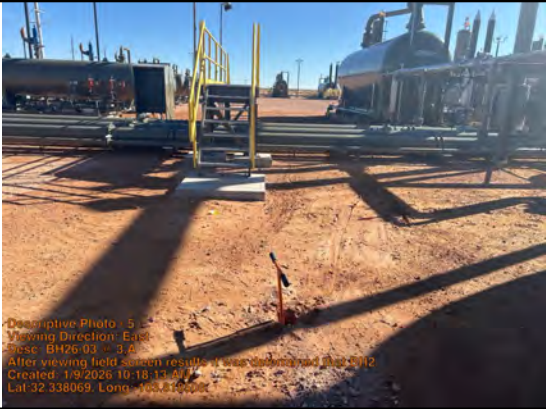
<p><small>Descriptive Photo: 5 Viewing Direction: East Case: BH26-03 - 3' After viewing field screen results it was determined that BH26-03 Created: 1/9/2026 10:18:11 AM Lat:32.338069, Long: -103.110002</small></p>
<p>BH26-03 @ 3' After viewing field screen results it was determined that BH26-03 needed to be deeper</p>

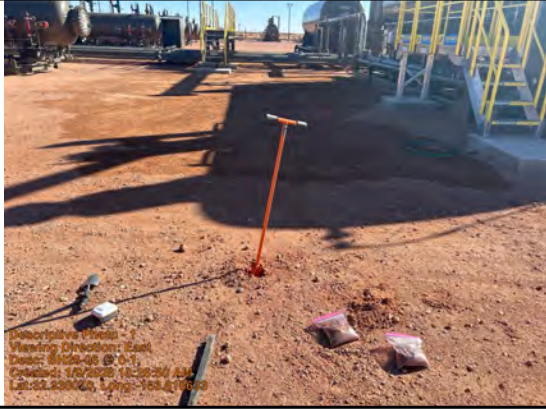
BH26-06 @ 0-1'

Describe Photo - 6
Viewing Direction: East
Date: 2/20/26 09:01
Created: 1/9/2026 12:28:20 AM
Lat: 32.337026, Long: 103.818375

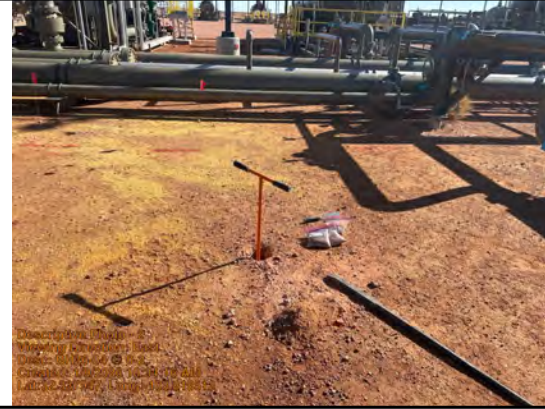
BH26-04 @ 0-2'

Describe Photo - 4
Viewing Direction: East
Date: 2/20/26 09:01
Created: 1/9/2026 12:28:20 AM
Lat: 32.337026, Long: 103.818375

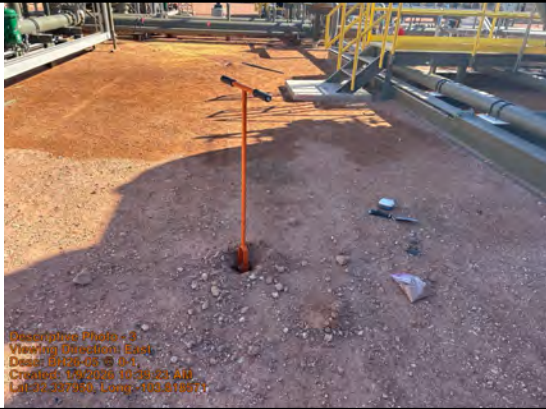
BH26-05 @ 0-1'

Describe Photo - 5
Viewing Direction: East
Date: 2/20/26 09:01
Created: 1/9/2026 12:28:20 AM
Lat: 32.337026, Long: 103.818375

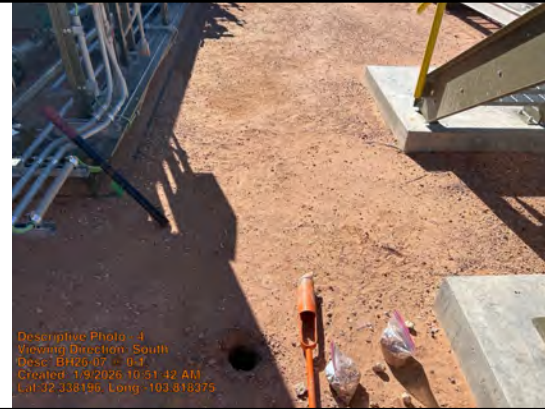
BH26-07 @ 0-1'

Describe Photo - 4
Viewing Direction: South
Date: 2/20/26 09:01
Created: 1/9/2026 10:51:42 AM
Lat: 32.338196, Long: 103.818375

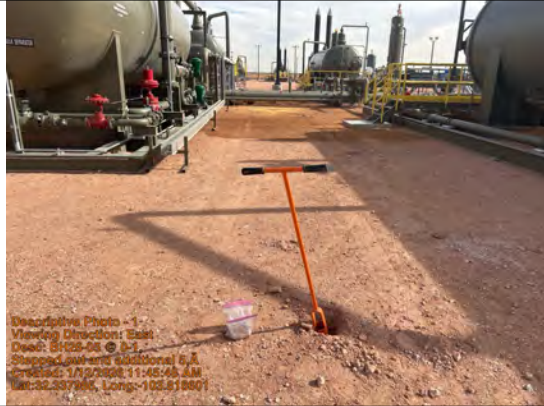
BH26-05 @ 0-1'
Stepped out and additional 5'

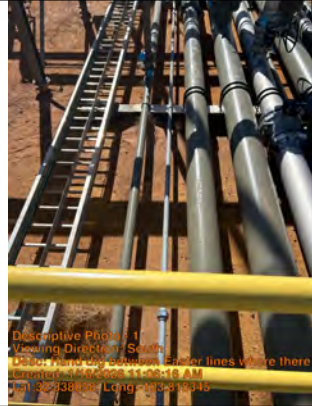
Description Photo - 1
Viewing Direction: South
Desc: Hand dig between Easter lines where there is no space to dig
Created: 1/15/2026 11:08:16 AM
Lat: 32.38100, Long: -103.16345

Hand dig between Easter lines where there is space

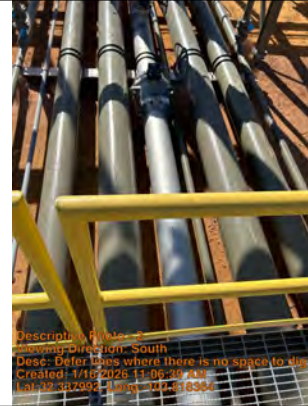
Description Photo - 2
Viewing Direction: South
Desc: Defer lines where there is no space to dig
Created: 1/15/2026 11:06:29 AM
Lat: 32.38100, Long: -103.16345

Defer lines where there is no space to dig

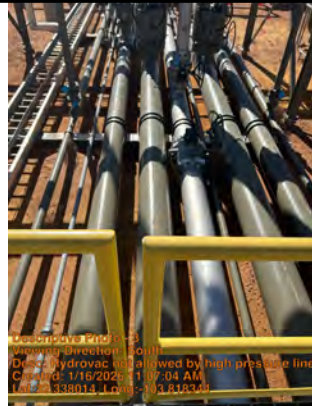
Description Photo - 3
Viewing Direction: South
Desc: Hydrovac not allowed by high pressure line
Created: 1/15/2026 11:07:04 AM
Lat: 32.38100, Long: -103.16345

Hydrovac not allowed by high pressure lines

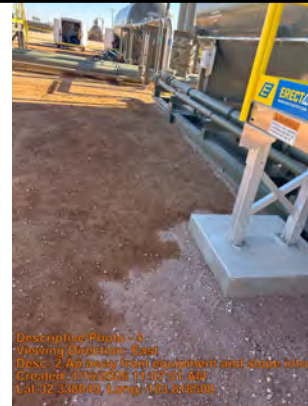
Description Photo - 4
Viewing Direction: East
Desc: 2' away from equipment and slope into excavation
Created: 1/15/2026 11:07:51 AM
Lat: 32.38100, Long: -103.16345

2' away from equipment and slope into excavation

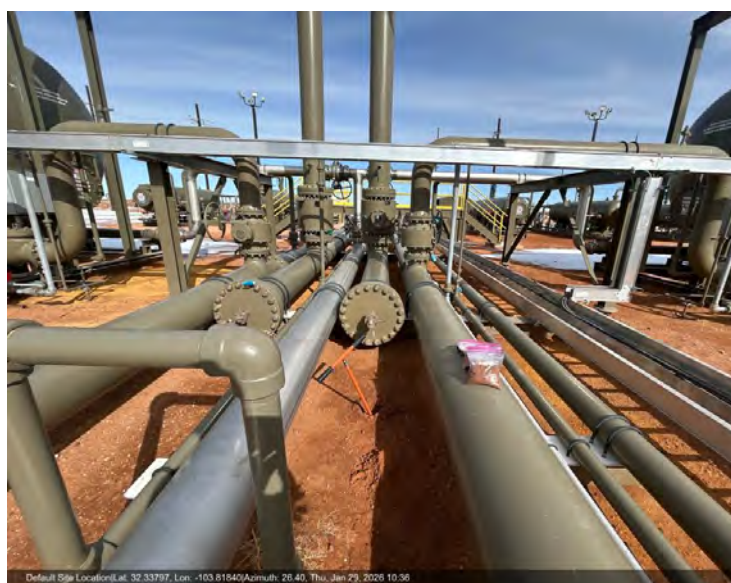
Date: 1/29/2026
 Time: 10:35
 Notes: BH26-11 @ 0.5'
 BH26-11 @ 1'
 BH26-11 @ 2'
 Latitude: 32.33796666666667
 Longitude: -103.81839722222222
 Direction: S

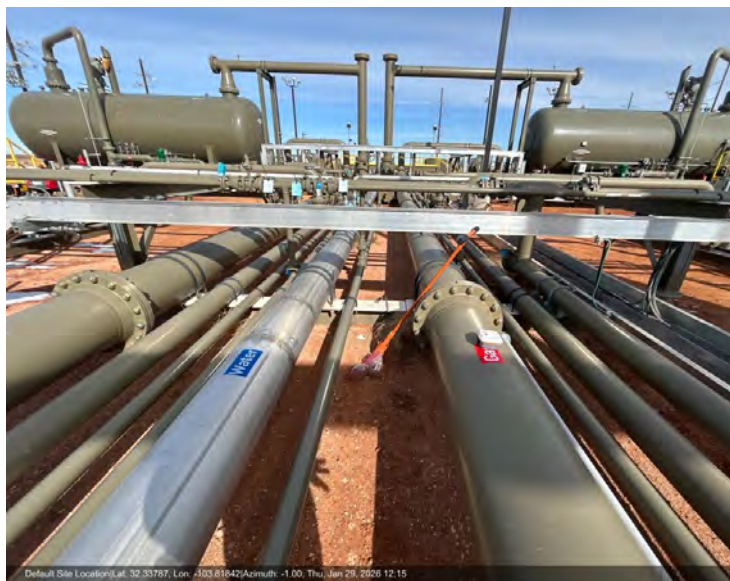
Date: 1/29/2026
Time: 10:43
Notes: BH26-12 @ 0.5'
BH26-12 @ 1'
Latitude: 32.33786944444444
Longitude: -103.81841944444444
Direction: W

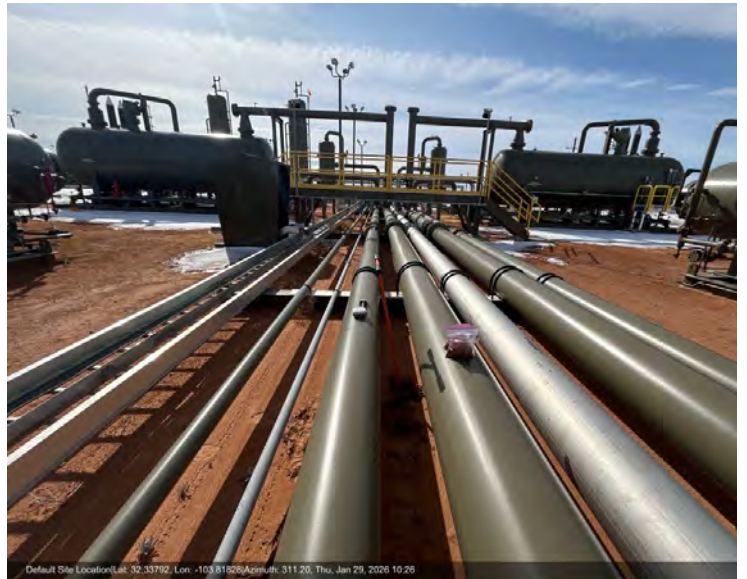
Date: 1/29/2026
Time: 10:25
Notes: BH26-10 @ 0.5'
BH26-10 @ 1'
Latitude: 32.33792222222225
Longitude: -103.81828333333333
Direction: W

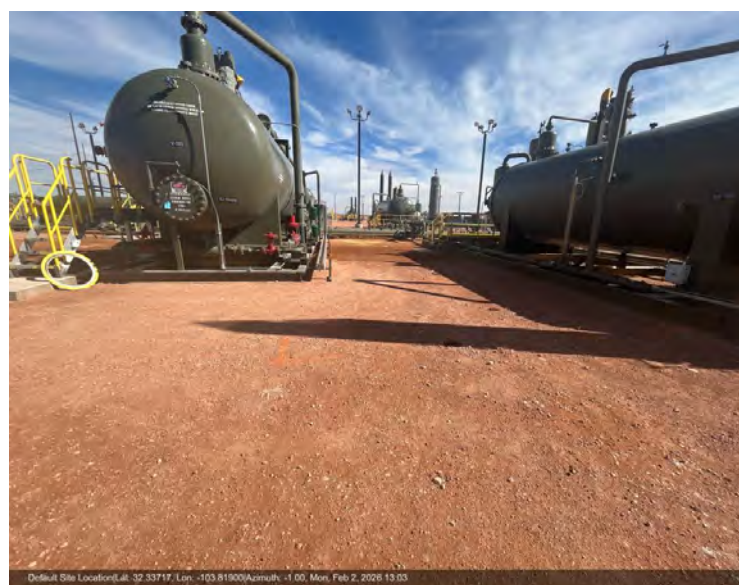
Date: 2/2/2026
 Time: 13:02
 Notes: Excavation zones marked
 Latitude: 32.33716944444445
 Longitude: -103.819
 Direction: E
