Remediation Work Plan

PLU 22 DTD CVB

nAPP2602937605

ExxonMobil Production Company

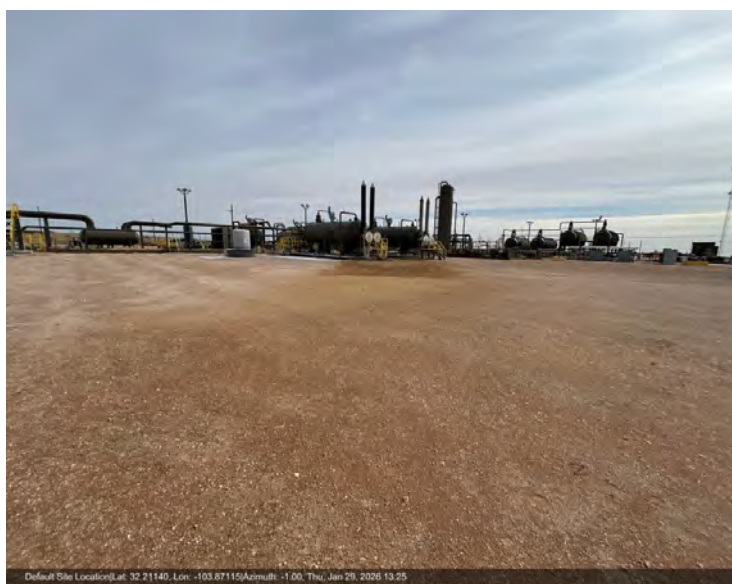
Date: 1/29/2026
Time: 13:03
Notes: Release
Latitude: 32.21140277777778
Longitude: -103.87114722222222
Direction: SW

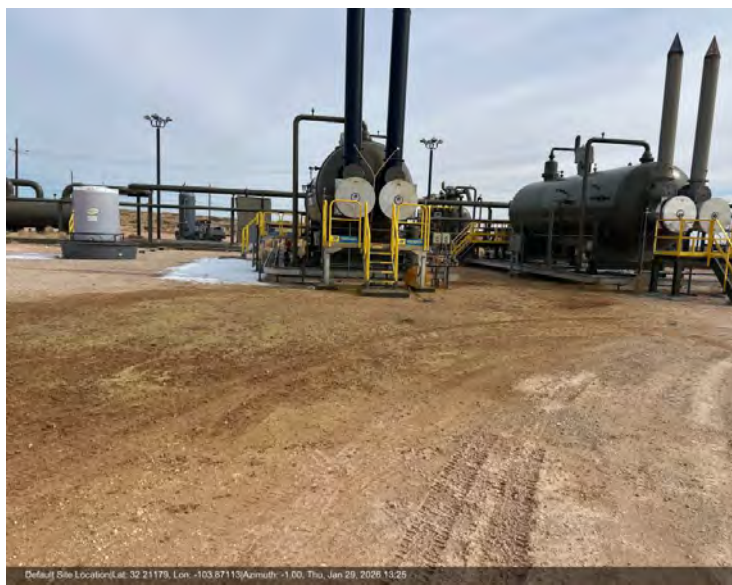
Date: 1/29/2026
Time: 13:03
Notes: Release
Latitude: 32.21179166666667
Longitude: -103.87113055555555
Direction: SW

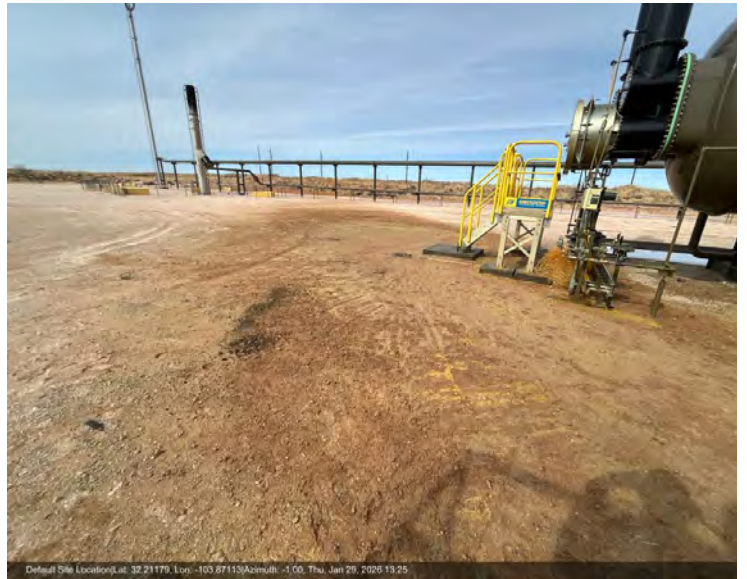
Date: 1/29/2026
Time: 13:03
Notes: Release
Latitude: 32.21179166666667
Longitude: -103.87113055555555
Direction: SW

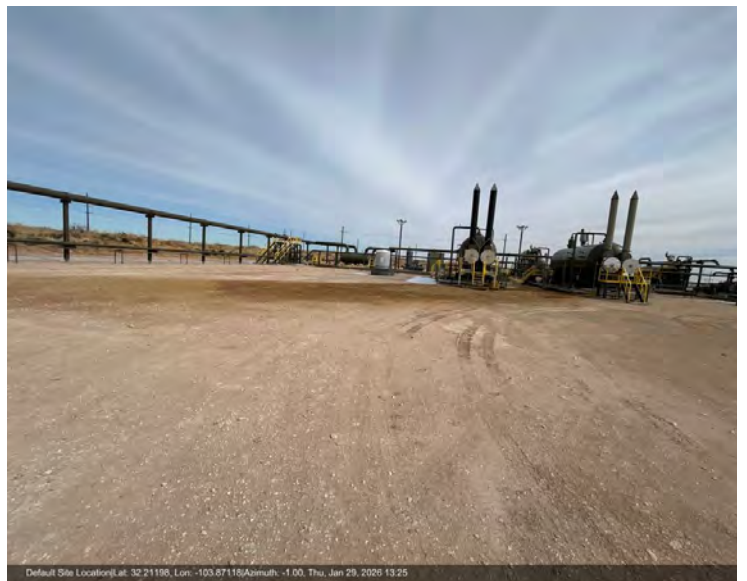
Date: 1/29/2026
Time: 13:03
Notes: Release
Latitude: 32.211975
Longitude: -103.87117777777777
Direction: SW

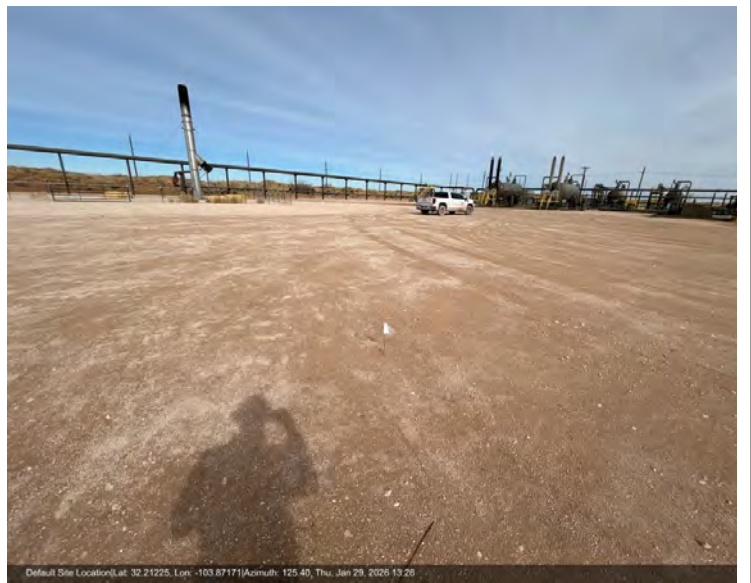
Date: 1/29/2026
Time: 13:25
Notes: 811 flags placed
Latitude: 32.212250000000004
Longitude: -103.87171111111111
Direction: S

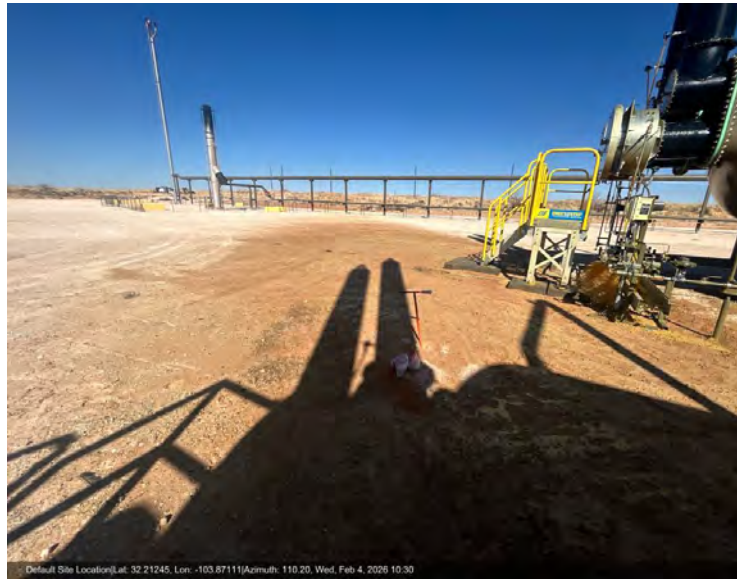
Date: 2/4/2026
Time: 10:30
Notes: BH26-05 @ 0'
BH26-05 @ 1'
BH26-05 @ 2'
Latitude: 32.212447222222224
Longitude: -103.87110833333332
Direction: N

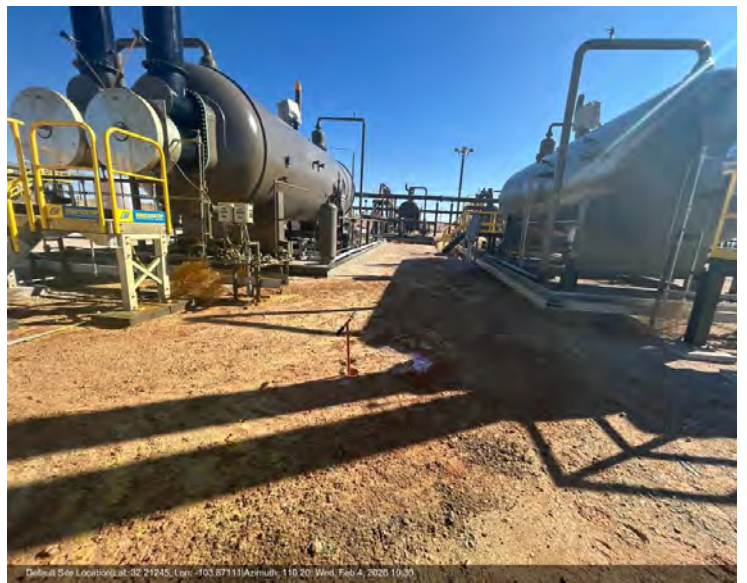
Date: 2/4/2026
Time: 10:30
Notes: BH26-05 @ 0'
BH26-05 @ 1'
BH26-05 @ 2'
Latitude: 32.212447222222224
Longitude: -103.87110833333332
Direction: N

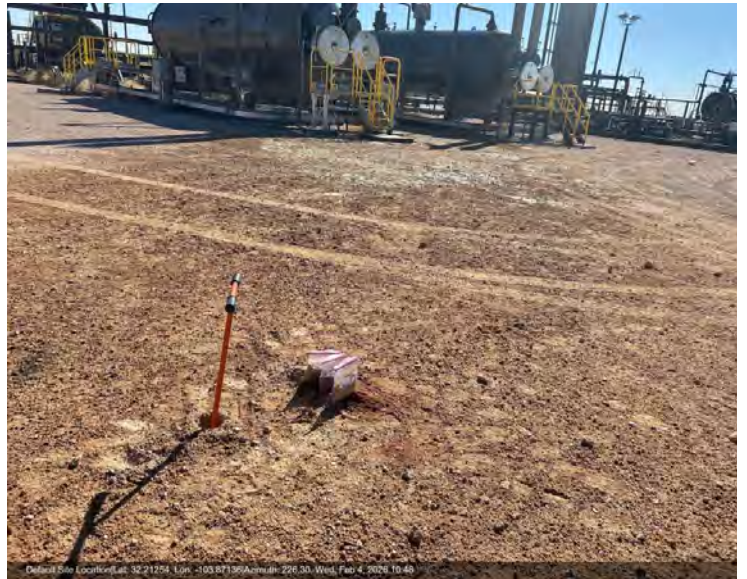
Date: 2/4/2026
Time: 10:38
Notes: BH26-06 @ 0'
BH26-06 @ 1'
BH26-06 @ 2'
Latitude: 32.21253611111111
Longitude: -103.87136111111111
Direction: NW

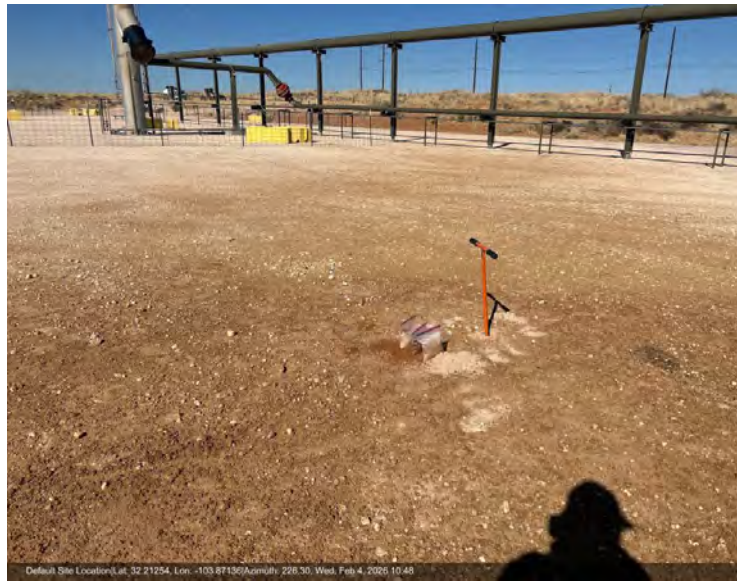
Date: 2/4/2026
Time: 10:38
Notes: BH26-06 @ 0'
BH26-06 @ 1'
BH26-06 @ 2'
Latitude: 32.21253611111111
Longitude: -103.87136111111111
Direction: NW

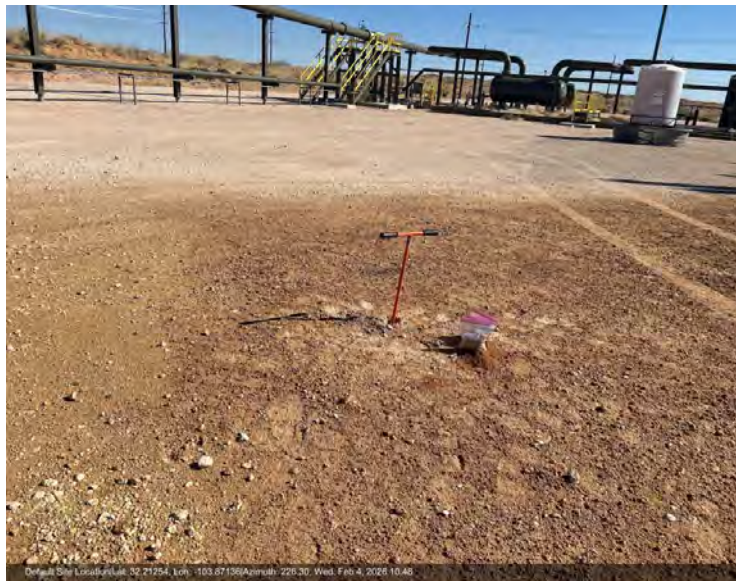
Date: 2/4/2026
 Time: 10:38
 Notes: BH26-06 @ 0'
 BH26-06 @ 1'
 BH26-06 @ 2'
 Latitude: 32.21253611111111
 Longitude: -103.87136111111111
 Direction: NW

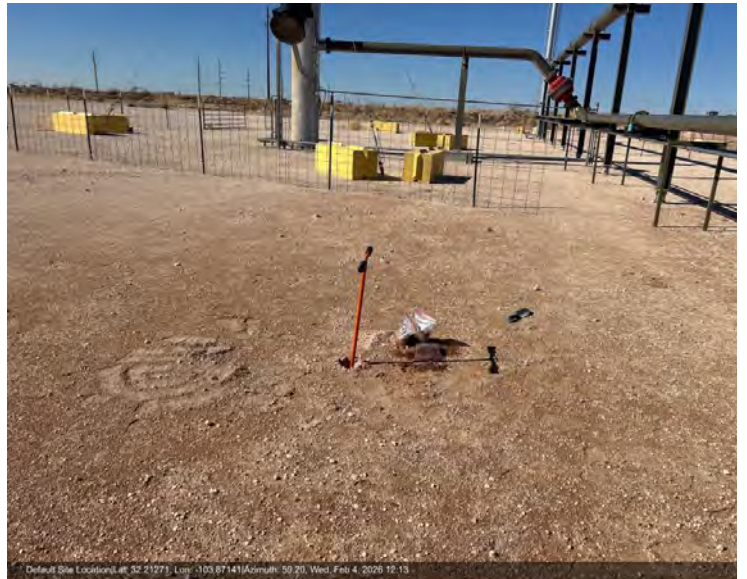
Date: 2/4/2026
Time: 10:49
Notes: BH26-07 @ 0'
BH26-07 @ 1'
BH26-07 @ 2'
Latitude: 32.21270833333334
Longitude: -103.87141388888888
Direction: S

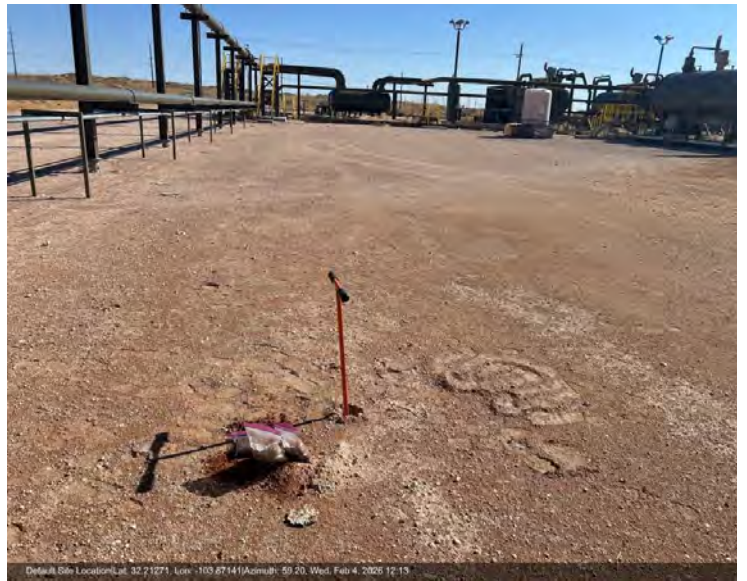
Date: 2/4/2026
Time: 10:49
Notes: BH26-07 @ 0'
BH26-07 @ 1'
BH26-07 @ 2'
Latitude: 32.21270833333334
Longitude: -103.87141388888888
Direction: S

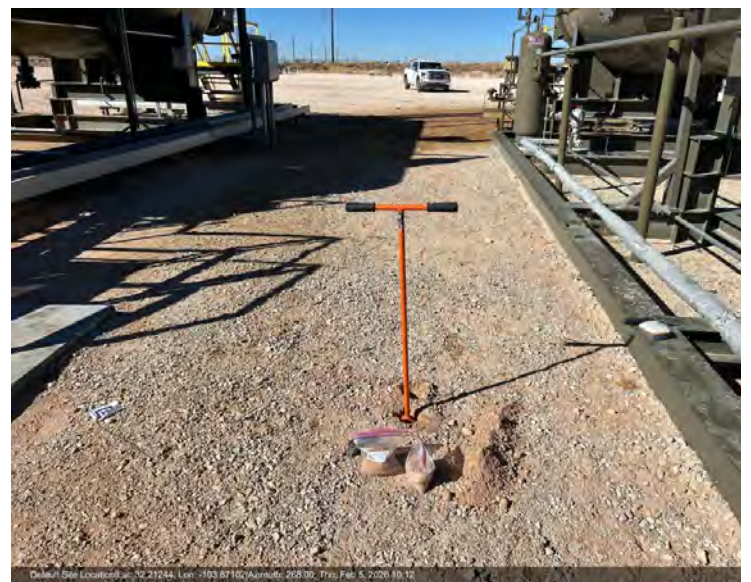
Date: 2/5/2026
Time: 10:06
Notes: BH26-01 @ 0'
BH26-01 @ 1'
Latitude: 32.21244444444445
Longitude: -103.87102499999999
Direction: S

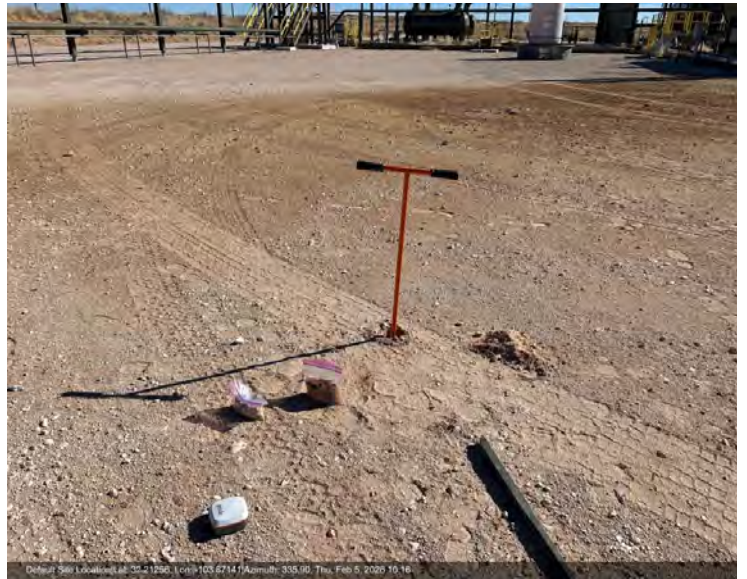
Date: 2/5/2026
Time: 10:12
Notes: BH26-02 @ 0'
BH26-02 @ 1'
Latitude: 32.212558333333334
Longitude: -103.87140555555555
Direction: E

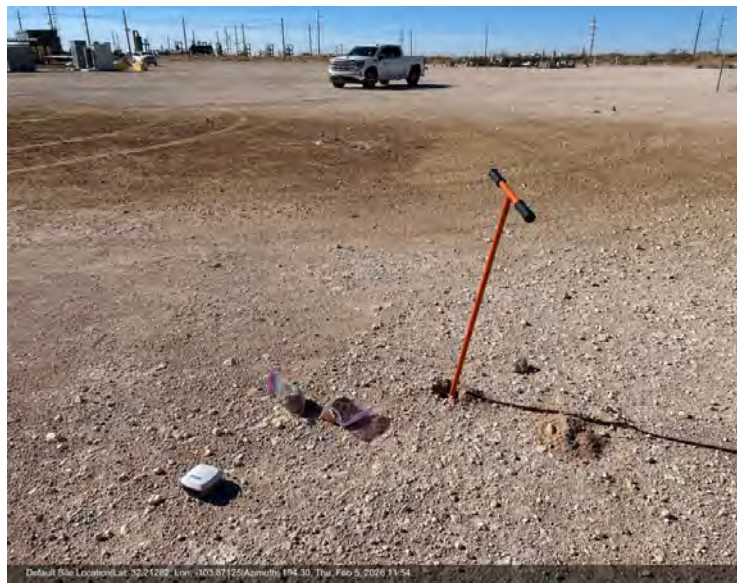
Date: 2/5/2026
Time: 10:17
Notes: BH26-04 @ 0'
BH26-04 @ 1'
Latitude: 32.212616666666667
Longitude: -103.871247222222221
Direction: N

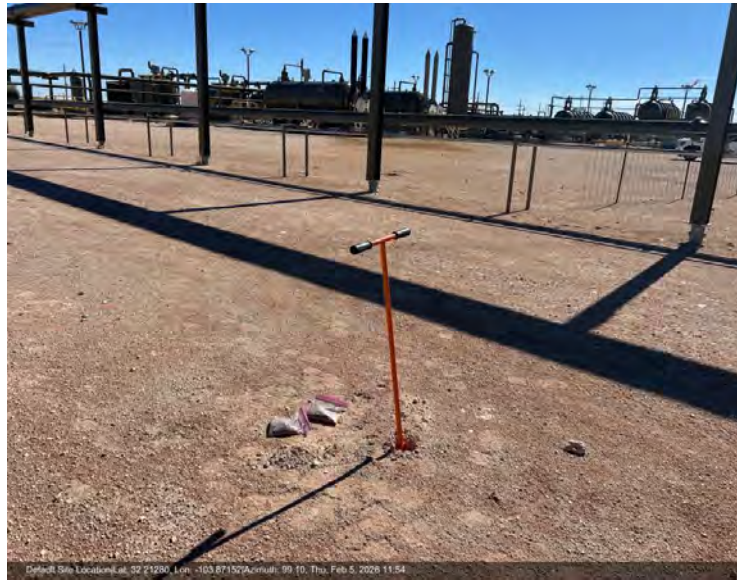
Date: 2/5/2026
Time: 11:54
Notes: BH26-03 @ 0'
BH26-03 @ 1'
Latitude: 32.21280277777778
Longitude: -103.87152222222221
Direction: S
