February 19, 2026

**Re: Release Characterization, Remediation Summary, and Deferral Request
REVISION 2
ConocoPhillips
Willow A State #001 Tank Battery Release
Unit Letter J, Section 03, Township 25 South, and Range 28 East
Eddy County, New Mexico
Incident ID NAPP2221332553
Landowner: NMSLO**

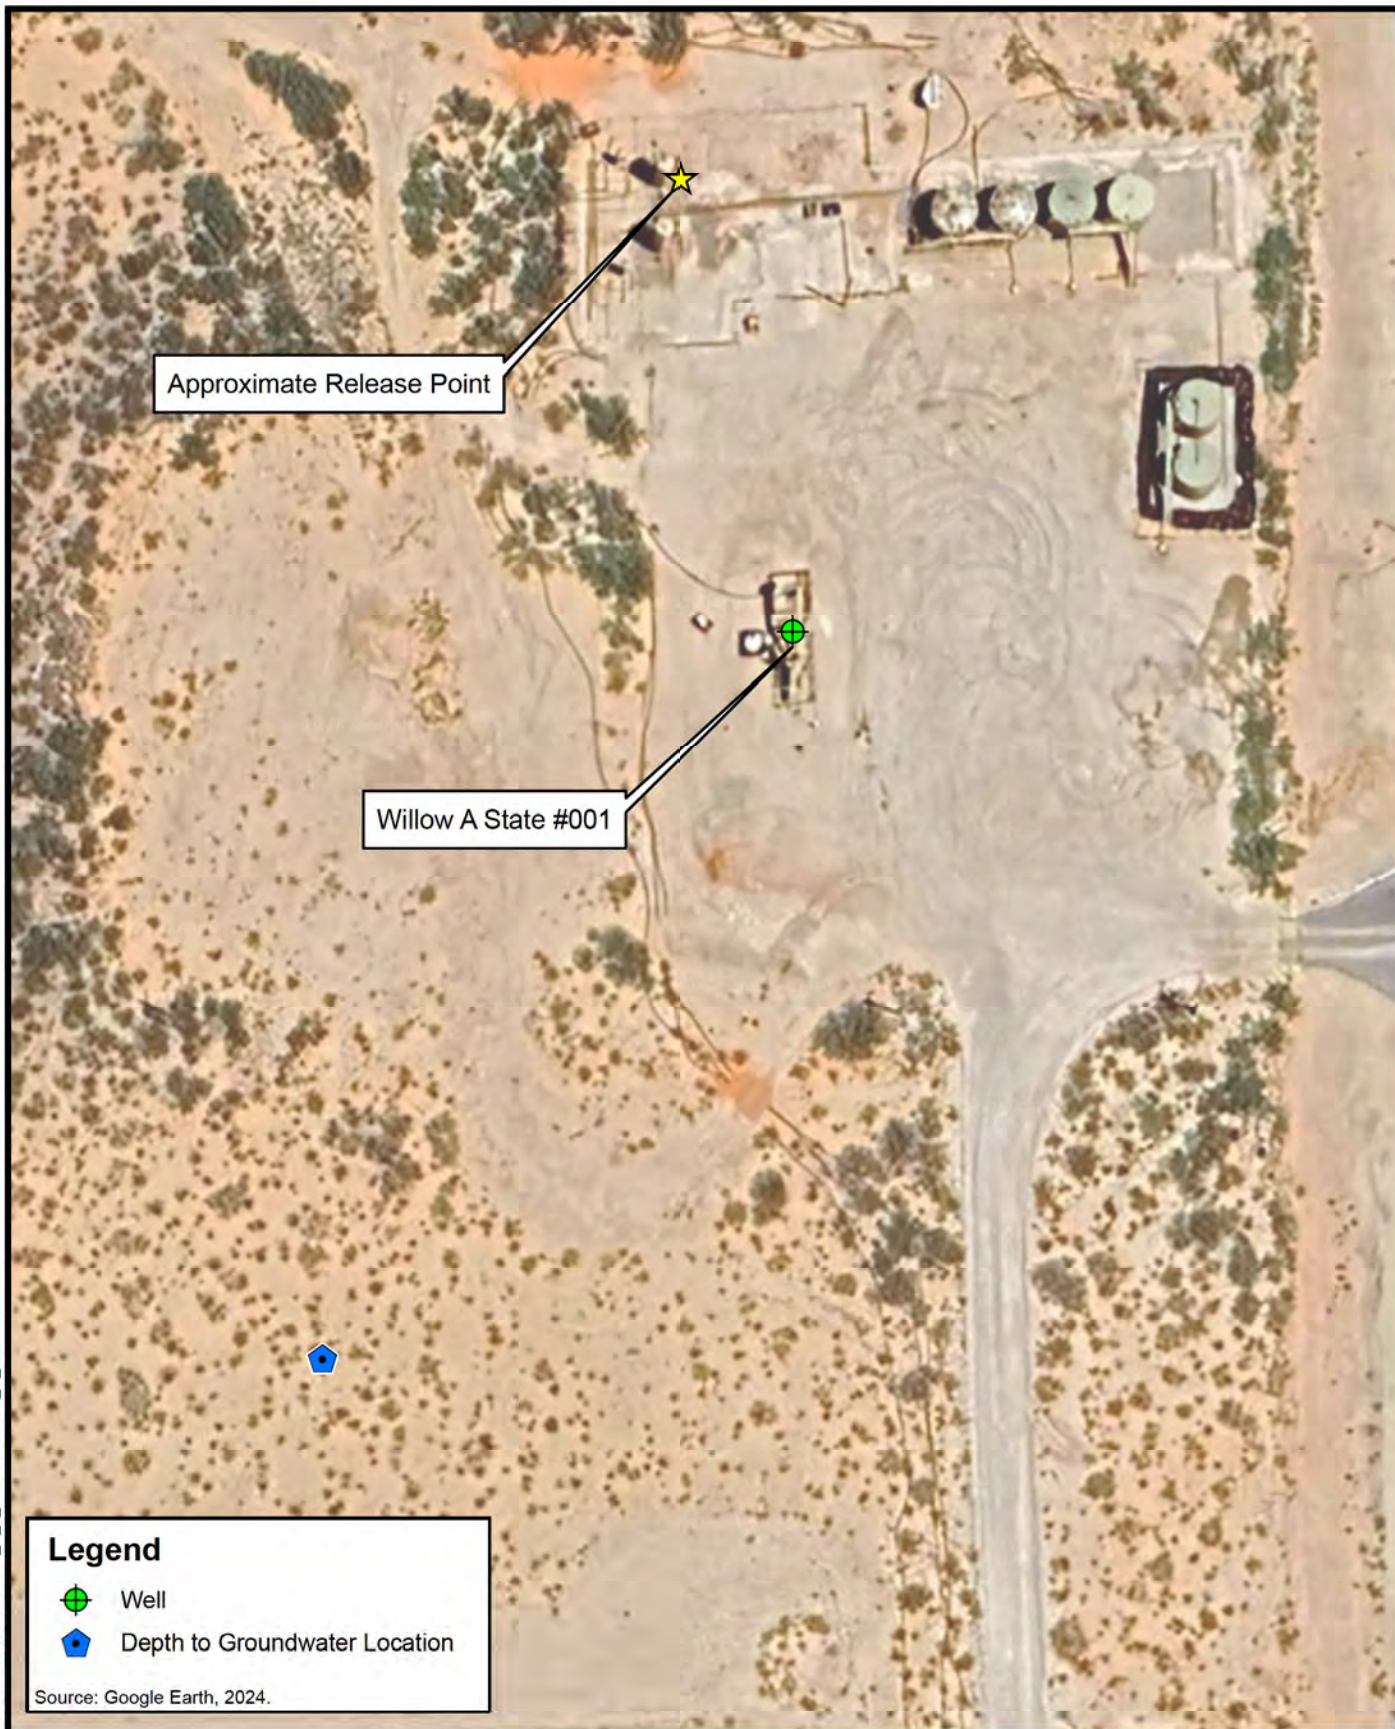
PROJECT NO.:	212C-MD-03573
DATE:	DECEMBER 20, 2024
DESIGNED BY:	LMV
Figure No.	4

**WILLOW A STATE #001 TANK BATTERY RELEASE
 REMEDIATION EXTENTS AND CONFIRMATION SAMPLING LOCATIONS**

Impacted soils were excavated as indicated in Figure 4. The areas within the release footprint were excavated to depths ranging from 0.5 to 8 feet below surrounding grade. Due to safety concerns, the excavation activities avoided disturbing the structural integrity of production equipment including the vertical separator, transfer pump and associated electrical conduit, tanks, and surface steel lines. The area immediately beneath the subsurface lines and north of the tank were hand dug to the maximum possible depth of 0.5 feet bgs, as these areas were not safely accessible to mechanical equipment. Photographs from the excavated areas prior to backfill are provided in Appendix D.

Initial confirmation soil sampling analytical results associated with locations FS-2 and NSW-1 exceeded the chloride RRAL of 600 mg/kg. The excavation floor was deepened, and sidewalls were expanded in these areas, and iterative confirmation samples were collected to encompass the original sample locations that triggered removal (nomenclature defined in Table 2) post-additional excavation. Final excavated areas, depths, and representative confirmation sample locations are indicated in Figure 4.

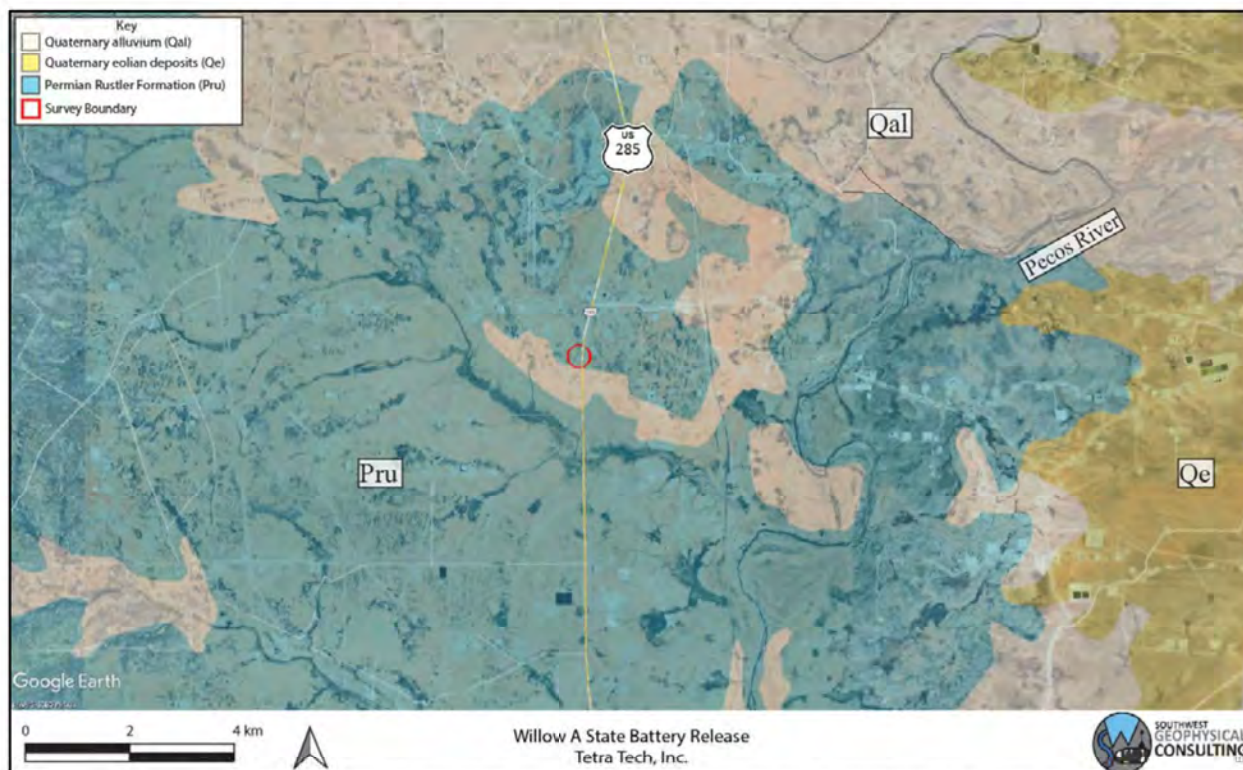
Figure 3: Geology overview. Geology map credit: The Digital Geologic Map of New Mexico in ARC/INFO Format. Background image credit: Google Earth. Image date: July 13, 2024. Image datum: WGS-84.

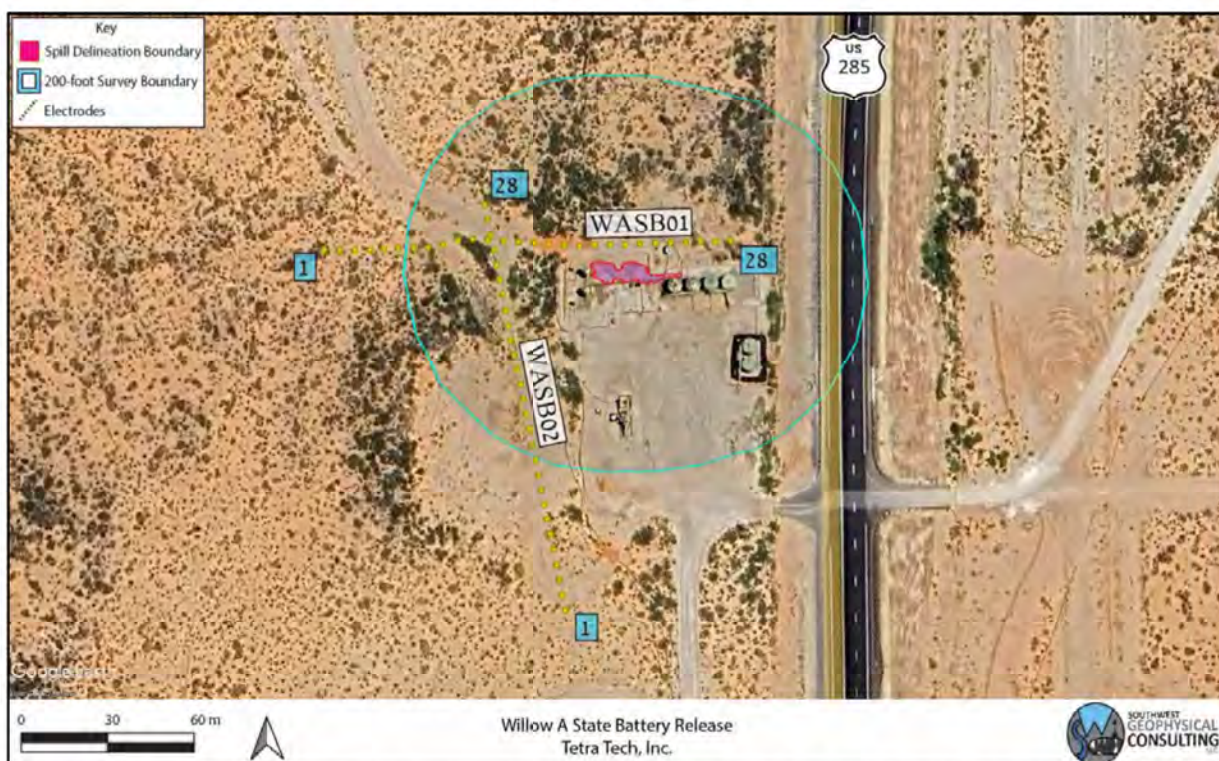
For this survey, an Advanced Geosciences Inc. (AGI) SuperSting™ Wifi R8 with a multi-electrode switchbox, a 28-electrode array of 40-centimeter-long electrodes, and a tablet controller were used to image the subsurface. This survey consisted of two resistivity lines in a dipole-dipole strong-gradient configuration; line one is laid out west to east while line two is laid out south to north. Both lines consisted of 28 electrodes at 5-meter spacing, resulting in 135-meter-long arrays (Figure 5, Table 1). A preconfigured command file was used to run the data collection (DDSG28). This electrode configuration provided a depth of investigation of 27 meters (89 feet) and a resolution of 2.5 to 3.0 meters (8.2 to 9.8 feet) within the first 5 to 8 meters (16 to 26 feet) from the surface. A Leica GS18 GPS was used to record electrode locations and elevations.

Figure 5: Geophysical survey overview. Two survey lines were conducted with 28 electrodes at 5-meter spacing (yellow dots denoted with blue numbers). Background image credit: Google Earth. Image date: July 13, 2024. Image datum: WGS-84.

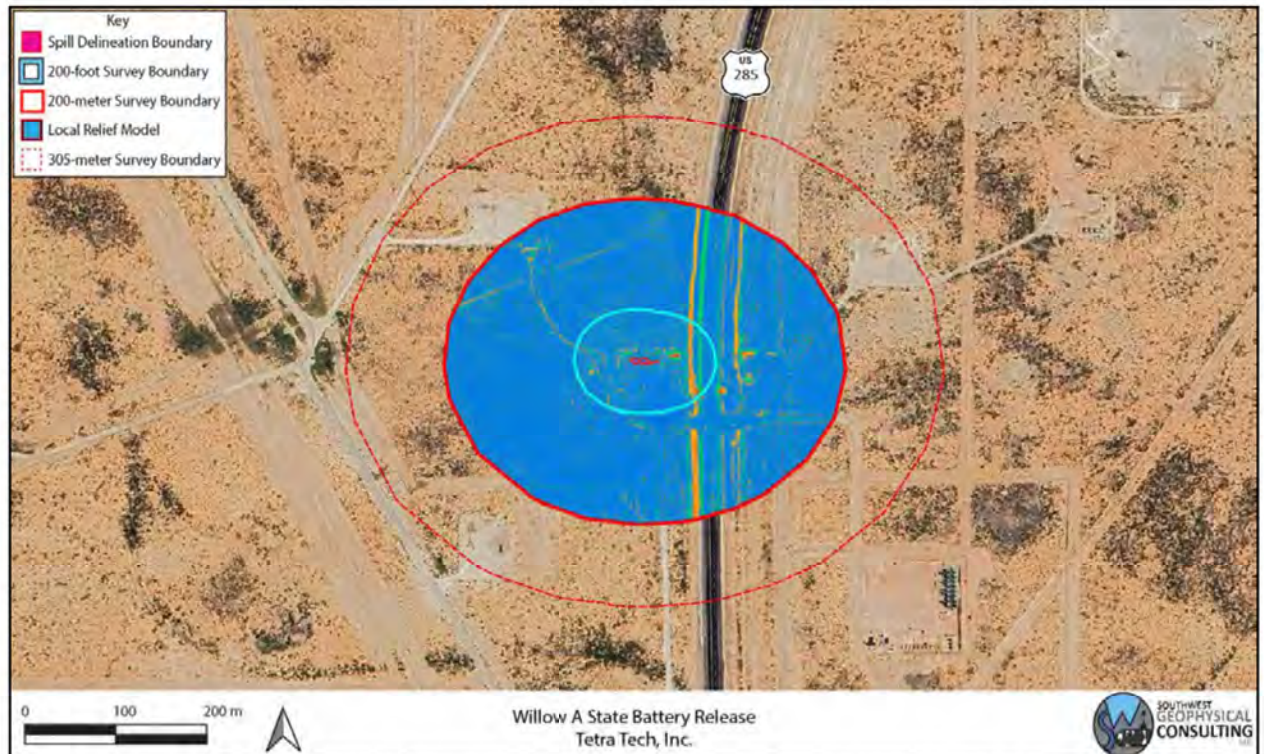
No springs exist within the 305-meter (1,000 foot) survey boundary (Figure 6).

Figure 6: Surface karst survey results. Background image credit: Google Earth. Image date: March 20, 2023. Image datum: WGS-84.

Caution should still be exercised while operating in this area due to the possibility of near-surface voids. Employing a BLM-CFO approved karst monitor on site during remediation activities should be considered.

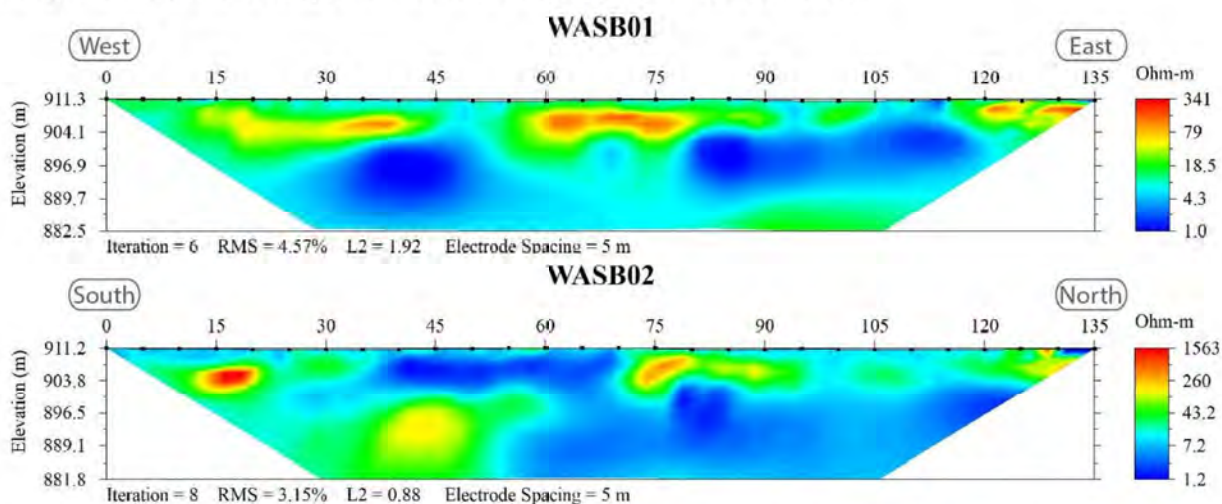
The results of this study indicate a well-layered geologic system with resistivities between 1 and 341 Ohm-m (**Figure 7**). Please keep in mind when viewing the 2D inverted resistivity sections that color maps can be widely different for each view. Always check the color map located on the right side of the image when viewing the 2D images to ensure you understand the range of resistivities presented. Distances along the top and depths along the left side are in meters. The color map along the right side is in Ohm-m. Due to the nature of the survey, shallower zones have higher resolution between electrodes than deeper zones; therefore, small features at depth will not be visible.

Figure 7: 2D inverted resistivity sections. Reds and oranges indicate higher resistivity values. Yellows and greens are medium-resistivity values. Blues are low-resistivity values. Please note that the color scale is relative.

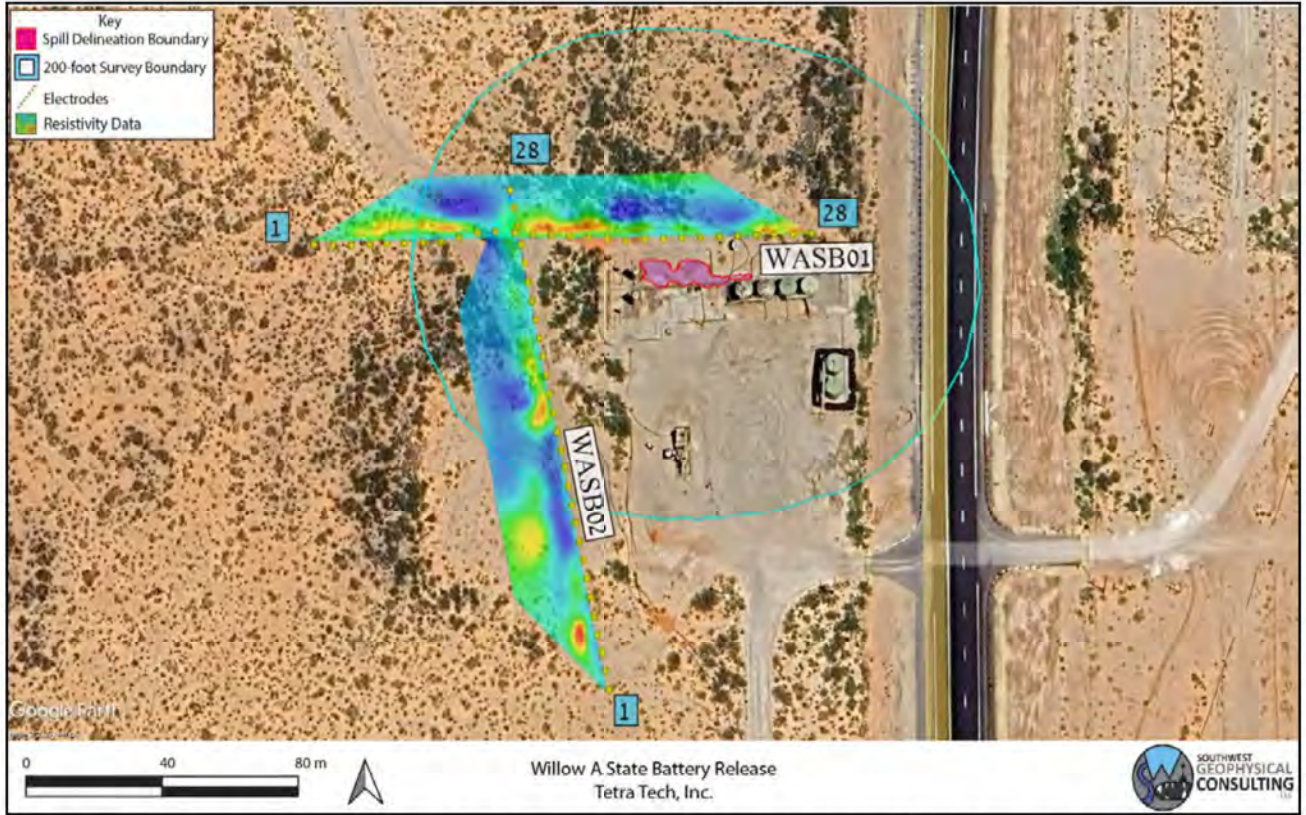
Figure 8: Data overlay. Colored trapezoids are the 2D inverted resistivity lines. Background image credit: Google Earth. Image date: July 13, 2024.

Within karst terrains like the project site, small air- or sediment-filled voids and/or brecciated zones and solutionally enlarged fractures that are below the resolution limit of the survey (2.5– 3.0 meters) may exist; these may be encountered during excavation, and if so, should be evaluated by a karst specialist prior to continued work.

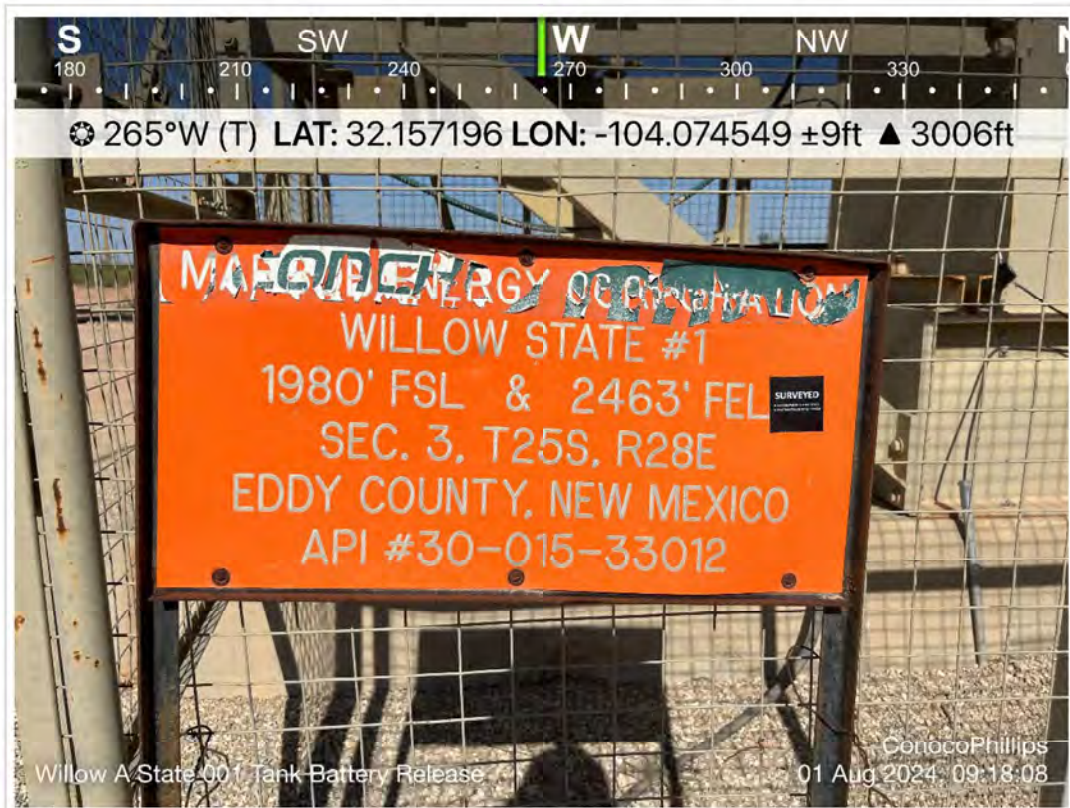
TETRA TECH, INC. PROJECT NO. 212C-MD-03573	DESCRIPTION	View of site signage.	1
	SITE NAME	Willow A State #001 Tank Battery Release	8/1/2024

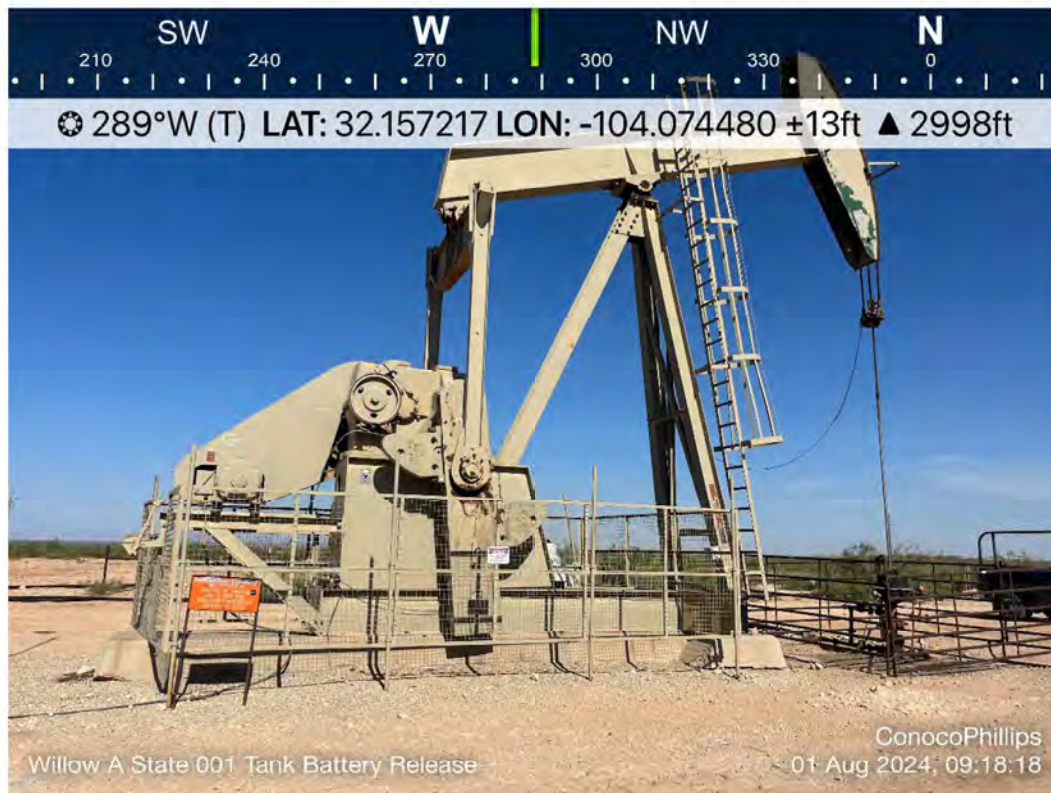
TETRA TECH, INC. PROJECT NO. 212C-MD-03573	DESCRIPTION	View west. View of wellhead area, south of tank battery facilities.	2
	SITE NAME	Willow A State #001 Tank Battery Release	8/1/2024

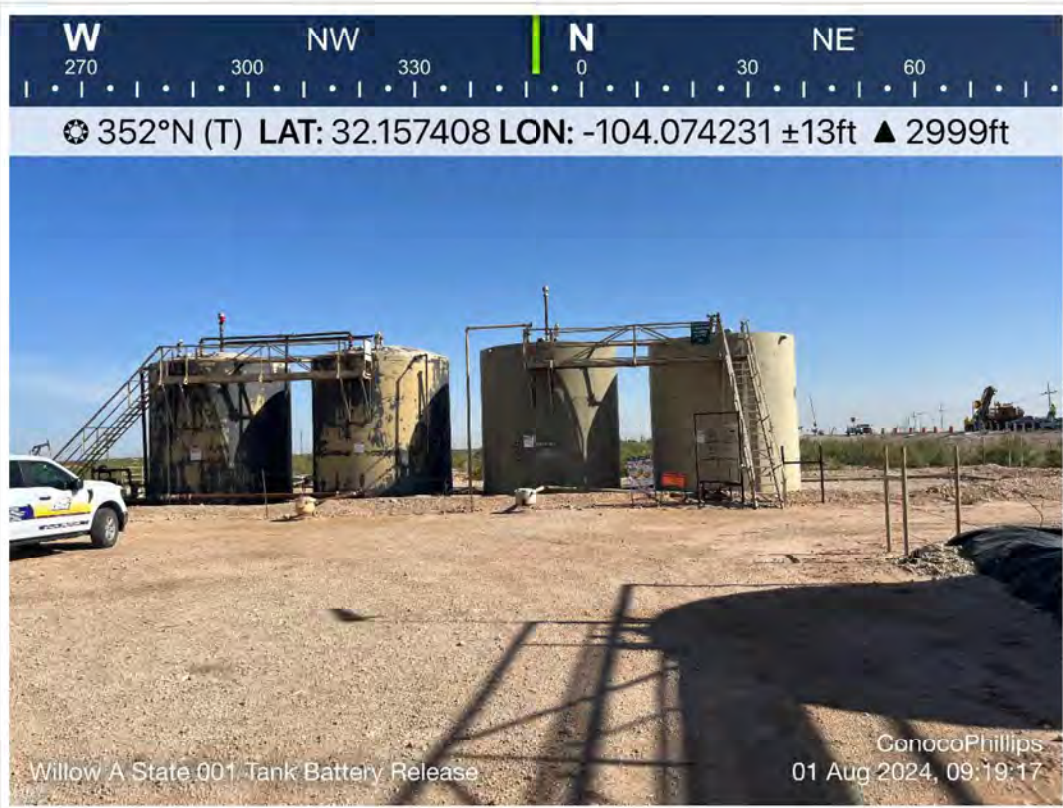
On behalf of ConocoPhillips, Tetra Tech conducted a visual Site inspection on August 1, 2024 to assess current Site conditions, document any observable impact, and photograph the area and surrounding equipment. Tetra Tech personnel observed an area of minor staining largely coinciding with the approximate release footprint. The staining was observed to remain within the existing facility berm.

TETRA TECH, INC. PROJECT NO. 212C-MD-03573	DESCRIPTION	View north. View of tank battery, located in same berm adjacent to release footprint.	3
	SITE NAME	Willow A State #001 Tank Battery Release	8/1/2024

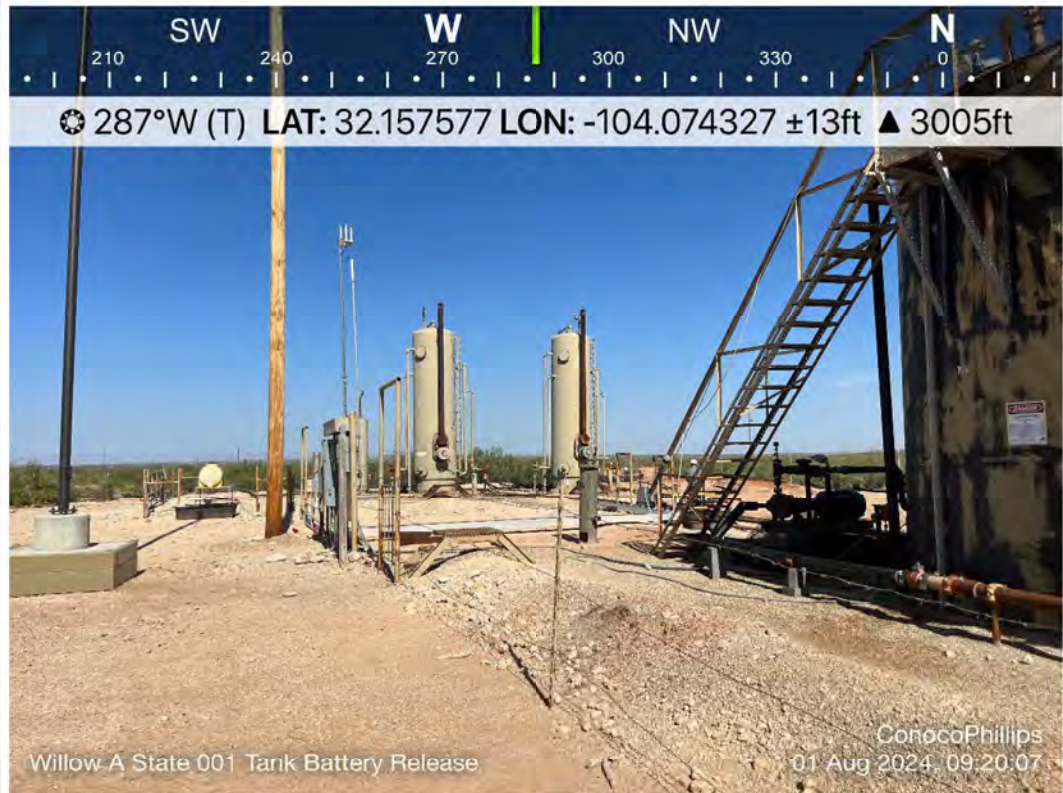
TETRA TECH, INC. PROJECT NO. 212C-MD-03573	DESCRIPTION	View west. Western edge of tank battery with facility berm in foreground and vessels in background.	4
	SITE NAME	Willow A State #001 Tank Battery Release	8/1/2024

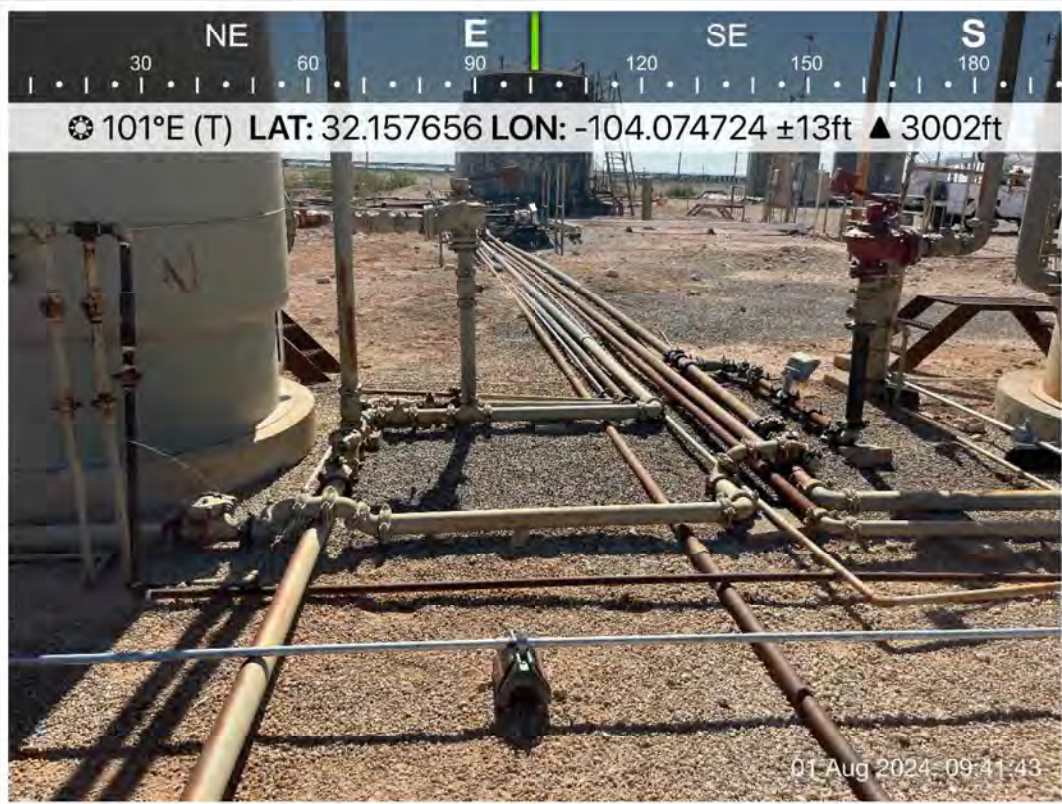
Outside the facility berm, several sets of surface polylines are spread across the ground surface north and west of the facility berm, hampering access for machine equipment to the release footprint. A Solaris Water Midstream, LLC tinhorn is located amongst the surface polylines, with a single polyline emerging from the tinhorn running westward. However, pending the removal of the northern berm, Tetra Tech observed that several areas of the release extent could be accessible to heavy equipment without destabilizing the production vessels and or piping. The facility equipment is indicated in Figure 3. Photographic documentation from the Site evaluation is included in Appendix D.

TETRA TECH, INC. PROJECT NO. 212C-MD-03573	DESCRIPTION	View east. Raised steel surface lines running between tank battery and vessels.	5
	SITE NAME	Willow A State #001 Tank Battery Release	8/1/2024

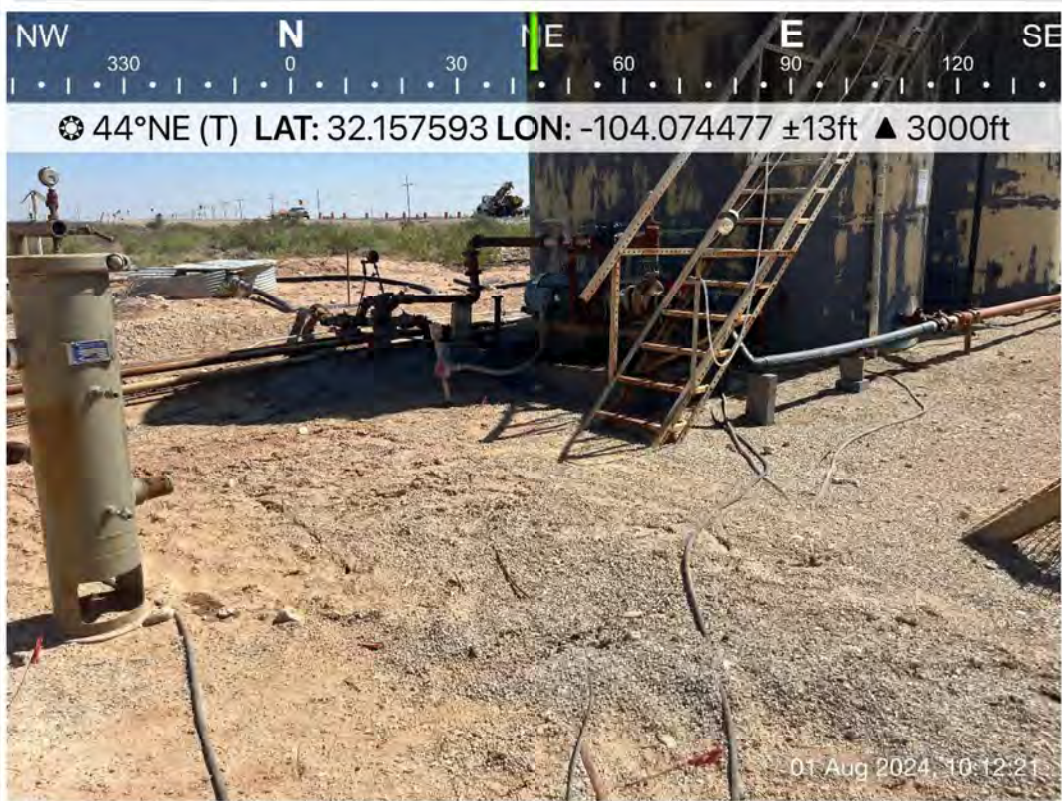
TETRA TECH, INC. PROJECT NO. 212C-MD-03573	DESCRIPTION	View northeast. West-side of tank battery with surface steel lines running west from north-side of tank battery.	6
	SITE NAME	Willow A State #001 Tank Battery Release	8/1/2024

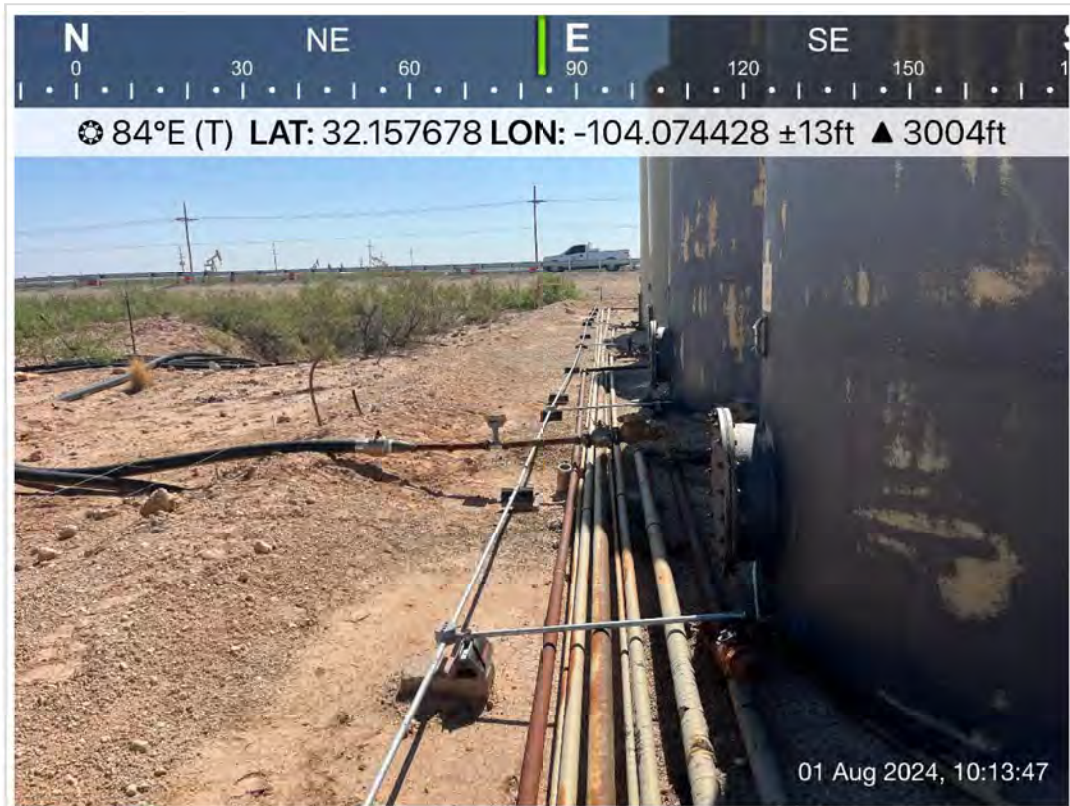
TETRA TECH, INC. PROJECT NO. 212C-MD-03573	DESCRIPTION	View east. North-side of tank battery, raised steel surface lines on north-side of tank battery.	7
	SITE NAME	Willow A State #001 Tank Battery Release	8/1/2024

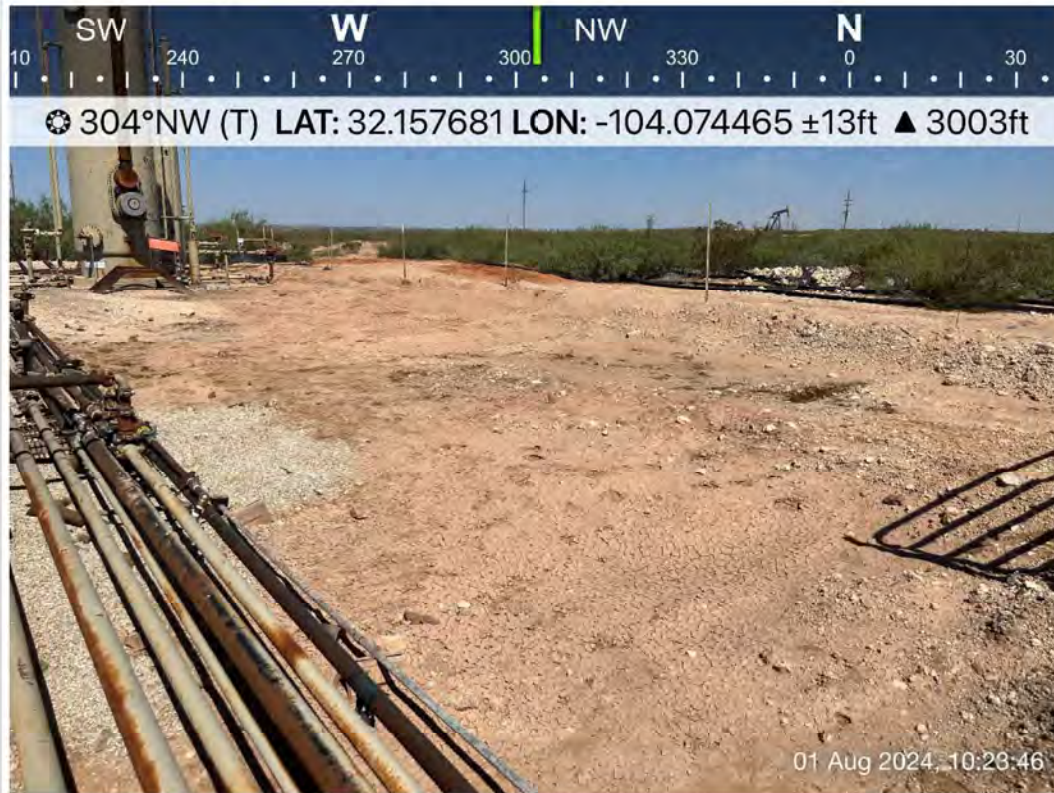
TETRA TECH, INC. PROJECT NO. 212C-MD-03573	DESCRIPTION	View northwest. North-side of raised steel lines. Area of release.	8
	SITE NAME	Willow A State #001 Tank Battery Release	8/1/2024

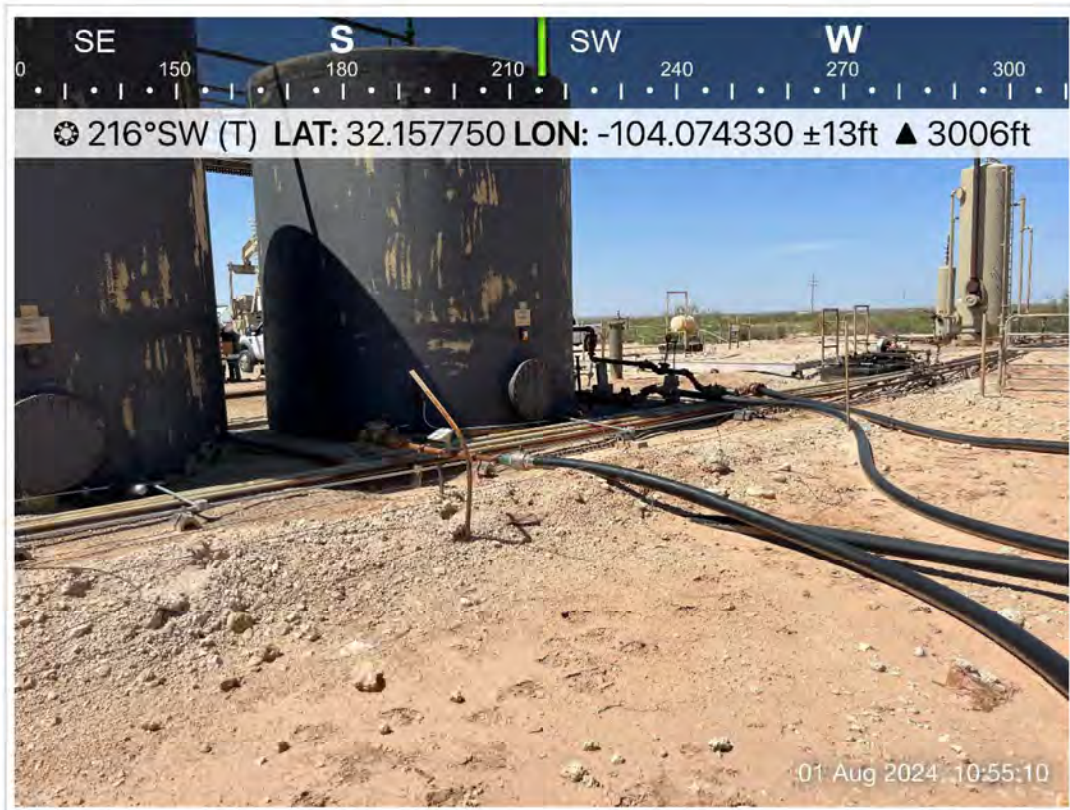
TETRA TECH, INC. PROJECT NO. 212C-MD-03573	DESCRIPTION	View southwest. North-side of tank battery. Surface flowlines emanating from raised steel lines.	9
	SITE NAME	Willow A State #001 Tank Battery Release	8/1/2024

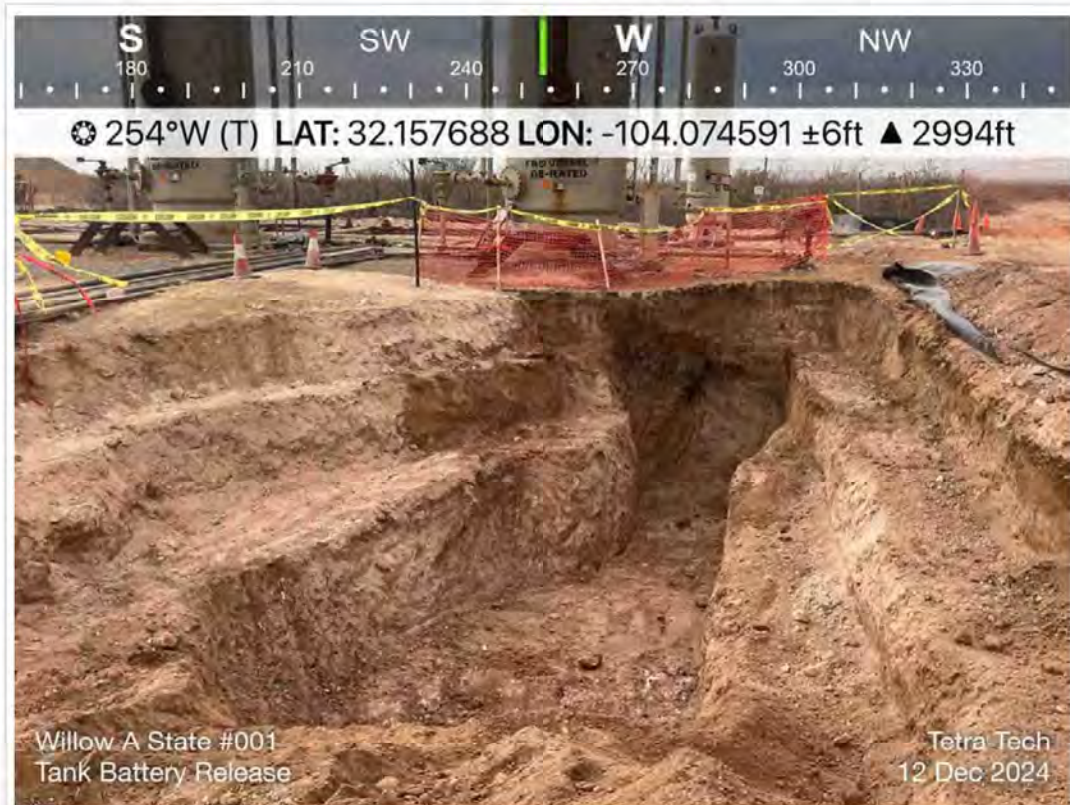
TETRA TECH, INC. PROJECT NO. 212C-MD-03573	DESCRIPTION	View west-southwest of benched 8 foot bgs excavation.	10
	SITE NAME	Willow A State #001 Tank Battery Release	12/12/2024

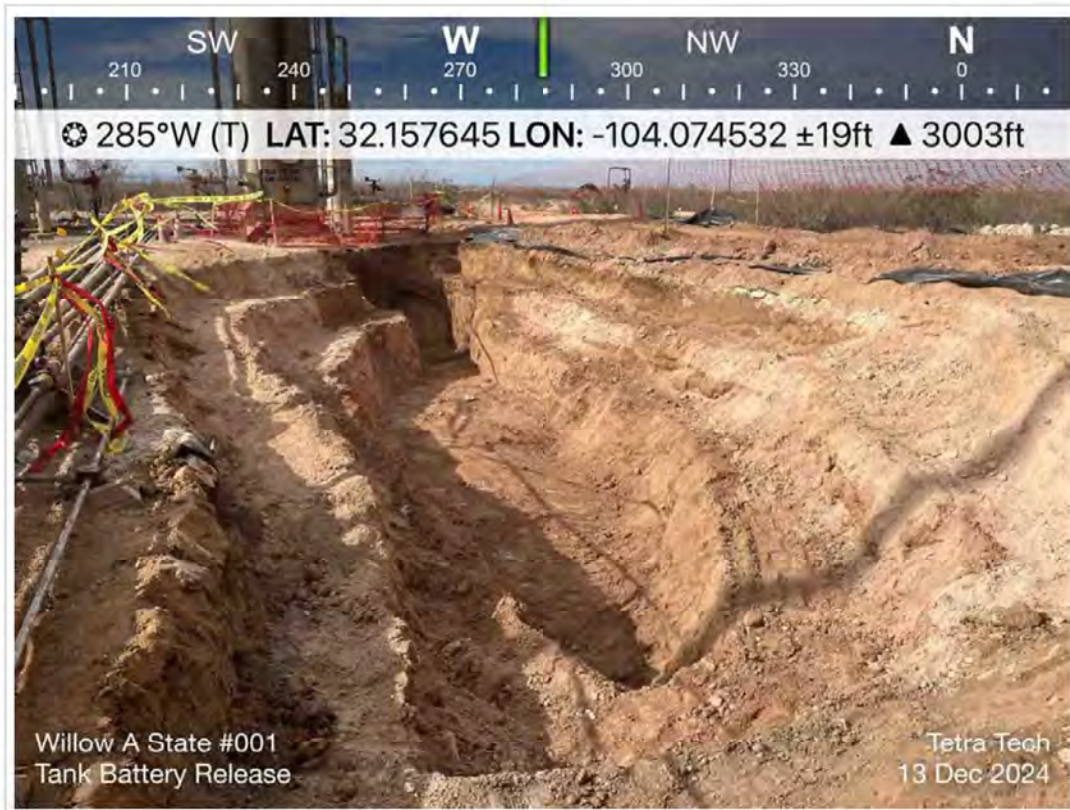
TETRA TECH, INC. PROJECT NO. 212C-MD-03573	DESCRIPTION	View west of benched excavation.	11
	SITE NAME	Willow A State #001 Tank Battery Release	12/13/2024

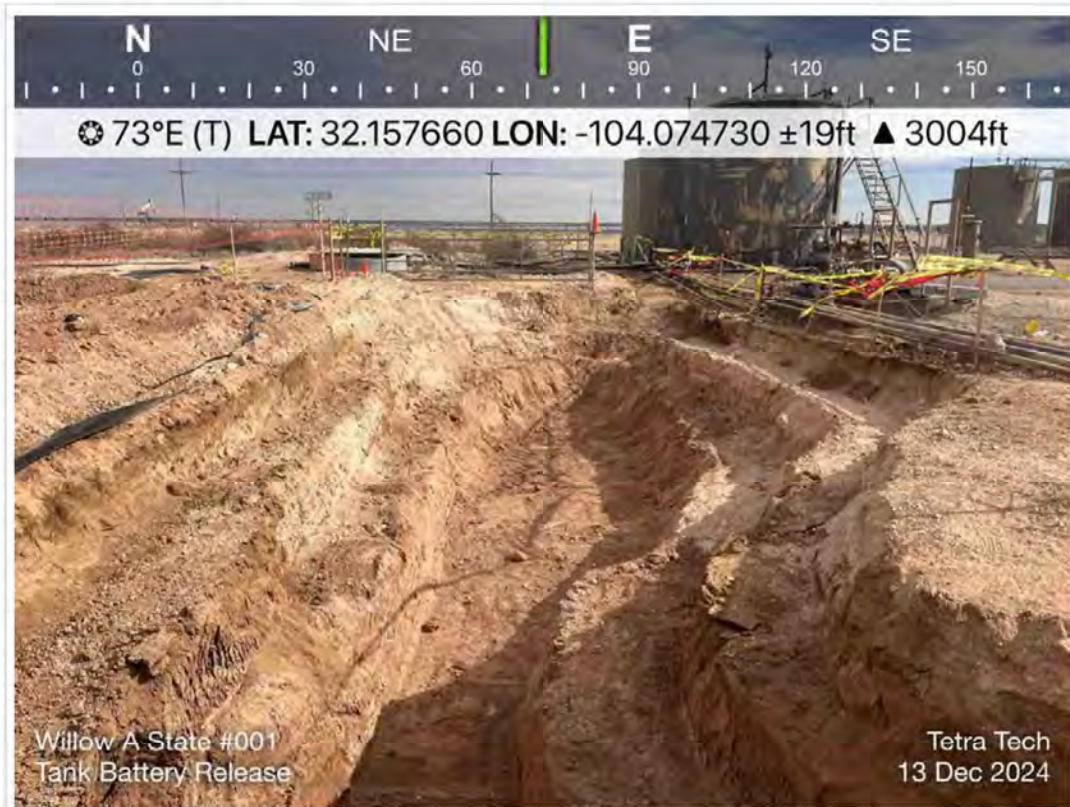
TETRA TECH, INC. PROJECT NO. 212C-MD-03573	DESCRIPTION	View northeast of benched 8 foot bgs excavation.	12
	SITE NAME	Willow A State #001 Tank Battery Release	12/13/2024

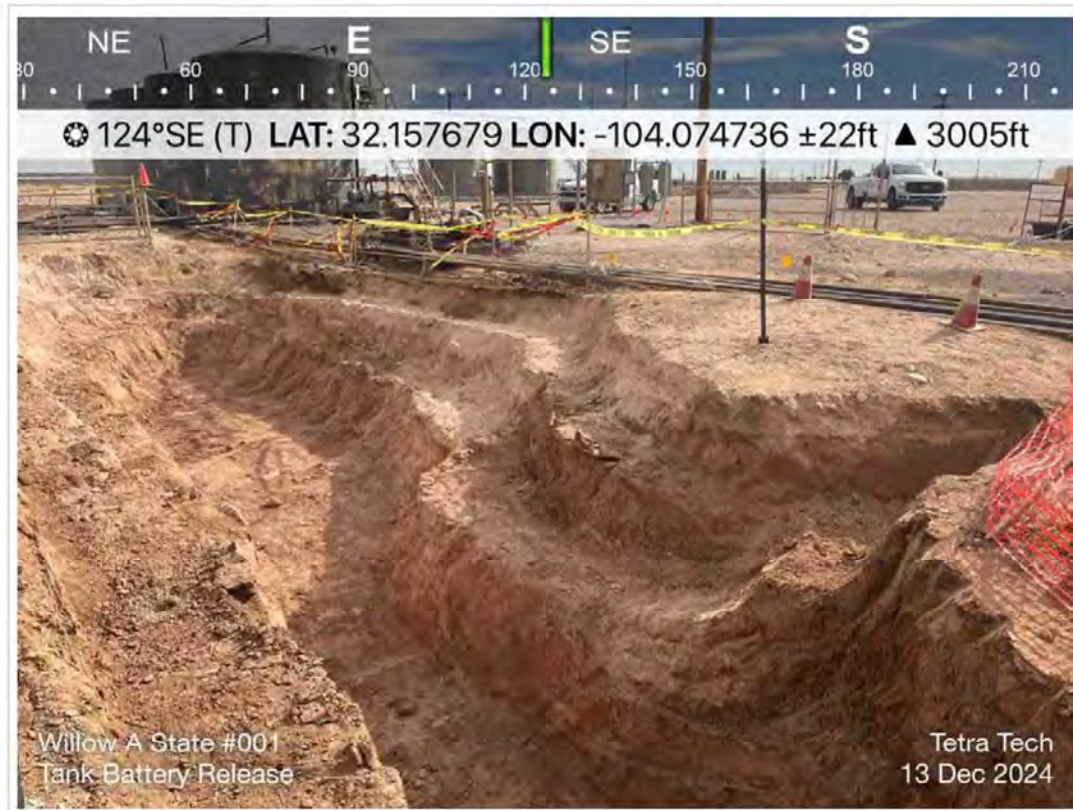
TETRA TECH, INC. PROJECT NO. 212C-MD-03573	DESCRIPTION	View southeast of benched excavation.	13
	SITE NAME	Willow A State #001 Tank Battery Release	12/13/2024

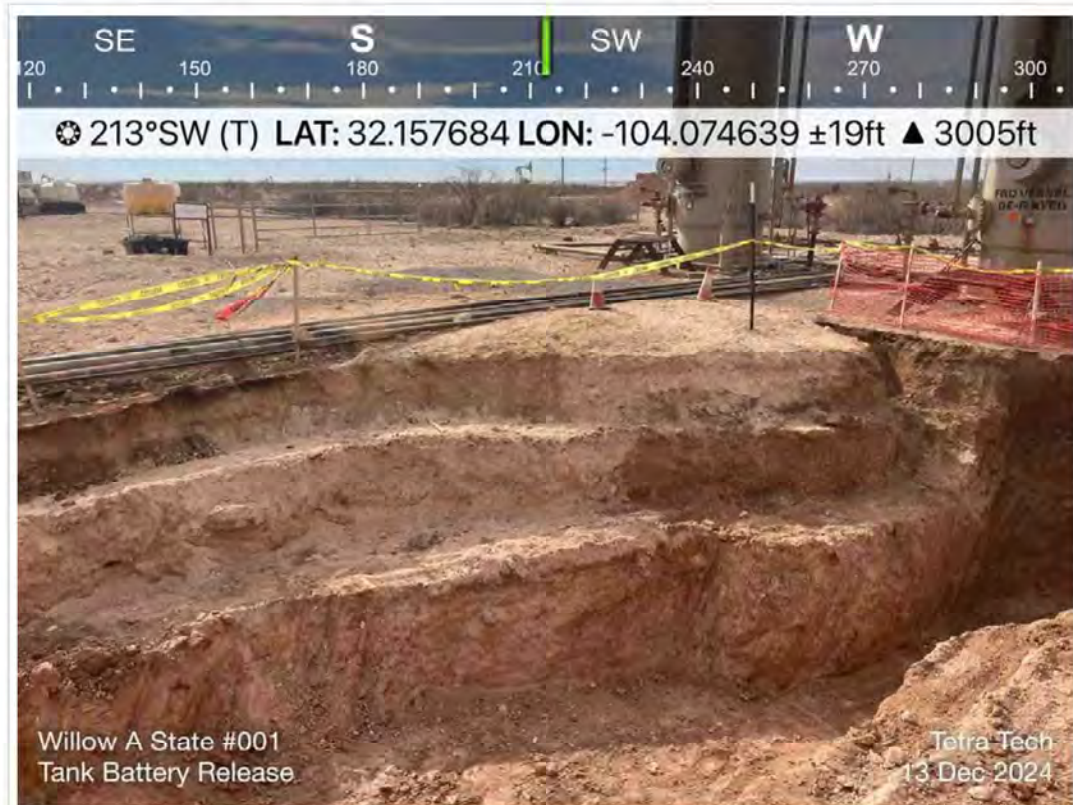
TETRA TECH, INC. PROJECT NO. 212C-MD-03573	DESCRIPTION	View east of east side of the excavation north of the steel lines and tank battery.	14
	SITE NAME	Willow A State #001 Tank Battery Release	12/13/2024

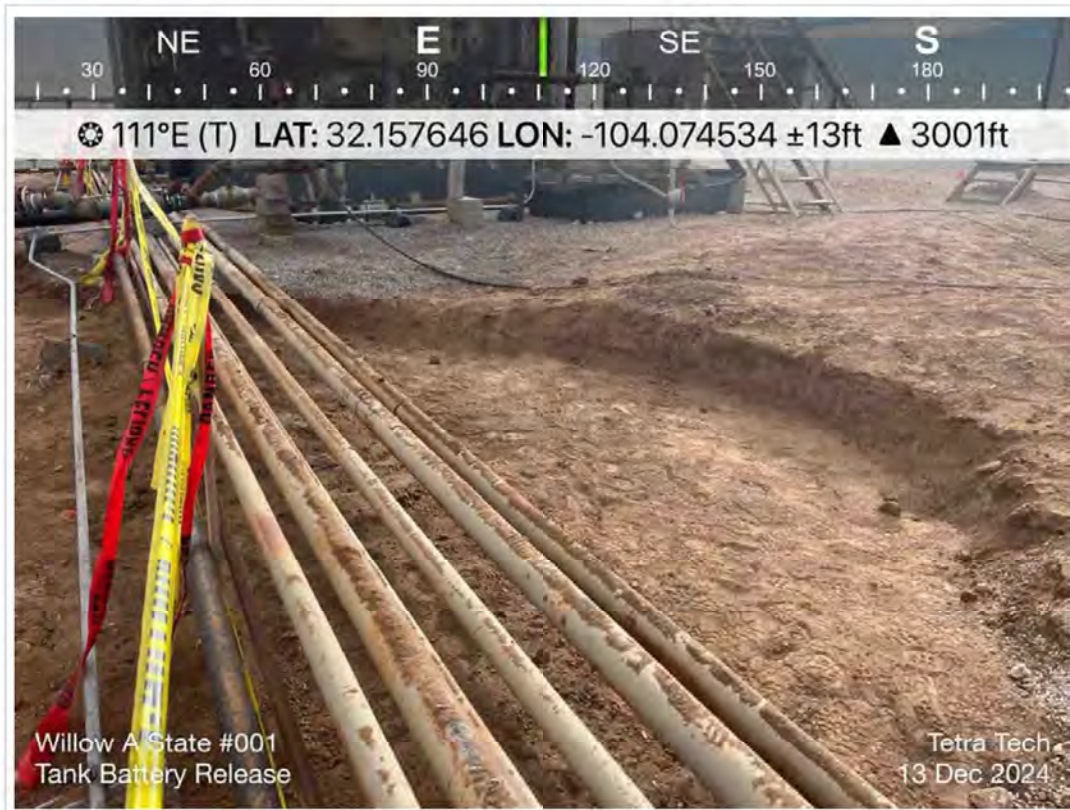
TETRA TECH, INC. PROJECT NO. 212C-MD-03573	DESCRIPTION	View east-southeast of excavation area beneath steel surface lines.	15
	SITE NAME	Willow A State #001 Tank Battery Release	12/13/2024

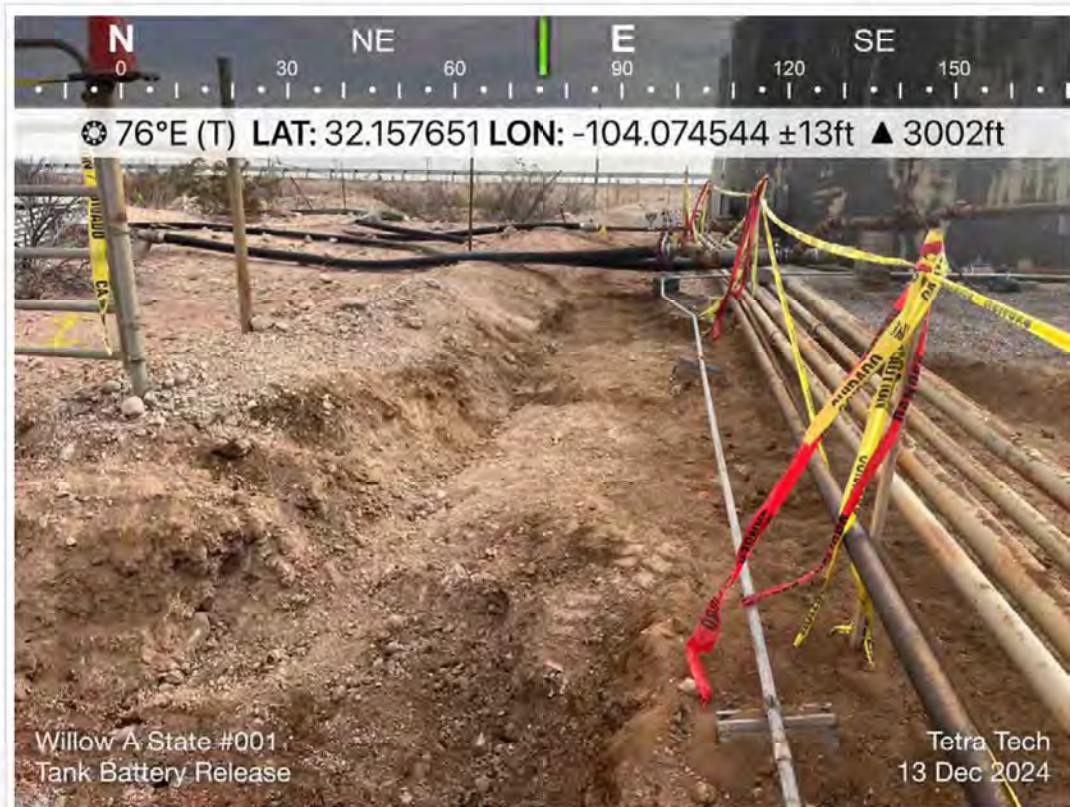
TETRA TECH, INC. PROJECT NO. 212C-MD-03573	DESCRIPTION	View east of east side of the excavation north of the steel lines and tank battery.	16
	SITE NAME	Willow A State #001 Tank Battery Release	12/13/2024
