February 19, 2026

**Re: Release Characterization, Remediation Summary, and Deferral Request
REVISION 2
ConocoPhillips
Willow A State #001 Tank Battery Release
Unit Letter J, Section 03, Township 25 South, and Range 28 East
Eddy County, New Mexico
Incident ID NAPP2221332553
Landowner: NMSLO**

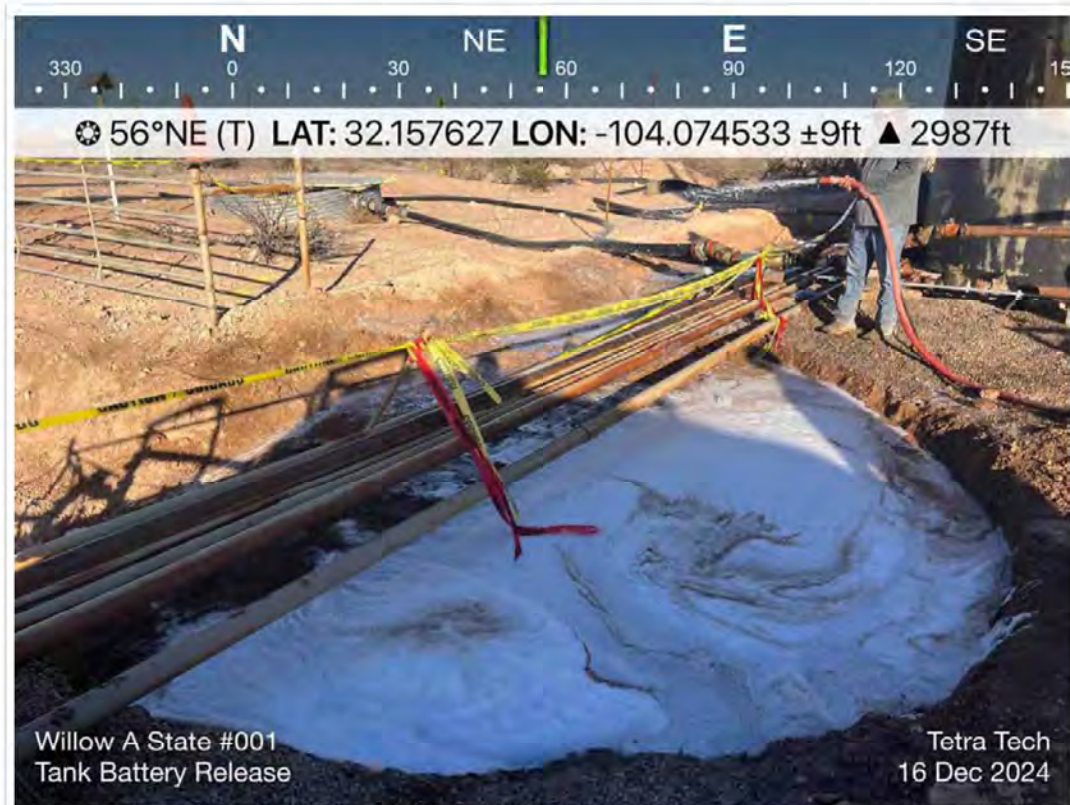
TETRA TECH, INC. PROJECT NO. 212C-MD-03573	DESCRIPTION	View northeast. Microblaze application in vicinity of SSW-1.	18
	SITE NAME	Willow A State #001 Tank Battery Release	12/16/2024

In accordance with the approved Work Plan and NMSLO conditions of approval, the excavation area was treated with approximately 2,000 gallons of 3% Micro-Blaze solution mixed with water prior to backfilling, as documented in the photographic log in Appendix D. The areas proposed for deferral are fully delineated. A depth to groundwater boring was drilled and verified that groundwater is not present at 55 feet bgs or less and the remaining contamination does not pose a threat to freshwater, human health, or the environment. The conditions of 19.15.29.13 NMAC will be implemented when completing abandonment of the facility and associated equipment.

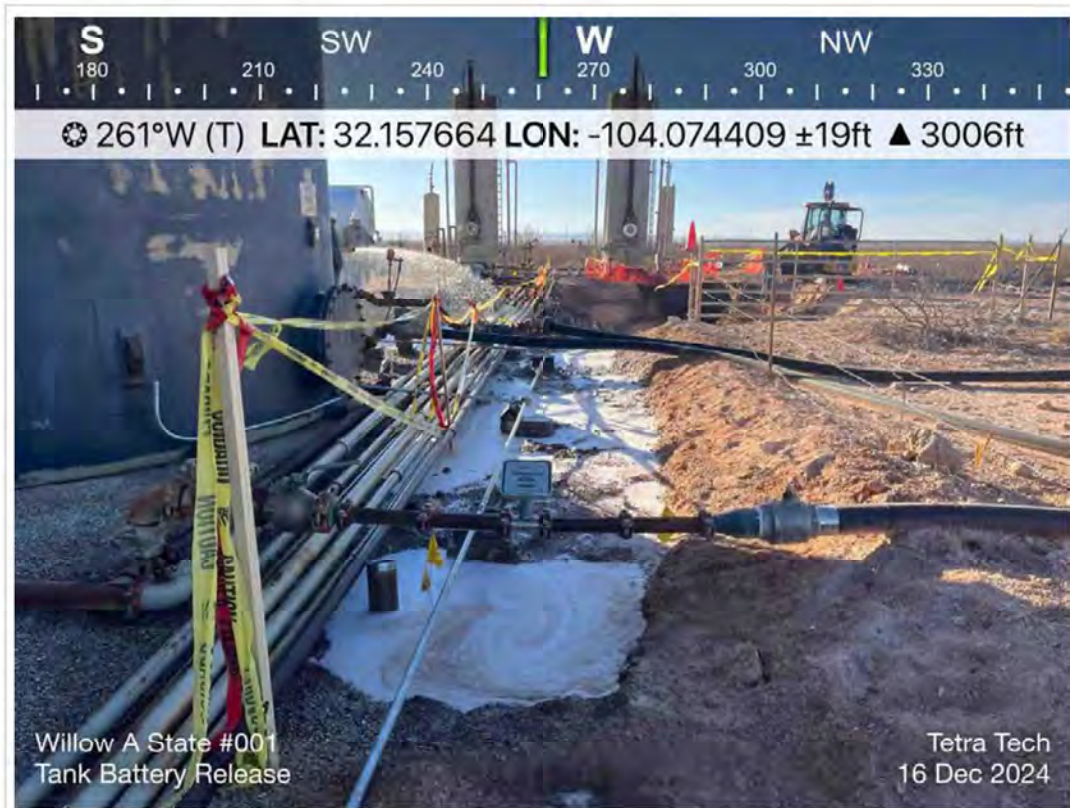
TETRA TECH, INC. PROJECT NO. 212C-MD-03573	DESCRIPTION	View west. Microblaze application in vicinity of FS-7 and NSW-2.	19
	SITE NAME	Willow A State #001 Tank Battery Release	12/16/2024

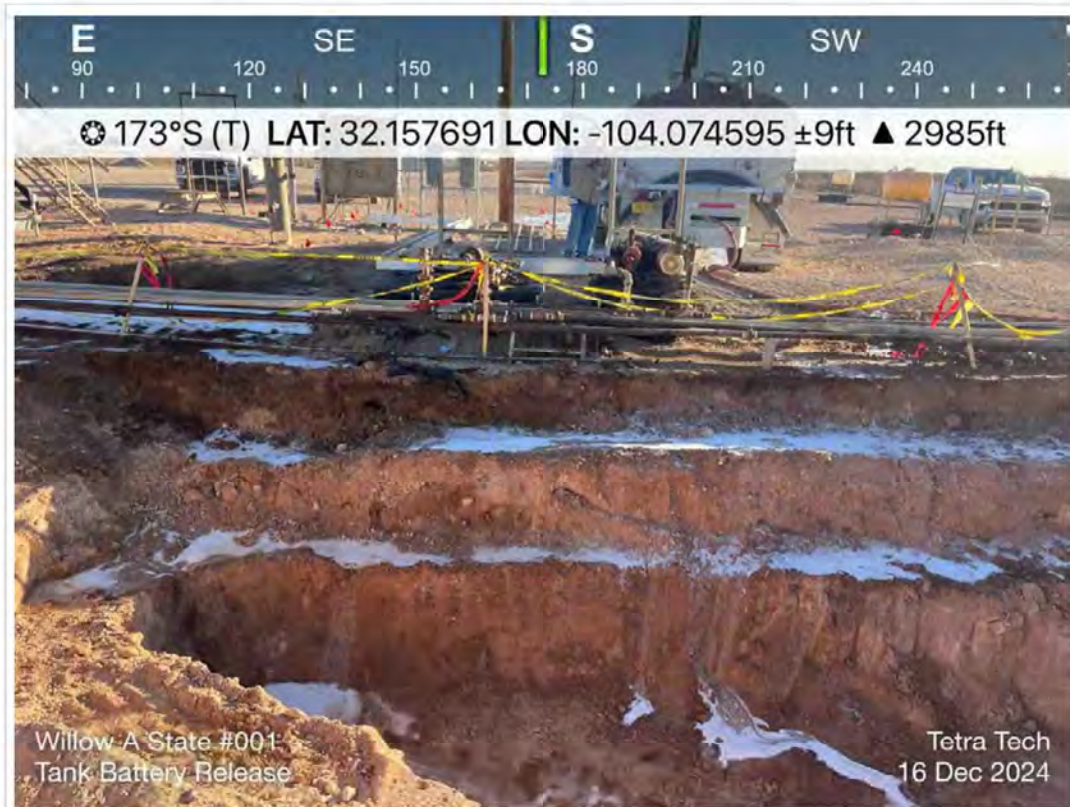
TETRA TECH, INC. PROJECT NO. 212C-MD-03573	DESCRIPTION	View south. Microblaze application in vicinity of ISW-5.	20
	SITE NAME	Willow A State #001 Tank Battery Release	12/16/2024

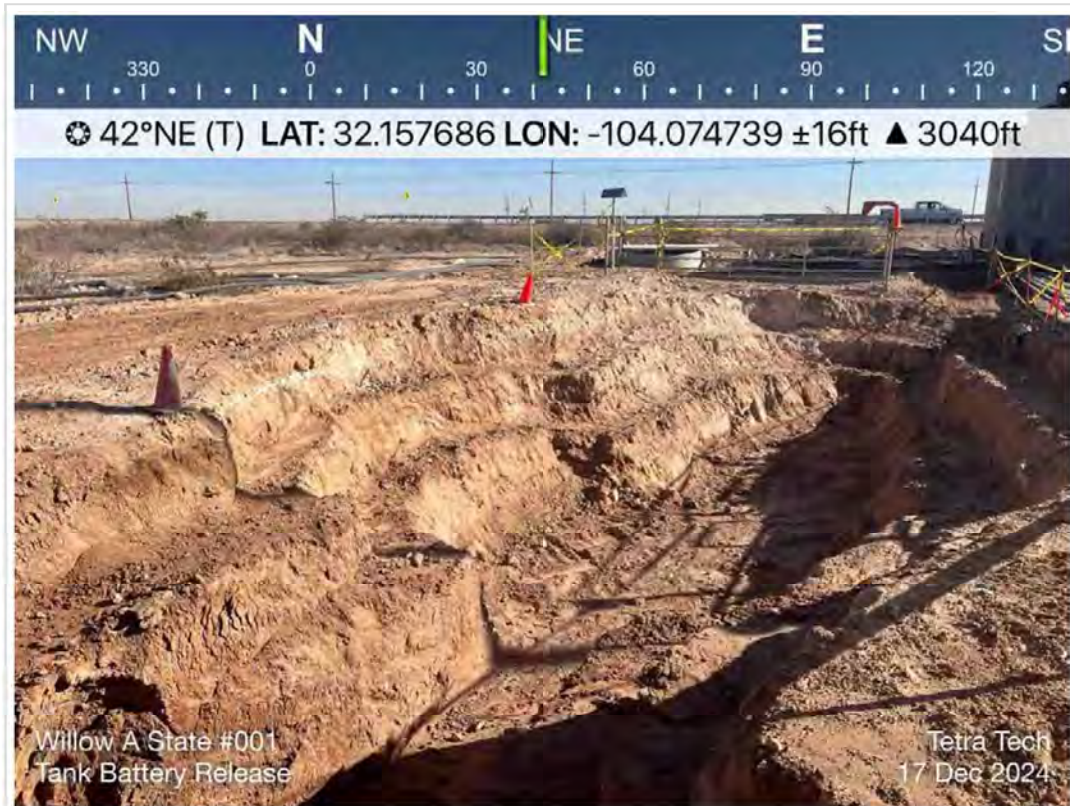
TETRA TECH, INC. PROJECT NO. 212C-MD-03573	DESCRIPTION	View northeast of step-out at NSW-1 and deepening FS-2.	21
	SITE NAME	Willow A State #001 Tank Battery Release	12/17/2024

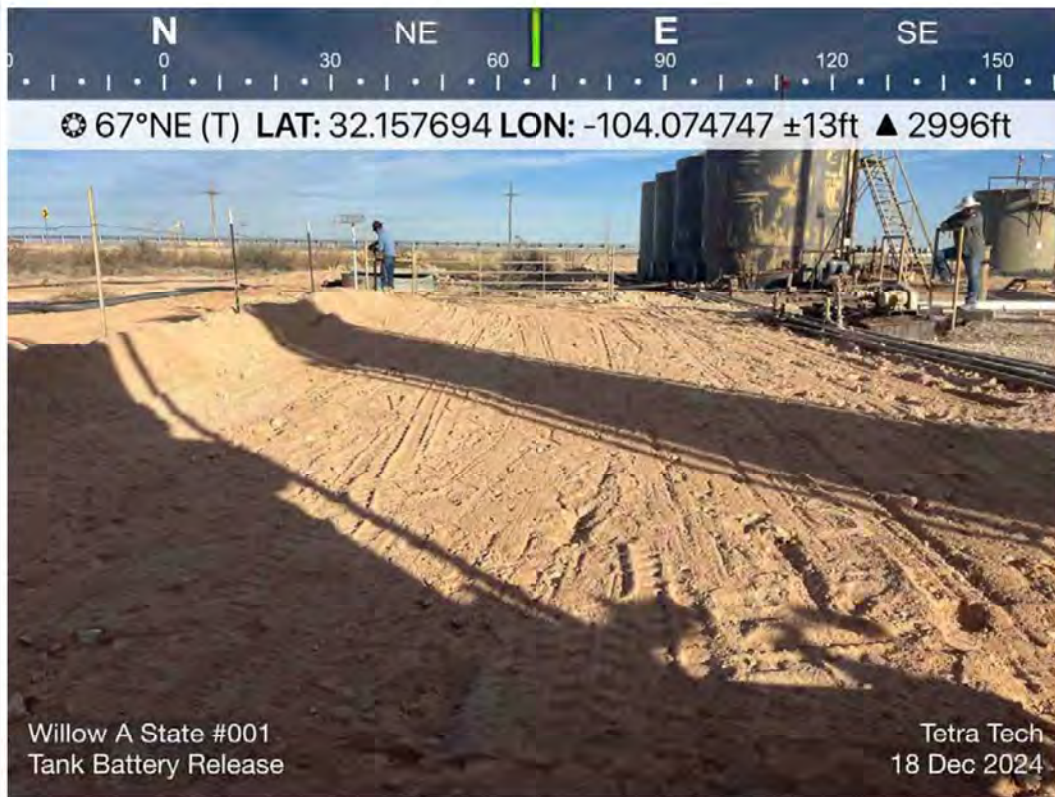
TETRA TECH, INC. PROJECT NO. 212C-MD-03573	DESCRIPTION	View east-northeast of backfilled excavation.	22
	SITE NAME	Willow A State #001 Tank Battery Release	12/18/2024

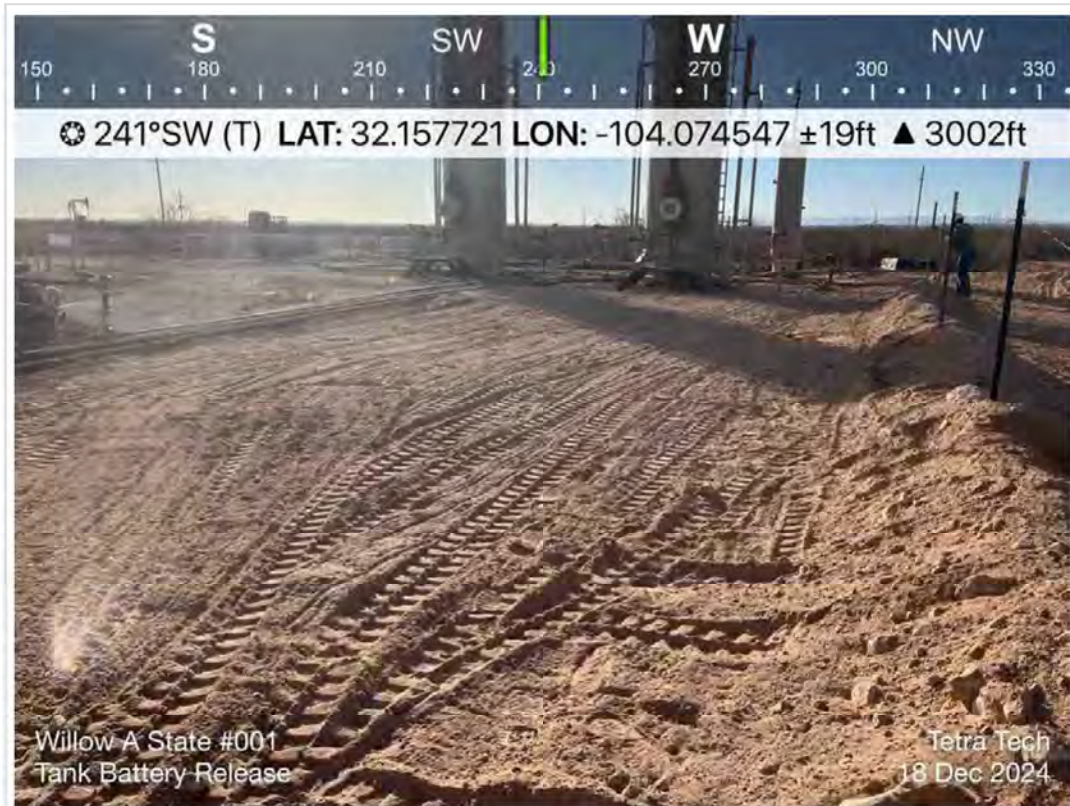
TETRA TECH, INC. PROJECT NO. 212C-MD-03573	DESCRIPTION	View southwest of backfilled excavation.	23
	SITE NAME	Willow A State #001 Tank Battery Release	12/18/2024

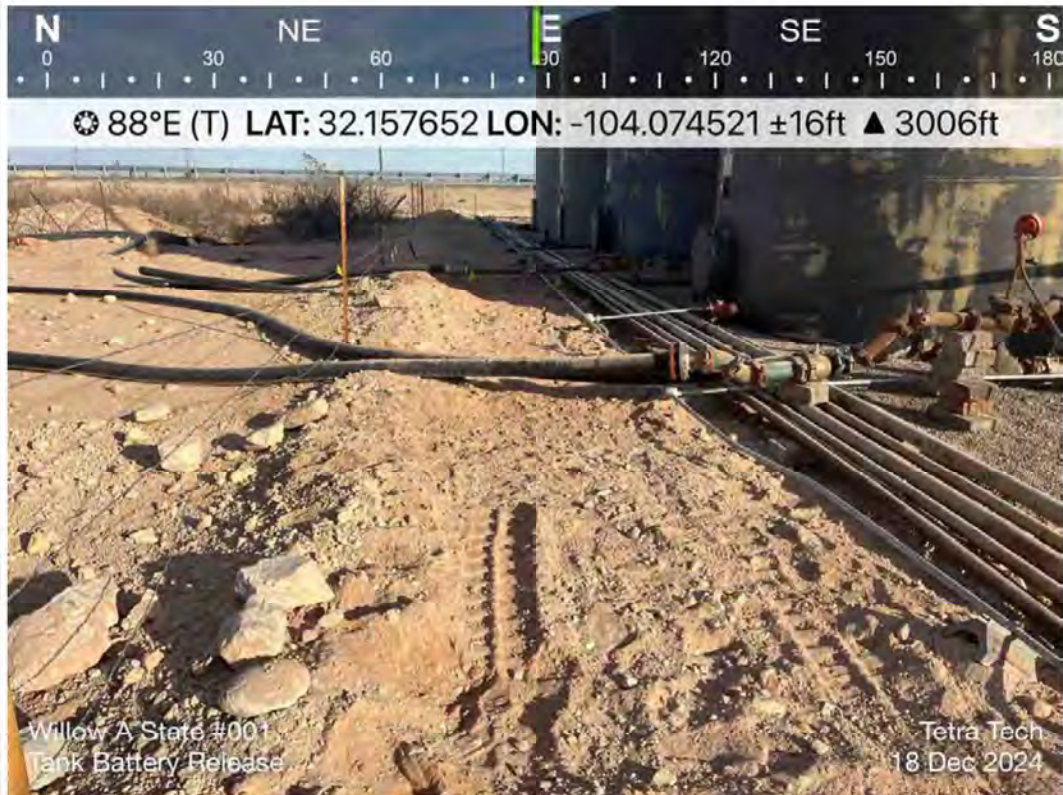
TETRA TECH, INC. PROJECT NO. 212C-MD-03573	DESCRIPTION	View east of backfilled excavation.	24
	SITE NAME	Willow A State #001 Tank Battery Release	12/18/2024

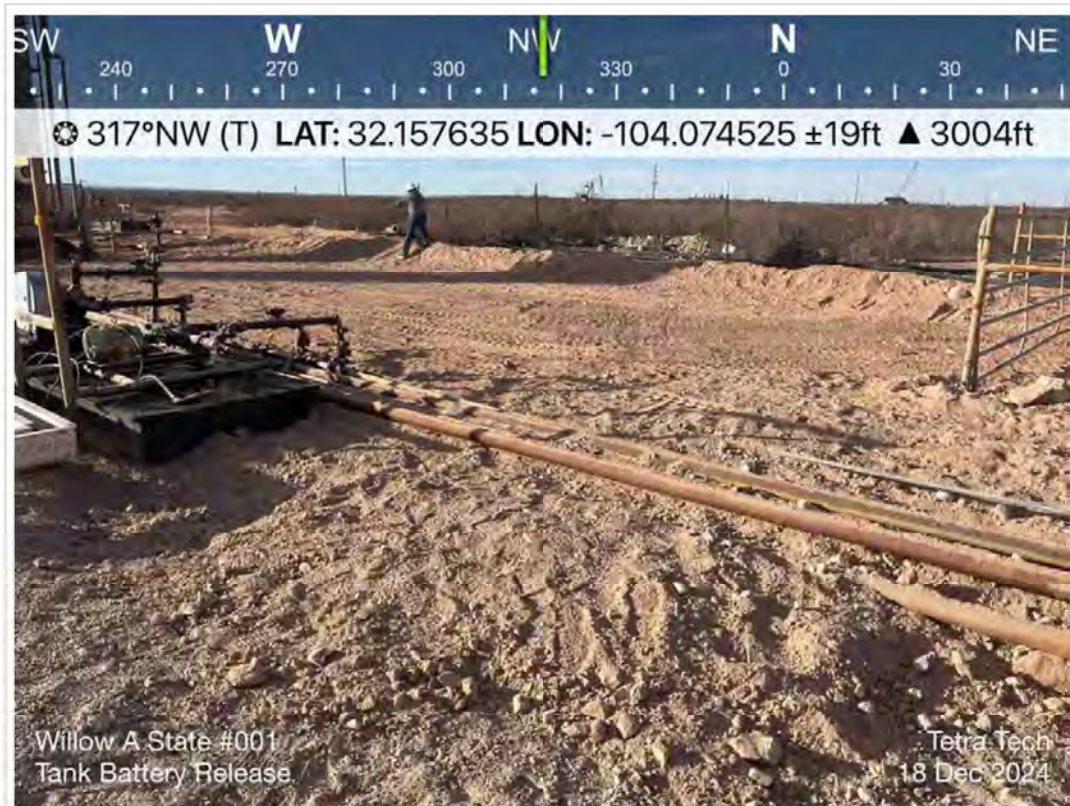
TETRA TECH, INC. PROJECT NO. 212C-MD-03573	DESCRIPTION	View northwest of backfilled excavation.	25
	SITE NAME	Willow A State #001 Tank Battery Release	12/18/2024
