## Release Assessment and Closure

Golden Graham 1 Federal Com CTB

Vertex File Number: 26A-00377

**Release Assessment and Closure**  
**Golden Graham 1 Federal Com CTB**  
**Unit L, Section 01, Township 26 South, Range 28 East**  
**Facility ID: fAPP2600632710**  
**County: Eddy**

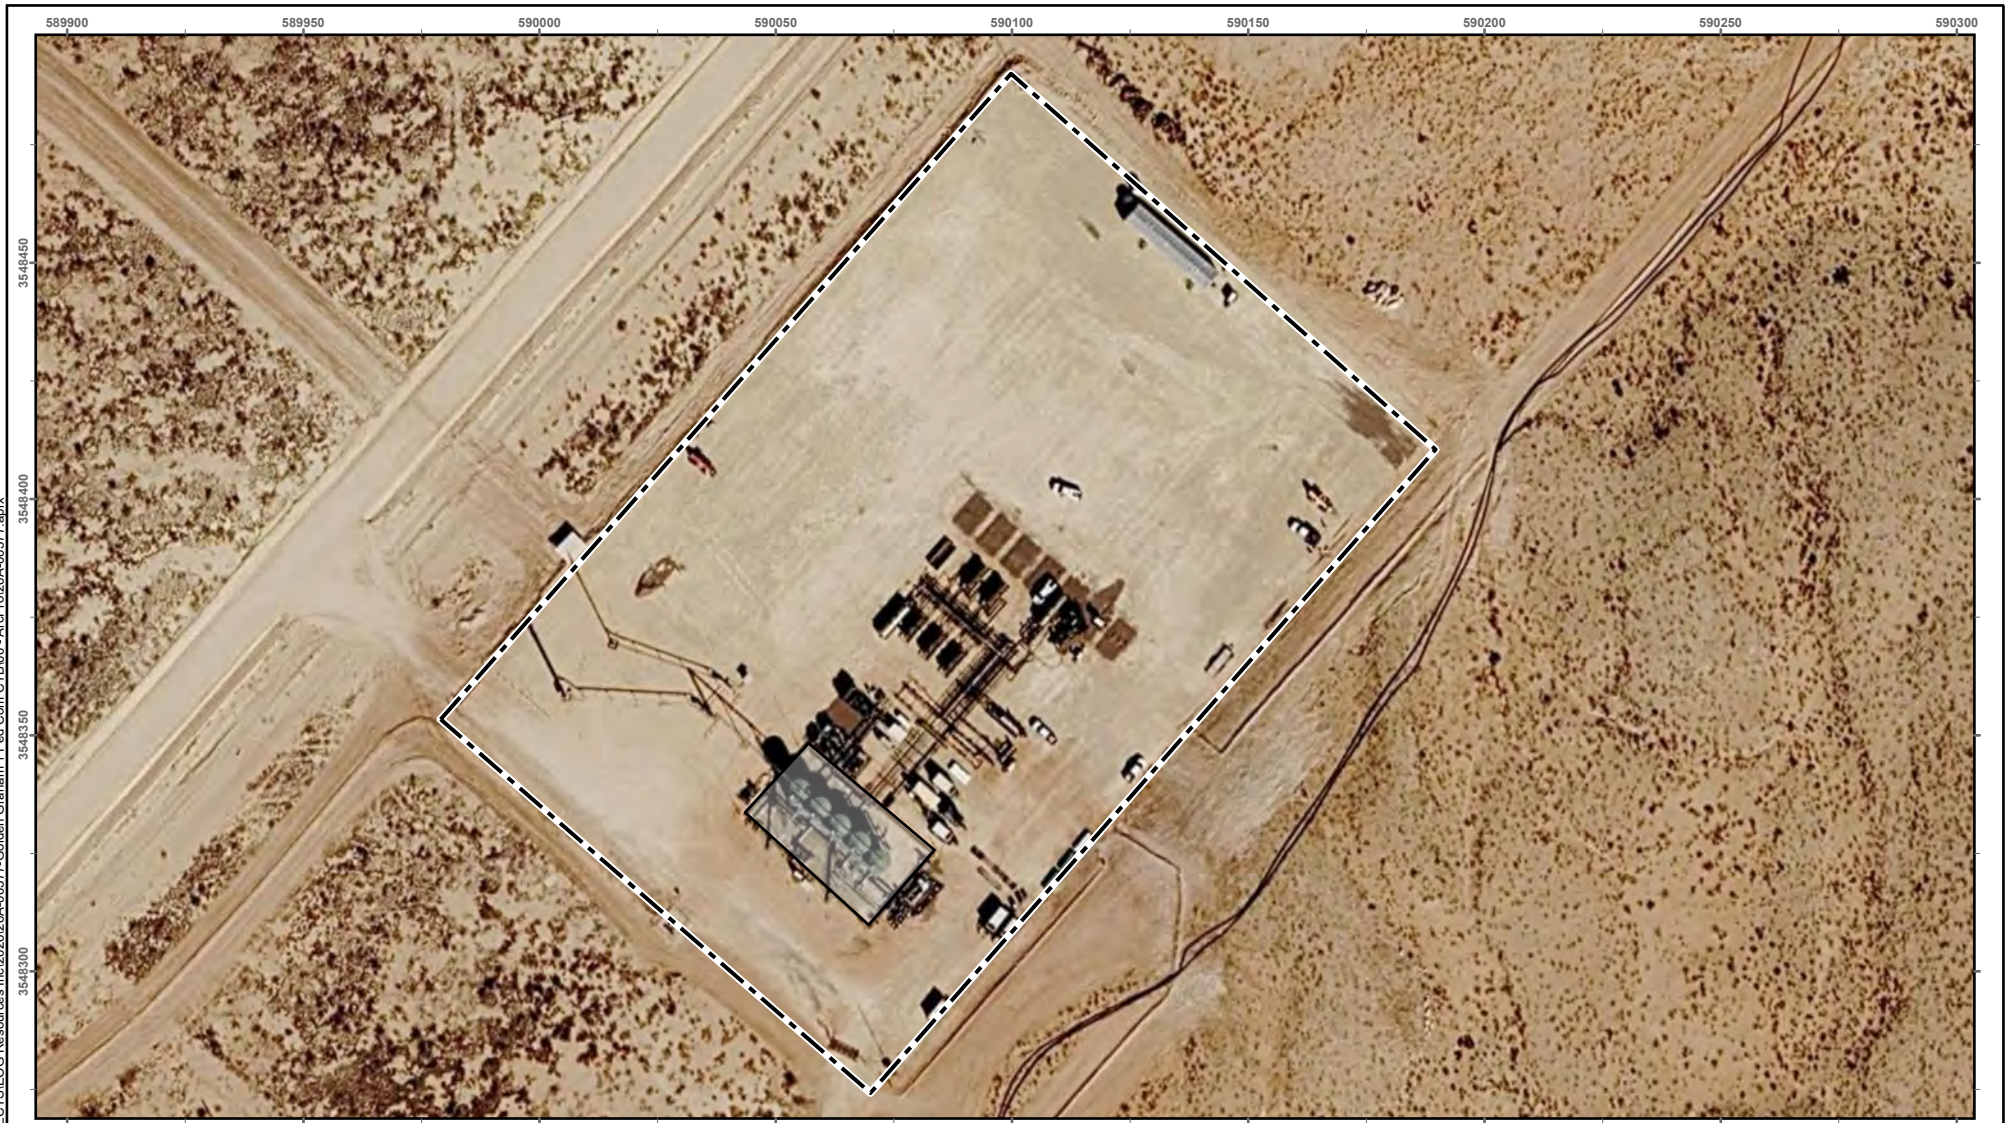
Pad Boundary

Containment Boundary (~7,744 sq.ft.)

**Liner Inspection Schematic**  
**Golden Graham 1 Federal Com CTB**

The site is located approximately 31 miles south of Carlsbad, New Mexico. The legal location for the site is Unit L, Section 1, Township 26 South and Range 28 East in Eddy County, New Mexico. The release area is located on New Mexico State Land Office property. An aerial photograph and site schematic are presented in Figure 1.

The location is typical of oil and gas exploration and production sites in the Permian Basin and is currently used for oil and gas production and storage. The following sections specifically describe the area surrounding the release area (Figure 1).

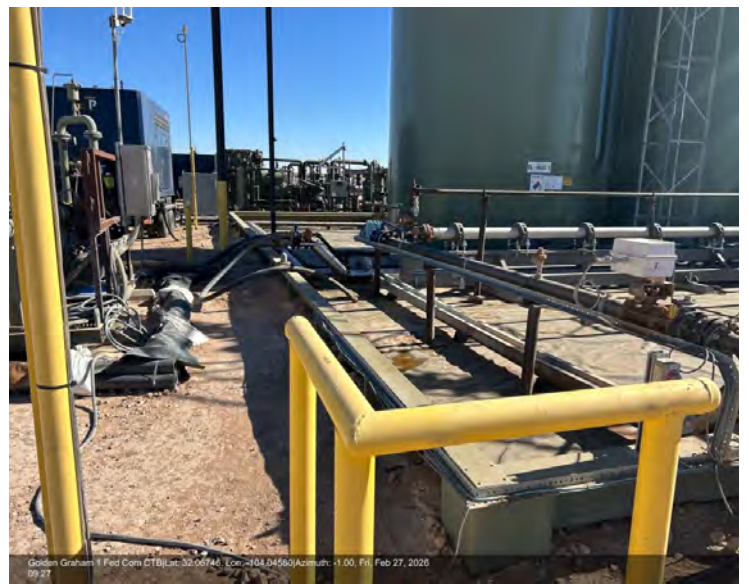
Date: 2/27/2026
Time: 09:27
Notes: Outside north wall
Latitude: 32.06746388888895
Longitude: -104.0458
Direction: N

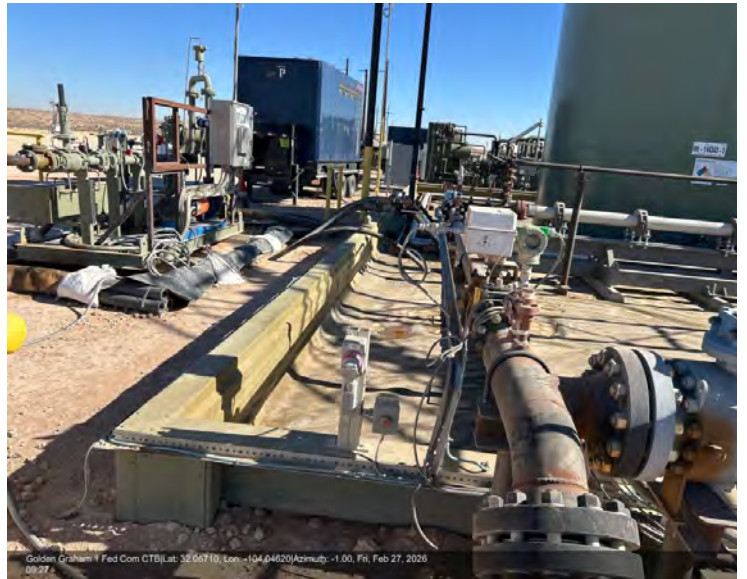
Date: 2/27/2026  
Time: 09:27  
Notes: Inside north wall  
Latitude: 32.06709722222222  
Longitude: -104.04619722222222  
Direction: N

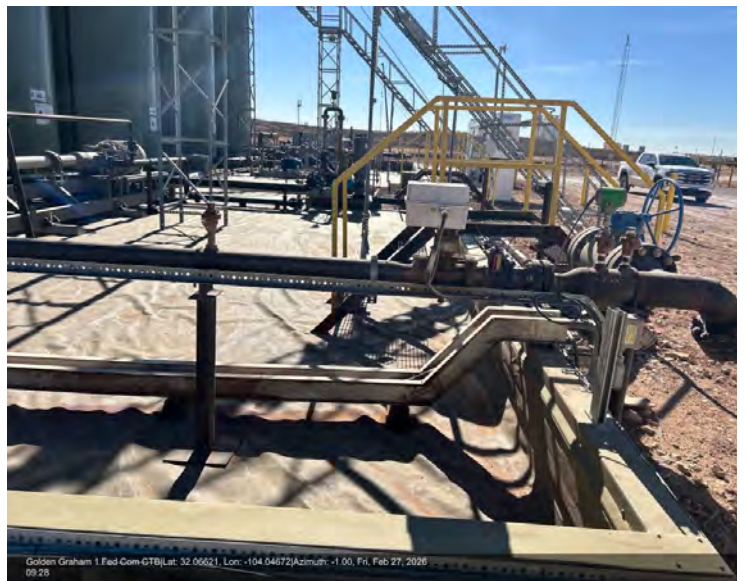
Date: 2/27/2026  
Time: 09:28  
Notes: Inside west wall  
Latitude: 32.06620833333333  
Longitude: -104.04672222222221  
Direction: NW

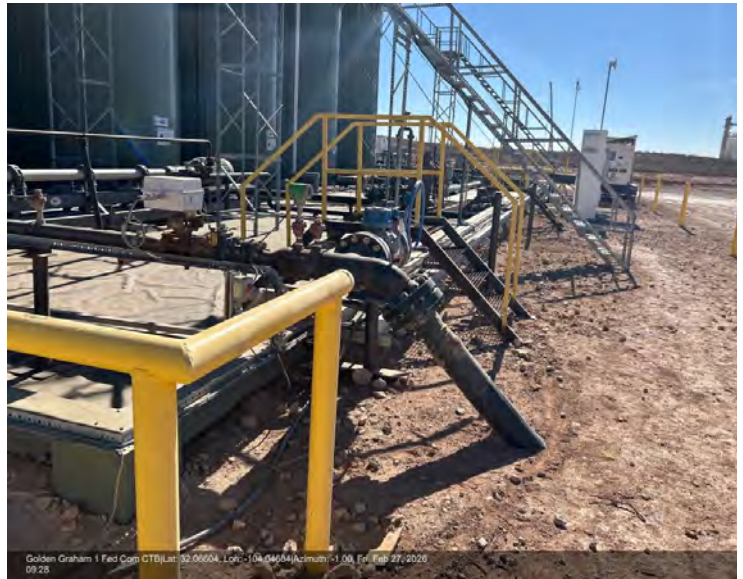
Date: 2/27/2026  
Time: 09:28  
Notes: Outside west wall  
Latitude: 32.06603888888888  
Longitude: -104.04684444444445  
Direction: NW

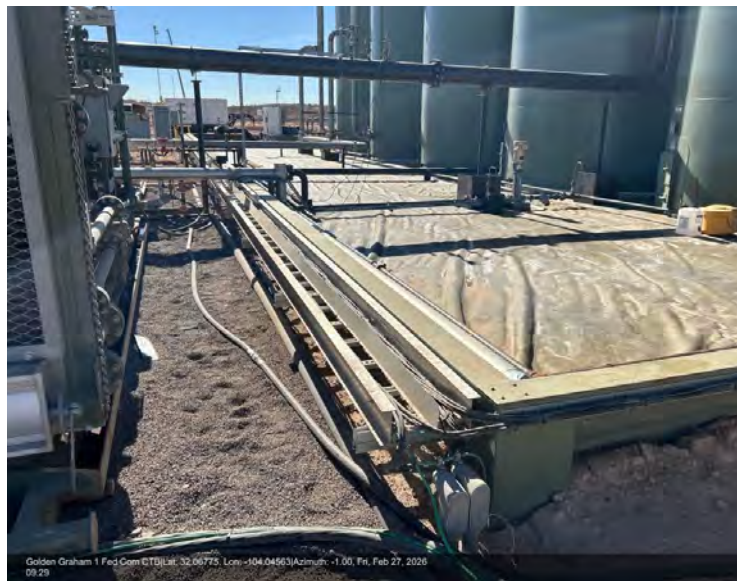
Date: 2/27/2026  
Time: 09:29  
Notes: Outside East wall  
Latitude: 32.067750000000004  
Longitude: -104.04563055555555  
Direction: W

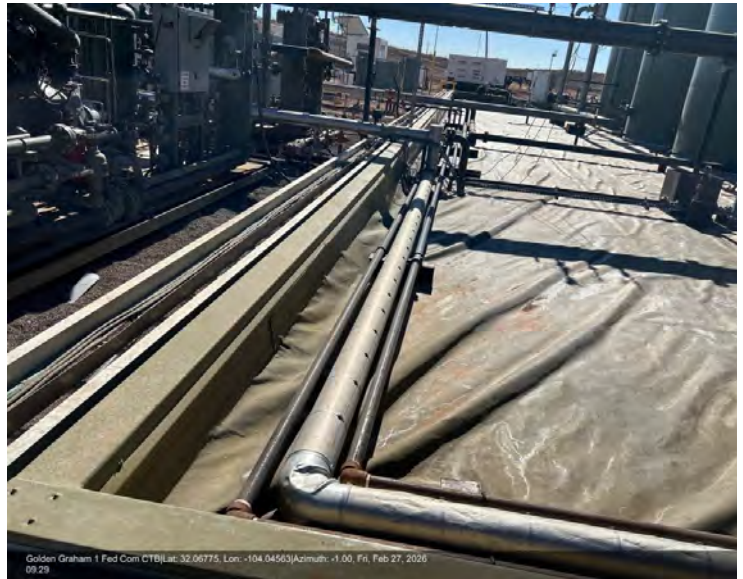
Date: 2/27/2026  
Time: 09:29  
Notes: Inside East wall  
Latitude: 32.067750000000004  
Longitude: -104.04563055555555  
Direction: W

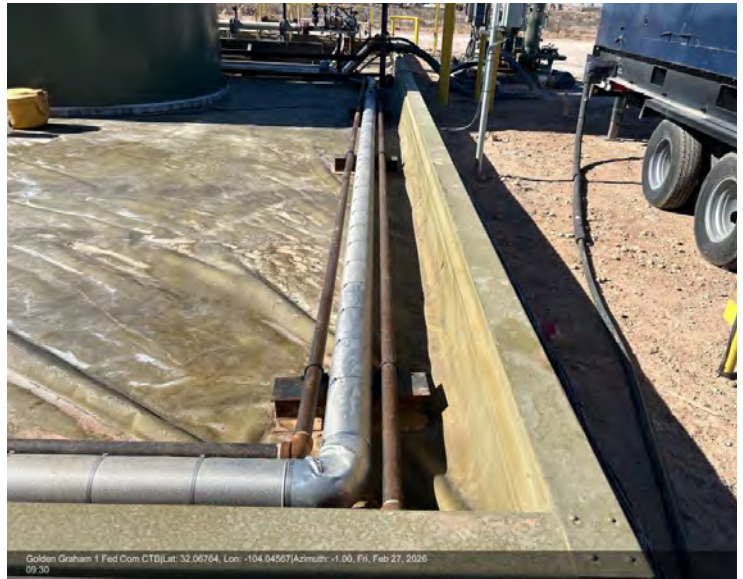
Date: 2/27/2026  
Time: 09:30  
Notes: Inside north wall  
Latitude: 32.067638888888894  
Longitude: -104.04566944444444  
Direction: W

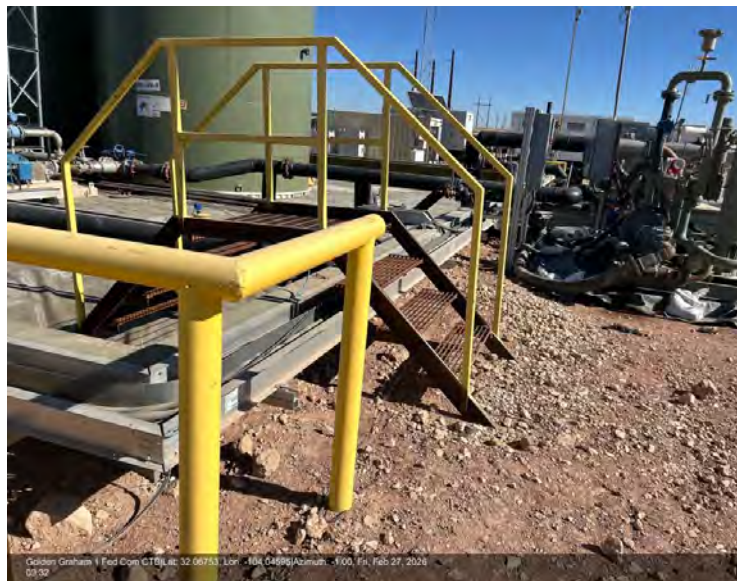
Date: 2/27/2026  
Time: 09:32  
Notes: Outside south wall  
Latitude: 32.067530555555556  
Longitude: -104.04595277777777  
Direction: N

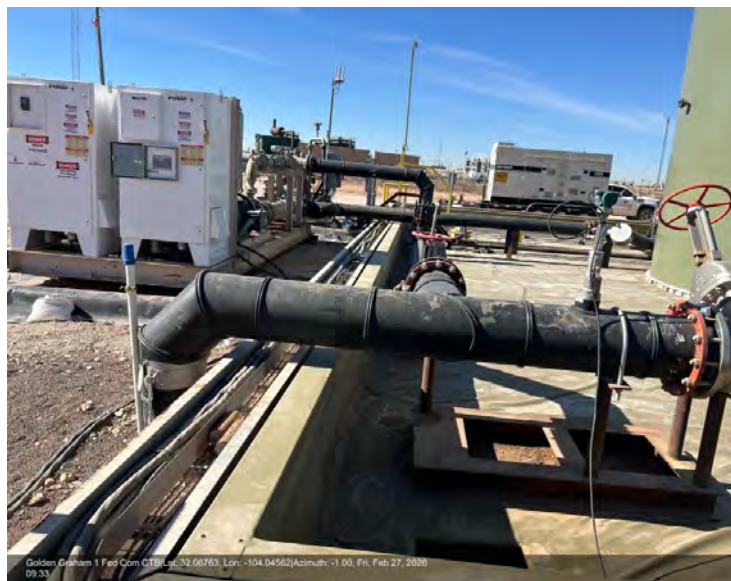
Date: 2/27/2026  
Time: 09:33  
Notes: Inside south wall  
Latitude: 32.06762777777778  
Longitude: -104.04561666666666  
Direction: SW

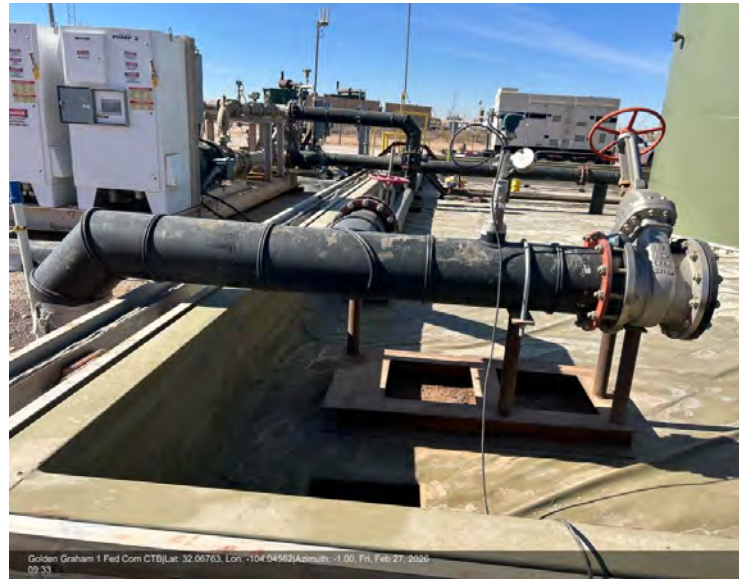
Date: 2/27/2026  
Time: 09:33  
Notes: Inside south wall  
Latitude: 32.0676277777778  
Longitude: -104.04561666666666  
Direction: SW

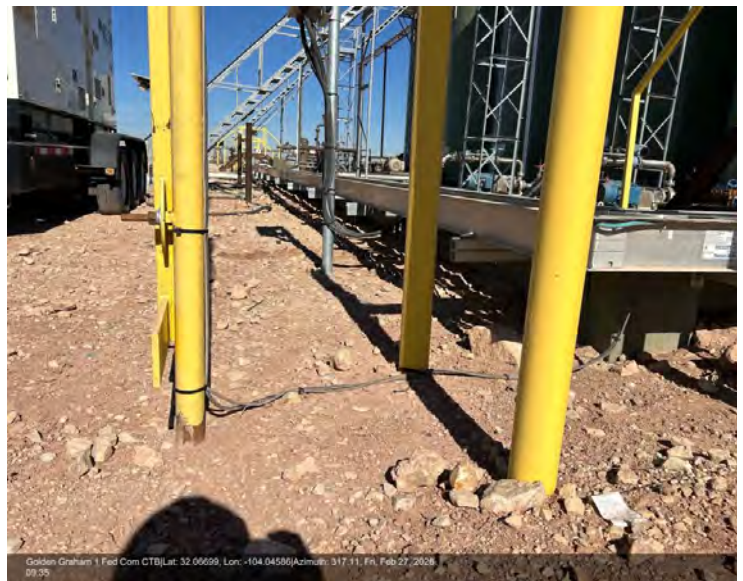
Date: 2/27/2026  
Time: 09:35  
Notes: Outside west wall  
Latitude: 32.06698888888889  
Longitude: -104.04586111111111  
Direction: SE

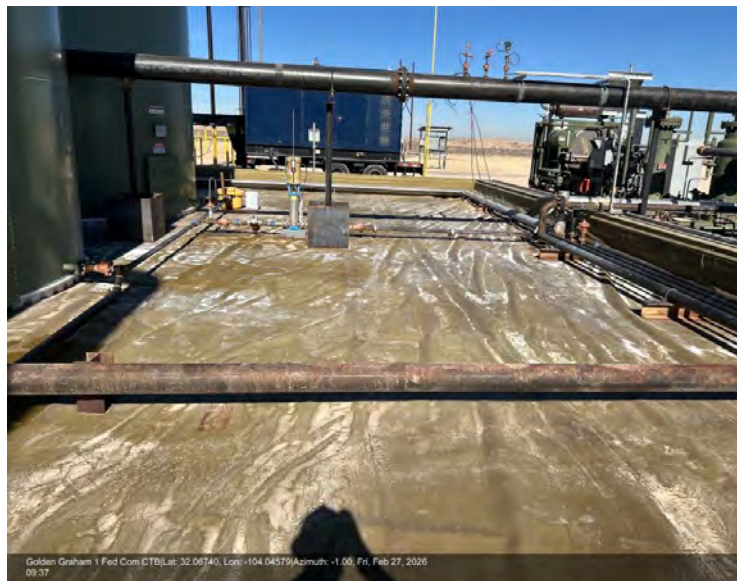
Date: 2/27/2026  
Time: 09:37  
Notes: Liner around equipment  
Latitude: 32.06740277777778  
Longitude: -104.04579166666666  
Direction: S

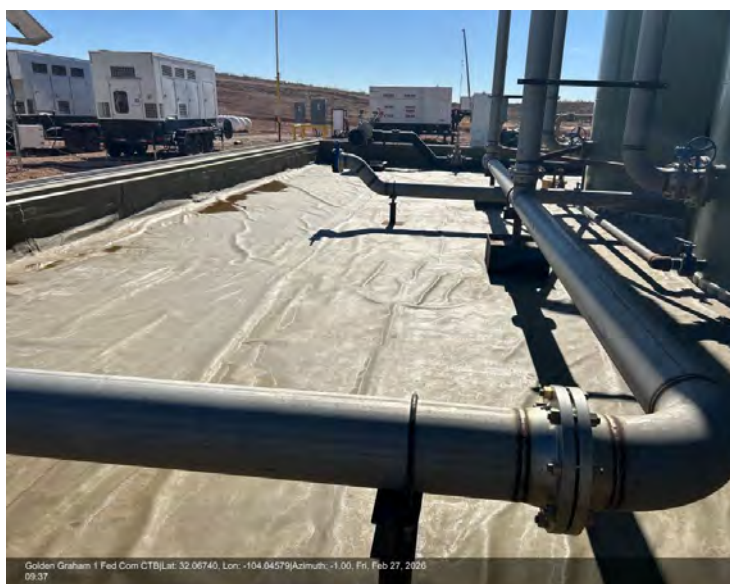
Date: 2/27/2026  
Time: 09:37  
Notes: Liner around equipment  
Latitude: 32.0674027777778  
Longitude: -104.04579166666666  
Direction: S

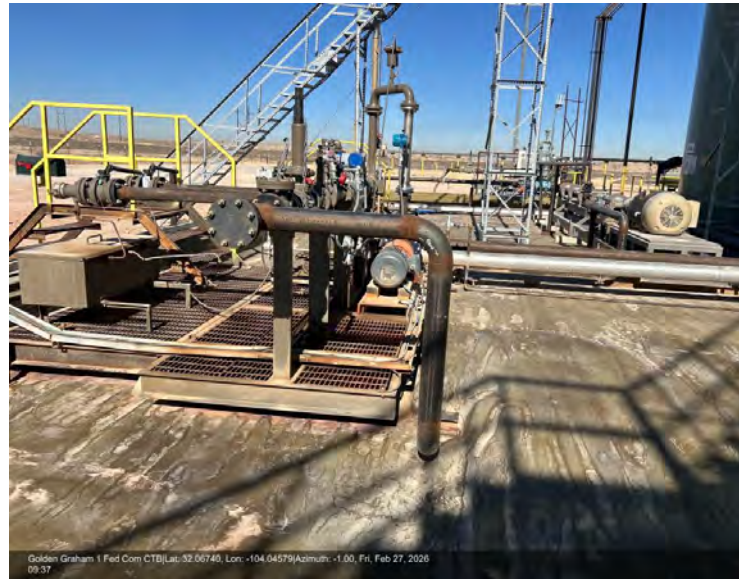
Date: 2/27/2026  
Time: 09:37  
Notes: Liner around equipment  
Latitude: 32.06740277777778  
Longitude: -104.04579166666666  
Direction: S

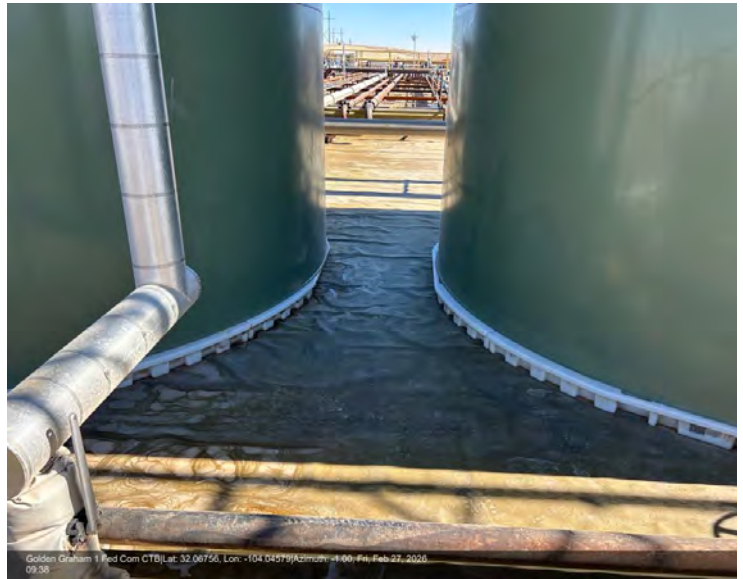
Date: 2/27/2026  
Time: 09:38  
Notes: In between tank 2 and 3  
Latitude: 32.0675555555556  
Longitude: -104.04579166666666  
Direction: NE

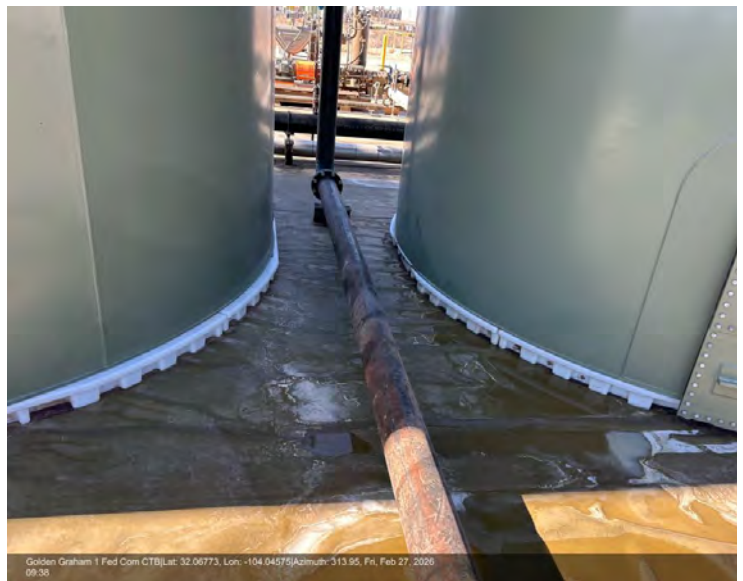
Date: 2/27/2026  
Time: 09:38  
Notes: In between tank 3 and 4  
Latitude: 32.067725  
Longitude: -104.04575277777778  
Direction: E

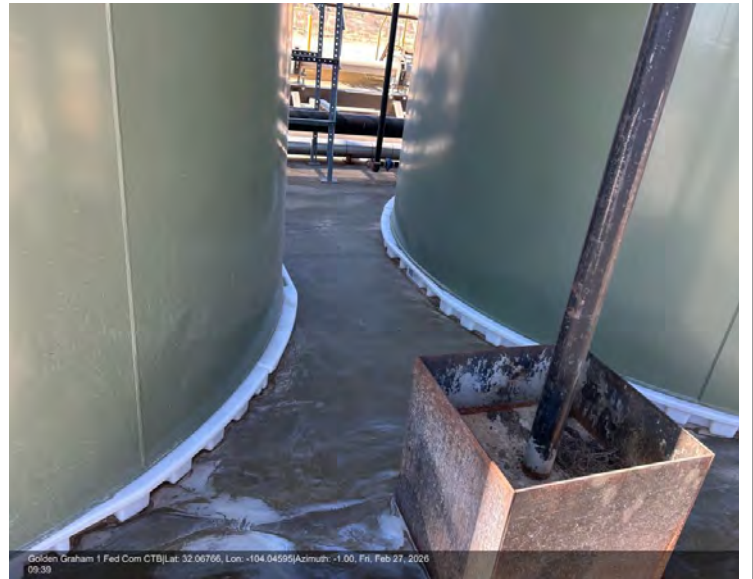
Date: 2/27/2026  
Time: 09:39  
Notes: In between tank 4 and 5  
Latitude: 32.067661111111114  
Longitude: -104.04595277777777  
Direction: S
