Re: Remediation Work Plan

E H Pipkin #009E
San Juan County, New Mexico
Hilcorp Energy Company
NMOCD Incident No: nAPP2535251190

Site Location Map

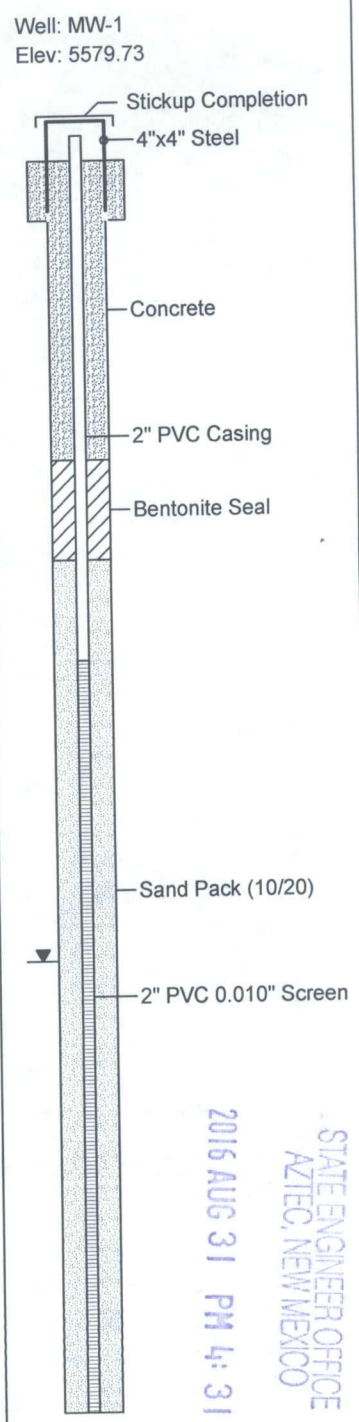
SS-4123 POD1
28N-11W-26.32

Animas Environmental Services, LLC. 624 East Comanche Farmington, NM 87401		MW-1		
ENTERPRISE PRODUCTS COMPANY LATERAL 6C PIPELINE GW INVESTIGATION SAN JUAN COUNTY, NEW MEXICO NE1/4 SW1/4, SEC. 26, T28N, R11W N36.63202, W107.97400			Date Started : 8/20/12 Date Completed : 8/20/12 Hole Diameter : 2.25 Drilling Method : HSA Sampling Method : Split Spoon		Lat. : N36.63216 Long. : W107.97405 Survey By : Enterprise Products Co. Logged By : Tom Long	
Depth in Feet	Surf. Elev. 5577	USCS	GRAPHIC	DESCRIPTION	Blow Count	PID (ppm)
0	5577	SC

Clayey Sand, Brown, Dry, No Odor, No Staining	85.8	85.8
2	5575					
4	5573	SM

Silty Sand, Brown, Fine Grained, Dry, No Odor, No Staining	87.4	87.4
6	5571					
8	5569	SP

Sand, Brown/Tan, Moist, No Odor, No Staining	190	190
10	5567					
12	5565	SP

Sand, Brown, Fine Grained, Wet, Very Little Recovery, Slight Odor	NA	NA
14	5563					
16	5561	CG

Cobble/Gravel, Brown, Wet, No Odor, No Staining	2.4	2.4

Sand, Gray, Fine Grained, Wet, Slight Odor, Slight Staining	15.3	15.3
22	5555					
24	5553					
26

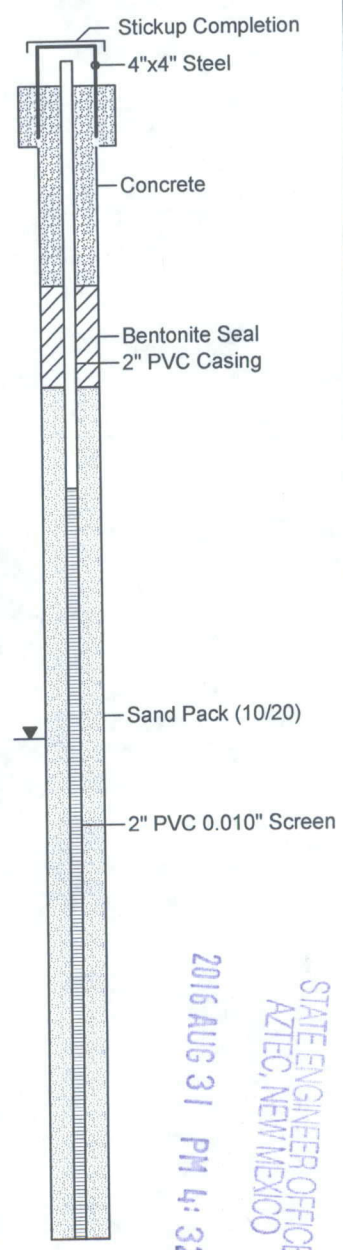
55-4123 POD 2
28N-11W-26.32

AES		Animas Environmental Services, LLC. 624 East Comanche Farmington, NM 87401		MW-2						
ENTERPRISE PRODUCTS COMPANY LATERAL 6C PIPELINE GW INVESTIGATION SAN JUAN COUNTY, NEW MEXICO NE1/4 SW1/4, SEC. 26, T28N, R11W N36.63202, W107.97400		Date Started : 8/20/12	Date Completed : 8/20/12	Hole Diameter : 2.25	Drilling Method : HSA	Sampling Method : Split Spoon	Lat. : N36.63228	Long. : W107.97419	Survey By : Enterprise Products Co.	Logged By : Tom Long
Depth in Feet	Surf. Elev. 5577	USCS	GRAPHIC	DESCRIPTION	Blow Count	PID (ppm)	Well: MW-2 Elev: 5579.39			
0	5577			Sand, Brown, Fine Grained, Moist, No Odor, No Staining			Stickup Completion 4"x4" Steel			
2	5575					93.1	Concrete			
4	5573	SP					Bentonite Seal 2" PVC Casing			
6	5571									
8	5569					108				
10	5567			Sand, Brown, Moist/Wet, No Odor, No Staining						
12	5565	SP					Sand Pack (10/20)			
14	5563						2" PVC 0.010" Screen			
16	5561			Sand, Brown, Medium Grained, Wet, Very Little Recovery, No Odor, No Staining

18	5559	SP				NA				
20	5557			Cobble/Gravel, Brown, Wet, Slight Odor, No Staining						
22	5555	CG				38.7				
24	5553									
26		SS		Sandstone, Gray, Fine Grained, Wet, Slight Odor, No Staining		16.1

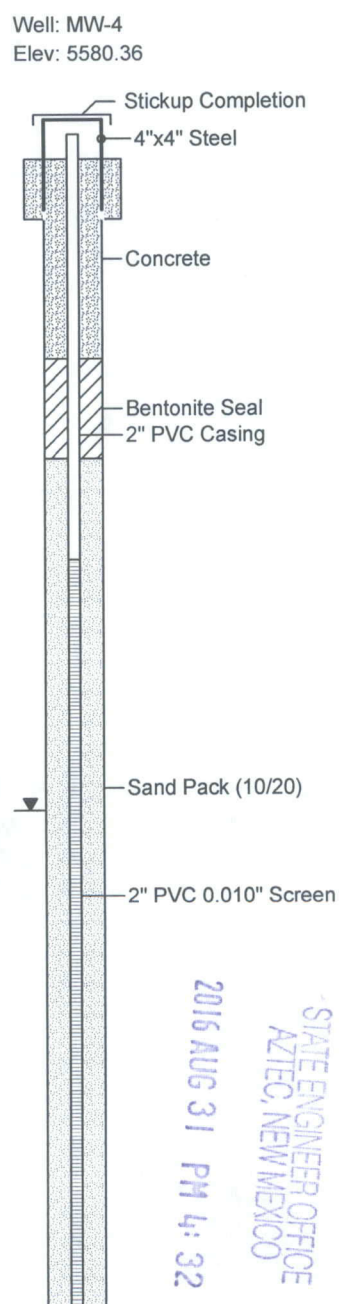
SI-4123 POD4
28N-11W-26.32

AES		Animas Environmental Services, LLC. 624 East Comanche Farmington, NM 87401		MW-4		
ENTERPRISE PRODUCTS COMPANY LATERAL 6C PIPELINE GW INVESTIGATION SAN JUAN COUNTY, NEW MEXICO NE1/4 SW1/4, SEC. 26, T28N, R11W N36.63202, W107.97400				Date Started : 8/21/12 Date Completed : 8/21/12 Hole Diameter : 2.25 Drilling Method : HSA Sampling Method : Split Spoon		
				Lat. : N36.63230 Long. : W107.97403 Survey By : Enterprise Products Co. Logged By : Tom Long		
Depth in Feet	Surf. Elev. 5578	USCS	GRAPHIC	DESCRIPTION	Blow Count	PID (ppm)
0	5578			Interbedded Sand and Clay, Brown, Fine Grained, Dry, No Odor, No Staining		
2	5576	SC

Sand, Brown, Fine Grained, Dry, No Odor, No Staining		
8	5570				54.8	
10	5568			Sand, Brown, Fine Grained, Wet, No Odor, No Staining		
12	5566	SP

Sand, Brown, Fine Grained, Wet, No Odor, No Staining, Very Little Recovery

Sandstone, Gray, Fine Grained, Wet, No Odor, No Staining	3.6

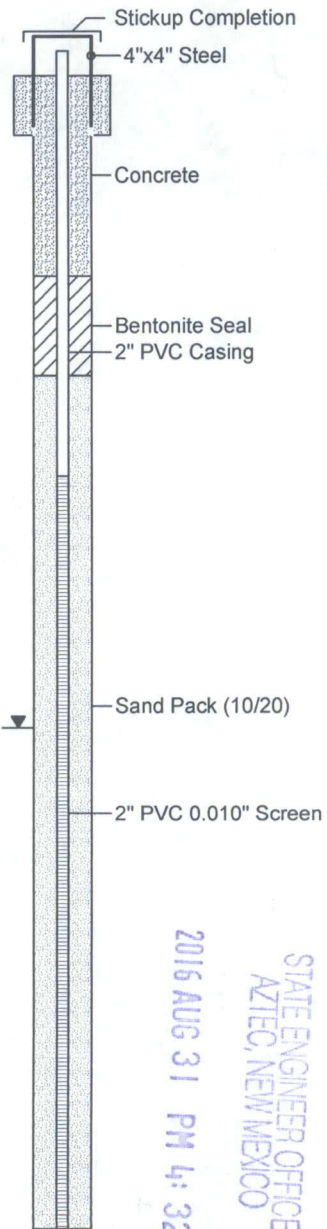
55-4123 PODS
28N-11W-26.32

Depth in Feet	Surf. Elev. 5581	USCS	GRAPHIC	DESCRIPTION	Blow Count	PID (ppm)
0	5581			Interbedded Sand and Clay, Brown, Fine Grained, Dry, No Odor, No Staining		
2	5579	SC

Clayey Sand, Brown, Fine Grained, Dry, No Odor, No Staining	0.5	
8	5573					
10	5571			Sand, Brown, Fine Grained, Wet, No Odor, No Staining		
12	5569	SP

Clayey Sand, Brown, Fine Grained, Wet, No Odor, No Staining	0.7	
18	5563					
20	5561			Sand, Brown, Fine to Coarse Grained, Wet, Some Gravel, No Odor, No Staining		
22	5559	SP

Sandstone, Gray, Fine Grained, Wet, No Odor, No Staining	0.8

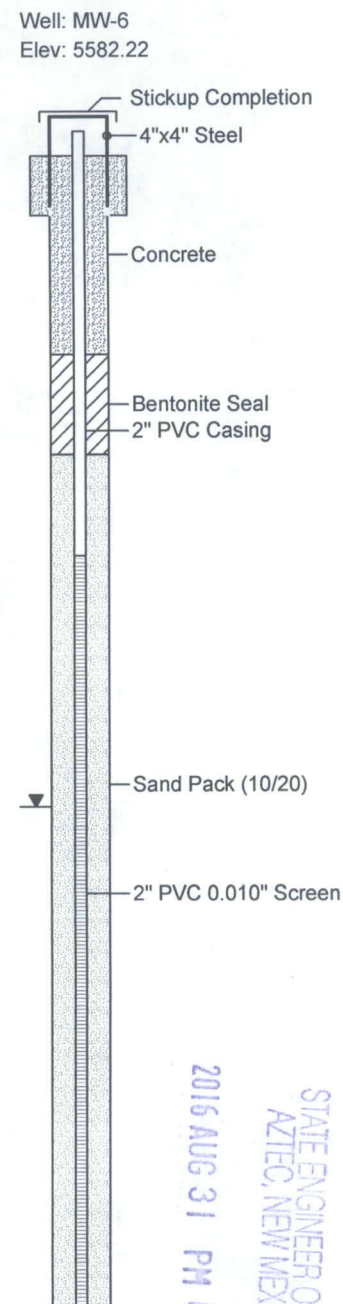
55-4123 POD6
28N-11W-26.32

AES		Animas Environmental Services, LLC. 624 East Comanche Farmington, NM 87401		MW-6		
ENTERPRISE PRODUCTS COMPANY LATERAL 6C PIPELINE GW INVESTIGATION SAN JUAN COUNTY, NEW MEXICO NE1/4 SW1/4, SEC. 26, T28N, R11W N36.63202, W107.97400				Date Started : 8/23/12 Date Completed : 8/23/12 Hole Diameter : 2.25 Drilling Method : HSA Sampling Method : Split Spoon		
				Lat. : N36.63201 Long. : W107.97427 Survey By : Enterprise Products Co. Logged By : Tom Long		
Depth in Feet	Surf. Elev. 5580	USCS	GRAPHIC	DESCRIPTION	Blow Count	PID (ppm)
0	5580	SM		Silty Sand, Brown, Fine Grained, Dry, No Odor, No Staining	0.3	0.3
2	5578					
4	5576	SP		Sand, Brown, Fine Grained, Dry, No Odor, No Staining	0.5	0.5
6	5574					
8	5572	SP		Sand, Brown, Fine Grained, Wet, No Odor, No Staining	0.6	0.6
10	5570					
12	5568	SP		Sand, Brown, Fine Grained, Some Clay, Wet, Slight Odor, Slight Staining	3.0	3.0
14	5566					
16	5564	SP		Sand, Brown, Fine to Coarse Grained, Some Gravel, Very Little Recovery, No Staining	NA	NA

18	5562					
20	5560	SS		Sandstone, Gray, Fine Grained, Wet, No Odor, No Staining	1.9	1.9
22	5558					
24	5556					
26

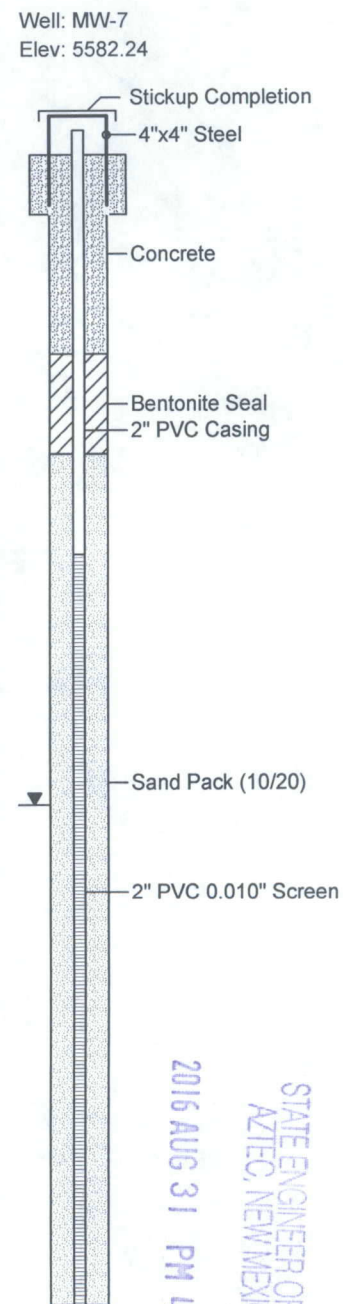
55-4123 P007
28N-11W-26.32

AES		Animas Environmental Services, LLC. 624 East Comanche Farmington, NM 87401		MW-7		
ENTERPRISE PRODUCTS COMPANY LATERAL 6C PIPELINE GW INVESTIGATION SAN JUAN COUNTY, NEW MEXICO NE1/4 SW1/4, SEC. 26, T28N, R11W N36.63202, W107.97400			Date Started : 8/23/12	Date Completed : 8/23/12	Lat. : N36.632122	
			Hole Diameter : 2.25	Drilling Method : HSA	Long. : W107.97444	
			Sampling Method : Split Spoon	Survey By : Enterprise Products Co.	Logged By : Tom Long	
Depth in Feet	Surf. Elev. 5579	USCS	GRAPHIC	DESCRIPTION	Blow Count	PID (ppm)
0	5579	SM		Silty Sand, Brown, Fine Grained, Dry, No Odor, No Staining	0.5	
2	5577					
4	5575	SC		Clayey Sand, Brown, Moist, No Odor, No Staining	0.6	
6	5573					
8	5571	SP		Sand, Brown, Fine Grained, Moist, No Odor, No Staining	0.5	
10	5569					
12	5567	SP		Sand, Brown, Fine Grained, Some Clay, Wet, Slight Odor, Slight Staining	0.7	
14	5565					
16	5563	SP		Sand, Brown, Fine to Coarse Grained, Some Gravel, Wet, No Odor, No Staining	0.5

18	5561					
20	5559	SS		Sandstone, Gray, Fine Grained, Wet, No Odor, No Staining	0.8	
22	5557					
24	5555					
26

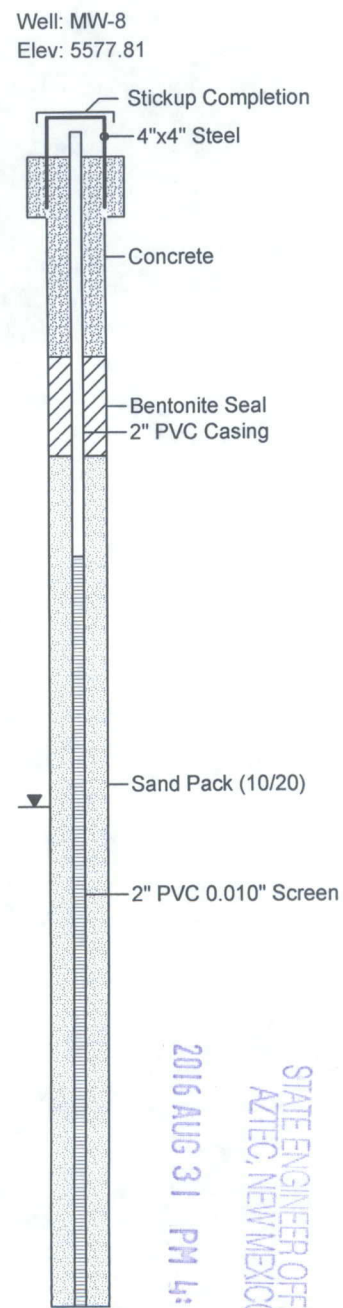
55-4123 POD 8
 28N-11W-26.32

Depth in Feet	Surf. Elev. 5576	USCS	GRAPHIC	DESCRIPTION	Blow Count	PID (ppm)
0	5576			Sand, Brown, Fine Grained, Dry, No Odor, No Staining		
2	5574	SP			82.8	
4	5572					
6	5570	SP		Sand, Brown, Fine Grained, Dry, No Odor, No Staining		
8	5568				219	
10	5566			Sand, Brown, Fine Grained, Wet, Slight Odor, No Staining		
12	5564	SP			144	
14	5562					
16	5560	SP		Sand, Gray, Fine to Medium Grained, Wet, Slight Odor, No Staining		
18	5558				147	
20	5556			Sand, Gray, Fine to Medium Grained, Some Gravel, Wet, Slight Odor, No Staining		
22	5554	SP			87.3	
24	5552					
26		SS		Sandstone, Gray, Fine Grained, Wet, Slight Odor, No Staining	16.9

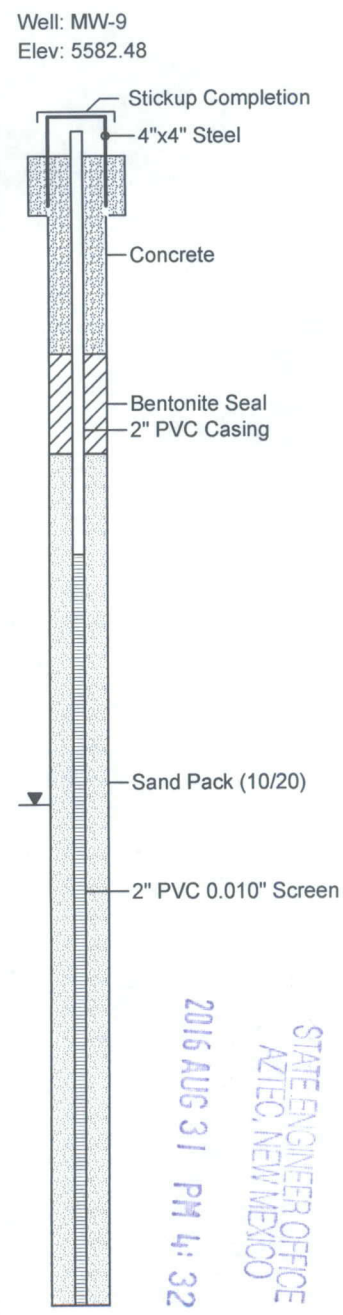
SS-4123 POD9
28N-11W-26.32

Depth in Feet	Surf. Elev. 5580	USCS	GRAPHIC	DESCRIPTION	Blow Count	PID (ppm)
0	5580			Sand, Brown, Fine Grained, Dry, No Odor, No Staining		
2	5578	SP

Silty Sand, Brown, Fine Grained, Dry, No Odor, No Staining		
8	5572	SM			0.3	
10	5570					
12	5568	SP

Sand, Brown, Fine Grained, Moist, No Odor, No Staining		
14	5566				0.4	
16	5564					
18	5562	SP

Sand, Gray, Fine to Medium Grained, Wet, No Odor, No Staining		
20	5560				0.2	
22	5558	SP

Sand, Gray, Some Gravel, Wet, No Odor, No Staining		
24	5556				0.1	
26		SS

Sandstone, Gray, Fine Grained, Wet, No Odor, No Staining

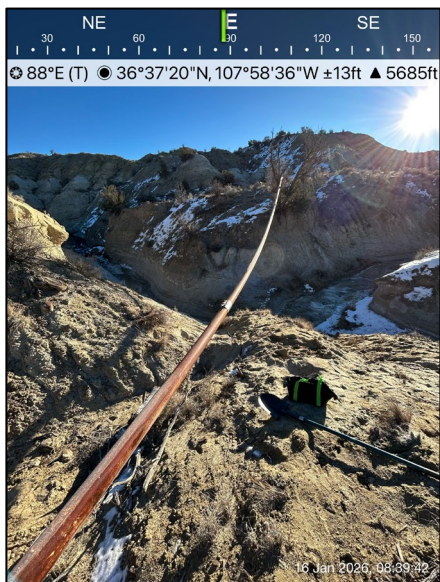
Photograph: 1 Date: 1/28/2026
Description: Pipeline crossing wash
View: East

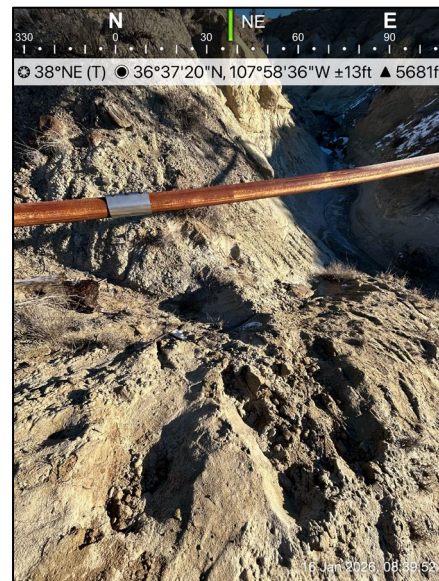
Photograph: 2 Date: 1/28/2026
Description: Repaired initial leak
View: Northeast

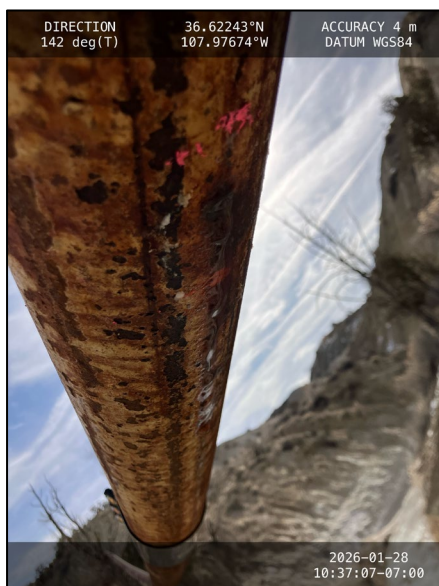
Due to the presence of elevated COCs identified during the initial Site visit, Ensolum personnel returned to the Site to further delineate the release and consider remediation options, on January 28, 2026. Upon arrival at the location, a second pinhole pipeline leak was discovered on the bottom of the pipeline and approximately 4 feet from the original release point. Additional liquids were observed dripping from the leak, and stained soil was visible directly beneath the leak. A fourth soil sample was collected from the saturated soil at ground surface directly below the

release (SS03), and a disposable container was placed below the point of release to collect dripping fluids. An earthen berm was also constructed around the visibly stained area to mitigate surface migration. Following the discovery of the second pipeline release, the pipeline was shut in and will be permanently decommissioned and abandoned.

Photograph: 3 Date: 1/28/2026
Description: Second leak
View: Direct

Based on the remote location of the release, access is extremely limited and mechanical equipment cannot be mobilized to the release area. Due to these access limitations, in addition to the small footprint of impacted soil and shallow bedrock, Hilcorp proposes to remove visibly impacted soil from the release area by hand, where feasible, and to a depth where the bedrock sandstone is encountered. The final extent of soil removal will be dictated, in part, by limitations imposed by the complex topography, and workers' health and safety while conducting soil removal activities. Where continued soil removal would pose unacceptable risk to worker safety, remaining impacted soil will be treated with amendment as described below. Impacted soil will be transported for off-Site disposal/treatment to the Envirotech Landfarm in San Juan County, New Mexico. Following removal of obviously impacted soils above bedrock, Hilcorp proposes applying Micro-Blaze Emergency Liquid Spill Control (Micro-Blaze[®]) amendment to remediate remaining hydrocarbon impacted soil and sandstone through enhanced bioremediation techniques. Micro-Blaze[®] is a liquid amendment designed to enhance/supplement the natural biological degradation of residual hydrocarbons in impacted media. Based on the manufacturer's application guidelines, approximately 1 gallon of concentrated Micro-Blaze[®] can treat 5 to 7 cubic yards of TPH impacted soil. Based on this application rate, one gallon of Micro-Blaze[®] will need to be diluted to a 3 to 10 percent (%) solution and applied to the impacted soil per the manufacturer's recommendations. Micro-Blaze[®] product information is included as Appendix D.

Once field screening indicates that all impacted soil has been removed to the maximum extent practicable, the Micro-Blaze[®] solution will be sprayed onto the underlying sandstone and surrounding soil outside of the release footprint. After approximately 2 months post-application, soil sampling will be conducted to assess the effectiveness of the initial Micro-Blaze[®] treatment. Five-point composite soil samples will be collected from the treated area at a frequency not exceeding 200 square feet per sample. The 5-point composite samples will be collected by placing five equivalent aliquots of soil into a 1-gallon, resealable plastic bag and homogenizing the samples by thoroughly mixing. Samples will be collected and submitted to Envirotech using the techniques described above and will be analyzed for TPH, BTEX, and chloride constituents. If the laboratory results indicate the treated samples still exceed NMOCD Closure Criteria, a second application of Micro-Blaze[®] will be implemented. The NMOCD will be notified two days in advance of each sampling event, and 5-point composite samples will be recollected from the same locations for analysis of TPH, BTEX, and chloride from the previously impacted area.

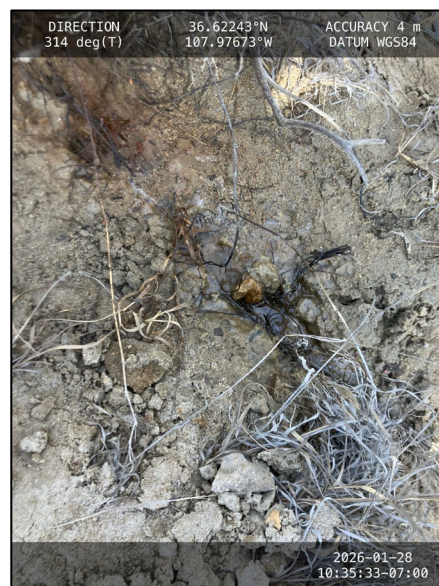
Laboratory analytical results for soil sample SS03 indicated elevated concentrations of benzene (22 mg/kg), BTEX (955mg/kg), TPH (7,140 mg/kg), and chloride (894 mg/kg). A summary of analytical results is presented in Table 1, with complete analytical results attached as Appendix B. Photographs taken during delineation activities are provided in Appendix C.

Photograph: 4 Date: 1/28/2026
Description: Stained soil and liquids close up
View: Direct
