**Re: Closure Request
Poker Lake CVX JV PB #006H
Incident Number nAB1732041425
Eddy County, New Mexico**

XTO Energy, Inc.
Closure Request
Poker Lake CVX JV PB #006H

Site Receptor Map

Site Map

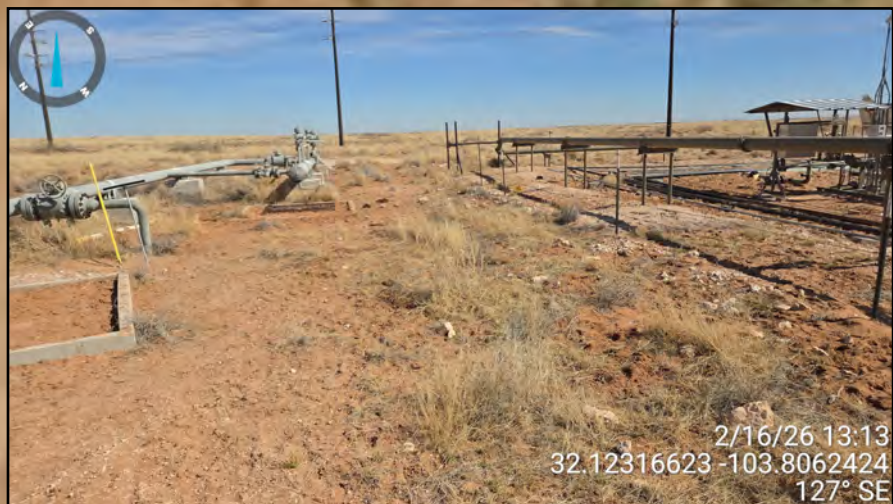
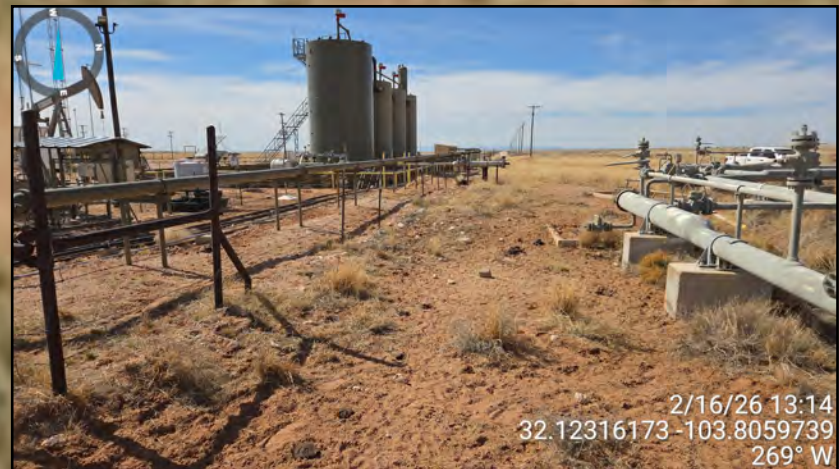
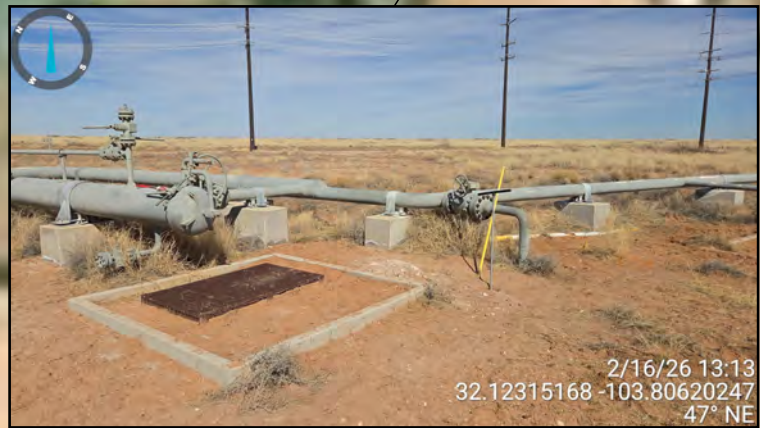
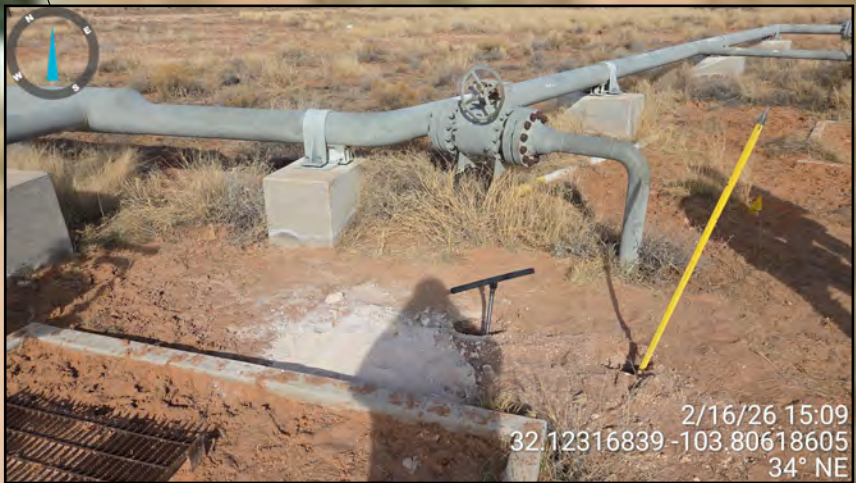
FIGURE

Closure Criteria. Based on laboratory analytical results, excavation of impacted soil was required. Laboratory analytical results are presented on Figure 2 and summarized in Table 1. Complete laboratory analytical reports are included in Appendix D.

On July 5, 2018, LTE personnel returned to the Site to oversee excavation activities. To direct excavation activities, soil was field screened for VOCs and chloride. Once field screening indicated impacted soil was adequately removed, an excavation soil sample was collected from the floor of the excavation extent. Excavation soil sample SS3A was collected from the excavation at depth of 1-foot bgs. Additional delineation soil samples SS5 and SS6 were collected from the surface to confirm the lateral extent of the release. The excavation extent and confirmation soil sample locations are presented on Figure 2. Photographic documentation is included in Appendix C.

Following confirmation of the soil sample location with the NMOCD, on February 16, 2026, Ensolum personnel visited the Site to conduct the additional requested delineation soil sampling. One borehole, BH01, was advanced via hand auger to a terminal depth of 4 feet bgs at the requested location. Discrete delineation soil samples were collected from the borehole at depths ranging from ground surface to 4 feet bgs. The delineation soil samples were field screened for VOCs and chloride. Field screening results and observations of the soil samples collected from the borehole were logged on a lithologic/soil sampling log, which is included in Appendix E. Photographic documentation and the delineation soil sample location is depicted on Figure 2.

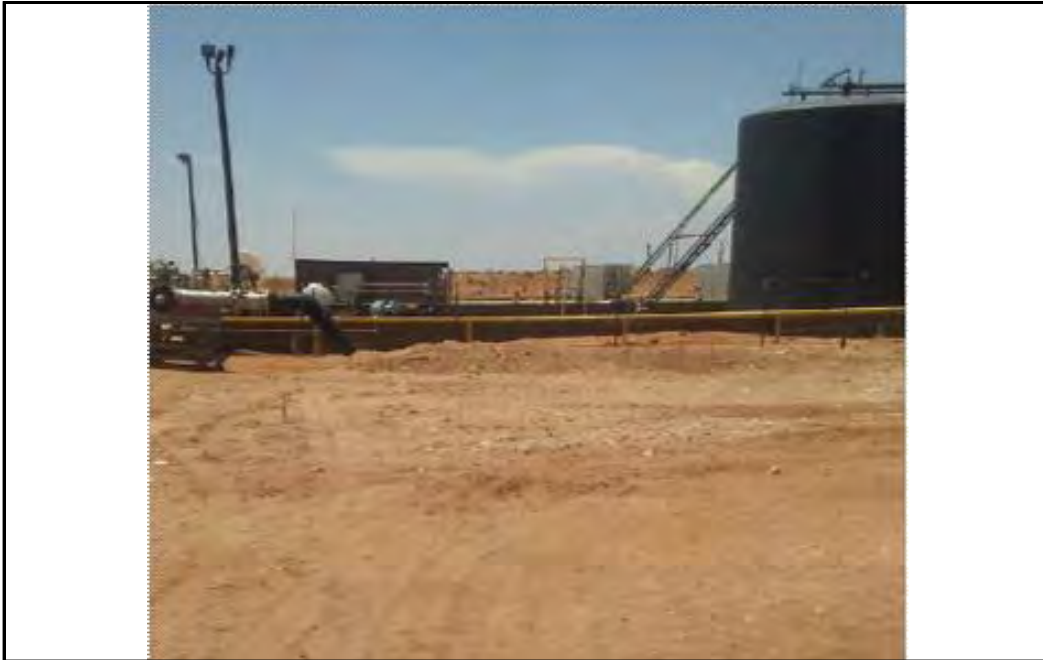
Photograph 1

Description: View of south release area.
