January 22, 2026

Hilcorp Energy Company  
Attn: Mr. Billy Ginn  
Environmental Specialist  
1201 Louisiana Street  
Houston, Texas 77002

**Re: 2025 Annual Groundwater Monitoring Report  
North Monument G/SA Unit #1416  
Unit Letter J, Sec 36, T19S, R36E  
GPS Coordinates: 32.6142911°N, -103.3041812°W  
Lea County, New Mexico  
NMOCD Release Number: nAPP2112649963**

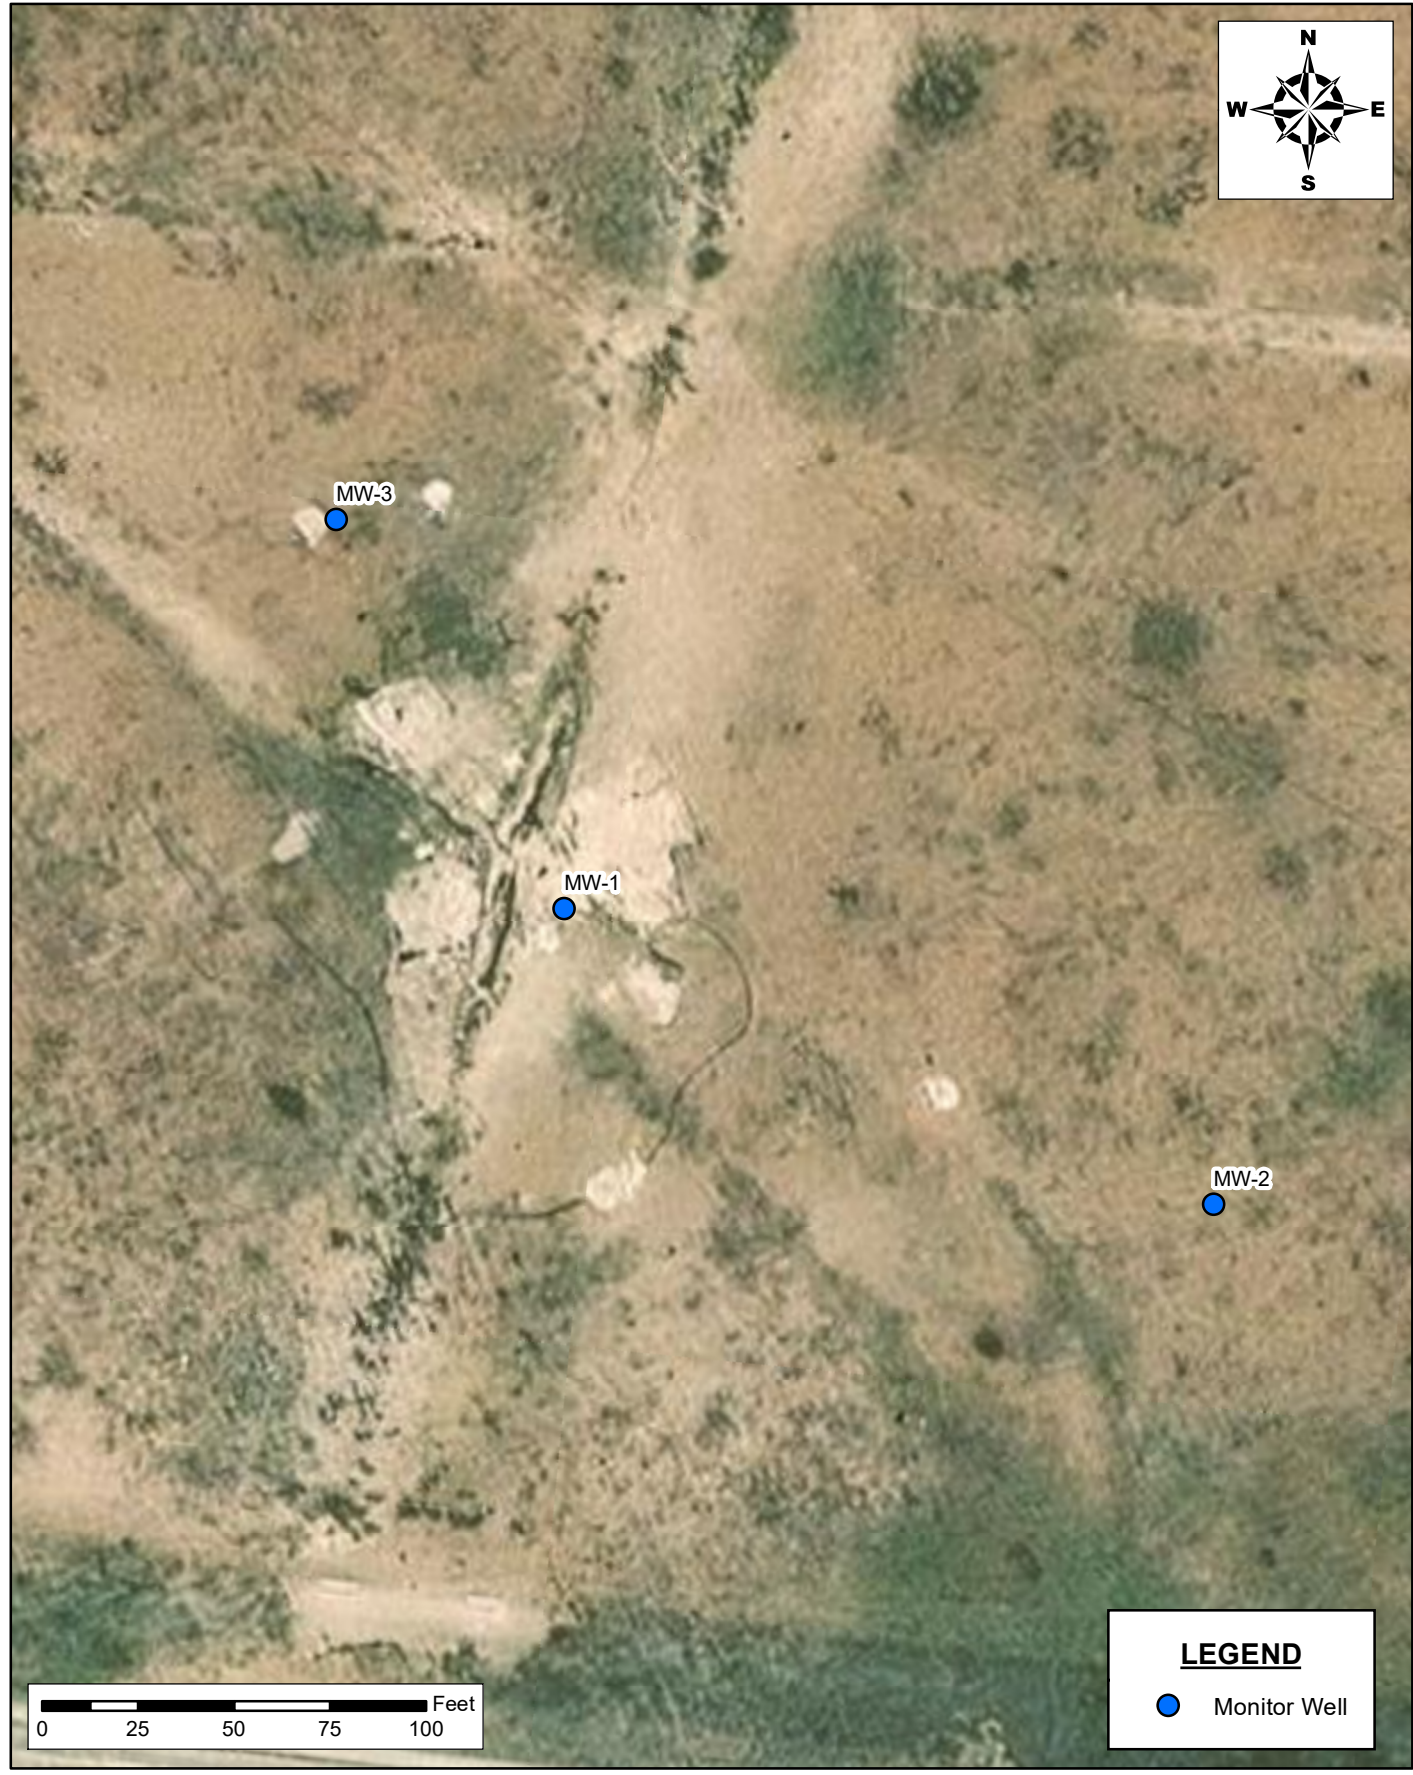
DRAWING NUMBER:  
**FIGURE 3**  
 SHEET NUMBER:  
**1 of 1**

On June 25 and December 5, 2025, NTGE was onsite to gauge each of the three (3) monitor wells. See Figure 3 for site monitoring well locations. Utilizing a water level indicator each of the wells were gauged from a mark on the north side of the well casing to depth of first encountered groundwater and the bottom of the well. The corrected groundwater depth was then calculated, and a gradient map developed. Figures 4A and 4B indicate the groundwater gradient at the site is to the southeast towards monitor well MW-2. This is consistent with previous gauging events at the site.

**MONITOR WELL LOCATION MAP**  
**SITE ASSESSMENT REPORT**  
 HILCORP ENERGY  
 NMGSAU WELL #1416  
 LEA COUNTY, NEW MEXICO  
 32.614291° -103.304181°

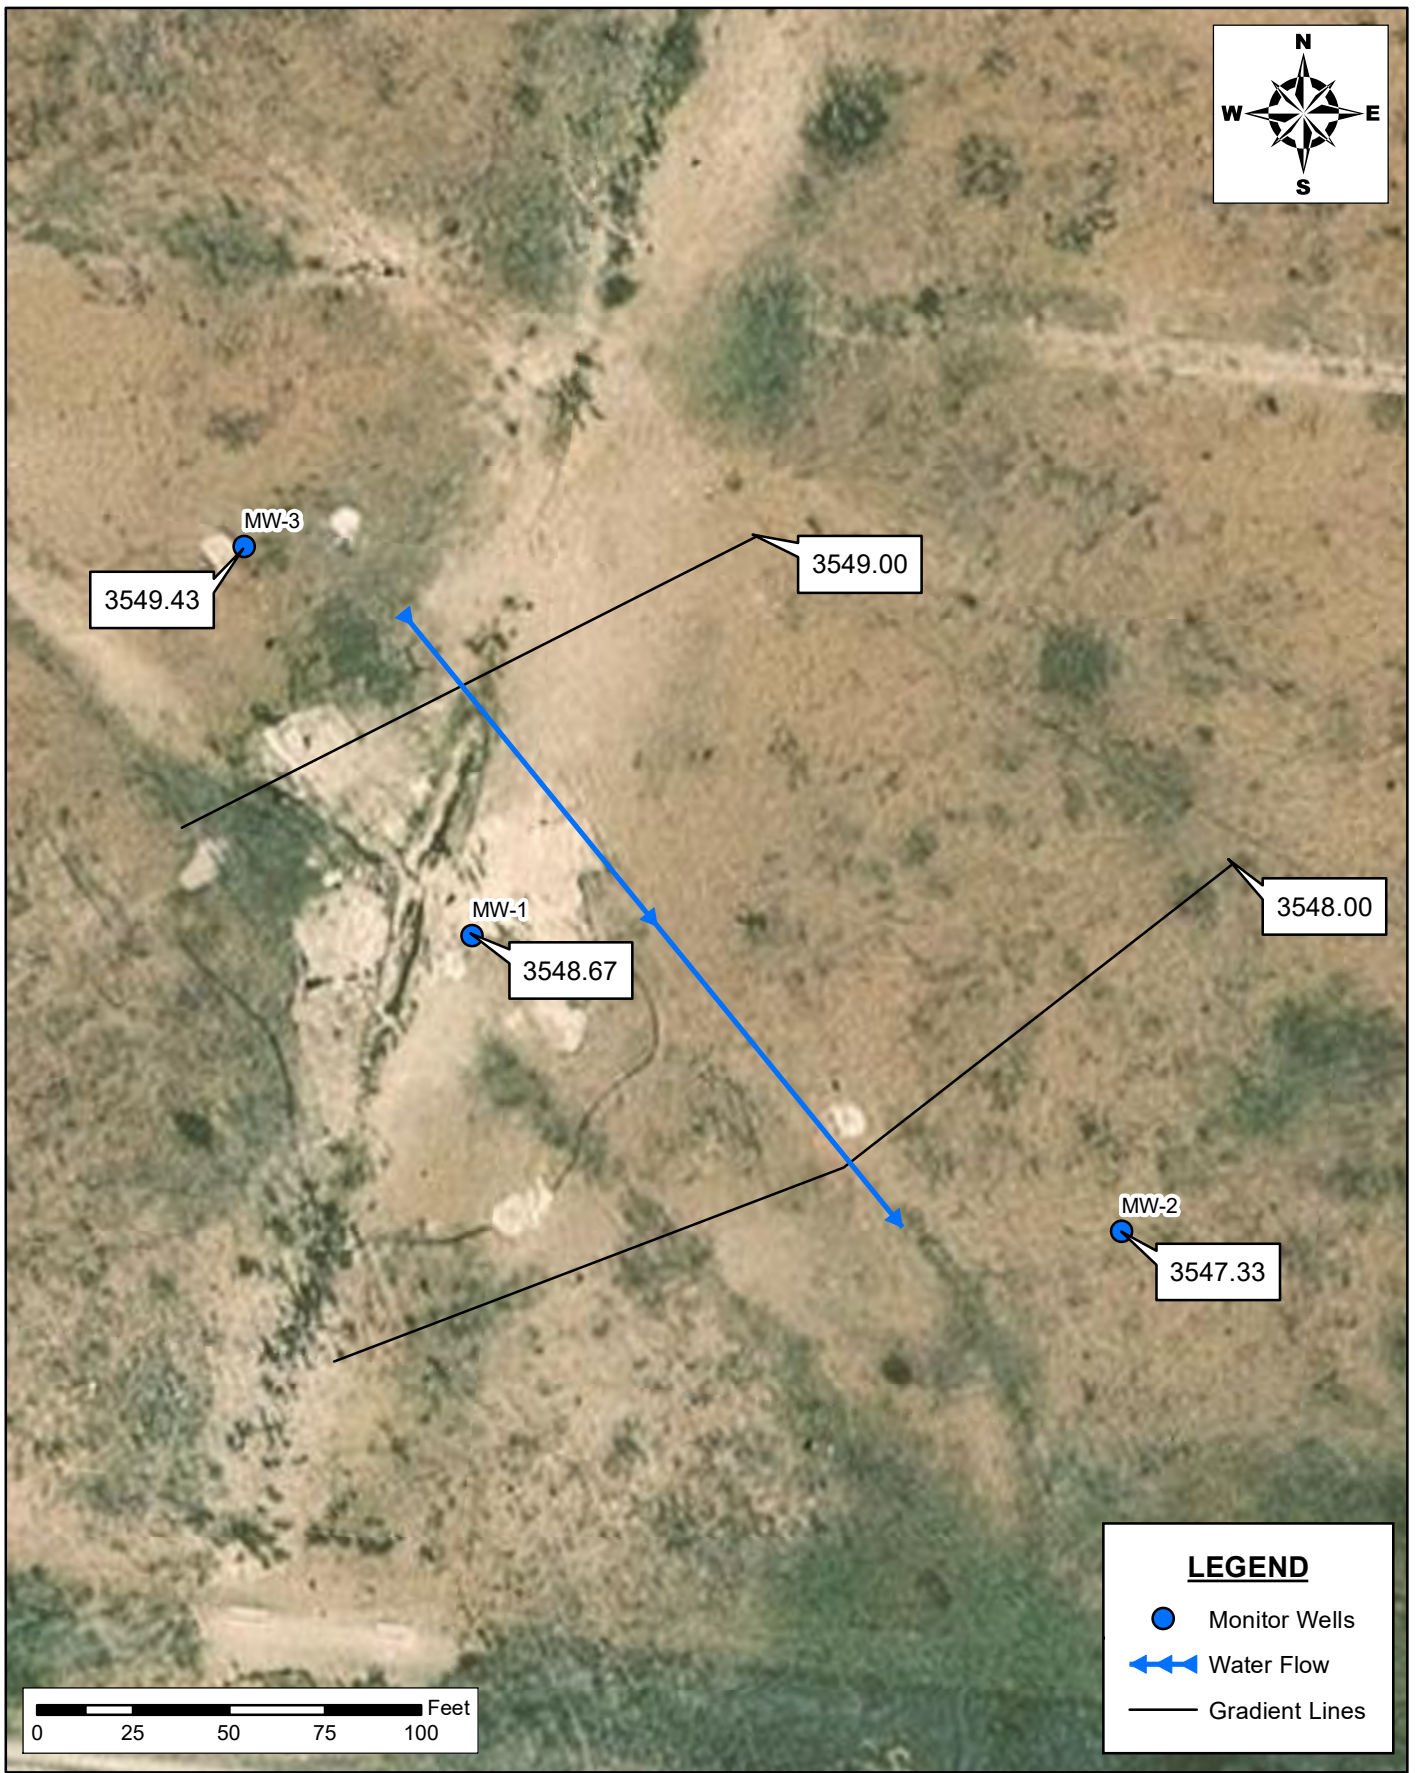
**FIGURE 4A**

**GROUNDWATER GRADIENT MAP  
SITE ASSESSMENT REPORT  
HILCORP ENERGY  
NMGSAU WELL #1416  
LEA COUNTY, NEW MEXICO  
32.614291° -103.304181°**

1. Base Image: ESRI Maps & Data 2017
2. Map Projection: NAD 1983
3. Gauged on 06/25/25
4. C.I. = 1.00'

Based on the current groundwater results, the Site gradient appears to be southeast towards monitoring well MW-2 which is consistent with previous sampling events. In addition, analytical concentrations were above the NMWQCC standards for benzene in monitor well MW-3, chlorides in monitor well MW-2, and TDS in monitor wells MW-2 and MW-3 throughout the year. All remaining analytes are below the NMWQCC

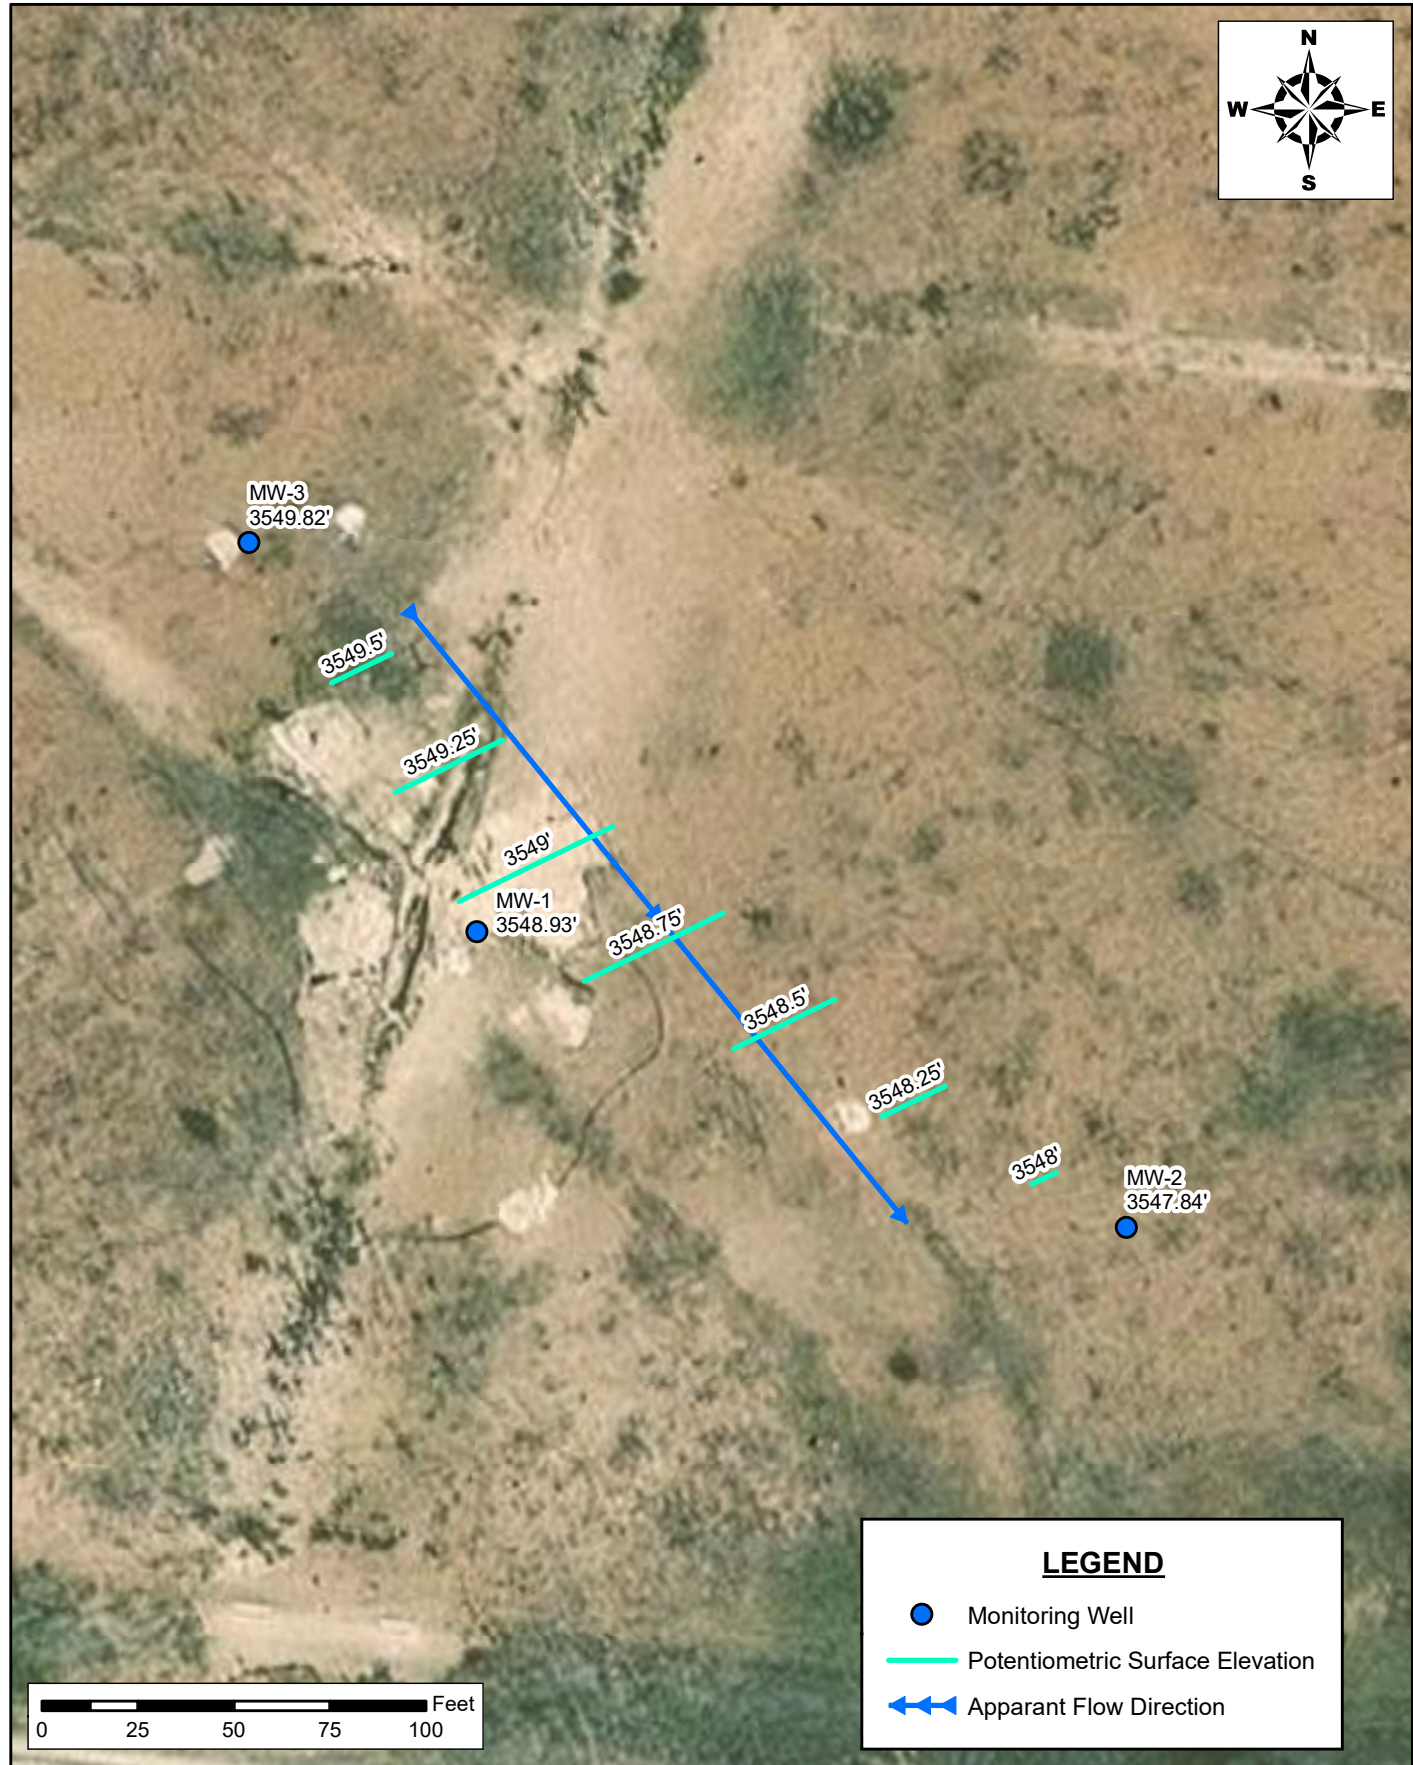
DRAWING NUMBER:  
**FIGURE 4B**  
 SHEET NUMBER:  
**1 of 1**

**GROUNDWATER GRADIENT MAP  
SITE ASSESSMENT REPORT**  
 HILCORP ENERGY  
 NMGSAU WELL #1416  
 LEA COUNTY, NEW MEXICO  
 32.614291° -103.304181°

1. Base Image: ESRI Maps & Data 2017
2. Map Projection: NAD 1983
3. Gauged on 12/05/25
4. C.I. = 1.00'

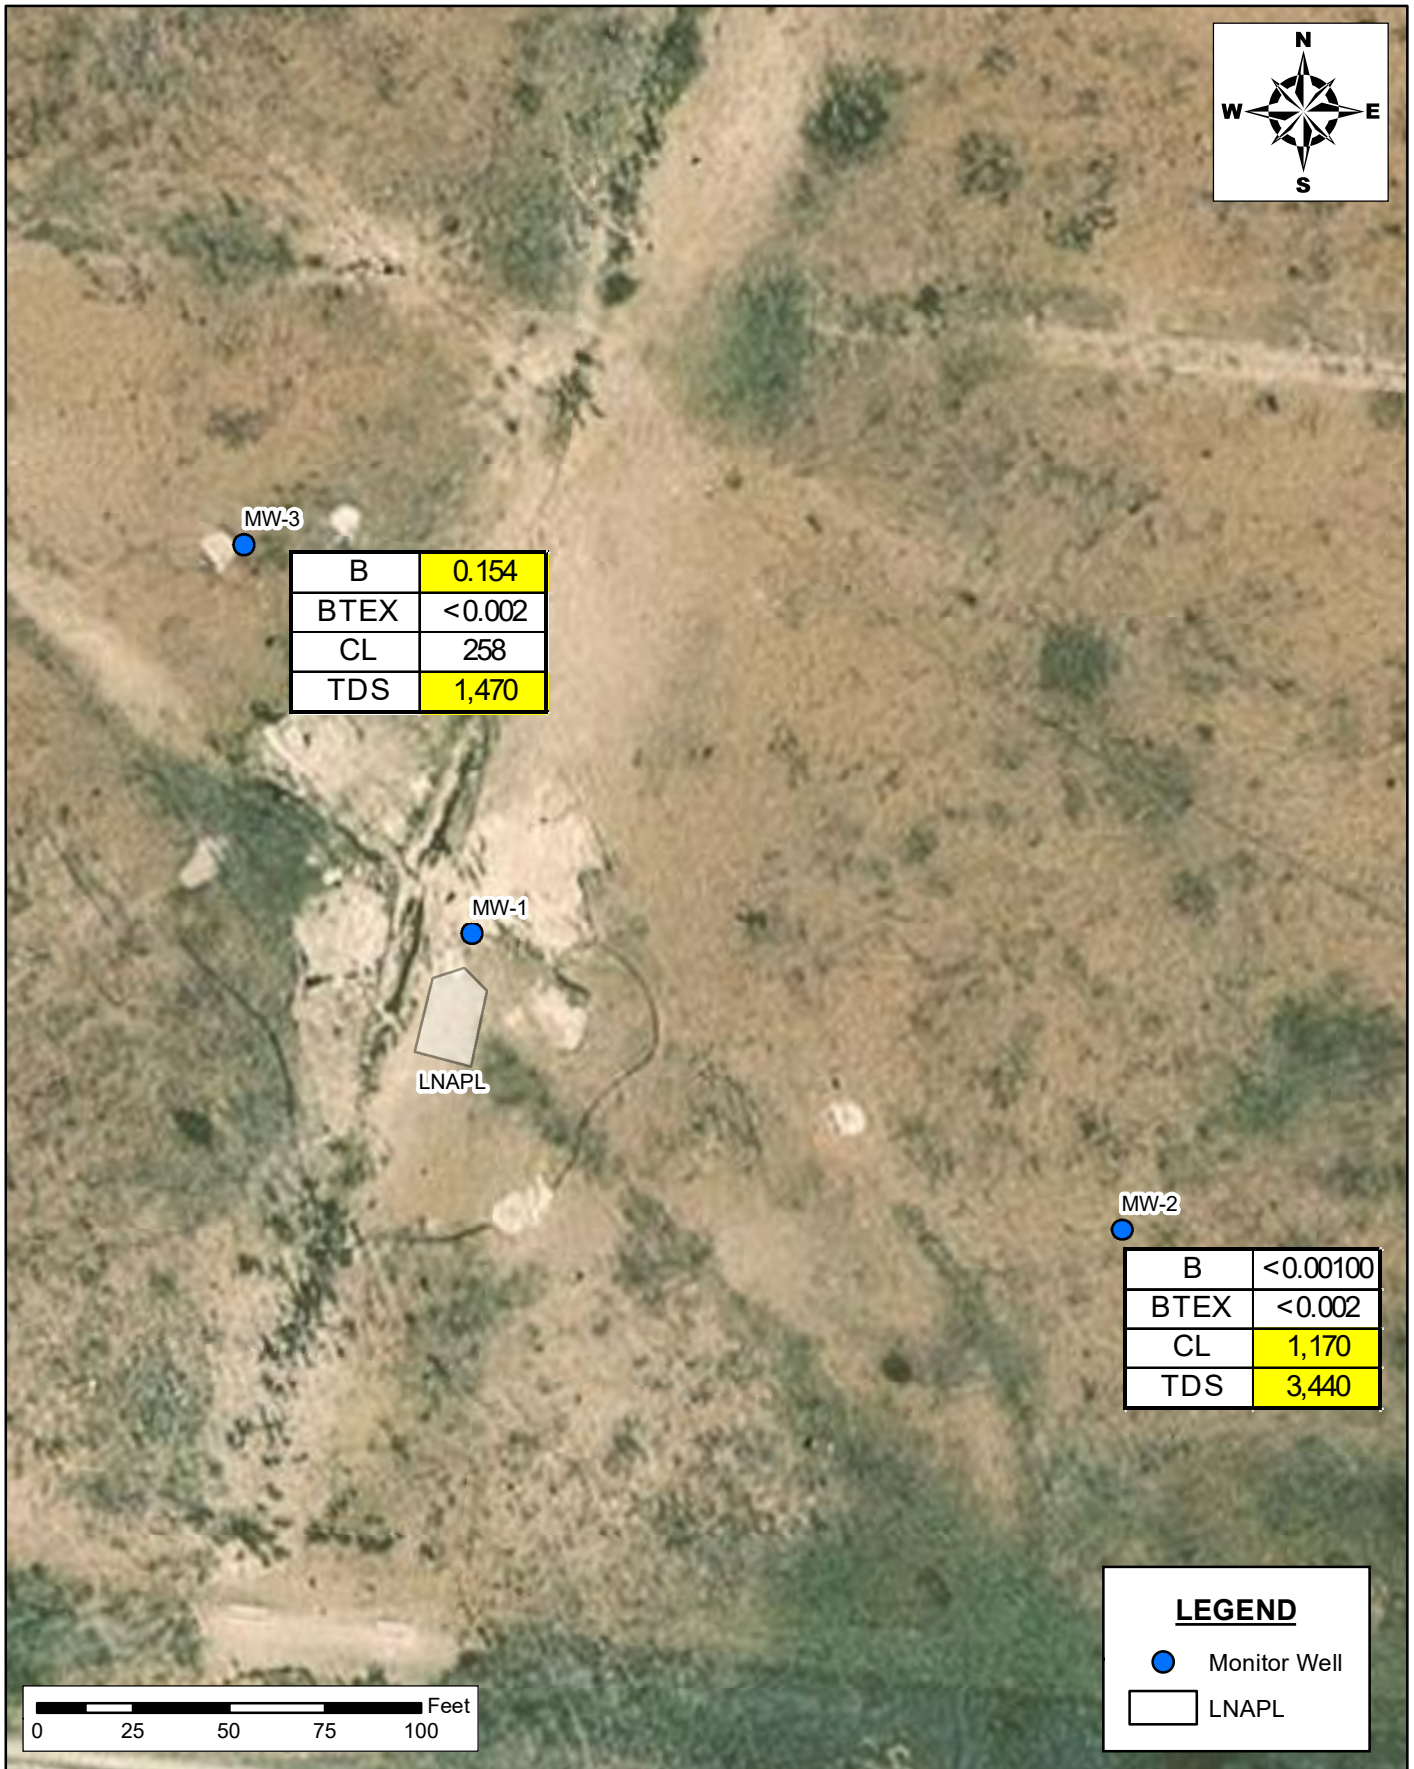
Analysis indicates that benzene concentrations exceeded the NMWQCC standards of 0.005 milligrams per liter (mg/L) for monitor well MW-3 with results of 0.154 mg/L (June 25, 2025) and 0.023 mg/L (December

5, 2025). In addition, the chloride concentrations exceeded the NMWQCC standard of 250 mg/L for monitor well MW-2 with concentrations of 1,170 mg/L (June 25, 2025) and 1,440 mg/L (December 5, 2025). The Total Dissolved Solids (TDS) exceeded the NMWQCC standard of 1,000 mg/L for monitor wells MW-2 and MW-3 throughout the year with results ranging from 1,070 mg/L in MW-3 on June 5, 2025, to 3,440 mg/L in MW-2 on December 5, 2025. All remaining analyzed analytes were below the NMWQCC standards. See Table 2 for groundwater analytical results along with Figures 5A and 5B, Dissolved Concentration Map. See Appendix A for laboratory analytical results.

<b>HYDROCARBON/TDS CONCENTRATION MAP                  SITE ASSESSMENT REPORT</b> HILCORP ENERGY NMGSAU WELL #1416 LEA COUNTY, NEW MEXICO 32.614291° -103.304181°			 <b>New Tech Global Environmental, LLC</b> 911 Regional Park Drive Houston, Texas 77060 T - 281.872.9300 F - 281.872.4521 Web: www.ntgenviromental.com	<b>NOTES:</b> 1. Base Image: ESRI Maps & Data 2017 2. Map Projection: NAD 1983 3. Results in mg/L Exceeds NMWQCC 4. LNAPL	DRAWING NUMBER: <b>FIGURE 5A</b> SHEET NUMBER: <b>1 of 1</b>
SCALE: AS SHOWN	DATE: 08/19/2025	PROJECT #: 2510088

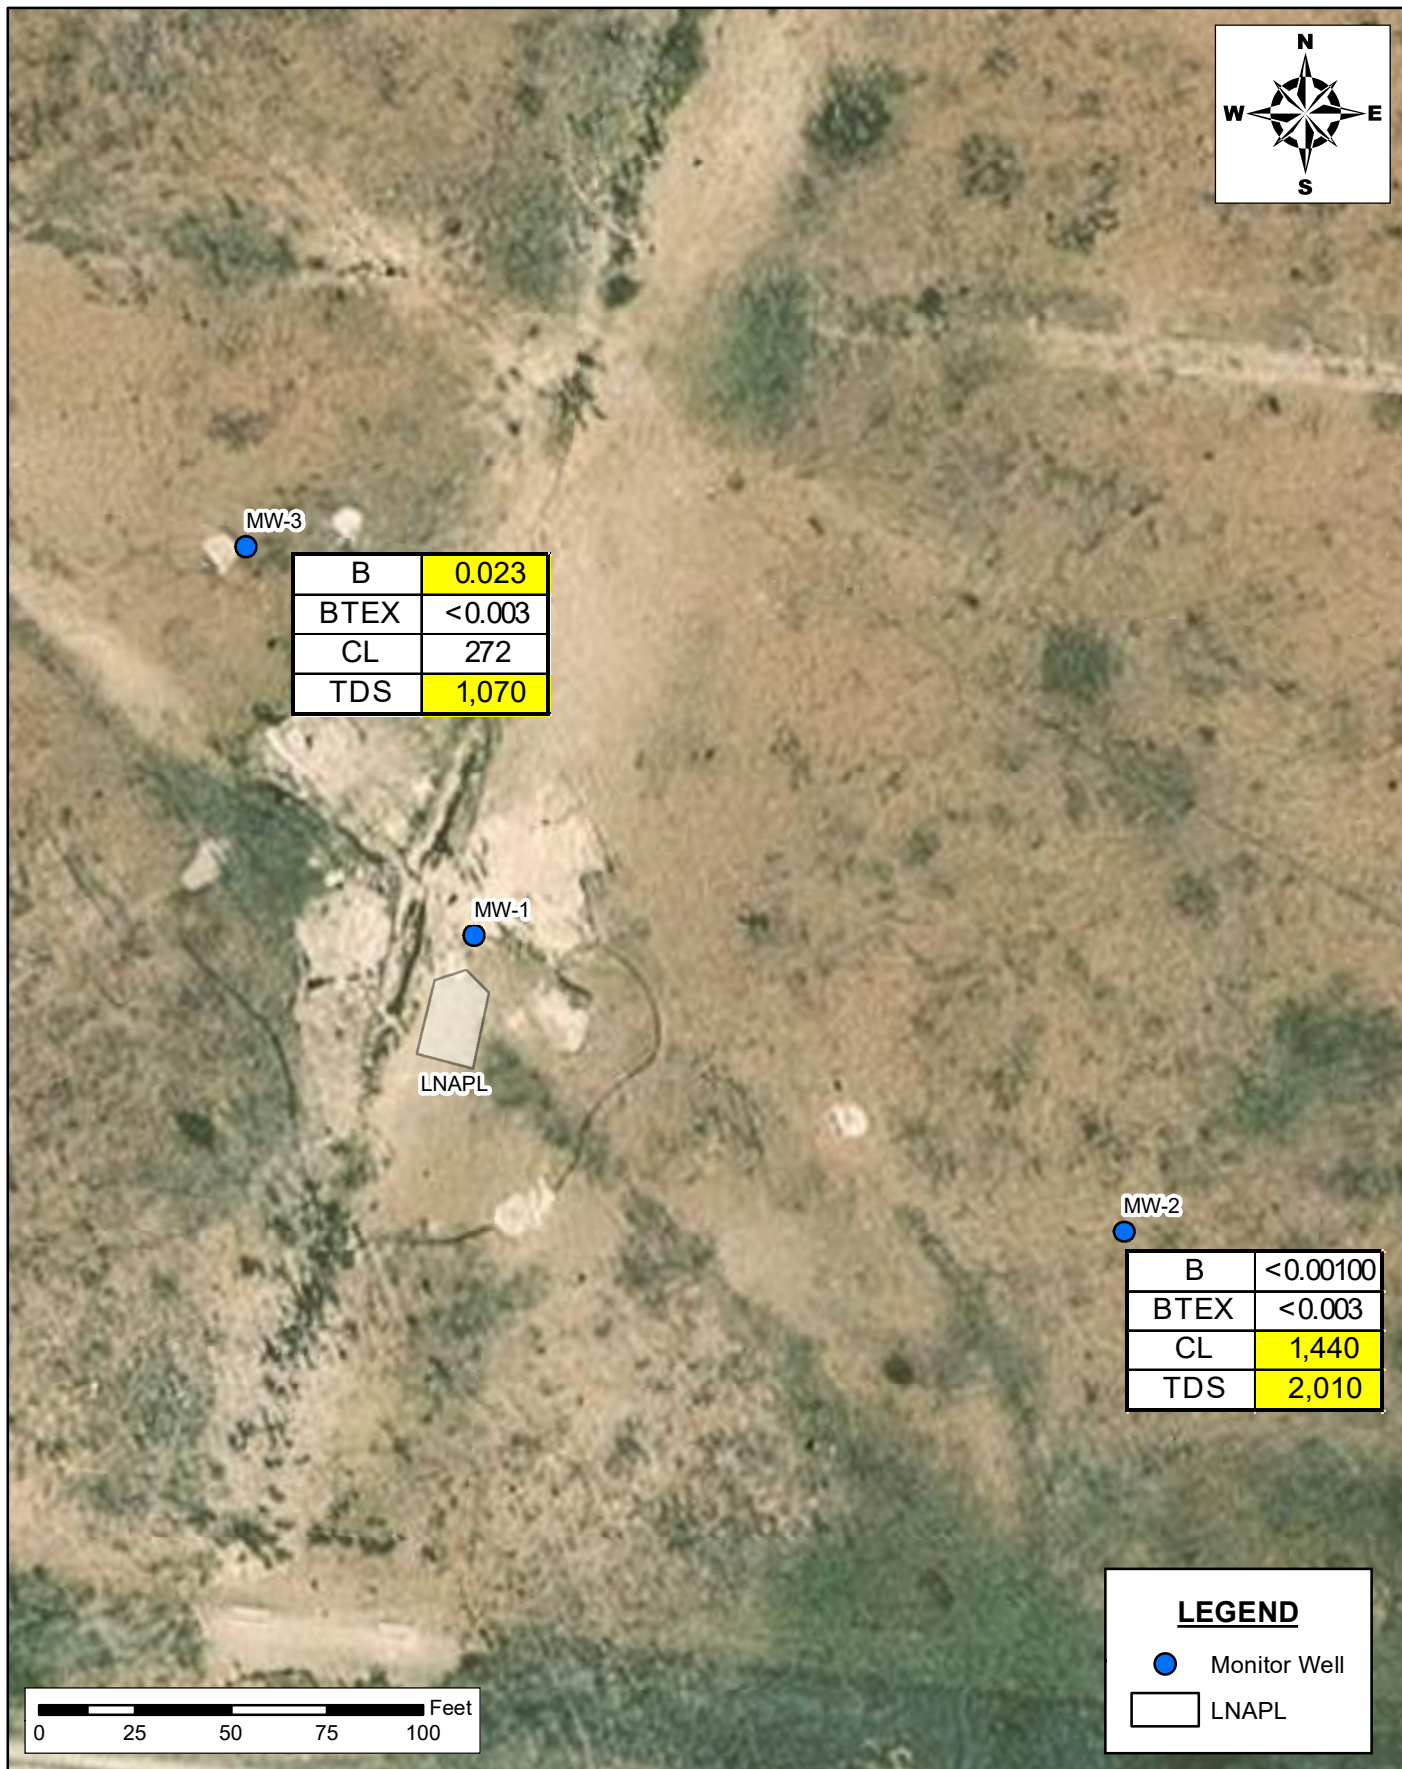
<p><b>HYDROCARBON/TDS CONCENTRATION MAP</b>  <b>SITE ASSESSMENT REPORT</b>                  HILCORP ENERGY                  NMGSAU WELL #1416                  LEA COUNTY, NEW MEXICO                  32.614291° -103.304181°</p>			<p> <b>NTG ENVIRONMENTAL</b>                  New Tech Global Environmental, LLC                  911 Regional Park Drive                  Houston, Texas 77060                  T - 281.872.9300                  F - 281.872.4521                  Web: www.ntgenviromental.com</p>		<p><b>NOTES:</b></p> <ol style="list-style-type: none"> <li>1. Base Image: ESRI Maps &amp; Data 2017</li> <li>2. Map Projection: NAD 1983</li> <li>3. Results in mg/L</li> <li>4. LNAPL</li> <li>5. Sampled on Dec 5, 2025</li> </ol>		<p>DRAWING NUMBER:  <b>FIGURE 5B</b>                  SHEET NUMBER:  <b>1 of 1</b></p>	
SCALE: AS SHOWN	DATE: 12/05/2025	PROJECT #: 2510088

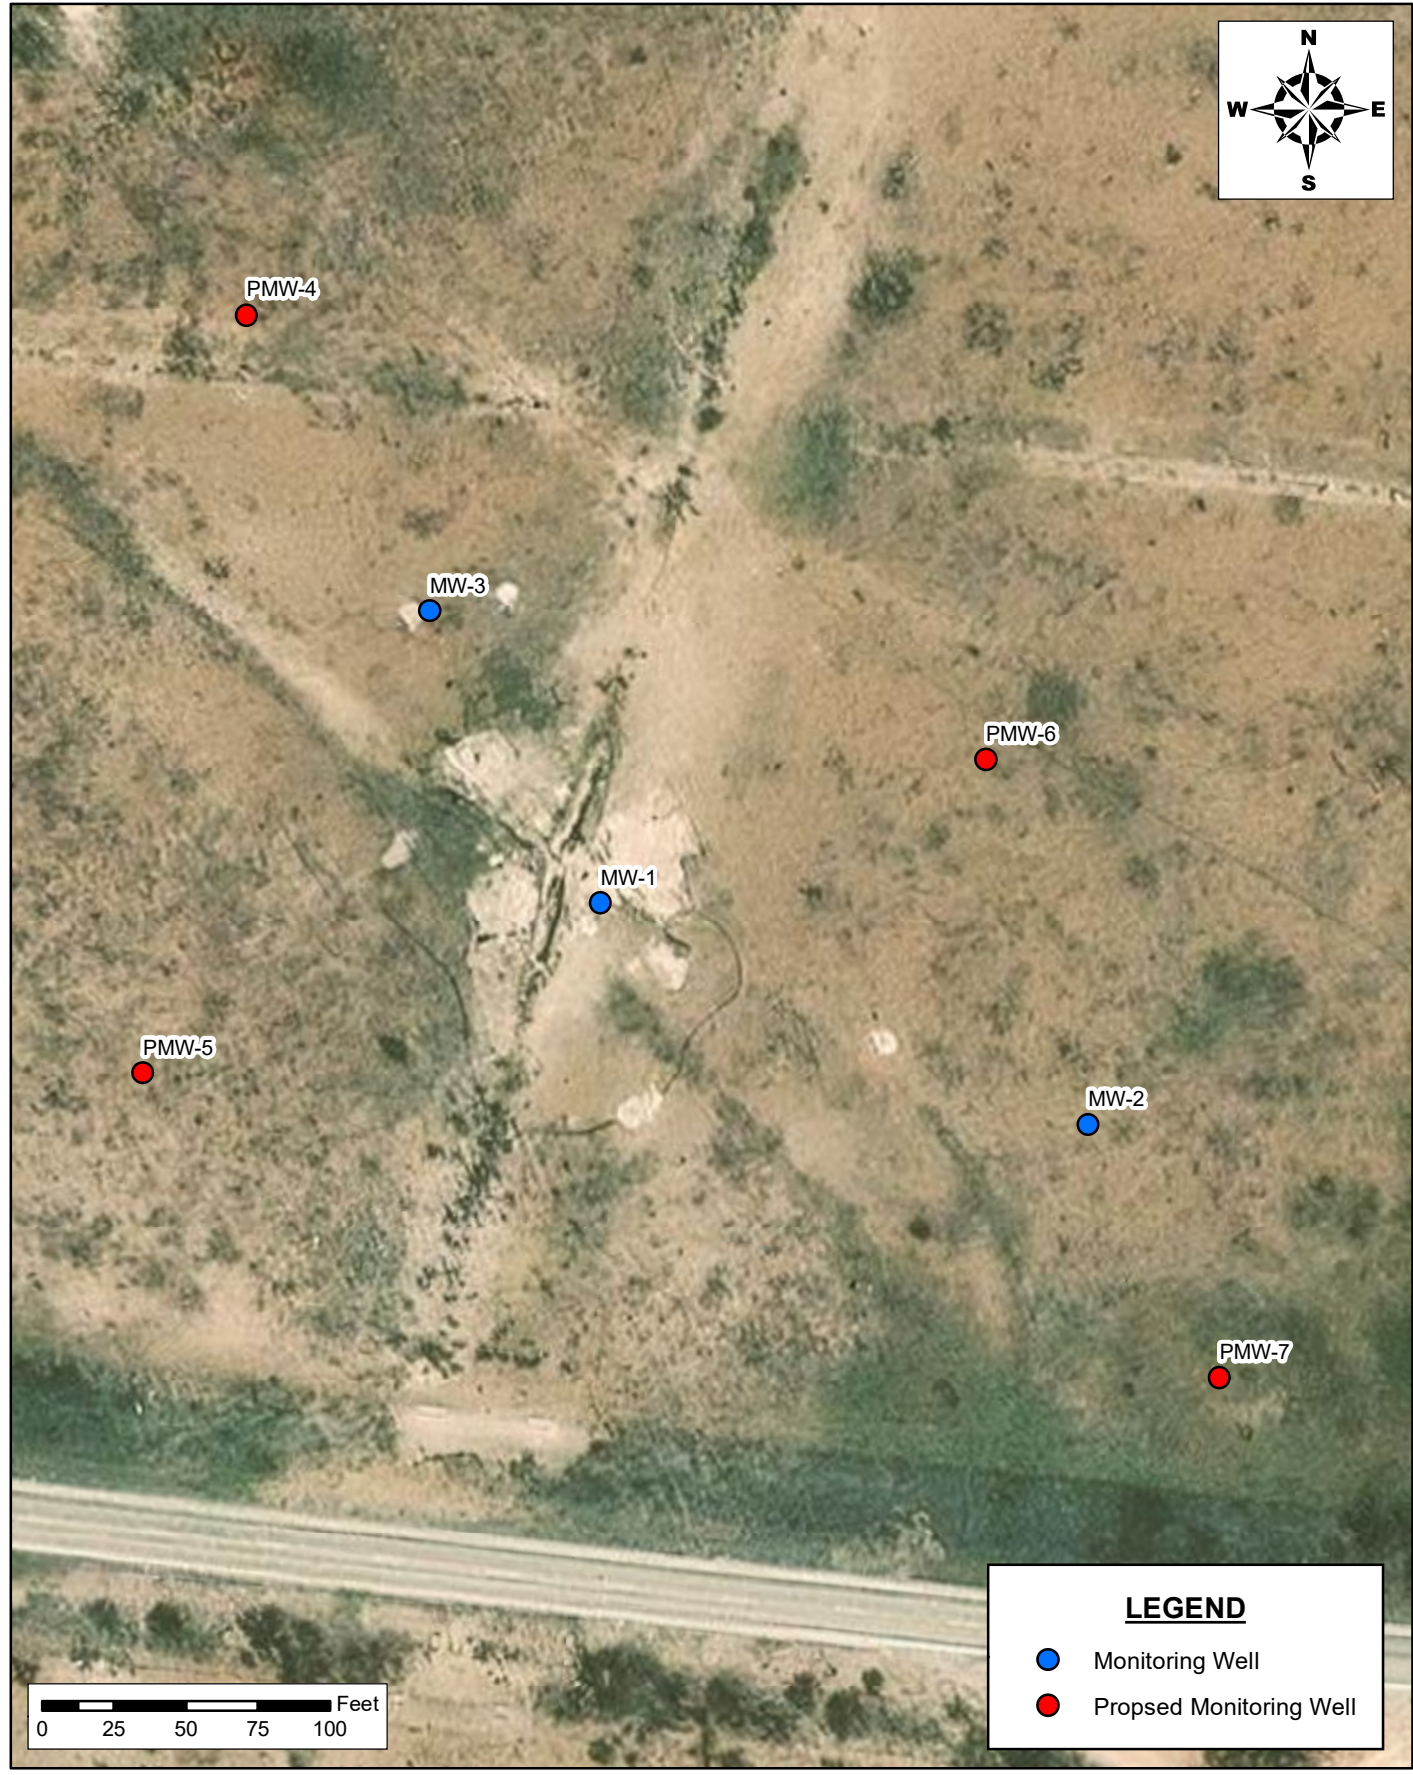
As of this report, the site groundwater does not appear to be delineated regarding LNAPL, benzene, chlorides or TDS. Hilcorp proposes installing four (4) monitor wells (PMW-4 through PMW-7) surrounding the existing wells to further delineate the groundwater and develop a more concise groundwater gradient at the site. The proposed monitor wells will be drilled by a licensed New Mexico driller with soil samples collected, and field screened. The soil sample with the highest photoionization detector (PID) reading and the sample directly above first encountered groundwater will be submitted to a New Mexico approved laboratory for analysis of BTEX, TPH and chloride. The wells will be installed with 2-inch diameter casing and 20 feet of 0.02" mesh screen, (approximately 15-feet into the underlying aquifer and 5-feet above aquifer to account for groundwater fluctuations). The wells will then be completed to the surface with 2-inch blank schedule 40 PVC pipe. The well will be sanded to 2-feet above the screen with bentonite slurry from the area 2-feet above screen to 2 ½ feet below ground surface. The well will then be completed to surface with concrete and a steel monument sleeve within a 3-foot by 3-foot pad. Once the wells have been completed, a New Mexico licensed land surveyor will be utilized to survey in the top of the casing, ground elevation, and surface pad in order to determine a more accurate groundwater gradient for the Site.. See Figure 6 for proposed monitor well locations.

<b>PROPOSED MONITOR WELL LOCATION MAP</b> HILCORP ENERGY NMGS AU WELL #1416 LEA COUNTY, NEW MEXICO 32.614291° -103.304181°			  <b>New Tech Global Environmental, LLC</b> 911 Regional Park Drive Houston, Texas 77060 T - 281.872.9300 F - 281.872.4521 Web: www.ntgenviromental.com	<b>NOTES:</b> 1. Base Image: ESRI Maps & Data 2017 2. Map Projection: NAD 1983	DRAWING NUMBER: <div style="text-align: center; border: 1px solid black; padding: 5px;"><b>FIGURE 6</b></div> SHEET NUMBER: <div style="text-align: center; border: 1px solid black; padding: 5px;"><b>1 of 1</b></div>
SCALE: AS SHOWN	DATE: 08/21/2025	PROJECT #: 2510088
