Liner Inspection & Closure Report

SOLARIS WATER MIDSTREAM LLC

Calderon Farms SWD
Incident ID: nAPP2532352492
Eddy County, NM

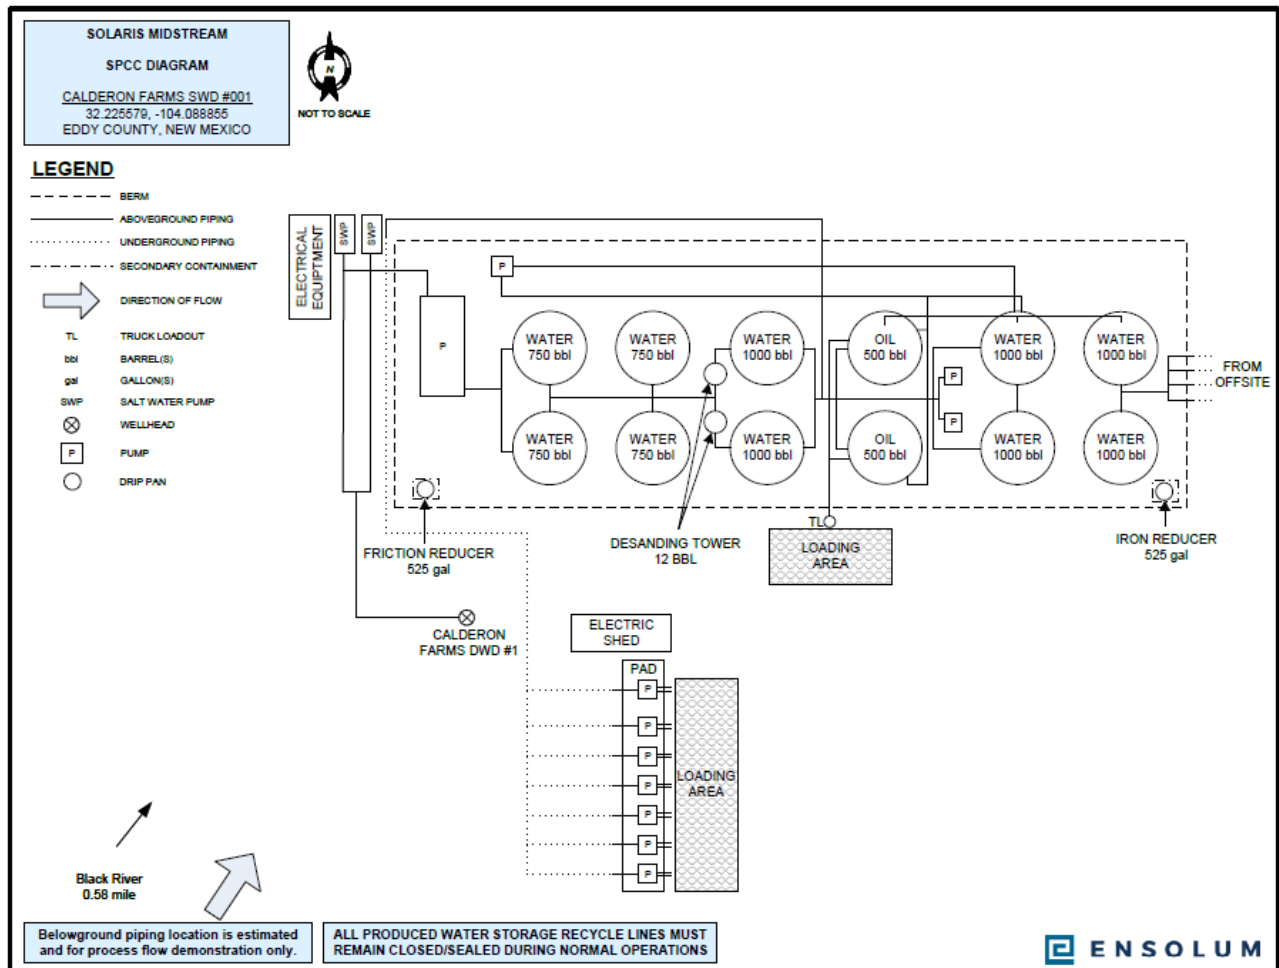
Site Diagram:

Company Name: SOLARIS WATER MIDSTREAM
 LLC Site: Calderon Farms SWD
 Lat/Long: (32.225579, -104.088855)
 NMOCD Incident ID: nAPP2532352492
 Incident Date: 11/19/25
 2-Day Notification Sent: YES
 Inspection Date: 12/19/2025
 Inspection Time: 2:00 PM
 Weather: Sunny
 Liner Type: Steel with Poly Liner

Inspection Question	Yes	No	Comments
Are there tears or holes in the liner?		X	
Is the liner retaining any fluids?		X	
Does the liner have integrity to contain a leak?	X

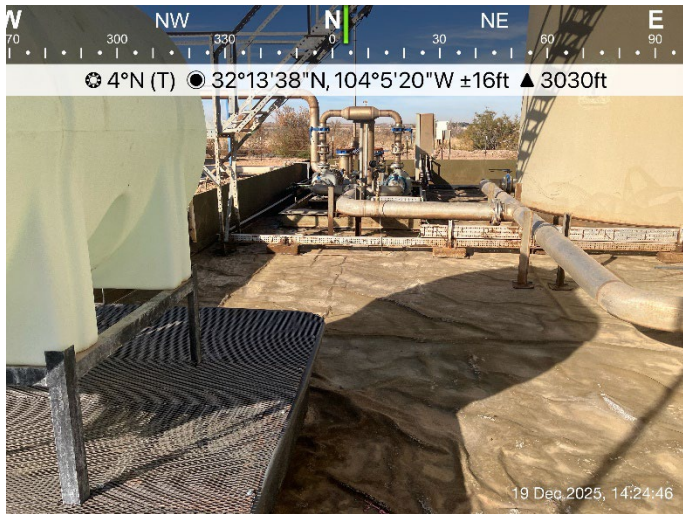
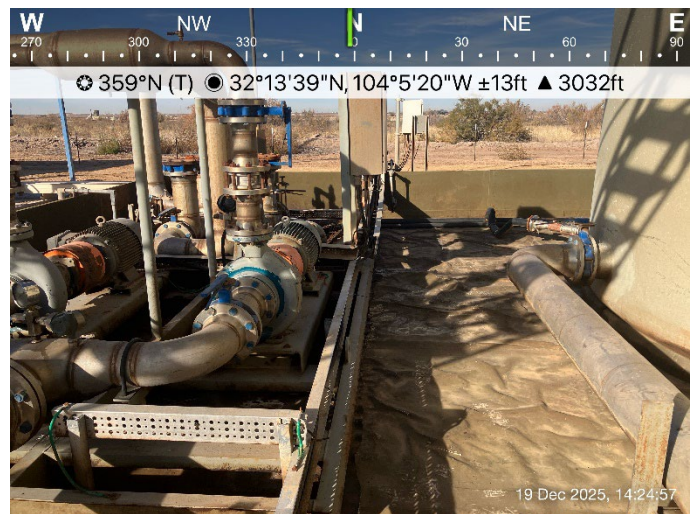
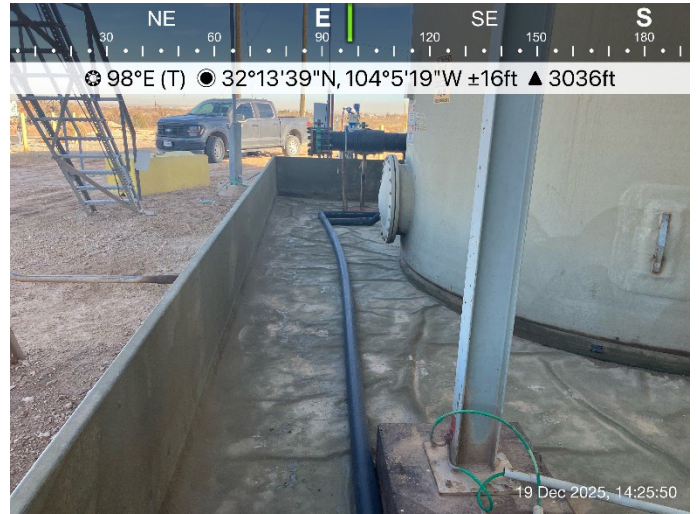
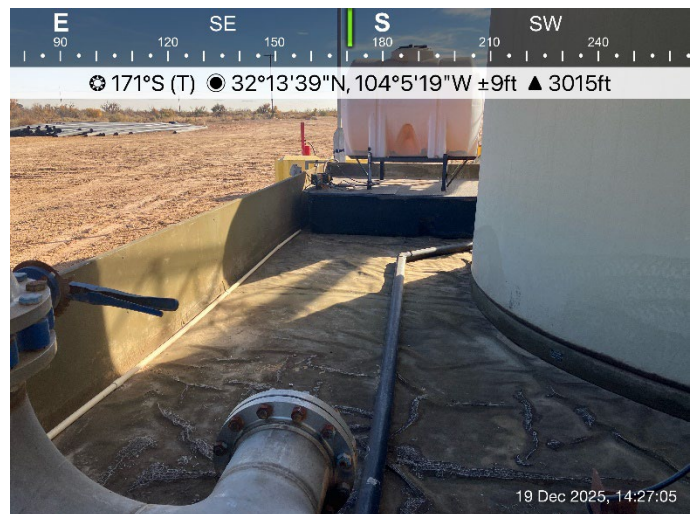
Photographic Documentation - Liner Inspection

On 12/16/2025, a C-141L was submitted and approved by the NMOCD. The containment liner was visually inspected on 12/19/2025 at 2:00 PM. Demonstration of liner integrity is documented below. No deficiencies were identified during the inspection. In accordance with NMAC 19.15.29, soil samples were not required. Solaris Midstream LLC is requesting closure for incident nAPP2532352492.
