Amended Remediation Summary & Deferral Request

Mewbourne Oil Company Top Gun Federal SWD #001

Eddy County, New Mexico
Unit Letter "A", Section 18, Township 23 South, Range 27 East
Latitude 32.310500° North, Longitude 104.222970° West
NMOCD Reference No. nAPP2507060025

Etech Environmental & Safety Solutions, Inc.
6309 Indiana Ave, Ste. D
Lubbock, Texas 79413

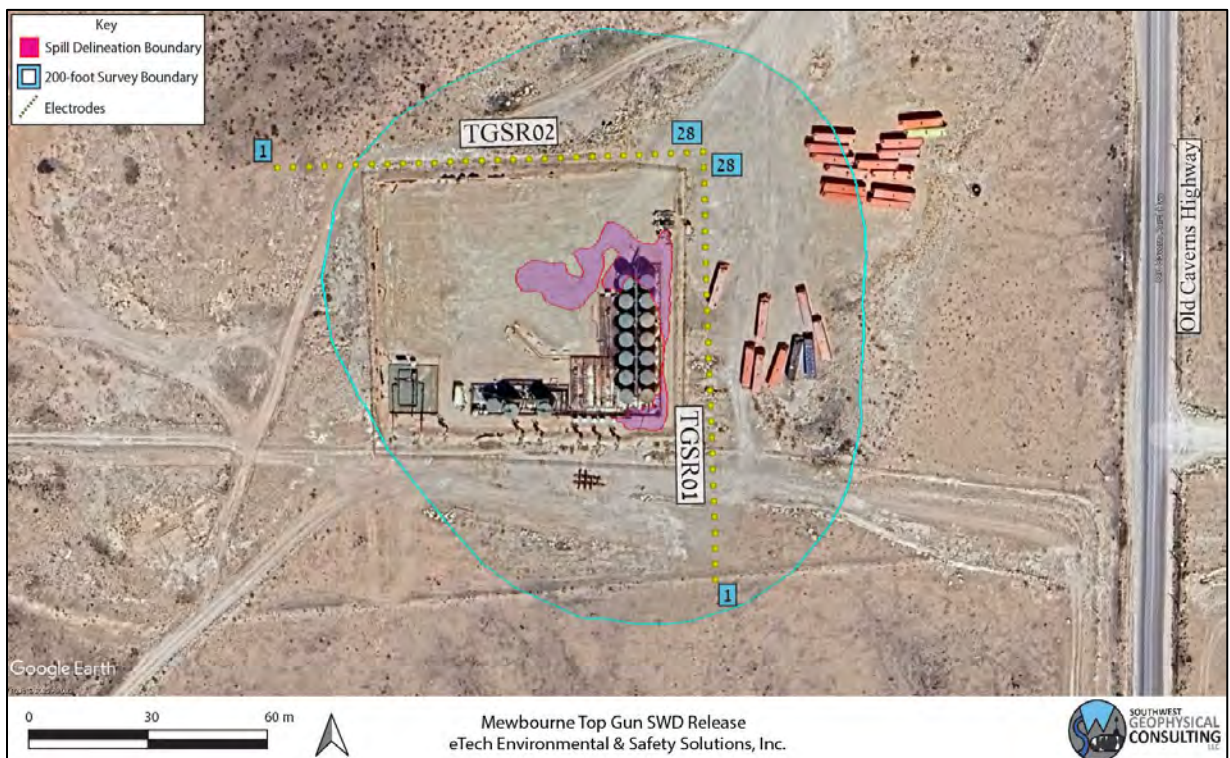
Figure 5: Geophysical survey overview. Two survey lines were conducted with 28 electrodes each at 5-meter spacing (yellow dots denoted with blue numbers). Background image credit: Google Earth. Image date: April 15, 2023. Image datum: WGS-84.

For this survey, an Advanced Geosciences Inc. (AGI) SuperSting™ Wifi R8 with a multi-electrode switchbox, a 28-electrode array of 40-centimeter-long electrodes, and a tablet controller were used to image the subsurface. This survey consisted of two resistivity lines in a dipole-dipole strong-gradient configuration; line one is laid out south to north while line two is laid out west to east. Both lines consisted of 28 electrodes at 5-meter spacing, resulting in 135-meter-long arrays (**Figure 5, Table 1**). A preconfigured command file was used to run the data collection (DDSG28). This electrode configuration provided a depth of investigation of 27 meters (89 feet) and a resolution of 2.5 to 3.0 meters (8.2 to 9.8 feet) within the first 5 to 8 meters (16 to 26 feet) from the surface. A Leica GS18 GPS was used to record electrode locations and elevations.

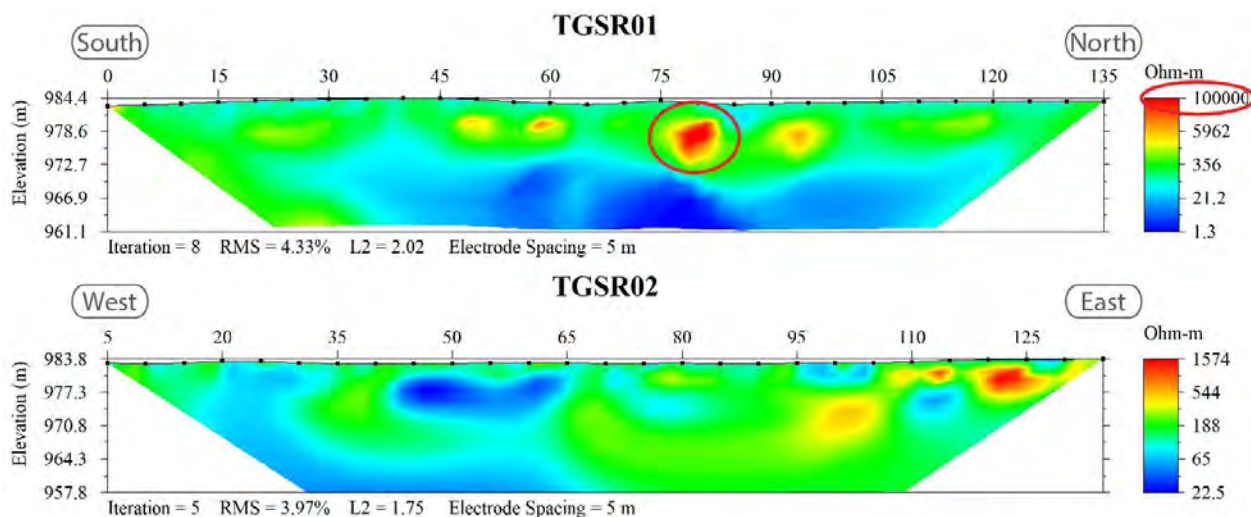
Figure 7: 2D inverted resistivity section. Red ellipse highlights high-resistivity anomaly. Reds and oranges indicate higher resistivity values. Yellows and greens are medium-resistivity values. Blues are low-resistivity values. Please note that the color scale is relative.

The results of this study indicate a moderately well-layered geologic system with resistivities between 1.3 and 5,962 Ohm-m (**Figure 7**). One high-resistivity anomaly is present with a resistivity of 100,000 Ohm-m. Please keep in mind when viewing the 2D inverted resistivity sections that color maps can be widely different for each view. Always check the color map located on the right side of the image when viewing the 2D images to ensure you understand the range of resistivities presented. Distances along the top and depths along the left side are in meters. The color map along the right side is in Ohm-m. Due to the nature of the survey, shallower zones have higher resolution between electrodes than deeper zones; therefore, small features at depth will not be visible.

The geophysical survey contains one high-resistivity anomaly with a value of 100,000 Ohm-m. This anomaly was investigated using air-rotary drilling by Jim Hawley of H & R Enterprises and Dave Decker of Southwest Geophysical Consulting and was found to be conglomerate overlying a layer of clay. **Therefore, no anomalies consistent with air-filled subsurface voids that could pose a collapse risk are interpreted to be under the TGSR geophysical survey area. Additionally, the resistivity data indicates well layered stratigraphy within the zone of the resistivity investigation, indicating stable ground.**

Small solutionally enlarged voids or fractures at or near the resolution limit of the survey (2.5 – 3.0 meters) may be present. Slightly higher-than-average resistivity areas less than 10 meters beneath the surface are interpreted as Gatuna Formation conglomerates. Due to their much lower resistivity values when compared with significant subsurface voids, these features should not be a concern during remediation efforts. Areas of moderate resistivity (yellows, and greens) near the surface are interpreted as dry gypsite soils and gypsum or dolomite bedrock of the Rustler Formation^[17] (**Figure 7** and **Figure 8**). Very low-resistivity areas between 1.3 – 10 Ohm-m may either represent fluid from the brine release, surface-to-subsurface hydrologic pathways, or a layer of either clays and halite lenses or moist or saturated layers within the Rustler Formation (**Figure 7**).

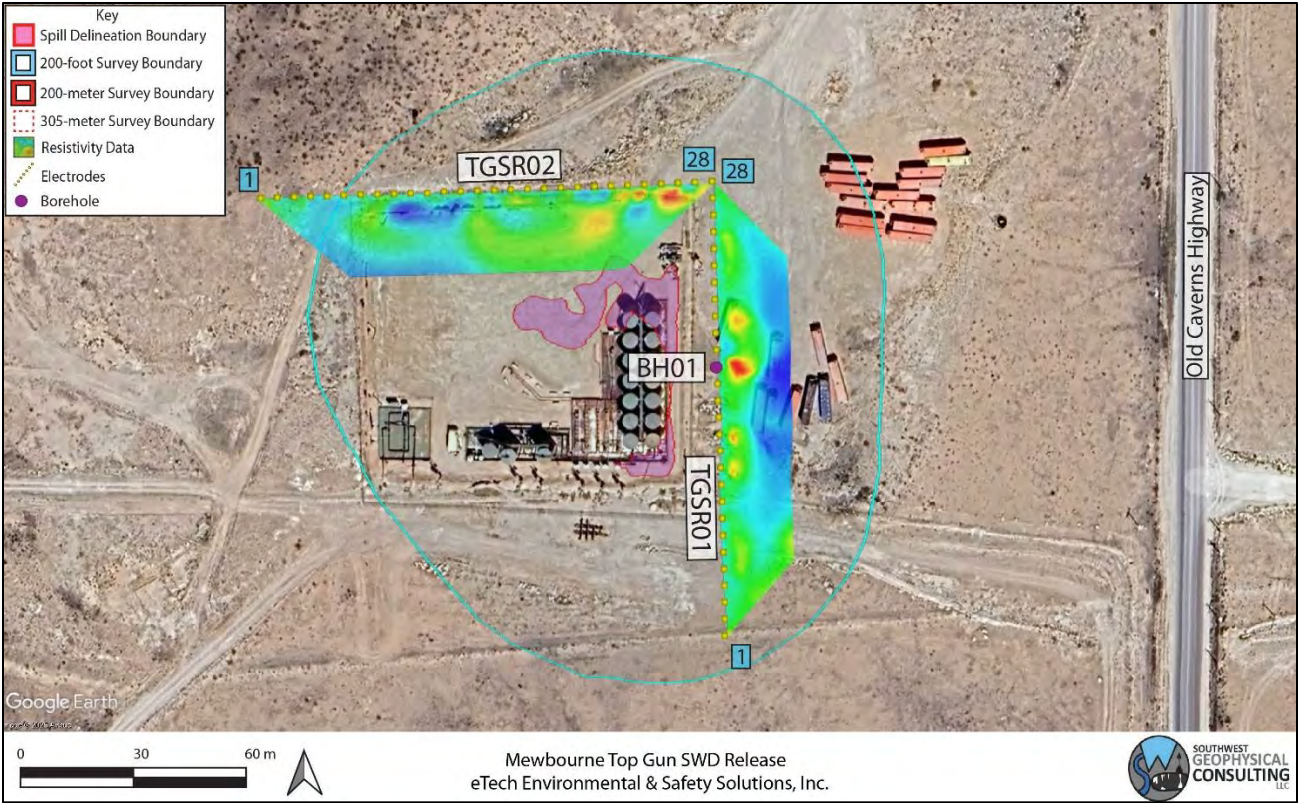
Figure 8: Data overlay. Colored trapezoids are the 2D inverted resistivity lines. Background image credit: Google Earth. Image date: April 15, 2023.

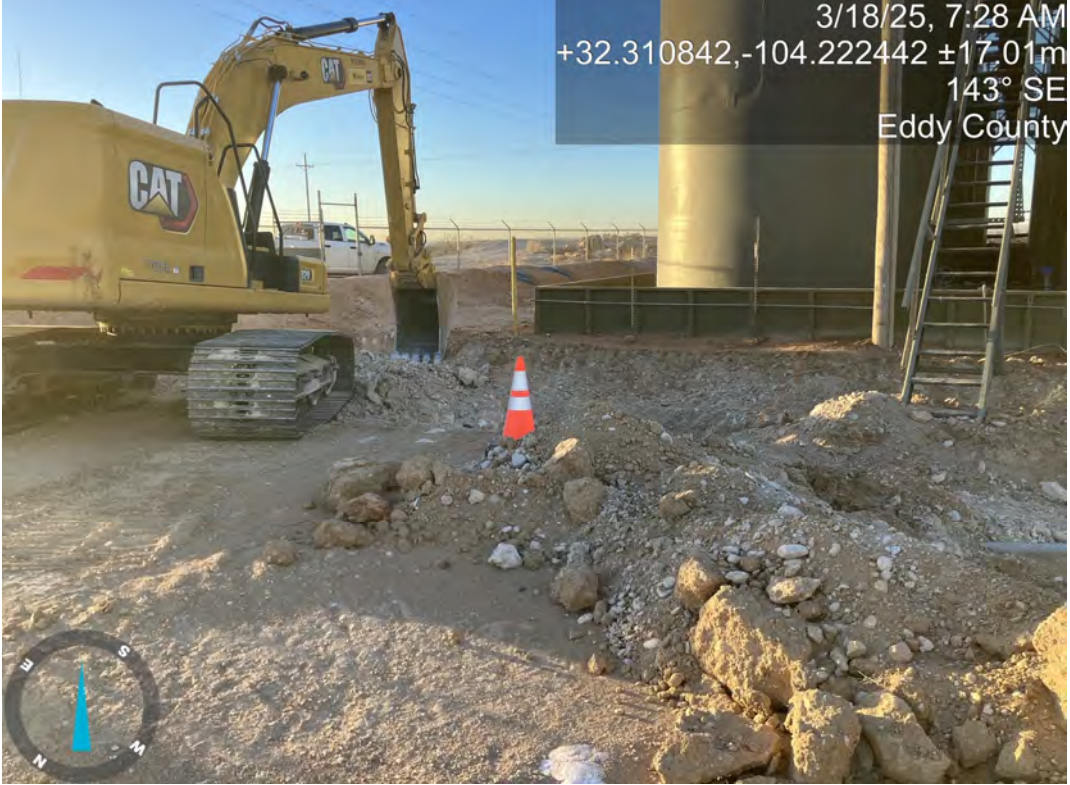
Photo Number: 5

<p>3/18/25, 7:28 AM +32.310842,-104.222442 ±17.01m 143° SE Eddy County</p>
Photo Direction: Southeast	
Photo Description: View of the excavated area.

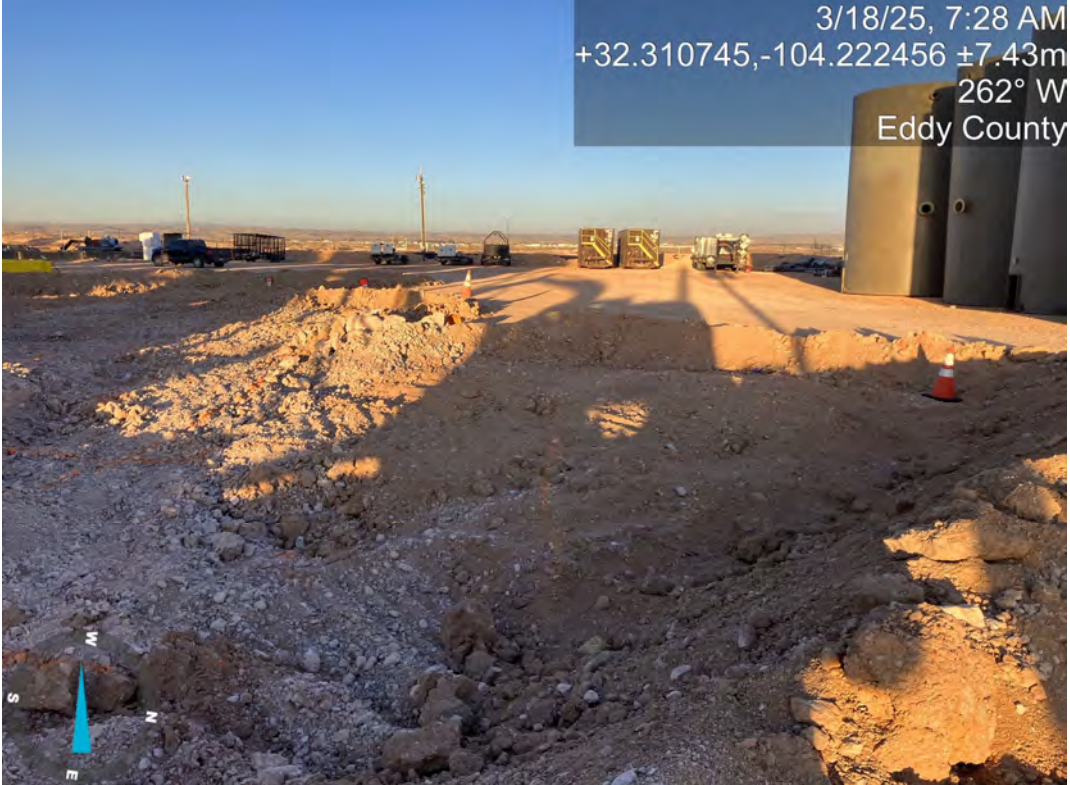
Photo Number: 6

<p>3/18/25, 7:28 AM +32.310745,-104.222456 ±7.43m 262° W Eddy County</p>
Photo Direction: West	
Photo Description: View of the excavated area.

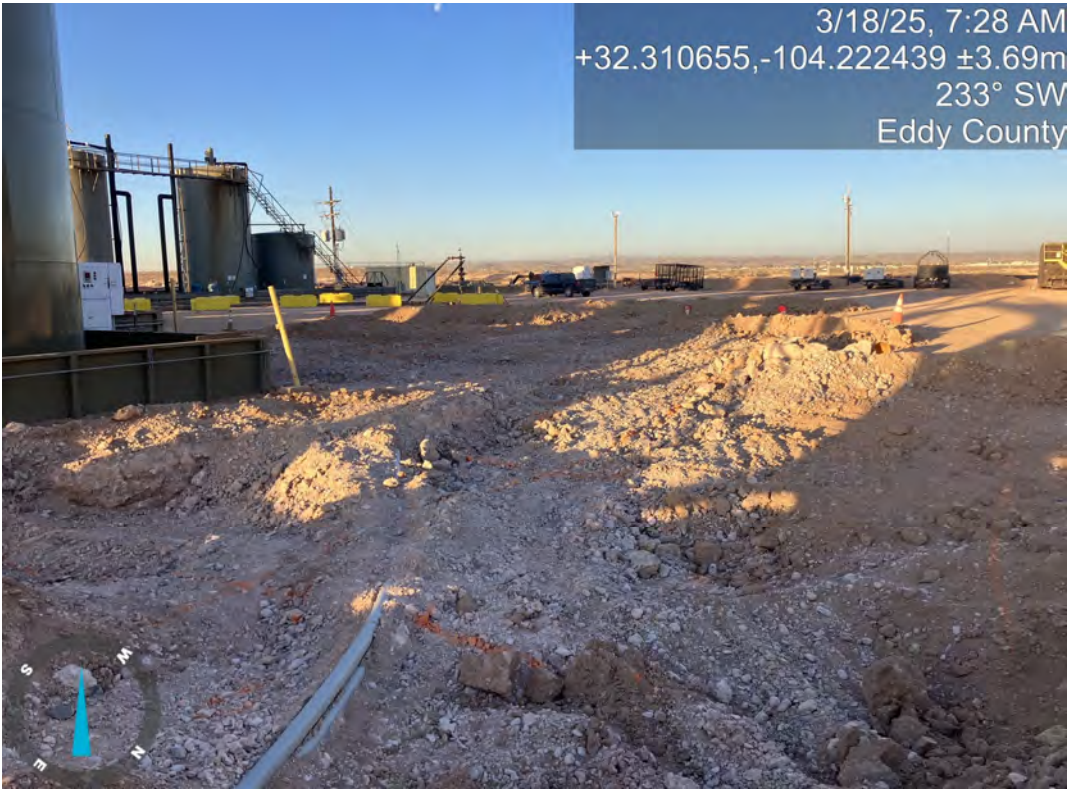
Photo Number: 7

Photo Direction: Southwest	
Photo Description: View of the excavated area.

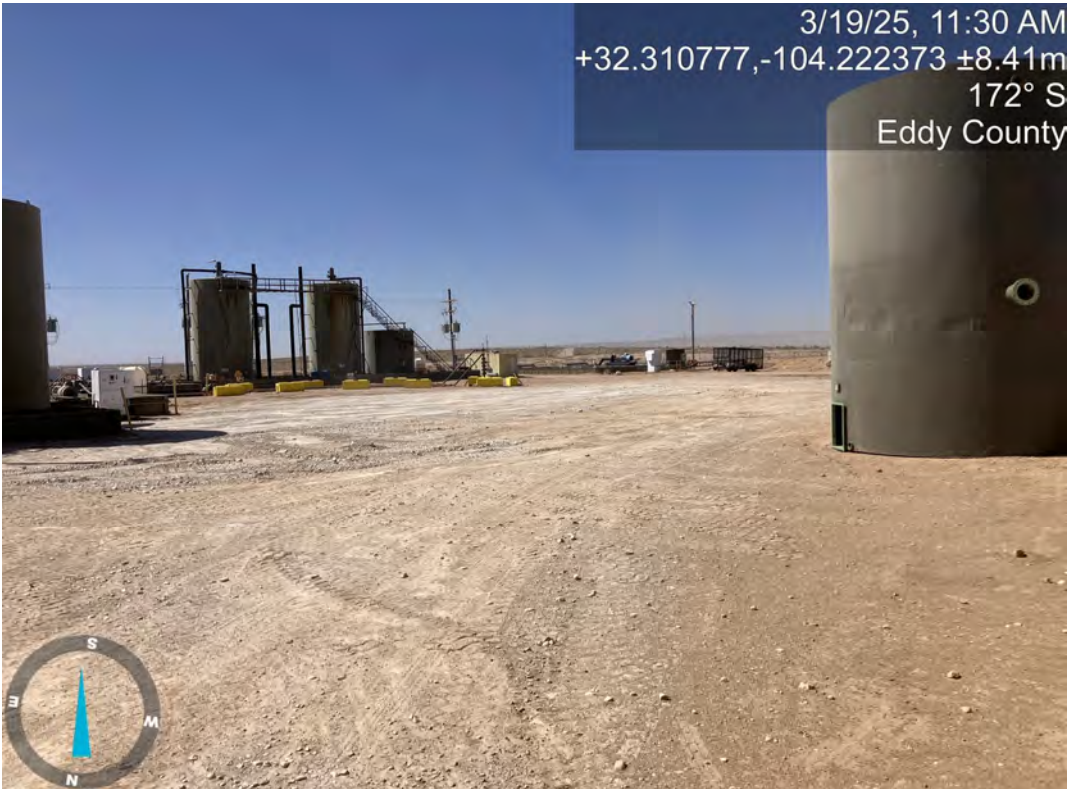
Photo Number: 8

Photo Direction: South	
Photo Description: View of the remediated area following backfill and regrading.

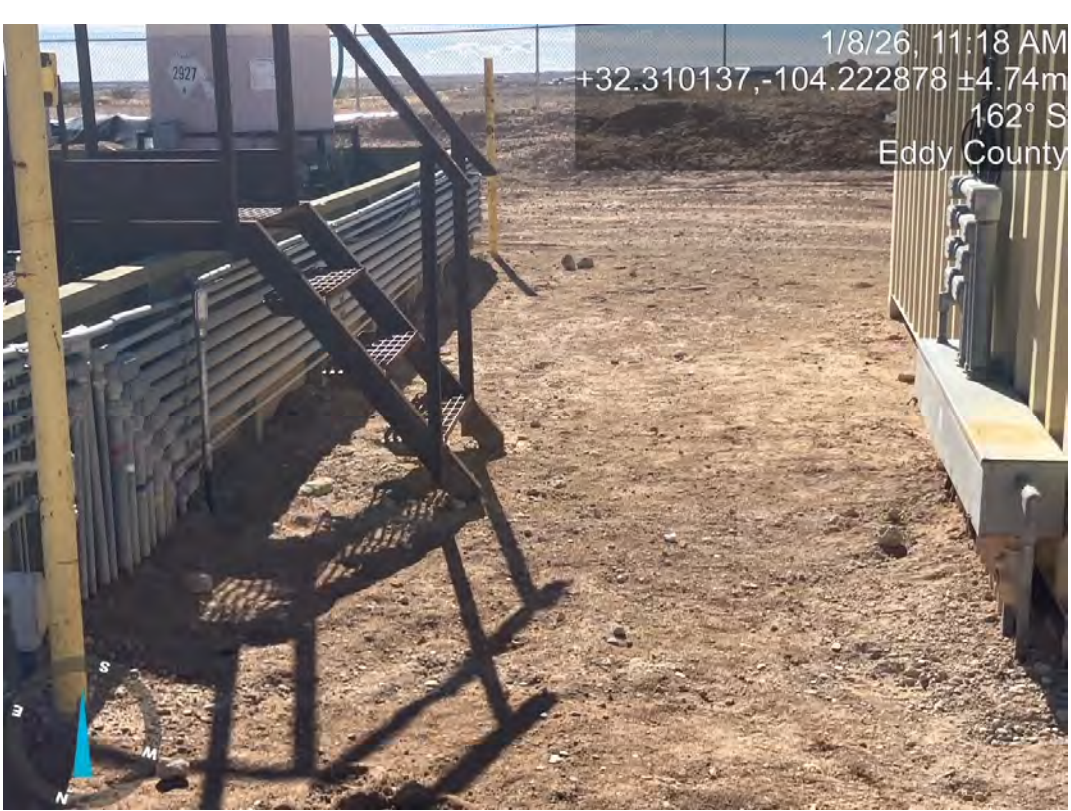
Photo Number: 13

Photo Direction: South-Southeast	
Photo Description: View of the Deferral Area(s)

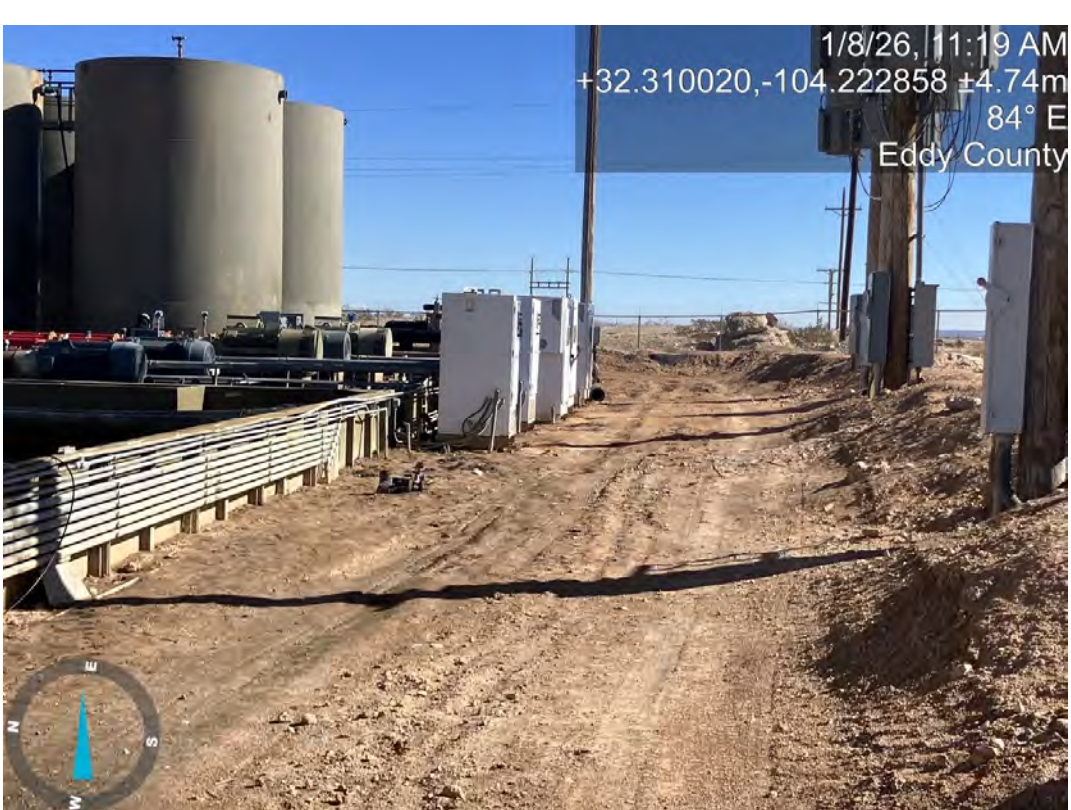
Photo Number: 14

Photo Direction: East	
Photo Description: View of the Deferral Area(s)
