**Re: Closure Request
PLU South Frac Pit
Incident Number NAPP2408034878
Eddy County, New Mexico**

Ensolum, LLC (Ensolum), on behalf of XTO Energy, Inc. (XTO), has prepared this *Closure Request* to document delineation, excavation, and soil sampling activities performed at the PLU South Frac Pit (Site). The purpose of excavation and soil sampling activities was to confirm the presence or absence of impacted soil from a release of produced water at the Site. XTO is submitting this *Closure Request*, describing delineation and excavation activities that have occurred and requesting no further remediation for Incident Number NAPP2408034878.

XTO Energy, Inc
PLU South Frac Pit
nAPP2408034878

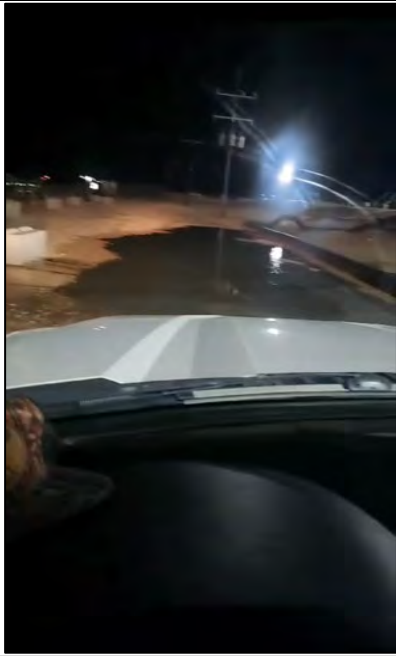
Photograph: 1 Date: 3/8/2024
Description: Initial release pooling
View: East

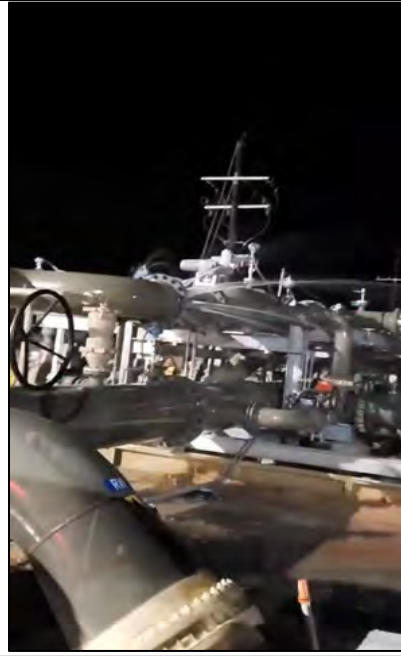
Photograph: 2 Date: 3/8/2025
Description: Point of release
View: North

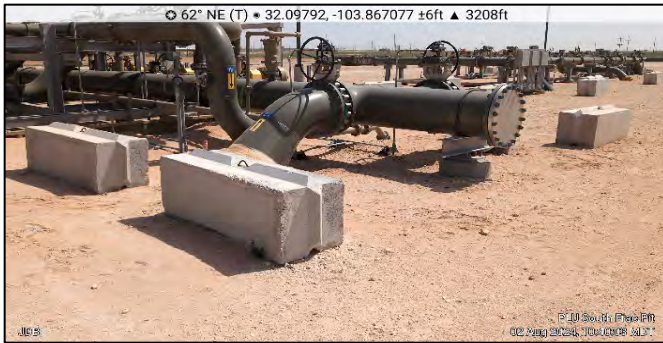
Photograph: 3 Date: 8/2/2024
Description: Delineation activities
View: Northeast

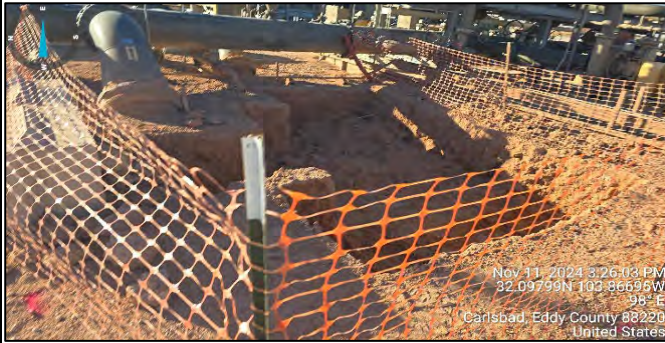
Photograph: 5 Date: 11/11/2024
Description: Final excavation extent; near FS01
View: East

The final excavation extent measured approximately 196 square feet. A total of approximately 22 cubic yards of waste-containing soil were removed during the excavation activities. The waste containing soil was transported and disposed of at the R360 Disposal Facility in Hobbs, New Mexico. The final excavation was backfilled with material purchased locally and was recontoured to match pre-existing Site conditions.

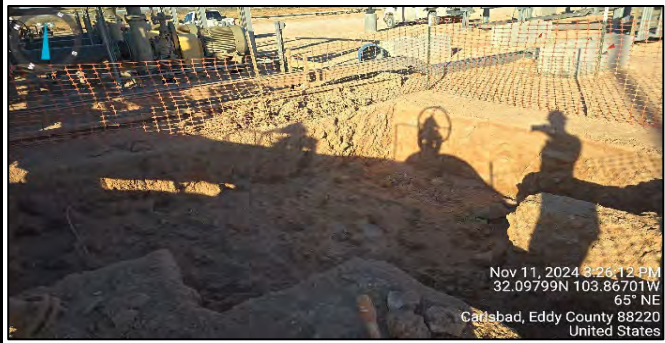
Photograph: 6 Date: 11/11/2024
Description: Final excavation extent; near FS01
View: Northeast

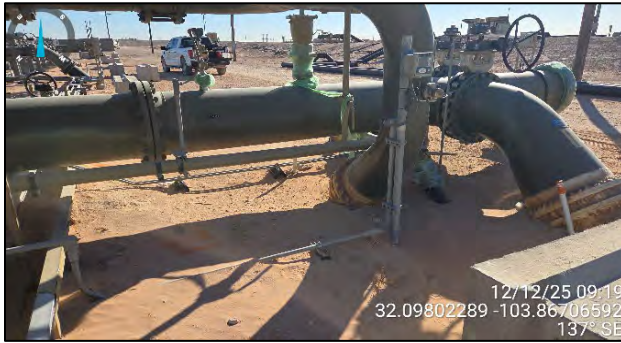
Photograph: 9 Date: 12/12/2025
Description: Confirmation sampling; near CS12
View: Southeast

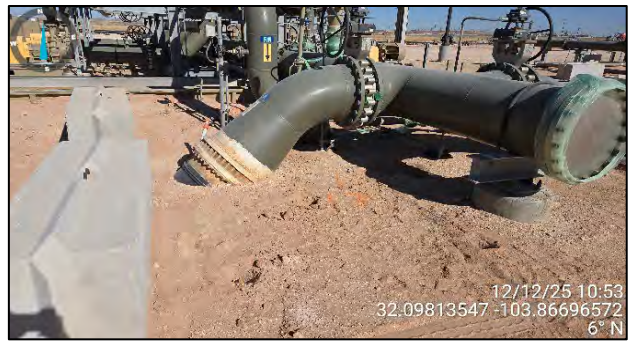
Photograph: 10 Date: 12/12/2025
Description: Confirmation sampling; near CS13
View: North

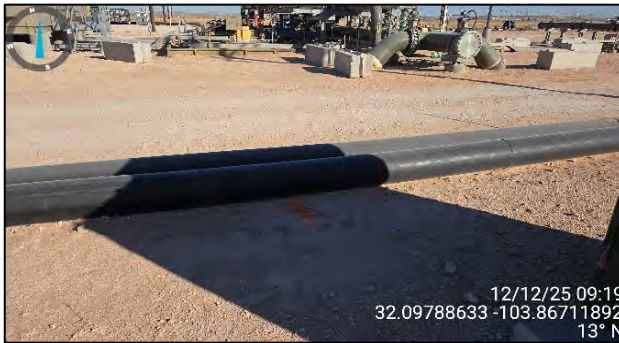
Photograph: 11 Date: 12/12/2025
Description: Confirmation sampling; near CS14
View: North

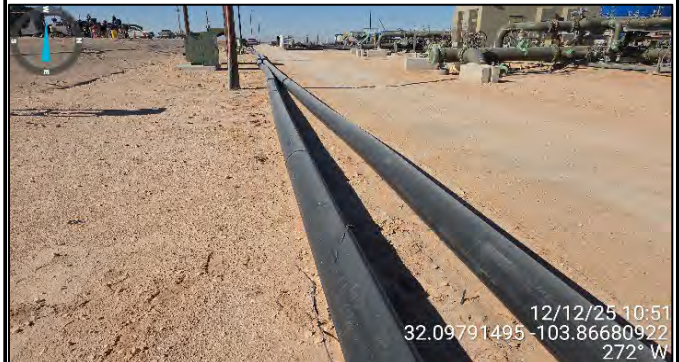
Photograph: 12 Date: 12/12/2025
Description: Confirmation sampling; near CS15
View: West

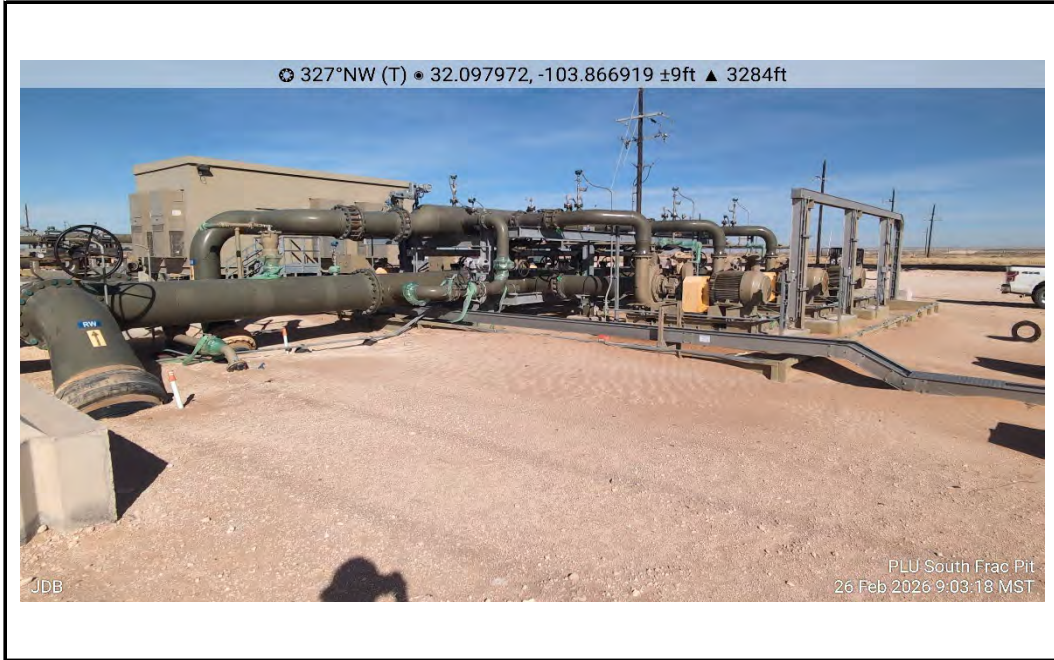
Photograph 13

Description: Delineation activities; near SS06

On February 26, 2026, Ensolum personnel returned to the Site to collect an additional delineation soil sample in accordance with the conditionally approved *Work Plan* dated January 26, 2026. One delineation soil sample, SS06, was collected immediately south of the lined containment that is present on the northside of the release extent. The sample was collected from a depth of 0.5 feet bgs between the release extent and mechanical barrier. The soil sample was collected, handled, and analyzed as described above at Cardinal in Hobbs, New Mexico. The additional delineation soil sample location is depicted on Figure 2. Photographic documentation of the additional soil sampling activities is provided in Appendix B.
