Closure Report
Honey Graham State 2H (11.29.24)
Eddy County, New Mexico
Unit N Sec 20 T26S R28E
32.020755°, -104.111470°
Incident Number: nAPP2433733625

Produced Water Release
Point of Release: Equipment Failure
Release Date: 11.29.2024
Volume Released: 40 barrels of Produced Water
Volume Recovered: 39 barrels of Produced Water

Re: Closure Report
Honey Graham State 2H (11.29.24)
Concho Operating, LLC
Incident ID: nAPP2433733625
Site Location: Unit N, S20, T26S, R28E
(Lat 32.020755°, Long -104.111470°)
Eddy County, New Mexico

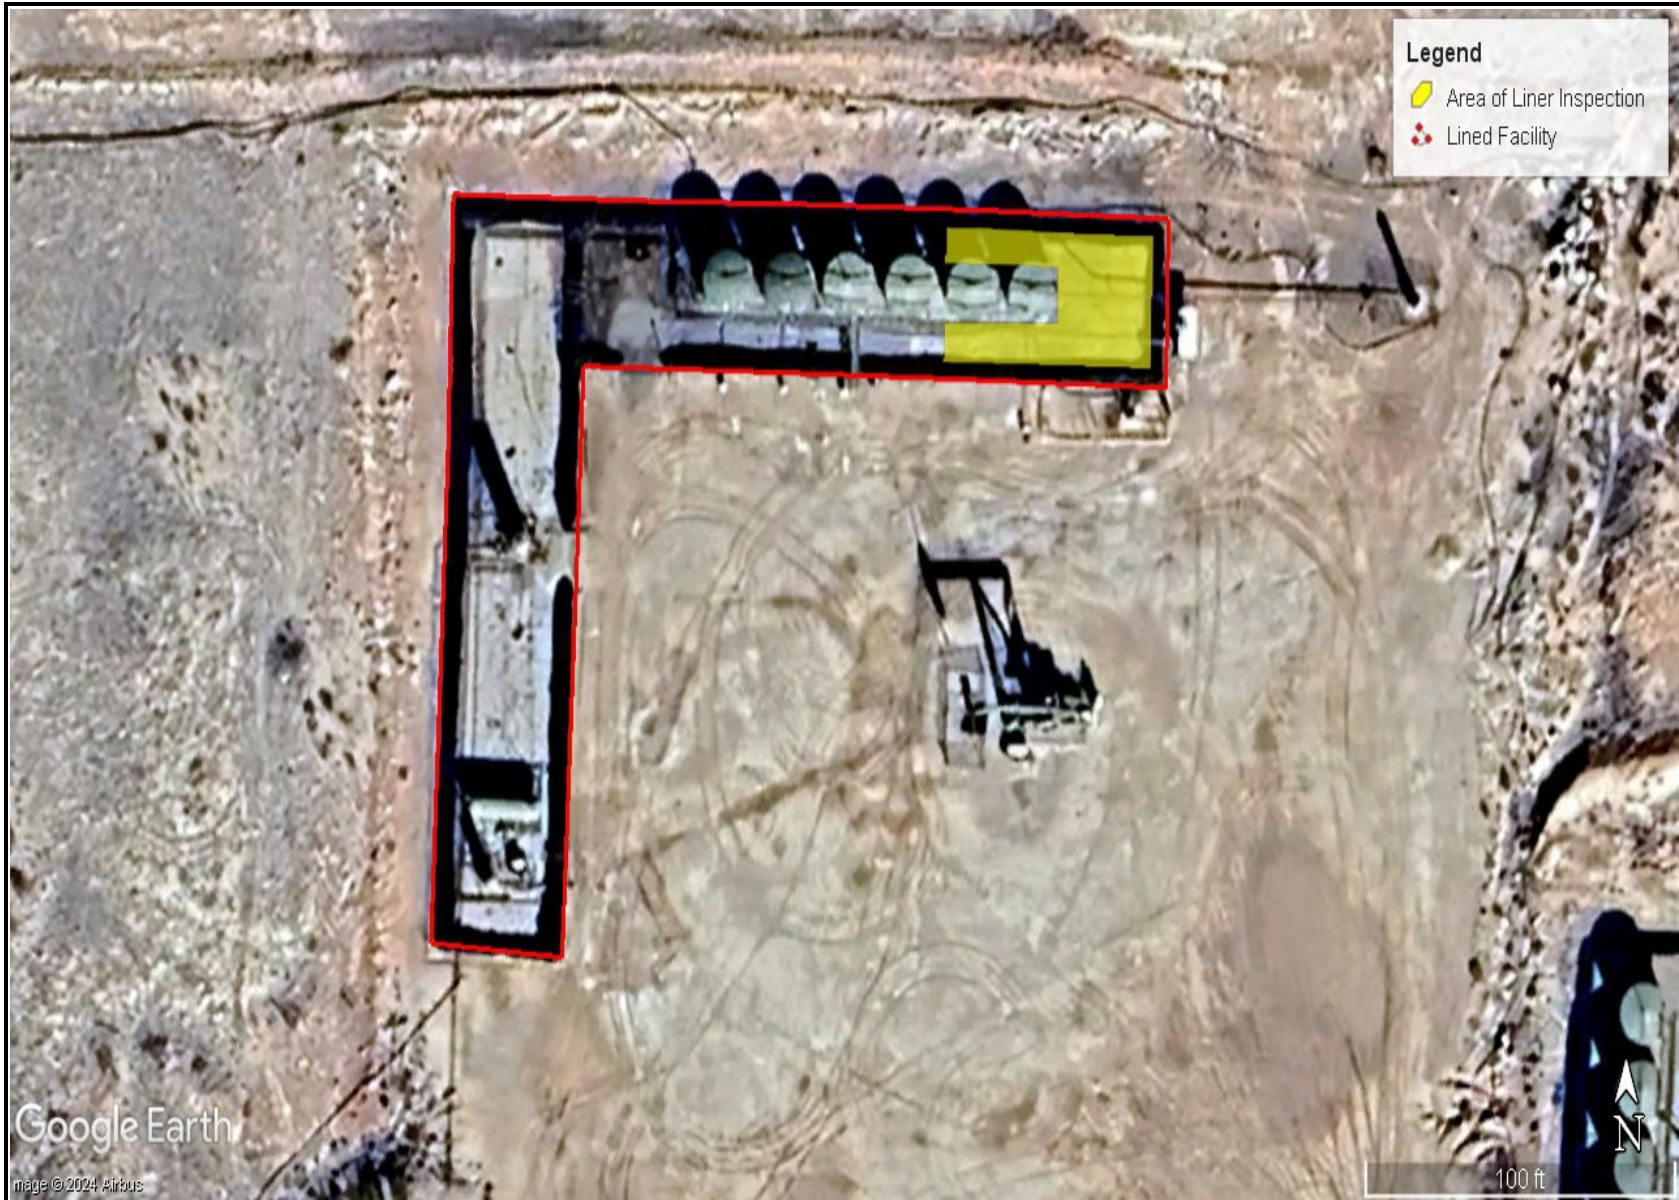
FIGURE 3

SECONDARY CONTAINMENT MAP
COG OPERATING, LLC
HONEY GRAHAM STATE 2H (11.29.24)
EDDY COUNTY, NEW MEXICO
32.020755°, -104.111470°

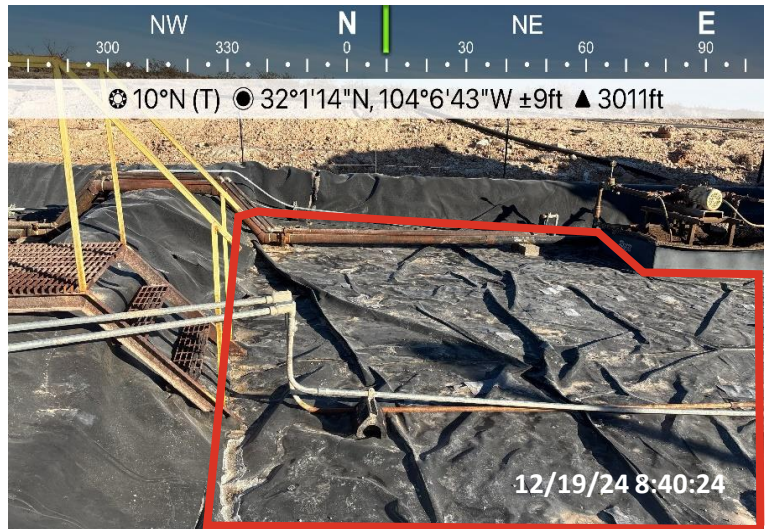
Photograph No. 1

View North of the exposed liner after the pea gravel was removed. The red outline is the area of the liner inspection.

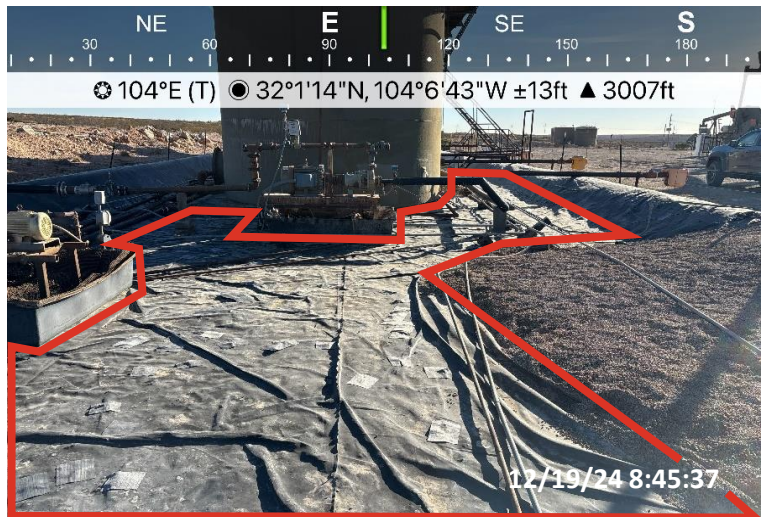
Photograph No. 2

View East of the exposed liner after the pea gravel was removed. The red outline is the area of the liner inspection.

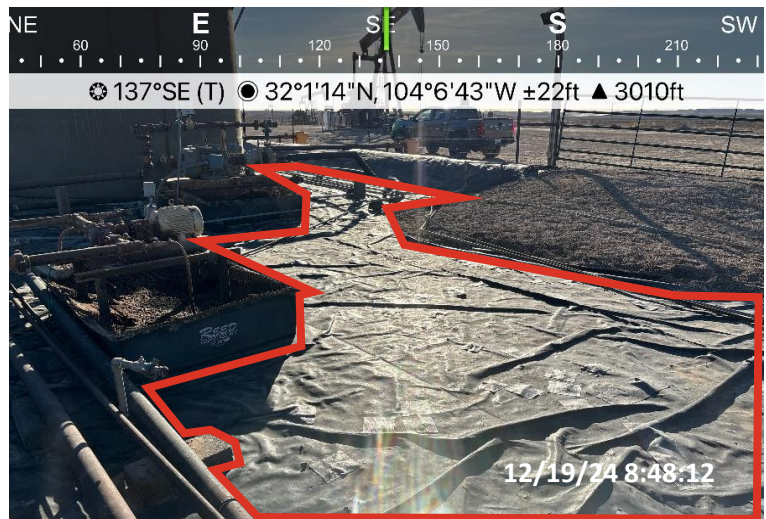
Photograph No. 3

View Southeast of the exposed liner after the pea gravel was removed. The red outline is the area of the liner inspection.

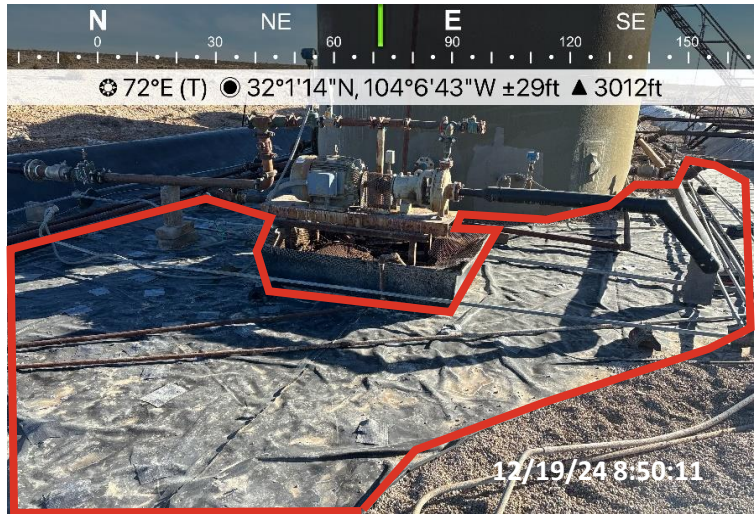
Photograph No. 4

View East of the exposed liner after the pea gravel was removed. The red outline is the area of the liner inspection.

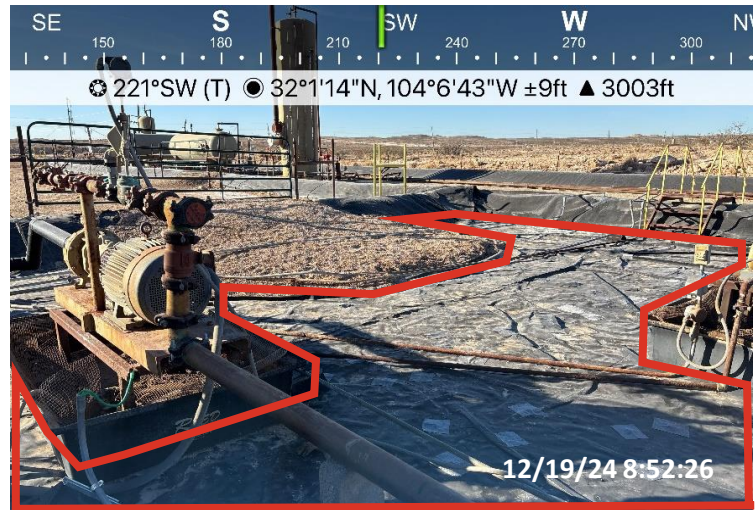
Photograph No. 5

View Southwest of the exposed liner after the pea gravel was removed. The red outline is the area of the liner inspection.

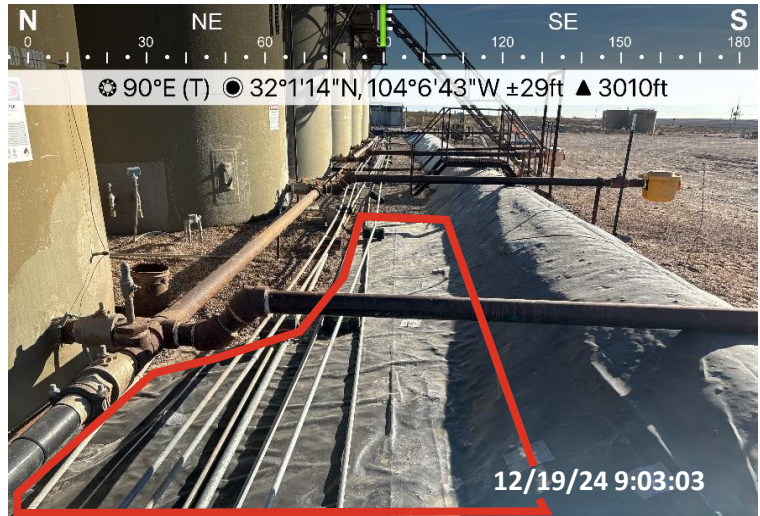
Photograph No. 10

View East of the exposed liner after the pea gravel was removed. The red outline is the area of the liner inspection.
