Revised Remediation Summary and Deferral Request

**State J 2 #017
30-025-33277
Incident #nSAP0225252743
Lease B0-1534
Lea County, New Mexico**

Prepared For:

Southwest Royalties, Inc.
P.O. Box 53570
Midland, Texas 79710

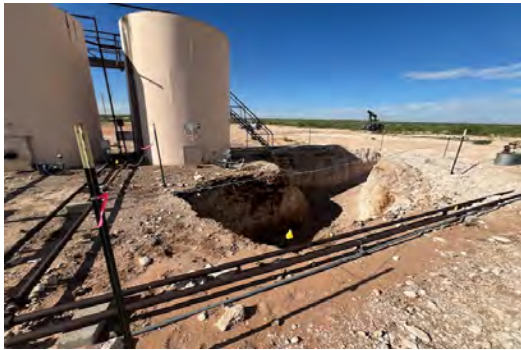
View to SW of E TB excavation (8/7/25).

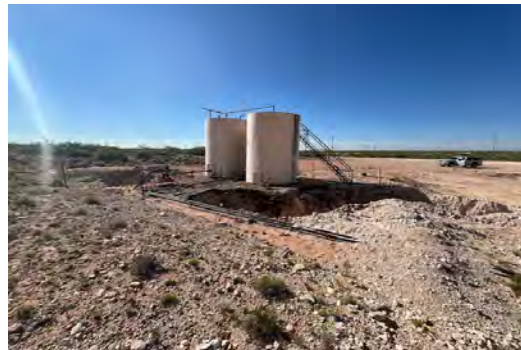
View to SE of TB excavations (8/7/25).

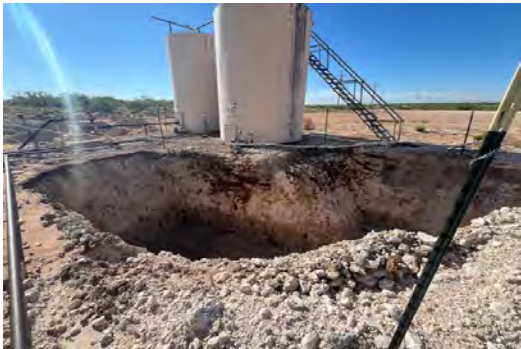
View to SE of W TB excavation (8/7/25).

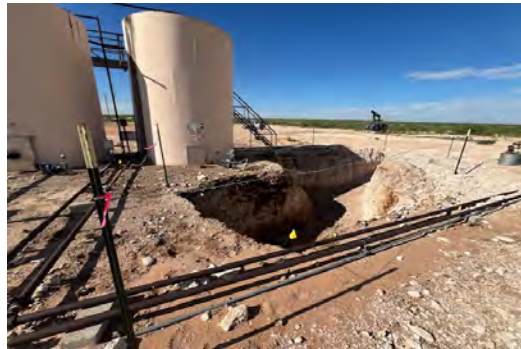
View to SW of E TB excavation (8/7/25).

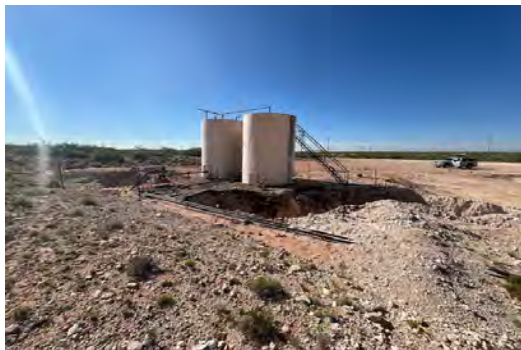
View to SE of TB excavations (8/7/25).

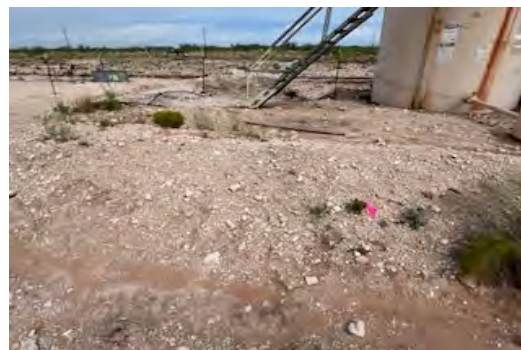
View to N of flag at S-10 location (9/17/25).

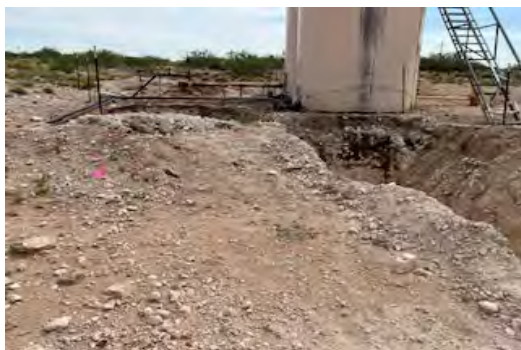
View to E of flag at S-11 location (9/17/25).

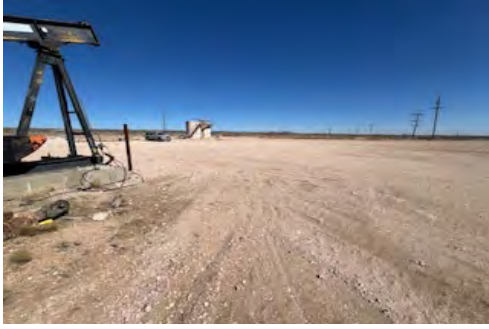
View to NW of backfilled excavation at wellhead (nAPP2511834534).

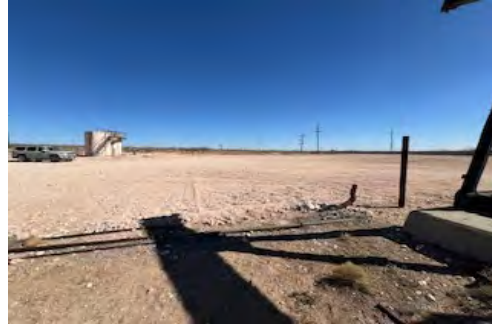
View to NW of backfilled excavation at wellhead (nAPP2511834534).

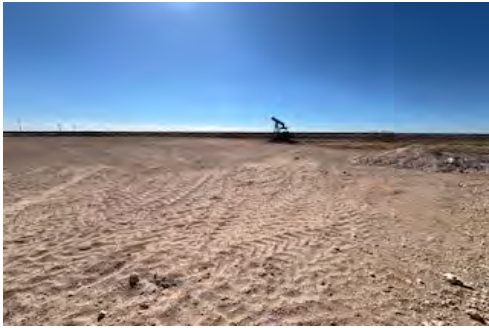
View to SW of backfilled excavation at wellhead (nAPP2511834534).

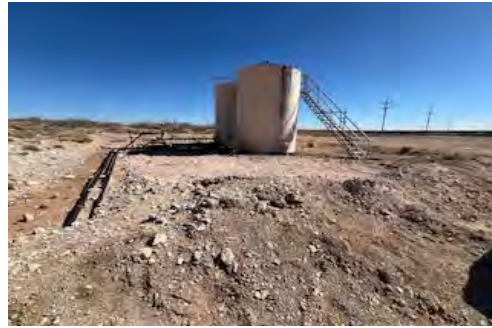
View to E of backfilled excavations at battery (nSAP0225252743).

As Closure and/or deferral of each Incident was approved by both the NMOCD and ECO, the excavations were backfilled with 372 cubic yards of clean soil from January 5 to January 9, 2026. The impacted surface areas were restored to pre-release conditions, and the berm surrounding the tanks was reinforced to ensure containment of fluids if another release were to occur.

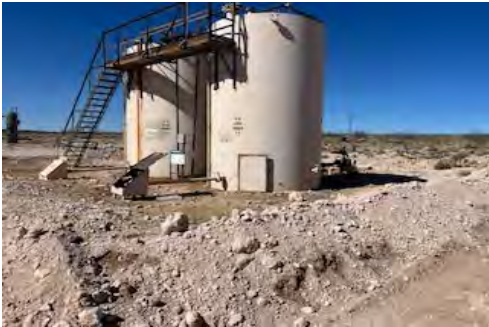
View to NW of backfilled excavations at battery (nSAP0225252743).

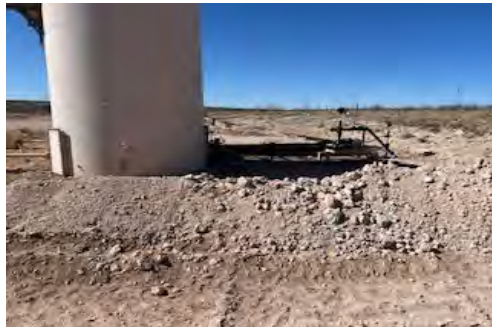
View to S of backfilled excavations at battery (nSAP0225252743).

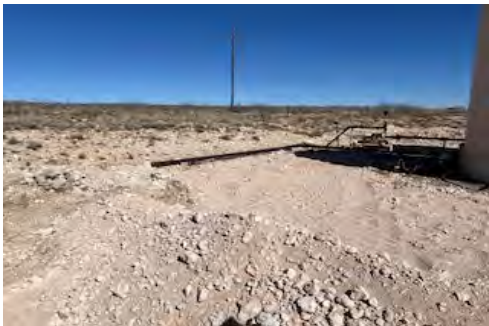
View to SE of backfilled excavations at battery (nSAP0225252743).
