**Re: 2026 Revised Remediation Work Plan  
Remuda Basin Battery Unit #1  
Incident Number NHMP1413240586  
Facility ID fAPP2126043451  
Eddy County, New Mexico**

Ensolum, LLC (Ensolum), on behalf of XTO Energy, Inc. (XTO), has prepared the following *2026 Revised Remediation Work Plan (RRWP)* to propose additional remedial activities to address impacted soil resulting from the April 27, 2014, produced water release at the Remuda Basin Battery Unit #1 (Site). On May 12, 2020, a *Deferral Request* was prepared on behalf of XTO by LT Environmental, Inc. (LTE) and submitted to the New Mexico Oil Conservation Division (NMOCD) documenting delineation soil sampling and excavation activities completed at the Site. NMOCD approved XTO's deferral request on September 27, 2022, with the stipulation that final remediation of the remaining impacted soil would occur during any future major deconstruction, alteration and/or abandonment. A *2026 Remediation Work Plan (RWP)* was submitted to the NMOCD on January 28, 2026, proposing additional delineation of impacts and installation of a clay liner to provide an artificial hydraulic barrier to stop downward migration of the impacts towards groundwat

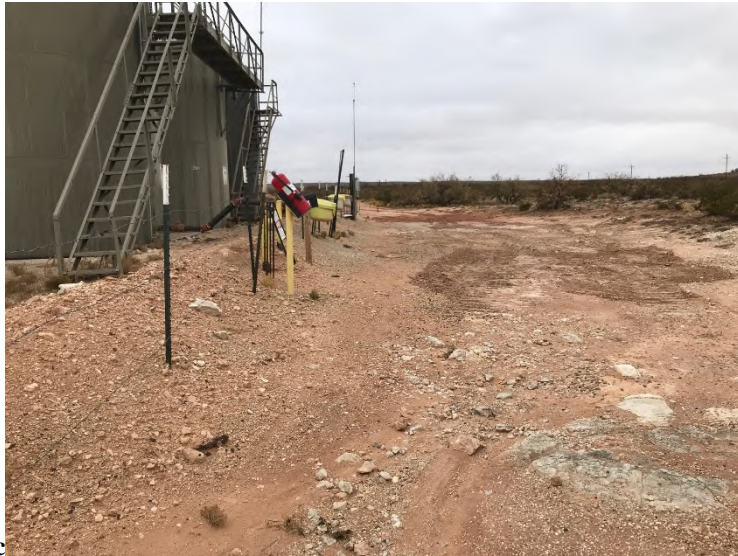
**Photograph 1:** View of loading area – looking east.

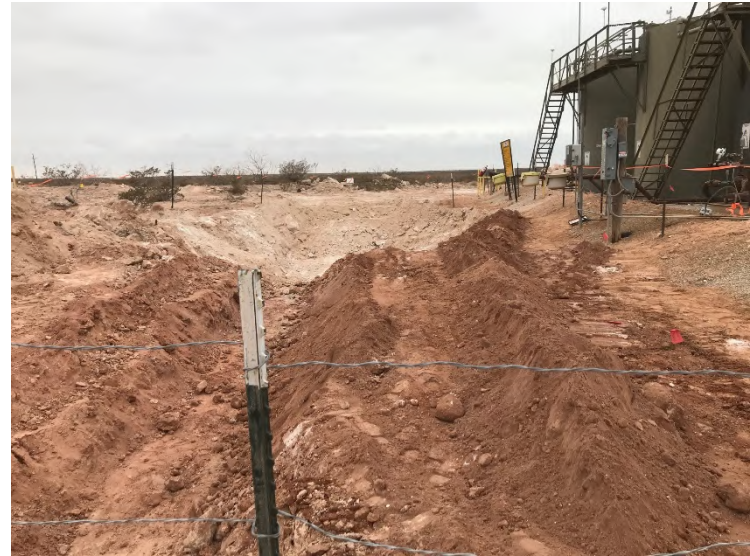
**Photograph 2:** View of pad and excavation – looking west

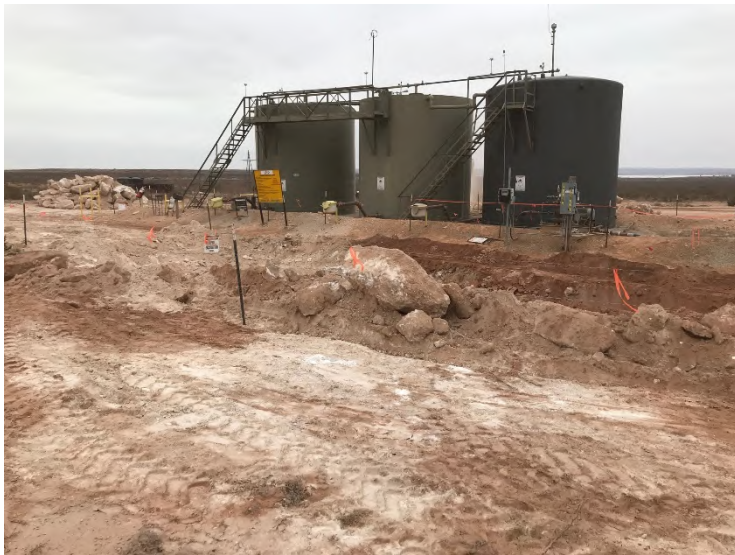
**Photograph 3:** View of tank battery and excavation - looking north west.

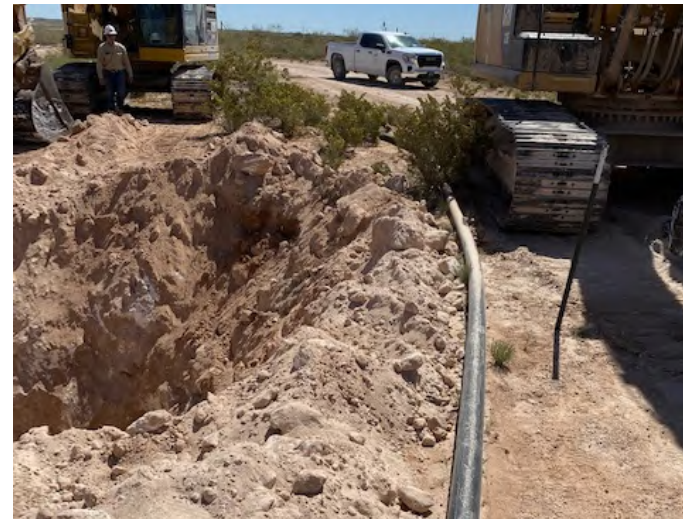
**Photograph 4:** View of open excavation – looking east.
