**Re: Remediation Work Plan  
Poker Lake Unit CVX JV PC #006H  
Incident Number nAB1730536457  
Eddy County, New Mexico**

Ensolum, LLC (Ensolum) on behalf of XTO Energy, Inc. (XTO), has prepared this *Remediation Work Plan (Work Plan)* to document site assessment, delineation, and soil sampling activities at Poker Lake Unit CVX JV PC #006H (Site). The purpose of the remediation activities was to assess for the presence or absence of impacts to soil following a 2017 release of produced water in a pipeline right-of-way (ROW). The following *Work Plan* describes remedial activities that have occurred and proposes to excavate impacted soil and install a soil boring to investigate depth to groundwater to confirm the Closure Criteria at the Site.

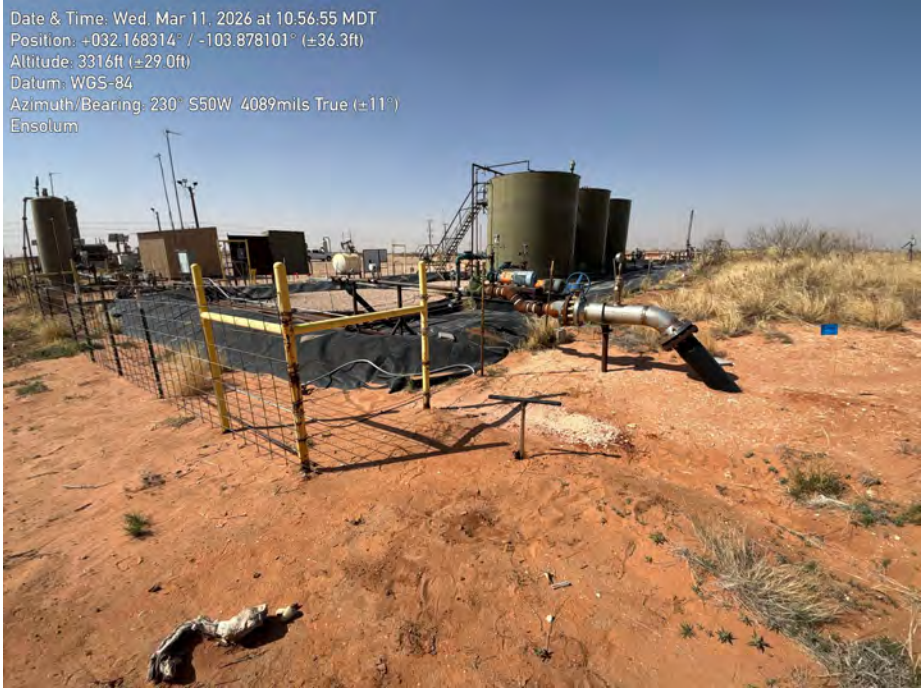
<p><u>Description</u> Assessment sampling activities; near SS01</p>		
<p><u>View</u> Southwest</p>		
<p><u>Photograph</u> 2</p>	<p><u>Date</u> 3/12/2026</p>	<p>Date &amp; Time: Thu, Mar 12, 2026 at 15:04:31 MDT            Position: +032.168295° / -103.878221° (±30.3ft)            Altitude: 3318ft (±22.6ft)            Datum: WGS-84            Azimuth/Bearing: 130° S50E 2311mils True (±11°)            Ensolum</p>

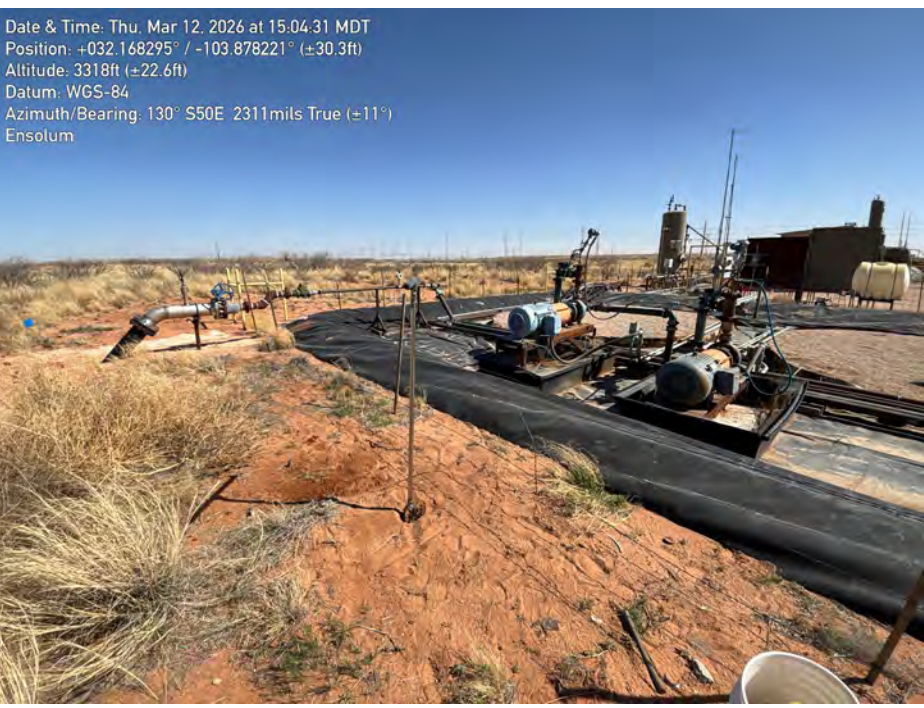
<p><u>Description</u> Assessment sampling activities; near SS05</p>		
<p><u>View</u> Southeast</p>

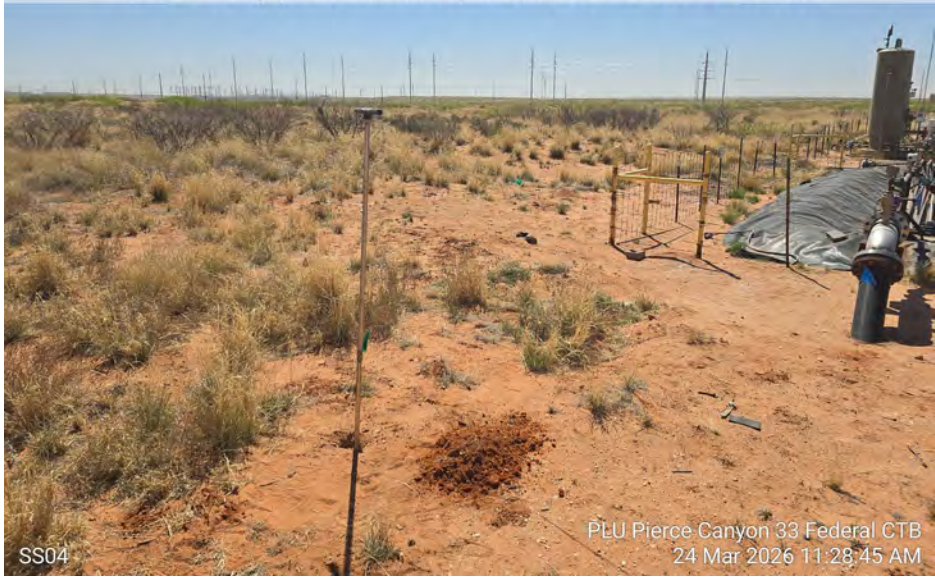
<p style="font-size: small;">SS04              PLU Pierce Canyon 33 Federal CTB              24 Mar 2026 11:28:45 AM</p>
<p><u>Description</u> Assessment sampling activities; near SS04</p>		
<p><u>View</u> Southeast</p>		
<p><u>Photograph</u> 4</p>	<p><u>Date</u> 3/24/2026</p>	<div style="background-color: #002060; color: white; padding: 5px; text-align: center;"> <h2>North</h2> </div> <div style="background-color: #e0e0e0; padding: 5px; text-align: center;"> <p>☉ 3°N (T) • 32.168229, -103.87808 ±9ft ▲ 3215ft</p> </div>

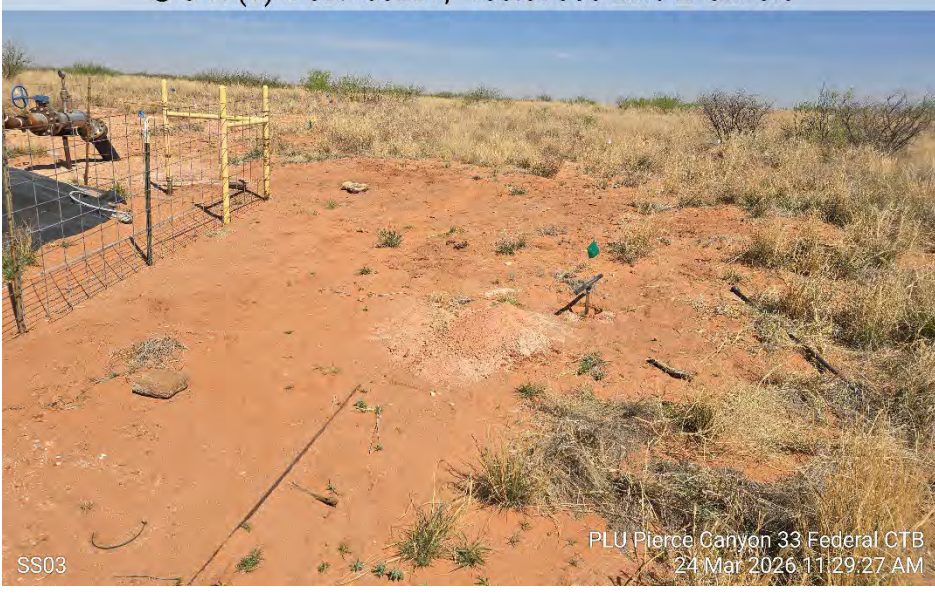
<p style="font-size: small;">SS03              PLU Pierce Canyon 33 Federal CTB              24 Mar 2026 11:29:27 AM</p>

<p><u>Description</u> Assessment sampling activities; near SS03</p>		
<p><u>View</u> North</p>
