RE: Mimosa Federal SWD #1 & #4 Battery Remediation Work Plan – 2RP-2967 (2RP-4162, 2RP-3351)  
Eddy County, New Mexico

**Mimosa Federal SWD #1 & #4 Battery**

**Remediation Work Plan**

**I-4-20S-24E**

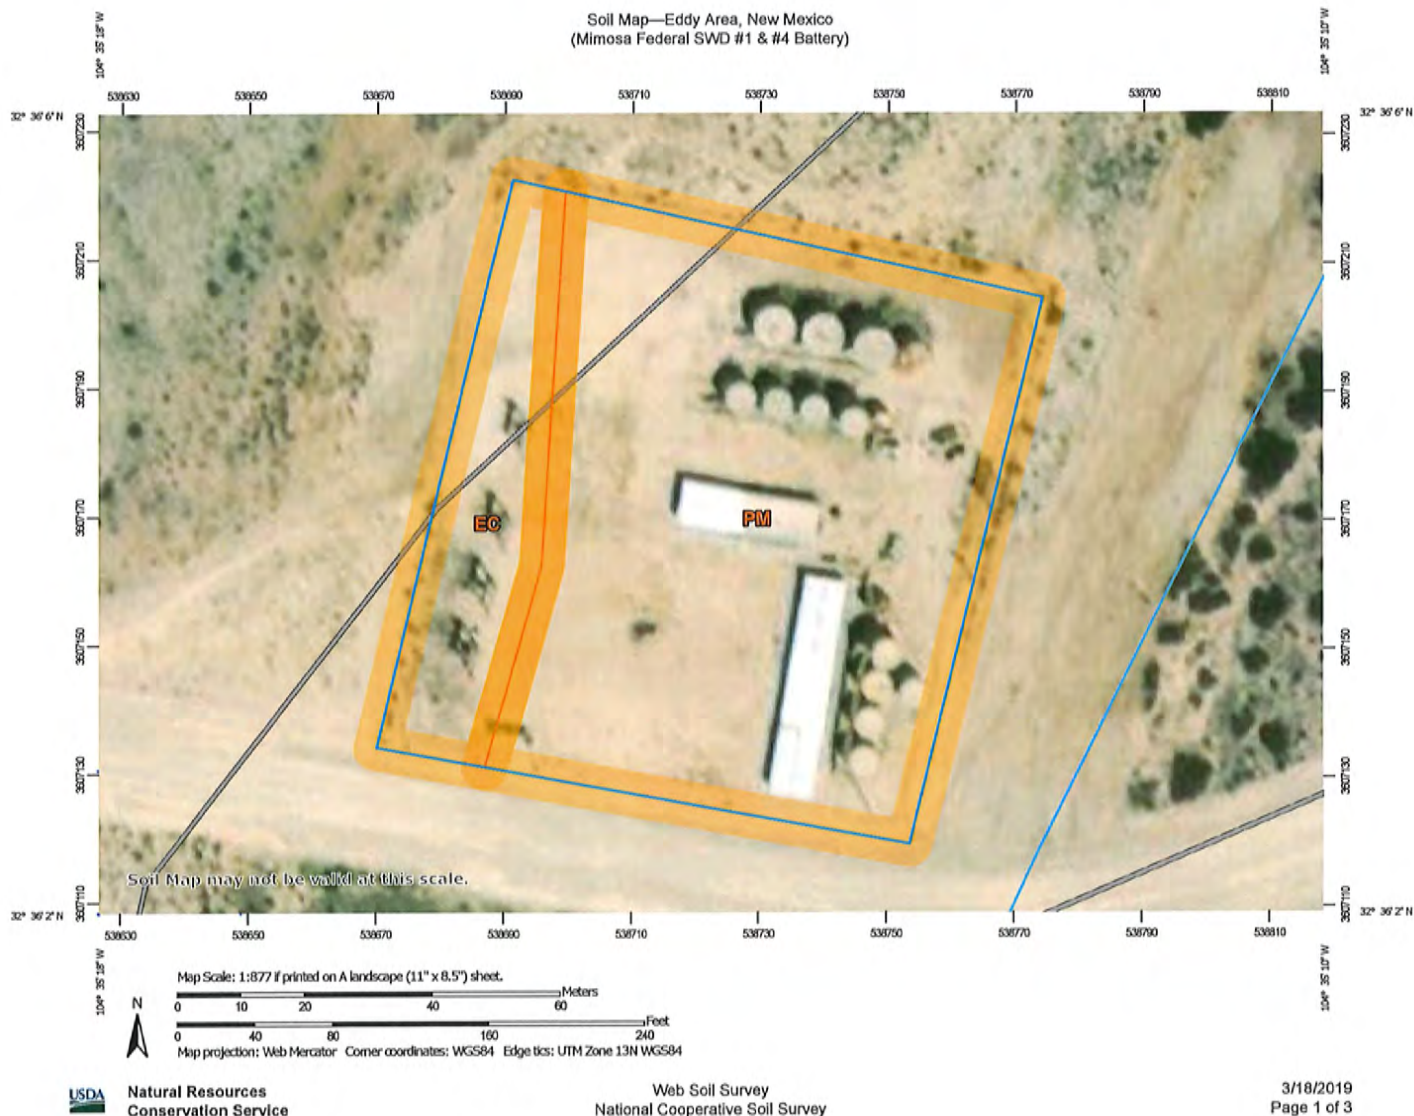
## NRCS Soil Map

Soil Map—Eddy Area, New Mexico  
(Mimosa Federal SWD #1 & #4 Battery)
