## Closure Report

### PLU 22 DTD CVB

ExxonMobil Production Company

Vertex Resource Services Inc.

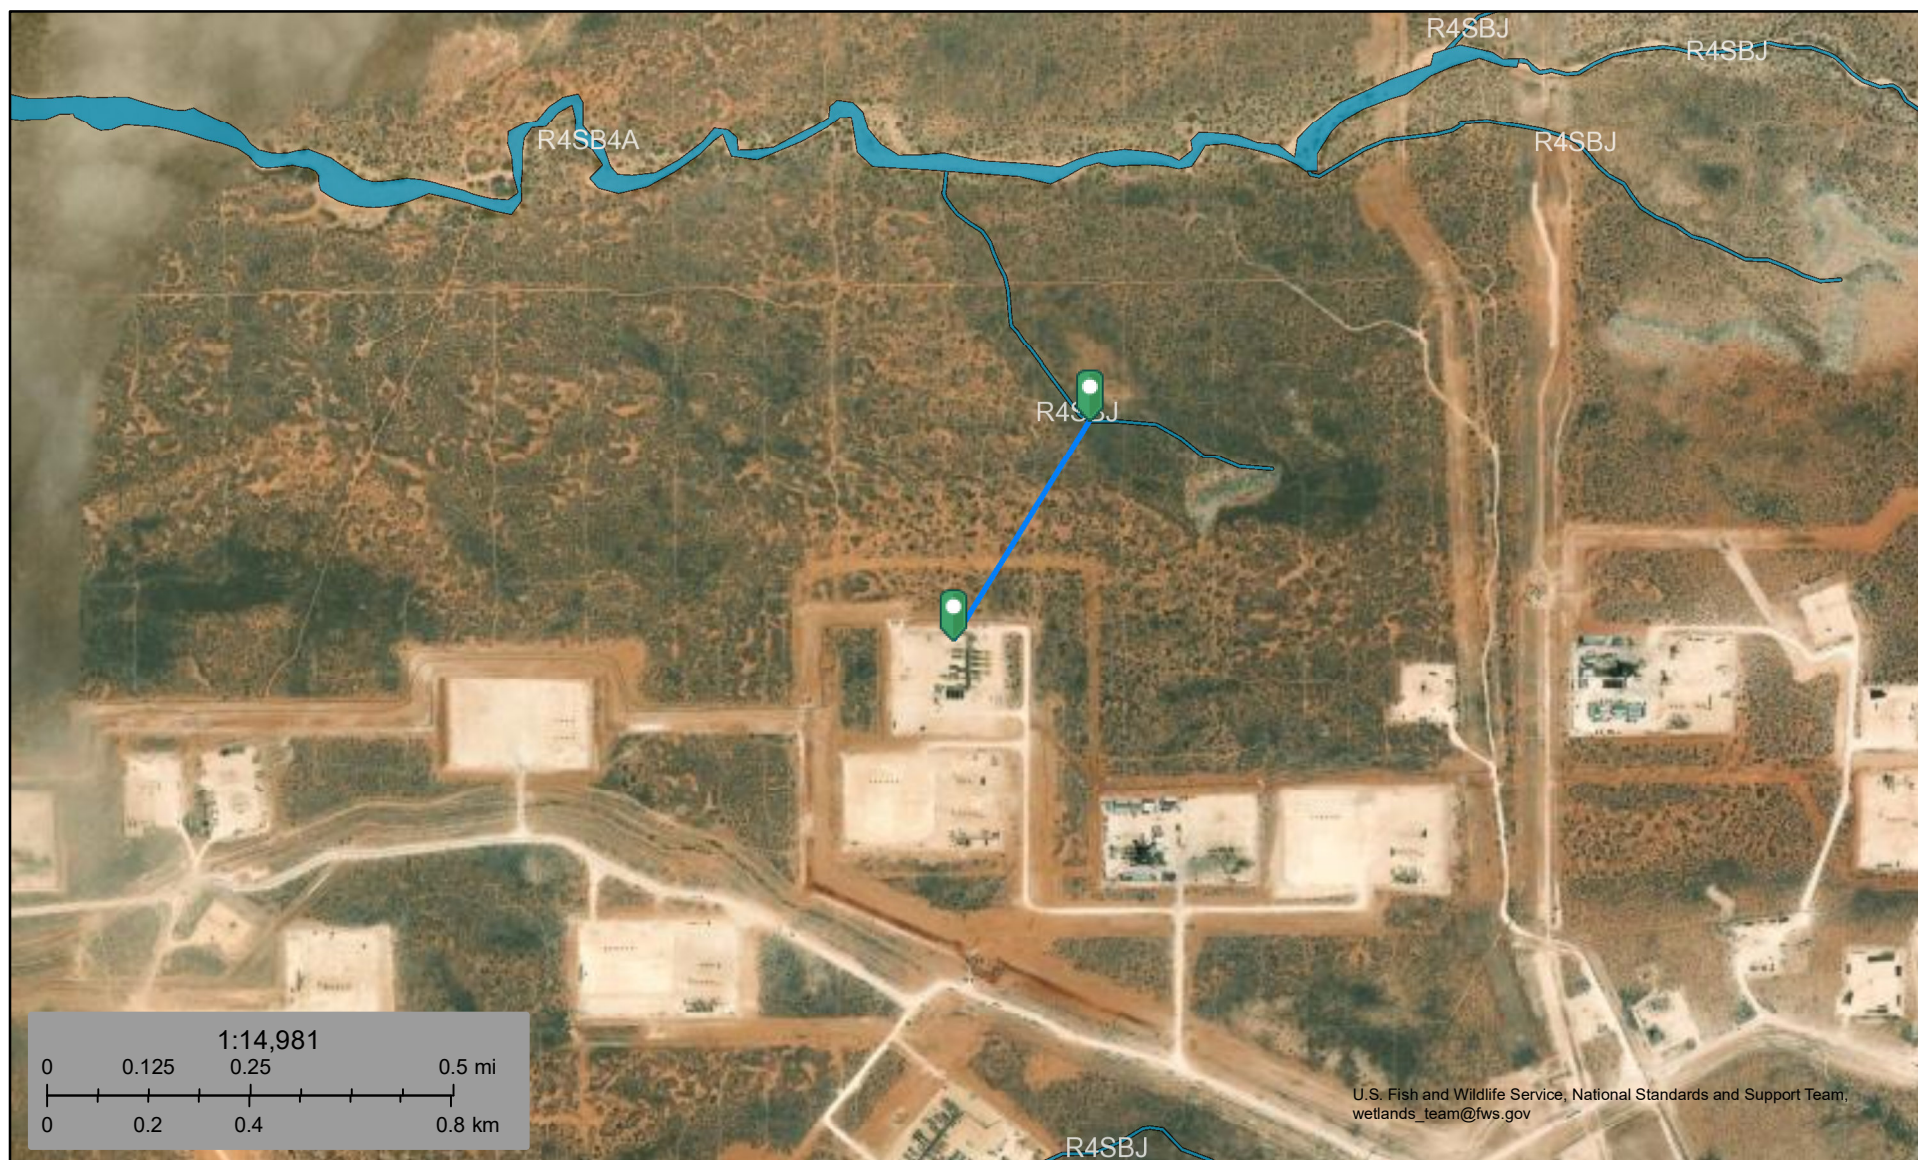
## Plate 3.1 - Watercourse - 1,420 ft NE

With the submission of the remediation work plan, the nearest watercourse to the Site was identified as, “between ½ and 1 mile” on the Site Characterization portion of the C-141. This has been reviewed and updated to, “1000 ft – ½ mile.” The watercourse and its relative location to the Site is presented on Plate 3.1 in Appendix A.

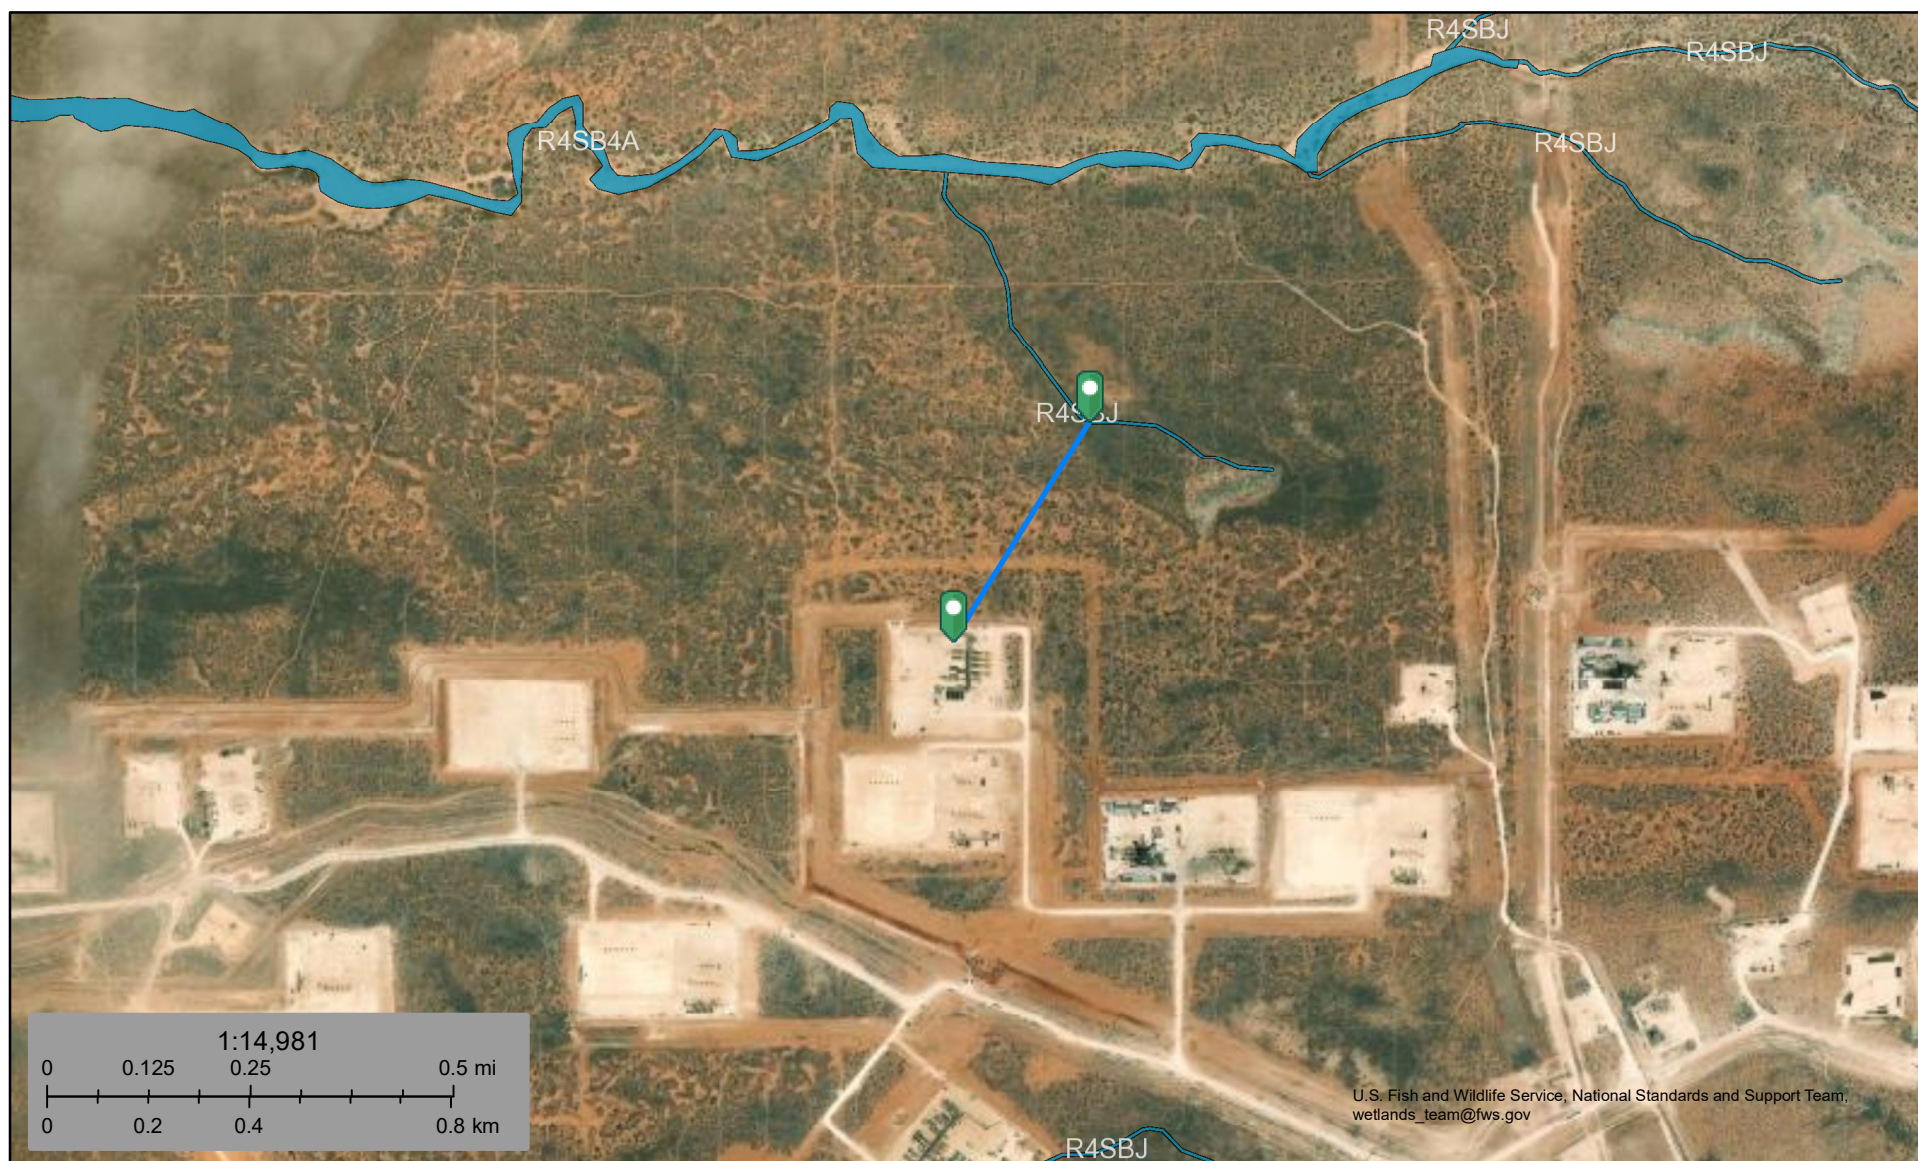
## Plate 5 - Wetland Riverine - 1,420 ft NE

updated to, "Between 1000 ft-1/2 mile" The wetland and its relative location to the Site is presented in Plate 5 of Appendix A.

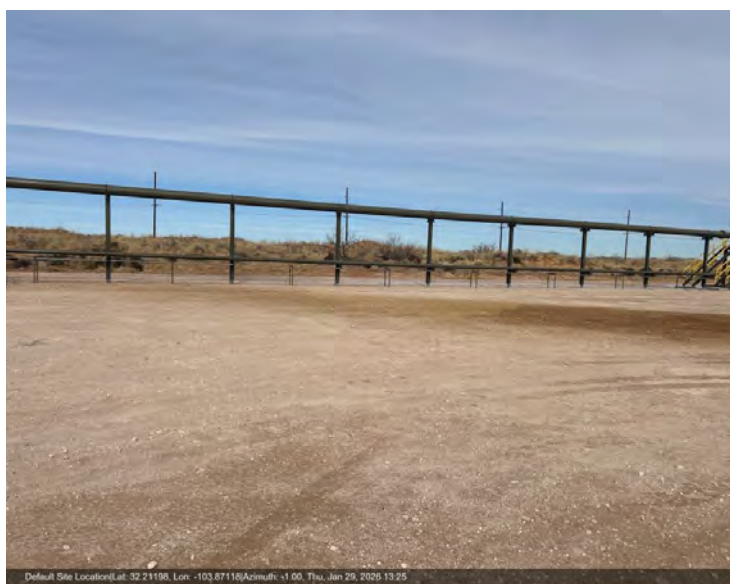
Date: 1/29/2026  
Time: 13:03  
Notes: Release  
Latitude: 32.211975  
Longitude: -103.87117777777777  
Direction: SW

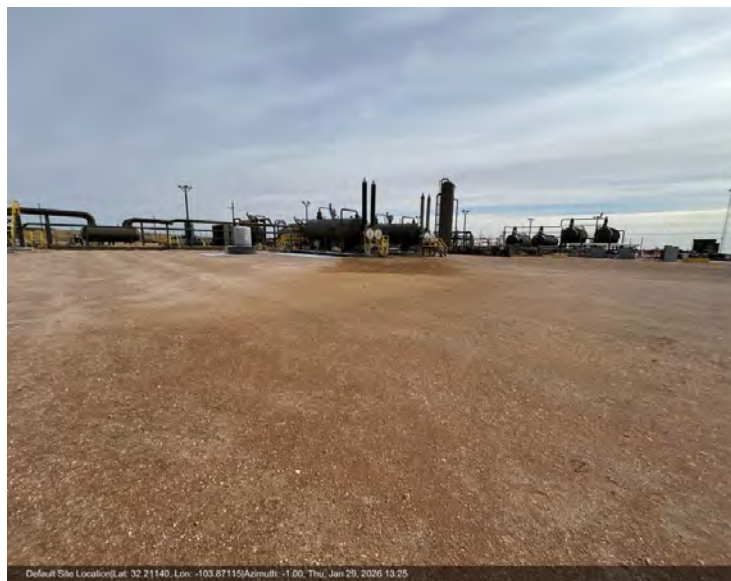
Date: 1/29/2026  
Time: 13:03  
Notes: Release  
Latitude: 32.21140277777778  
Longitude: -103.87114722222222  
Direction: SW

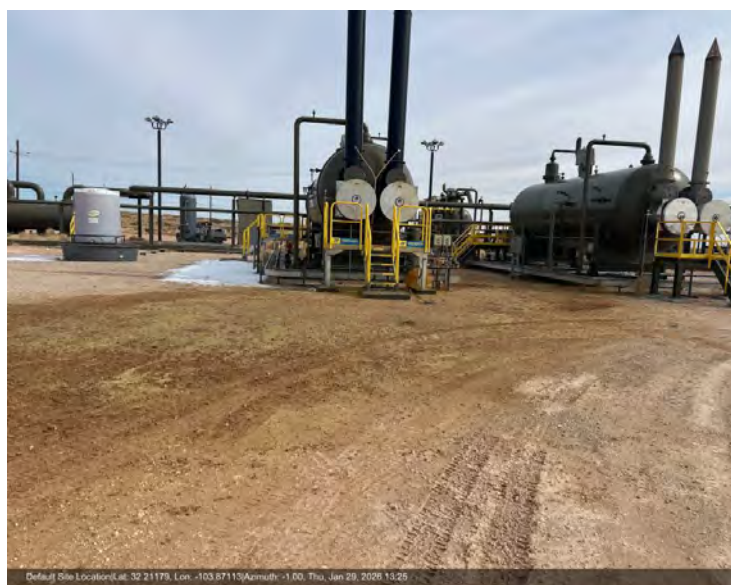
Date: 1/29/2026  
Time: 13:03  
Notes: Release  
Latitude: 32.21179166666667  
Longitude: -103.87113055555555  
Direction: SW

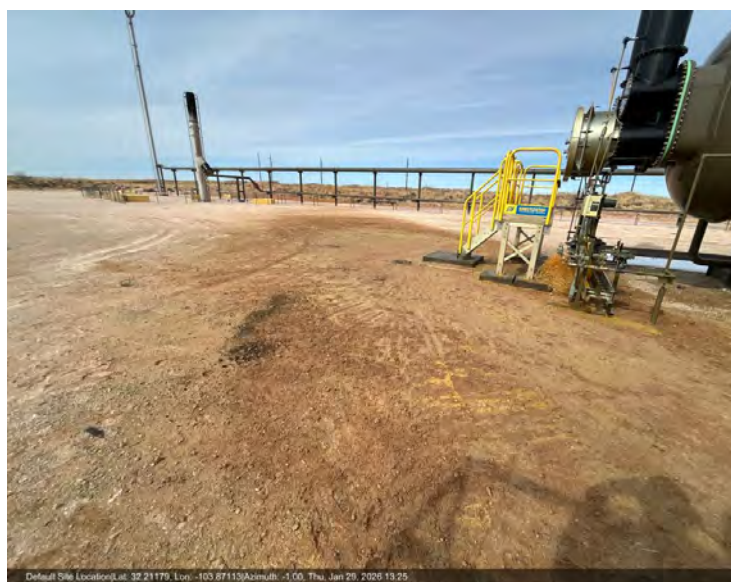
Date: 1/29/2026  
Time: 13:03  
Notes: Release  
Latitude: 32.21179166666667  
Longitude: -103.87113055555555  
Direction: SW

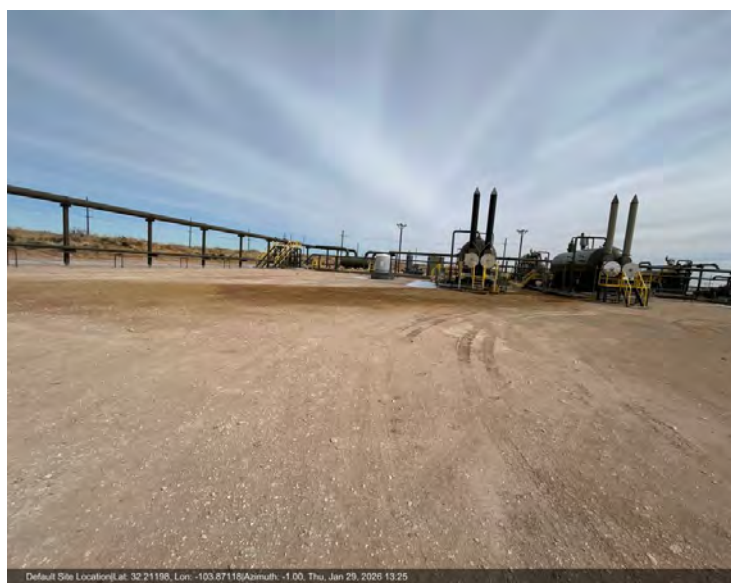
Date: 1/29/2026  
Time: 13:03  
Notes: Release  
Latitude: 32.211975  
Longitude: -103.87117777777777  
Direction: SW

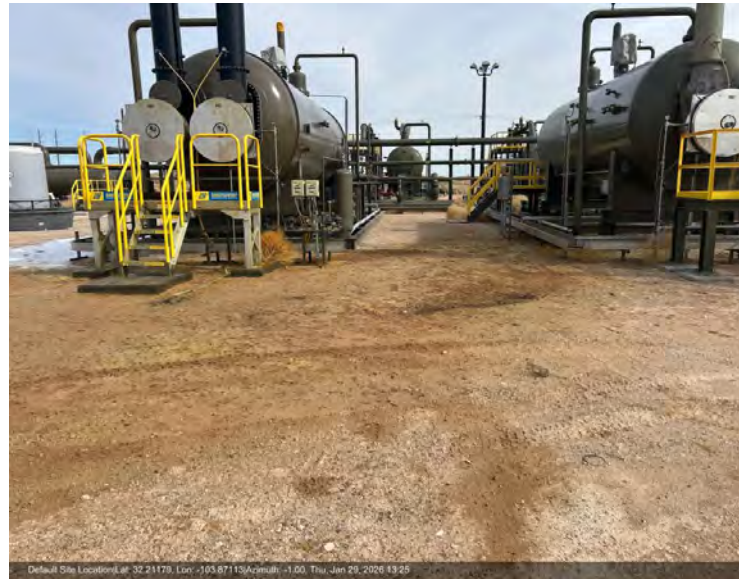
Date: 1/29/2026  
Time: 13:03  
Notes: Release  
Latitude: 32.21179166666667  
Longitude: -103.87113055555555  
Direction: SW

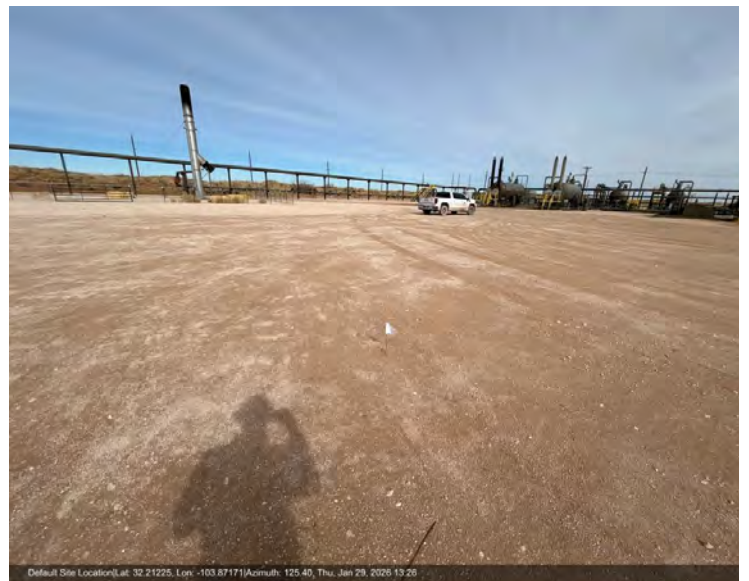
Date: 1/29/2026  
Time: 13:25  
Notes: 811 flags placed  
Latitude: 32.212250000000004  
Longitude: -103.87171111111111  
Direction: S

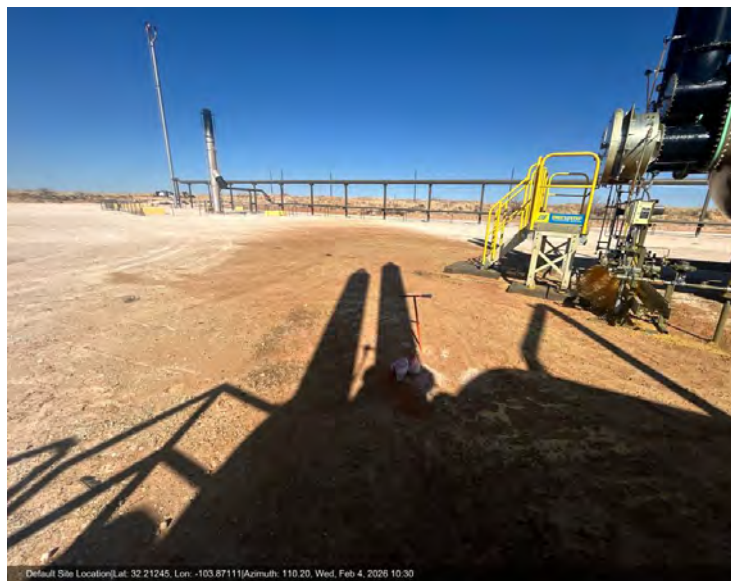
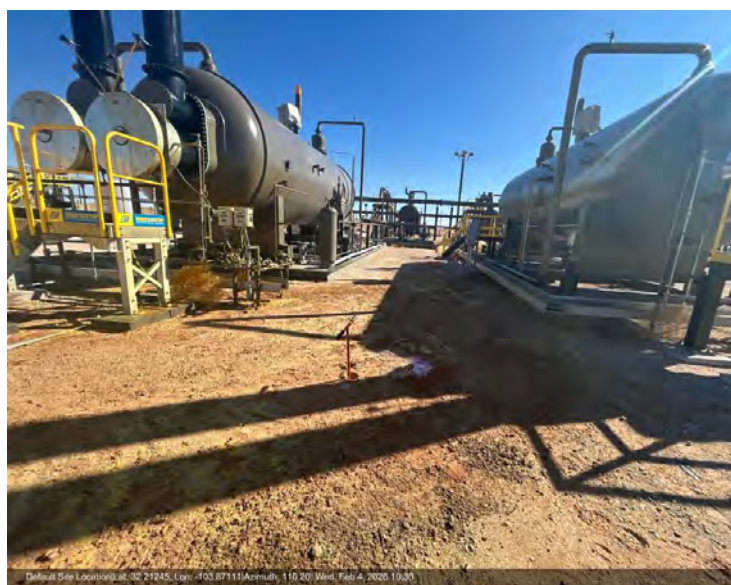
Date: 2/4/2026  
Time: 10:30  
Notes: BH26-05 @ 0'  
BH26-05 @ 1'  
BH26-05 @ 2'  
Latitude: 32.21244722222224  
Longitude: -103.87110833333332  
Direction: N

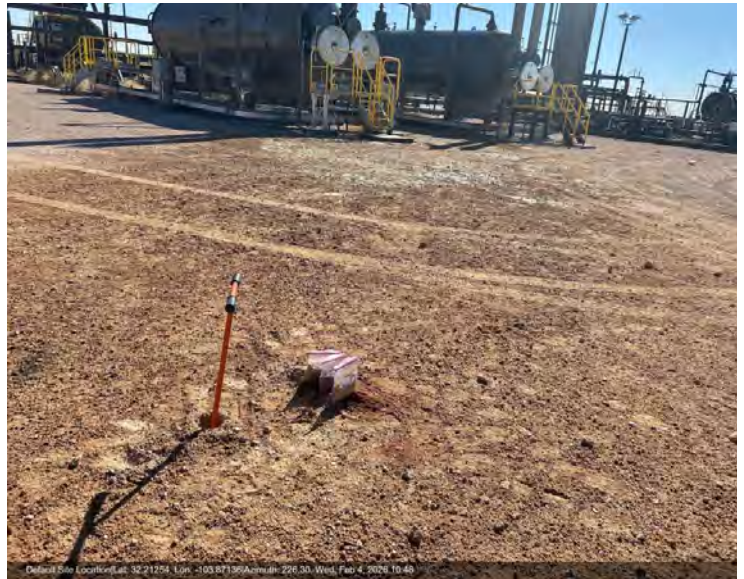
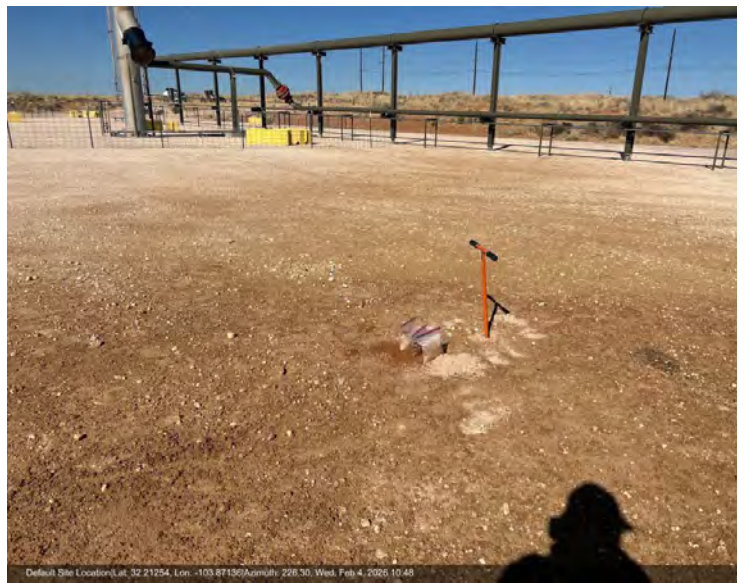
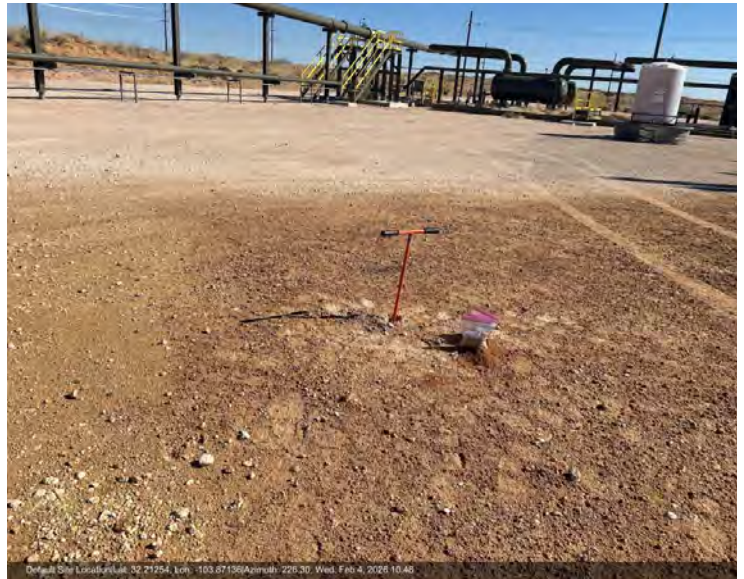
Date: 2/4/2026  
Time: 10:38  
Notes: BH26-06 @ 0'  
BH26-06 @ 1'  
BH26-06 @ 2'  
Latitude: 32.21253611111111  
Longitude: -103.87136111111111  
Direction: NW

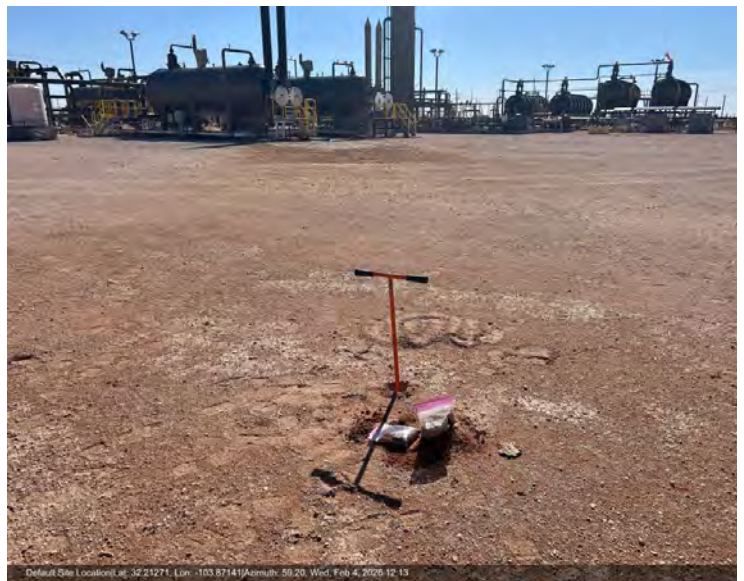
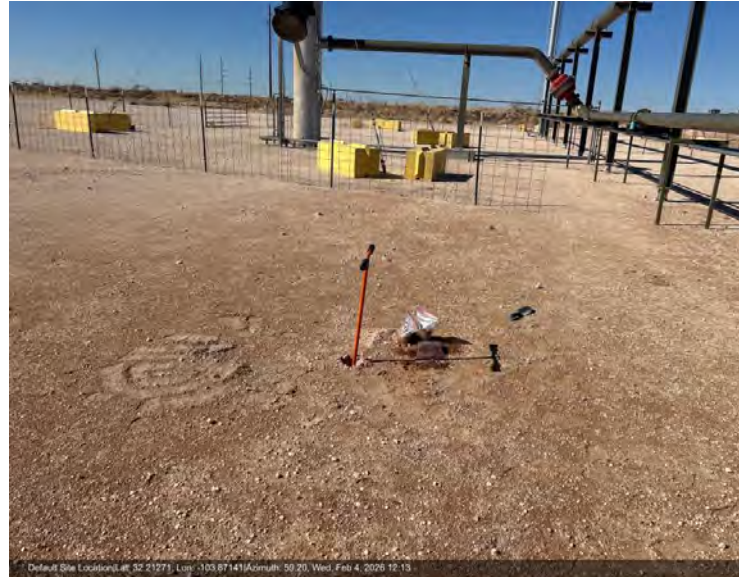
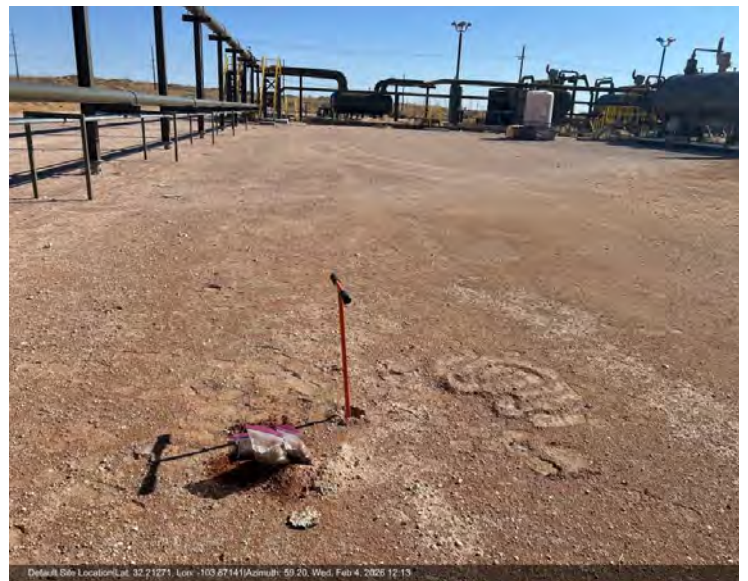
Date: 2/4/2026  
Time: 10:49  
Notes: BH26-07 @ 0'  
BH26-07 @ 1'  
BH26-07 @ 2'  
Latitude: 32.21270833333334  
Longitude: -103.87141388888888  
Direction: S

Date: 2/4/2026  
Time: 10:49  
Notes: BH26-07 @ 0'  
BH26-07 @ 1'  
BH26-07 @ 2'  
Latitude: 32.2127083333334  
Longitude: -103.87141388888888  
Direction: S

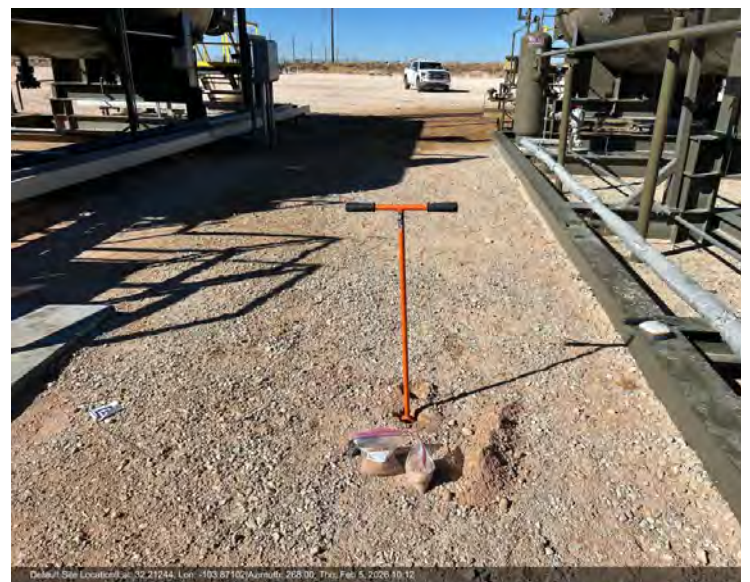
Date: 2/5/2026  
Time: 10:06  
Notes: BH26-01 @ 0'  
BH26-01 @ 1'  
Latitude: 32.21244444444445  
Longitude: -103.87102499999999  
Direction: S

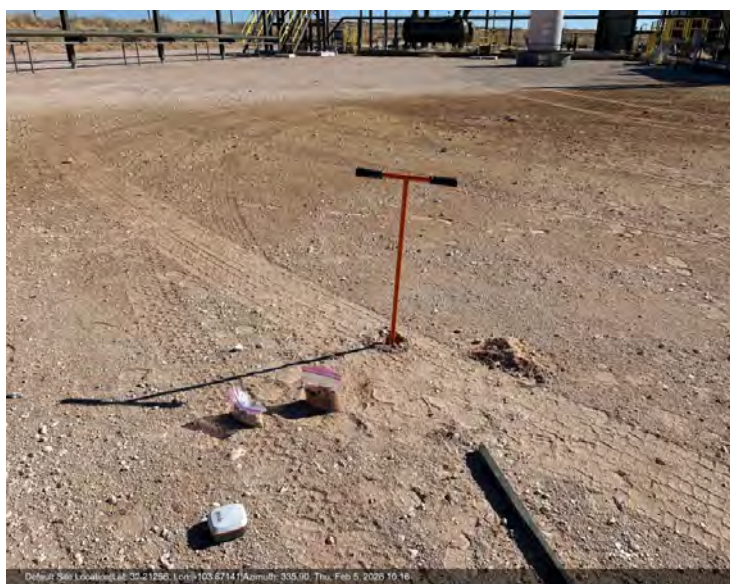
Date: 2/5/2026  
Time: 10:12  
Notes: BH26-02 @ 0'  
BH26-02 @ 1'  
Latitude: 32.212558333333334  
Longitude: -103.87140555555555  
Direction: E

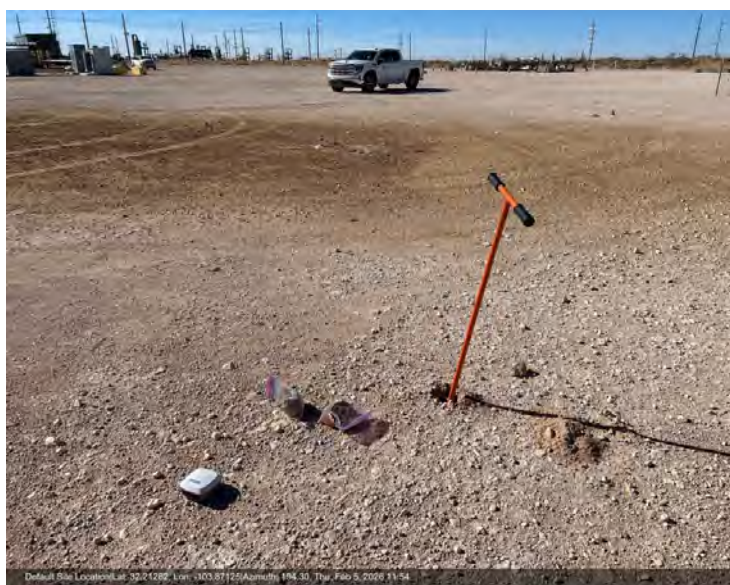
Date: 2/5/2026  
Time: 10:17  
Notes: BH26-04 @ 0'  
BH26-04 @ 1'  
Latitude: 32.212616666666667  
Longitude: -103.87124722222221  
Direction: N

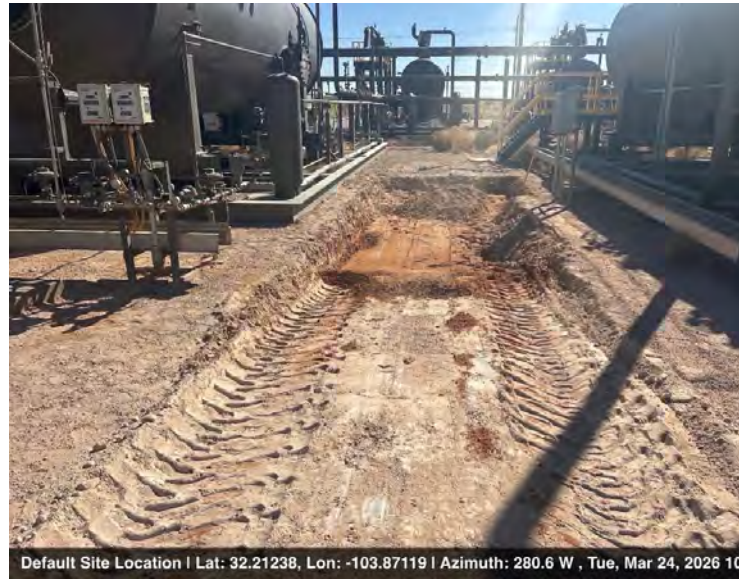
Date: 3/24/2026  
Time: 10:09  
Notes: Excavation began between compressors  
Latitude: 32.21238333333335  
Longitude: -103.87119444444444  
Direction: W

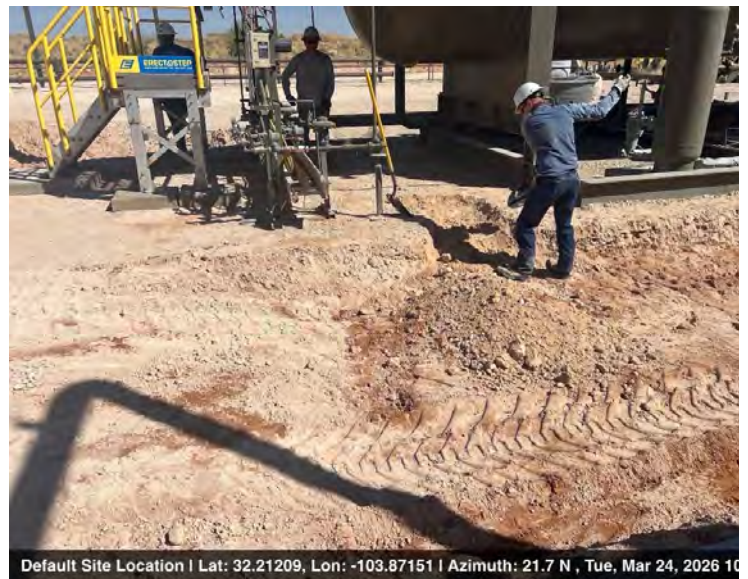
Date: 3/24/2026  
Time: 10:53  
Notes: Hand excavation began in areas not accessible by backhoe  
Latitude: 32.21208611111111  
Longitude: -103.87151388888888  
Direction: N

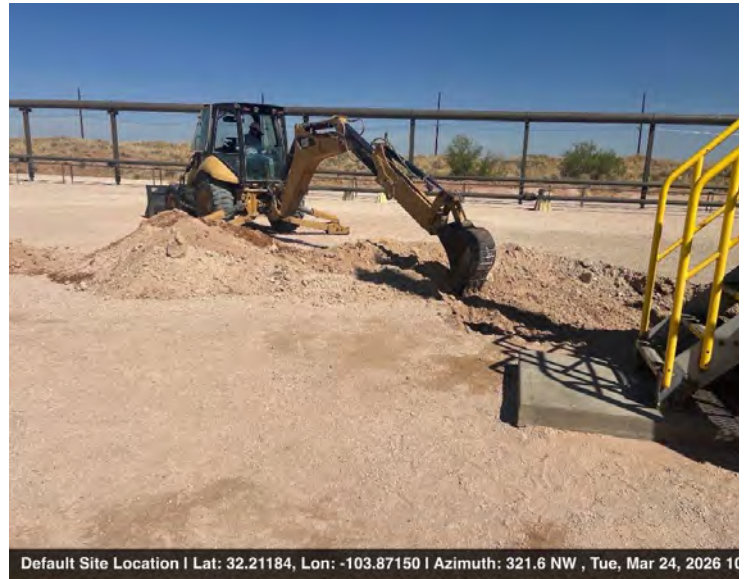
Date: 3/24/2026  
Time: 10:54  
Notes: Mechanical excavation began in open areas  
Latitude: 32.21184444444445  
Longitude: -103.87149722222222  
Direction: NW

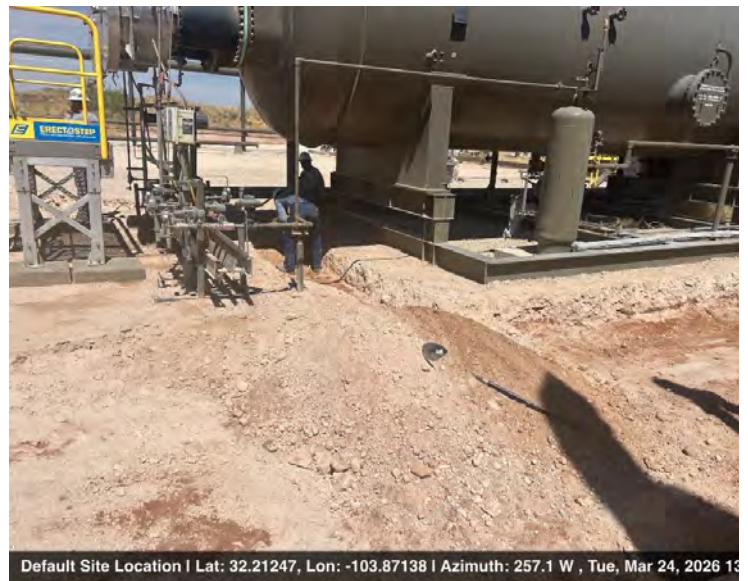
Date: 3/24/2026  
Time: 13:35  
Notes: Hand excavation in progress  
Latitude: 32.21246666666667  
Longitude: -103.87137777777777  
Direction: W

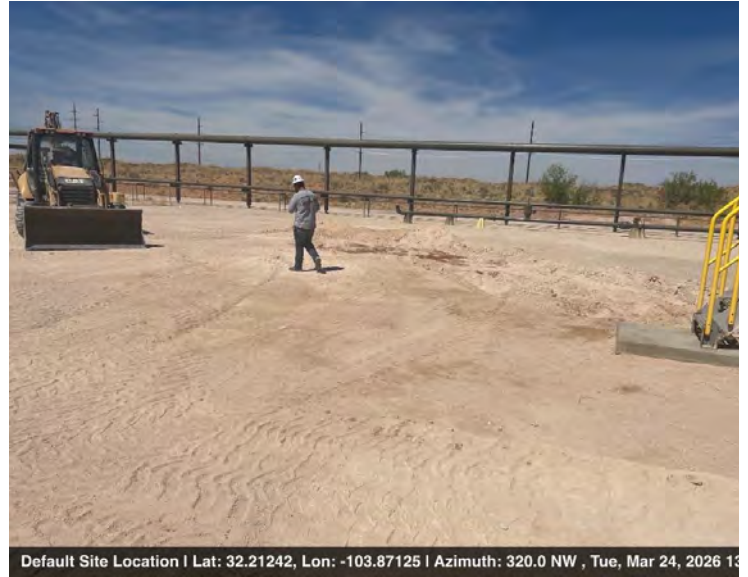
Date: 3/24/2026  
Time: 13:35  
Notes: Mechanical excavation in progress  
Latitude: 32.2124222222222  
Longitude: -103.8712472222221  
Direction: NW

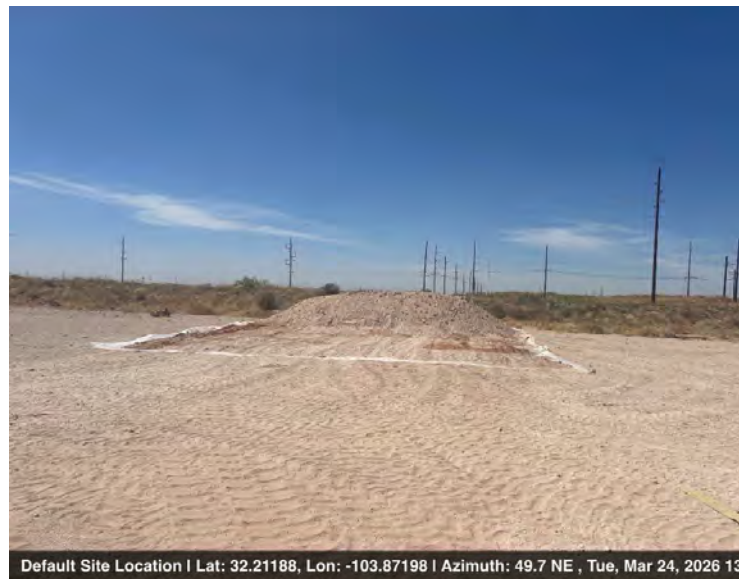
Date: 3/24/2026  
Time: 13:37  
Notes: Contaminated material placed on plastic liner on west side of pad  
Latitude: 32.2118777777778  
Longitude: -103.8719777777777  
Direction: NE

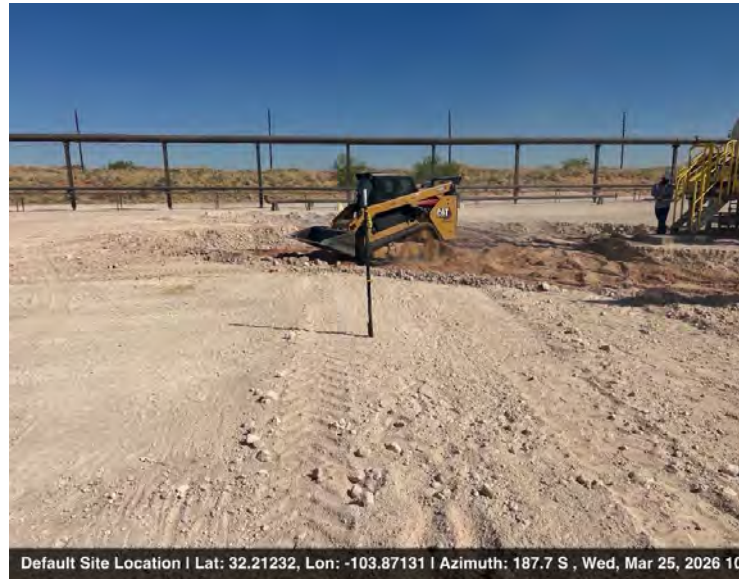
Date: 3/25/2026  
Time: 10:15  
Notes: Mechanical excavation continued in open areas  
Latitude: 32.2123194444445  
Longitude: -103.87131388888888  
Direction: S

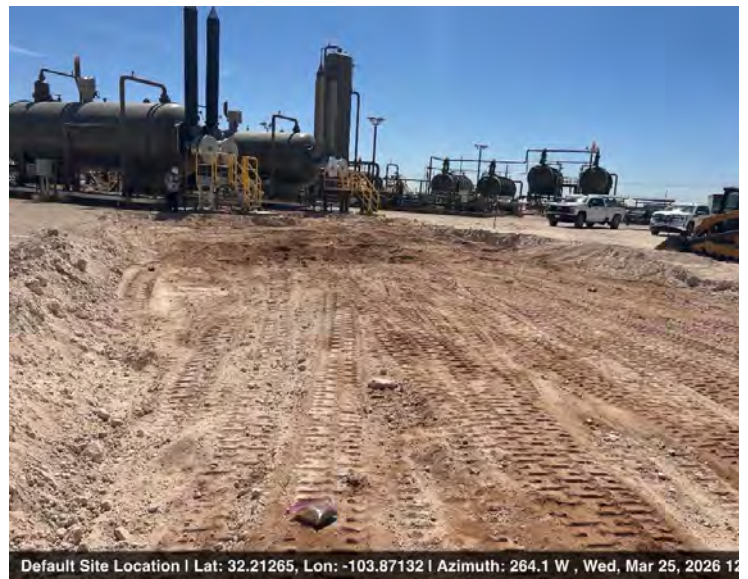
Date: 3/25/2026  
Time: 12:12  
Notes: Composite samples were collected through current excavation to ensure site criteria will be met during confirmation sampling  
Latitude: 32.21264722222222  
Longitude: -103.87132222222222  
Direction: W

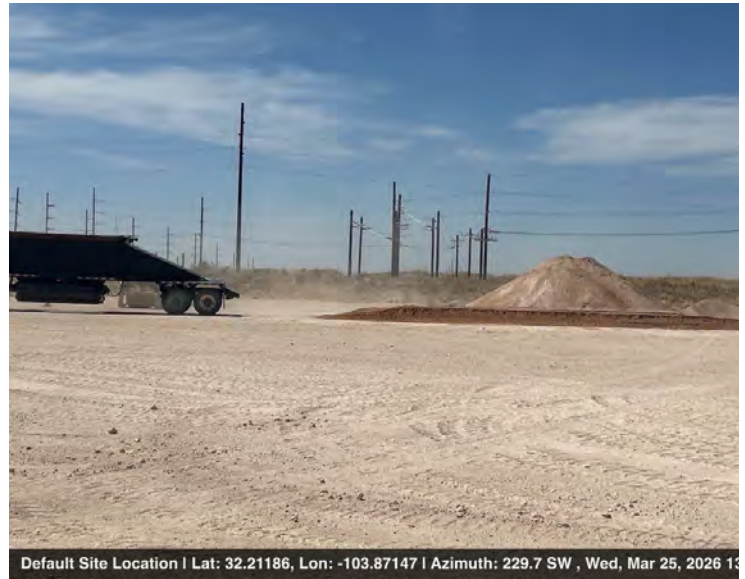
Date: 3/25/2026  
Time: 13:37  
Notes: Backfill material hauled to location  
Latitude: 32.2118555555556  
Longitude: -103.87147499999999  
Direction: SW

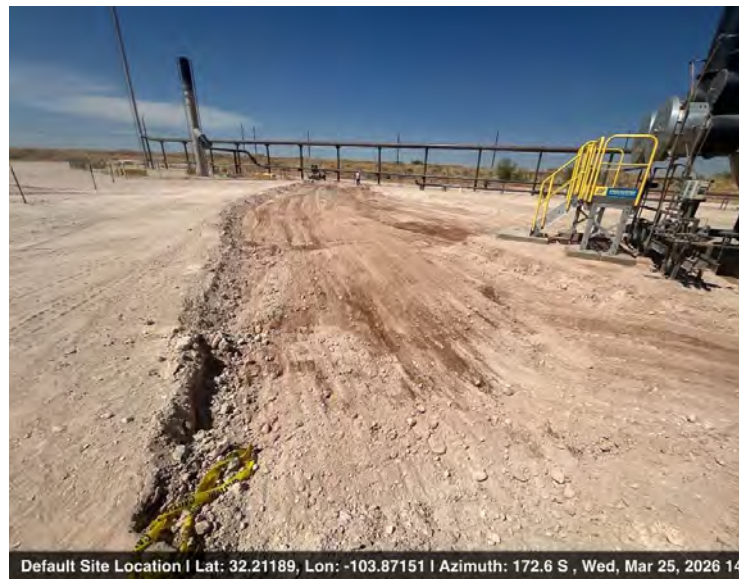
Date: 3/25/2026  
Time: 14:05  
Notes: Excavation in progress  
Latitude: 32.211891666666666  
Longitude: -103.87150555555554  
Direction: S

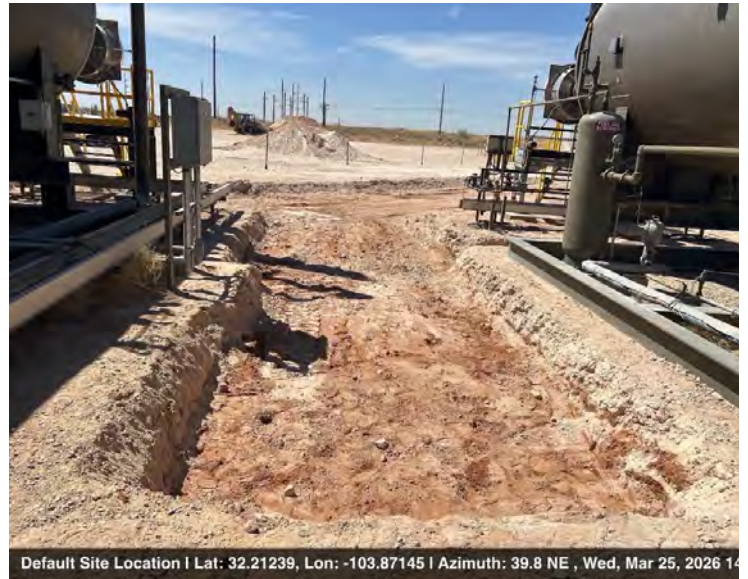
Date: 3/25/2026  
Time: 14:05  
Notes: Hand digging around compressors completed  
Latitude: 32.212386111111115  
Longitude: -103.8714527777778  
Direction: NE

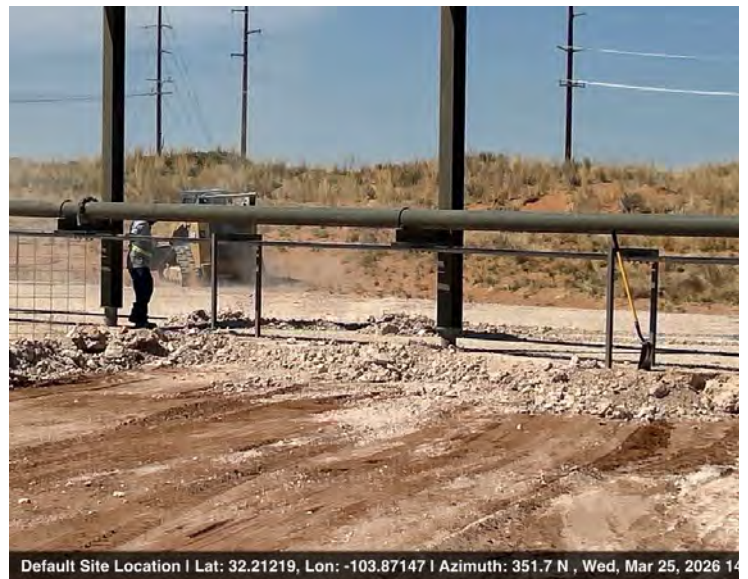
Date: 3/25/2026  
Time: 14:06  
Notes: Mechanical excavation north of flare line  
Latitude: 32.212186111111116  
Longitude: -103.87147499999999  
Direction: N

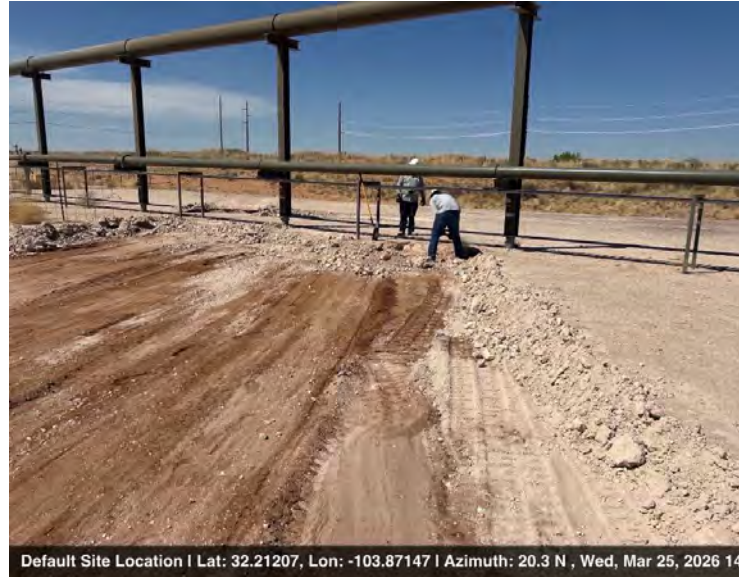
Date: 3/25/2026  
Time: 14:06  
Notes: Began hand digging beneath flare line  
Latitude: 32.21206944444445  
Longitude: -103.87147499999999  
Direction: N

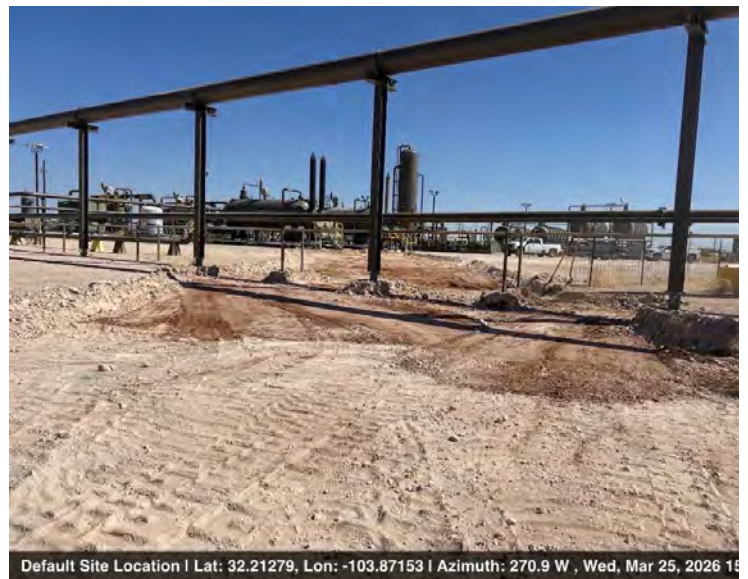
Date: 3/25/2026  
Time: 15:12  
Notes: Excavation completed  
Latitude: 32.21279444444445  
Longitude: -103.87152777777777  
Direction: W

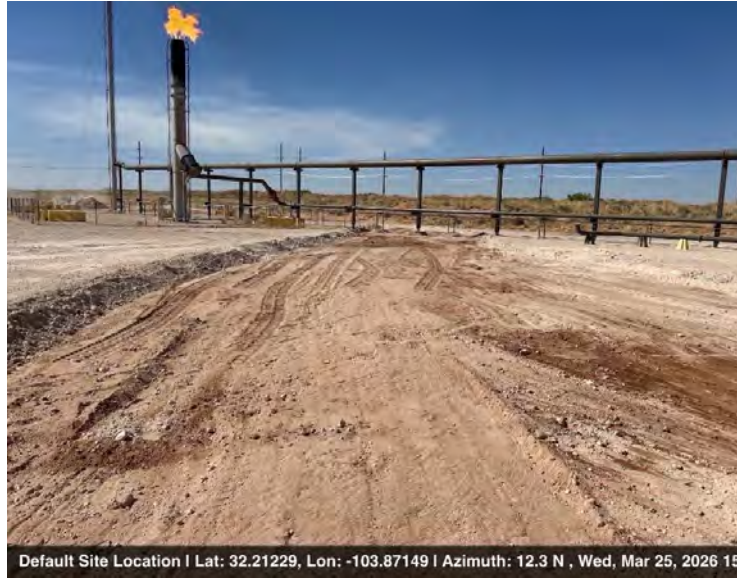
Date: 3/25/2026  
Time: 15:13  
Notes: Excavation completed  
Latitude: 32.21229166666667  
Longitude: -103.87148888888888  
Direction: N

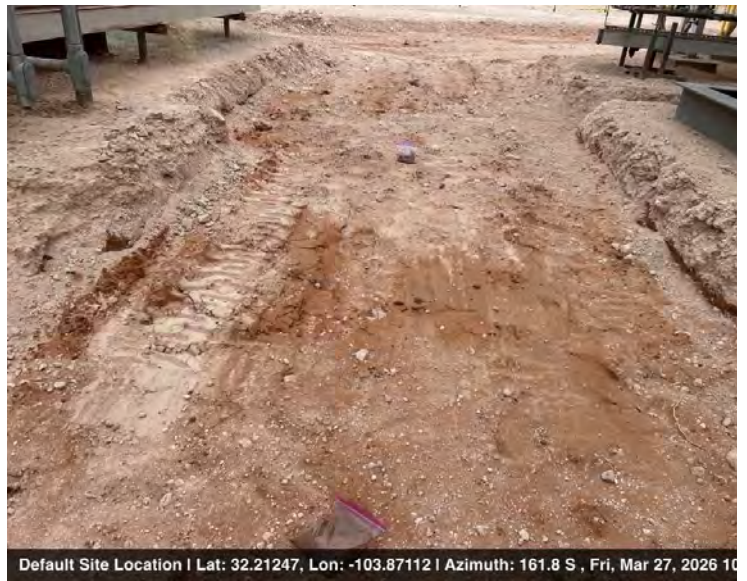
Date: 3/27/2026  
Time: 10:21  
Notes: BS26-01 through BS26-06 @ 1'  
Latitude: 32.2124666666667  
Longitude: -103.87112499999999  
Direction: S

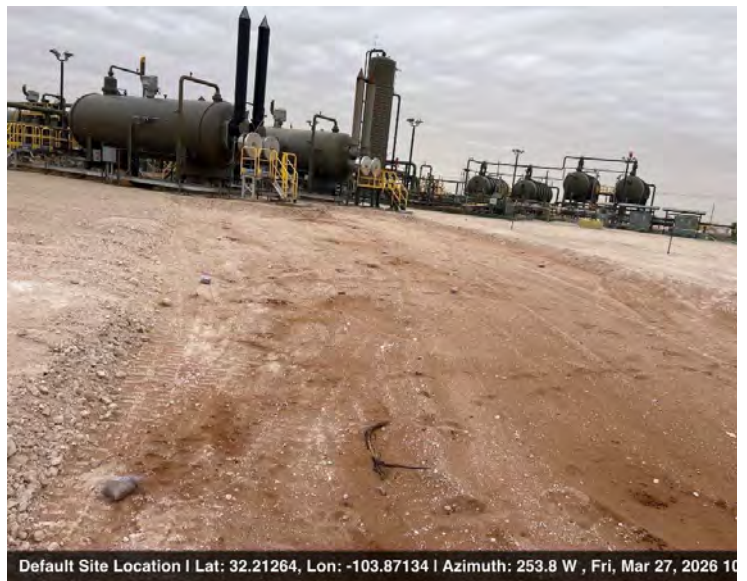
Date: 3/27/2026  
Time: 10:23  
Notes: BS26-07 though BS26-19 @ 1'  
Latitude: 32.2126444444445  
Longitude: -103.8713444444443  
Direction: W

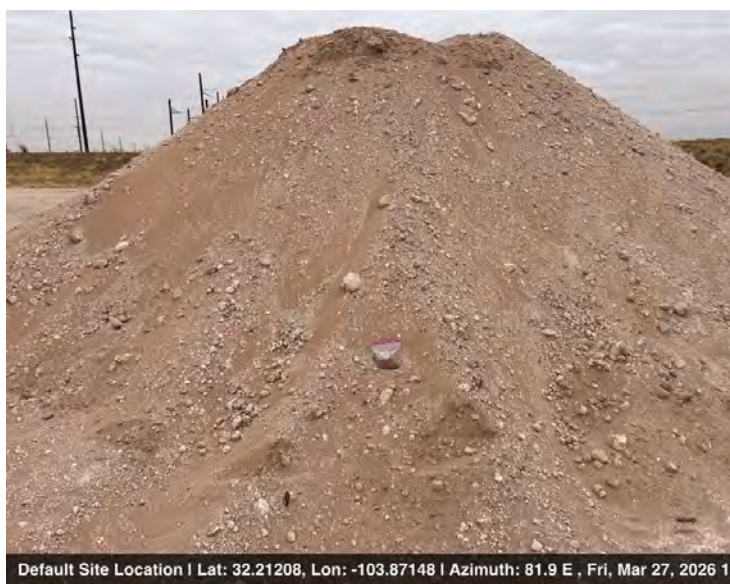
Date: 3/27/2026  
Time: 10:27  
Notes: BACKFILL sample  
Latitude: 32.21207777777778  
Longitude: -103.87148333333333  
Direction: E

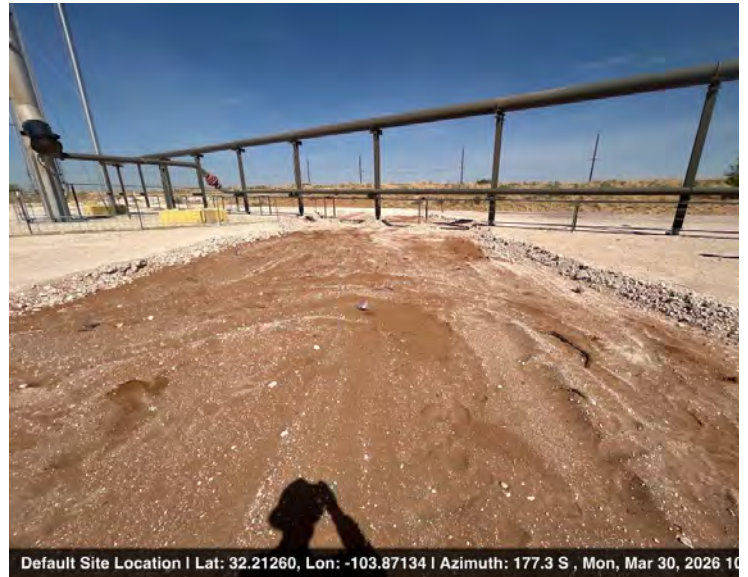
Date: 3/30/2026  
Time: 10:43  
Notes: BS26-20 through BS26-29 @ 1'  
Latitude: 32.2126  
Longitude: -103.87133888888889  
Direction: S

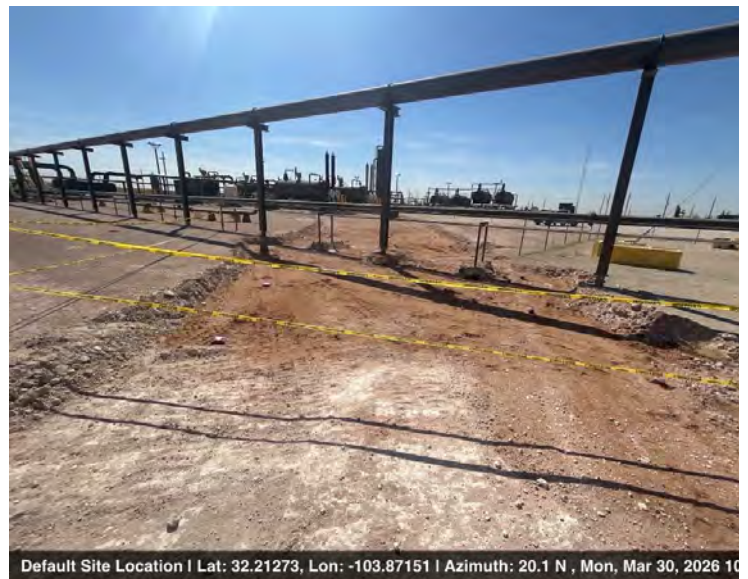
Date: 3/30/2026  
Time: 10:54  
Notes: BS26-20 through BS26-35 @ 1'  
Latitude: 32.21273055555556  
Longitude: -103.87151388888888  
Direction: N

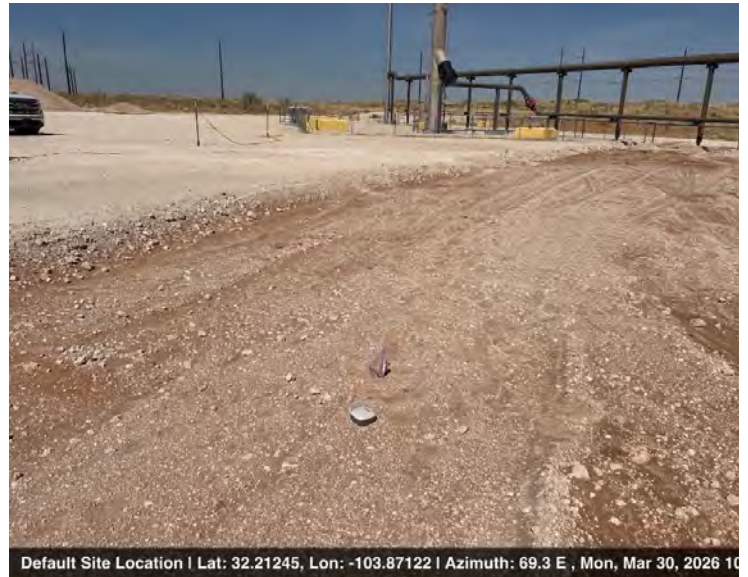
Date: 3/30/2026  
Time: 10:58  
Notes: BS26-36 @ 1'  
Latitude: 32.21245277777778  
Longitude: -103.87122222222222  
Direction: E
