## Closure Report

### PLU 22 DTD CVB

ExxonMobil Production Company

Vertex Resource Services Inc.

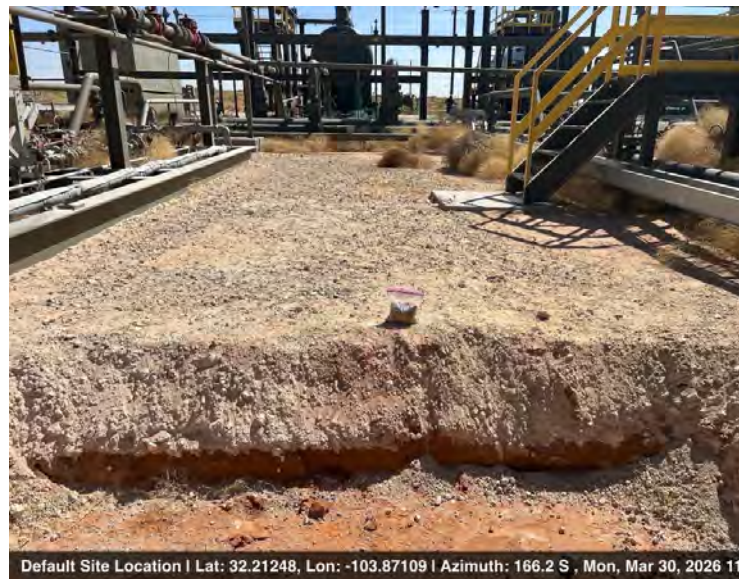
Date: 3/30/2026  
Time: 11:00  
Notes: WS26-01 @ 0-1'  
Latitude: 32.21248055555556  
Longitude: -103.87109444444444  
Direction: S

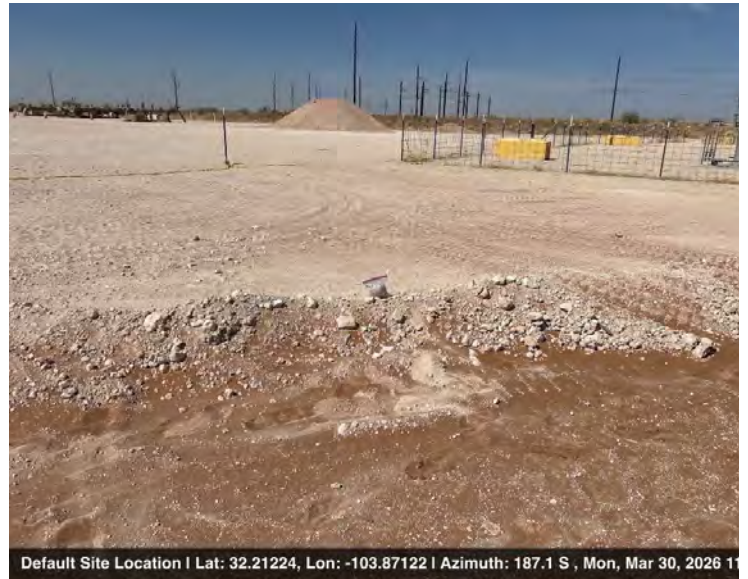
Date: 3/30/2026  
Time: 11:01  
Notes: WS26-02 @ 0-1'  
Latitude: 32.21223888888889  
Longitude: -103.87122222222222  
Direction: S

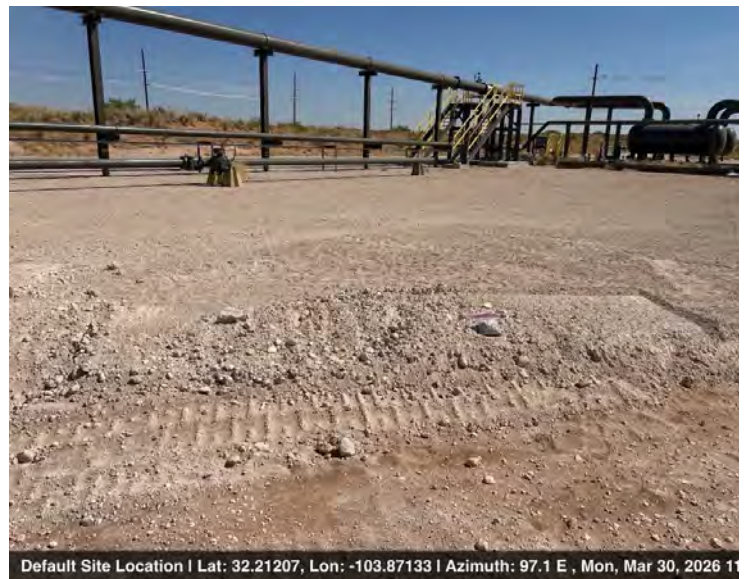
Date: 3/30/2026  
Time: 11:01  
Notes: WS26-03 @ 0-1'  
Latitude: 32.21206666666667  
Longitude: -103.87133055555555  
Direction: E

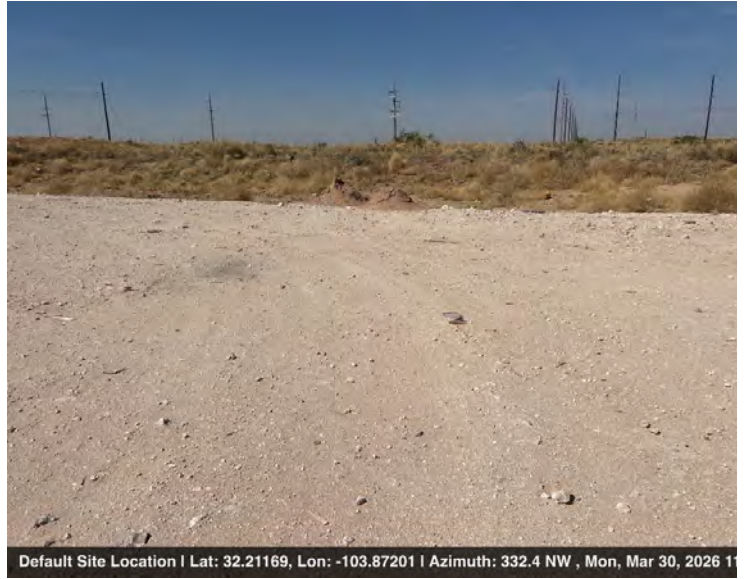
Date: 3/30/2026  
Time: 11:09  
Notes: SS26-01 @ 0'  
Taken from portion of pad where contaminated  
material was placed on plastic liner  
Latitude: 32.21168611111111  
Longitude: -103.87201111111111  
Direction: N
