## Amended Release Assessment and Closure

Ross Draw 35 CTB 3

Unit A, Section 35, Township 26 South, Range 30 East

Facility I.D: fAPP2534942182

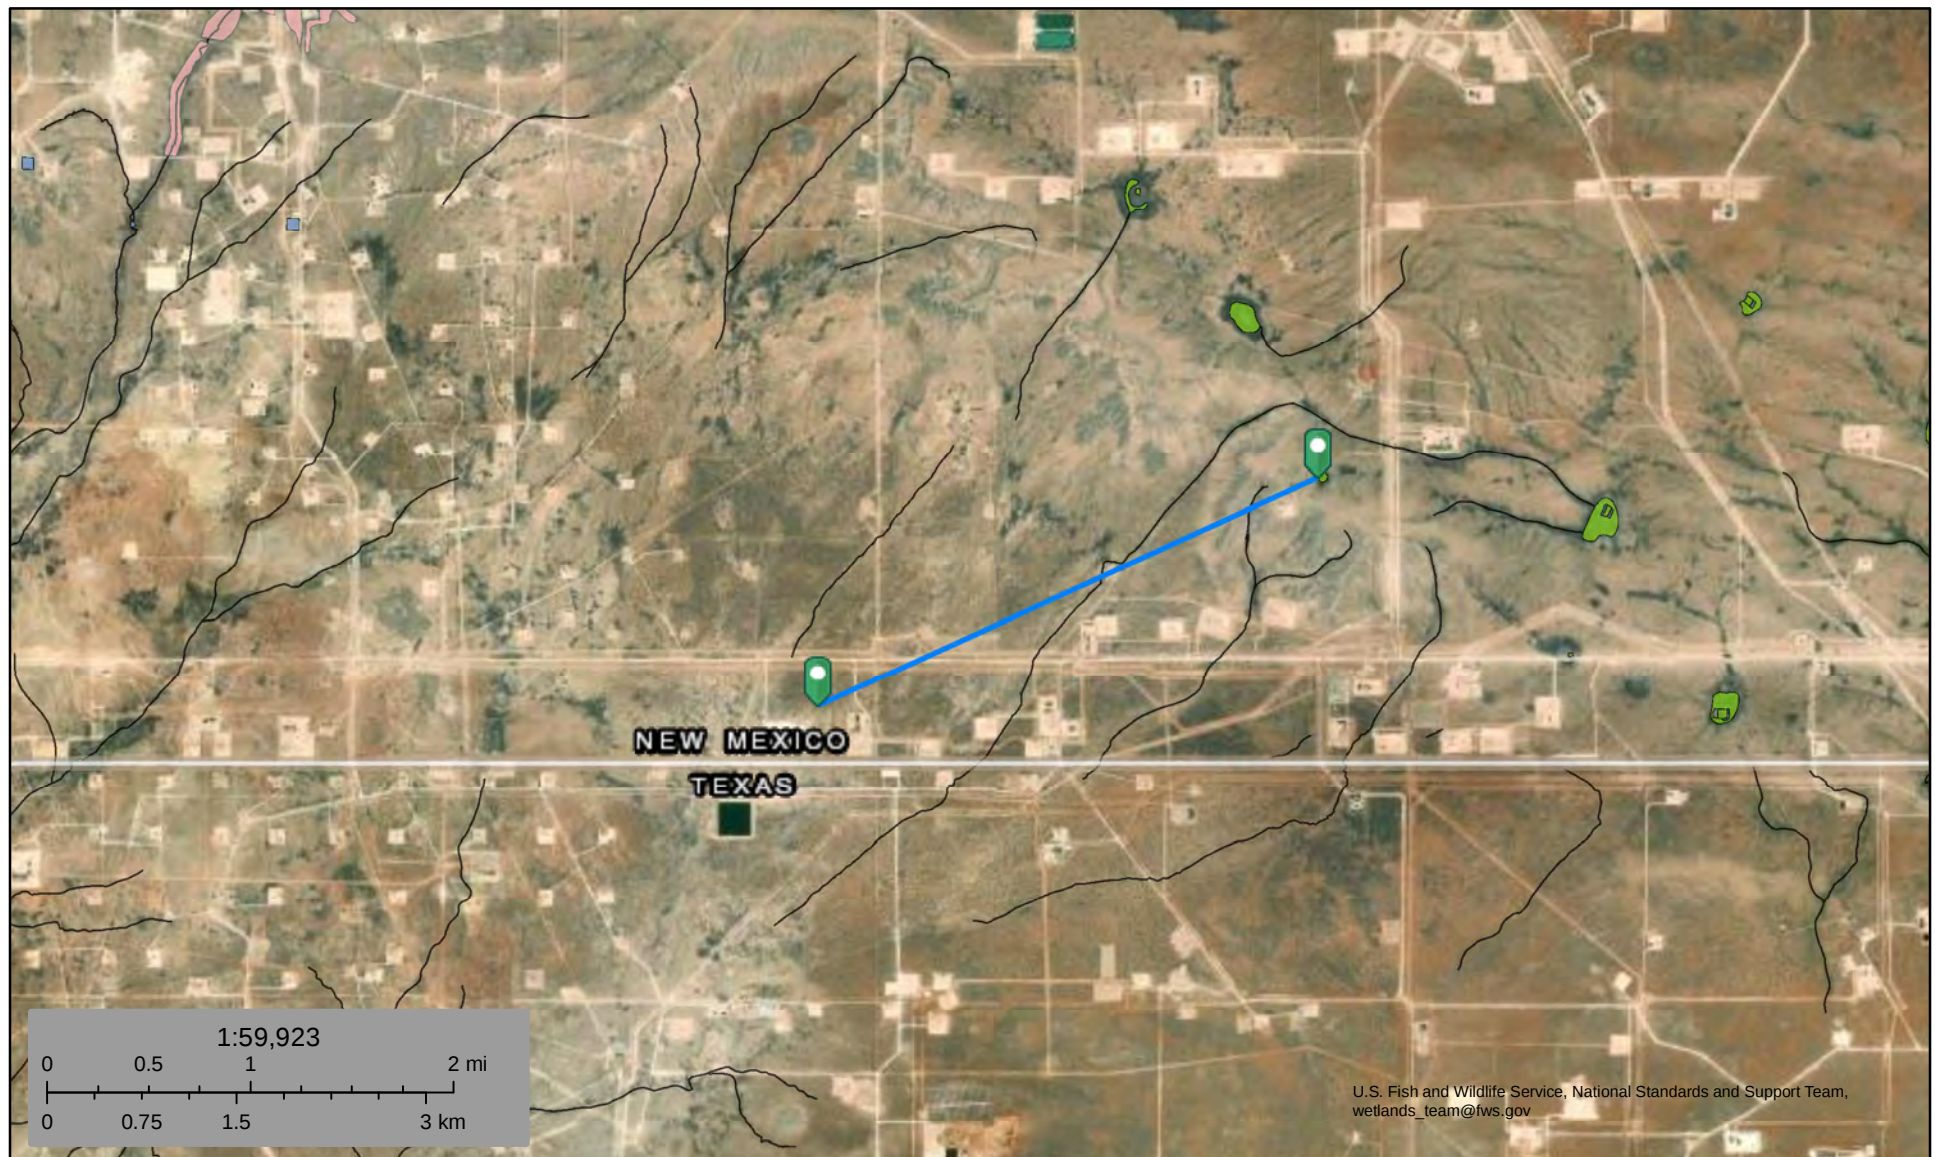
**Wetlands**

## Palustrine Wetland Playa 2.29 mi NE

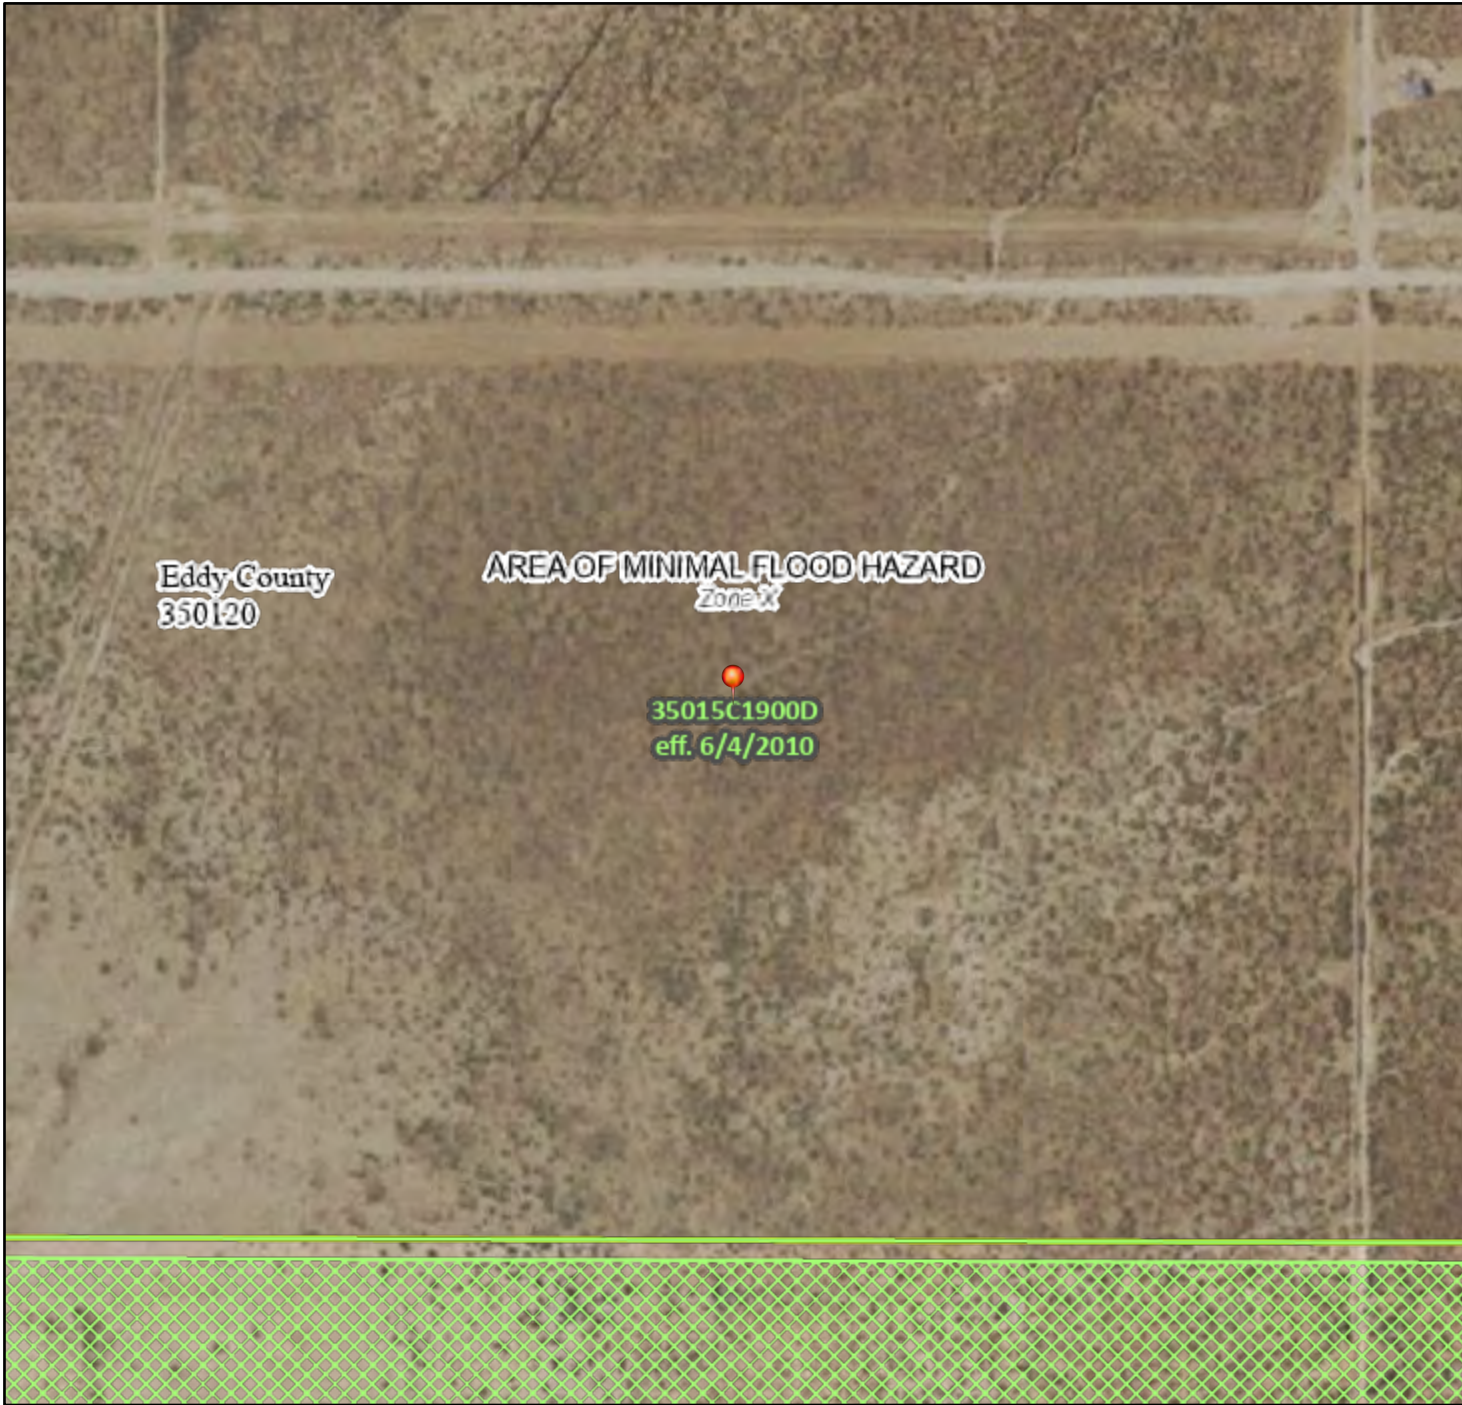
# National Flood Hazard Layer FIRMMette

The flood hazard information is derived directly from the authoritative NFHL web services provided by FEMA. This map was exported on 3/25/2026 at 9:09 PM and does not reflect changes or amendments subsequent to this date and time. The NFHL and effective information may change or become superseded by new data over time.

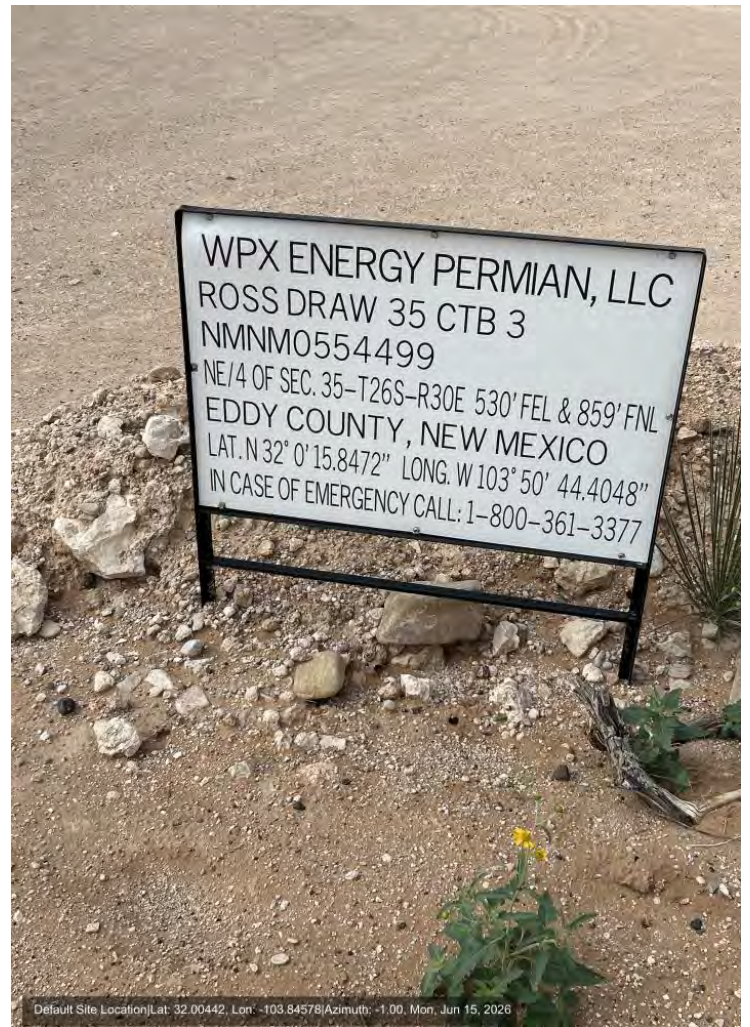
Date: 6/15/2026  
Time: 09:17  
Notes: Site information Placard  
Latitude: 32.004416666666664  
Longitude: -103.84578055555555  
Direction: SW

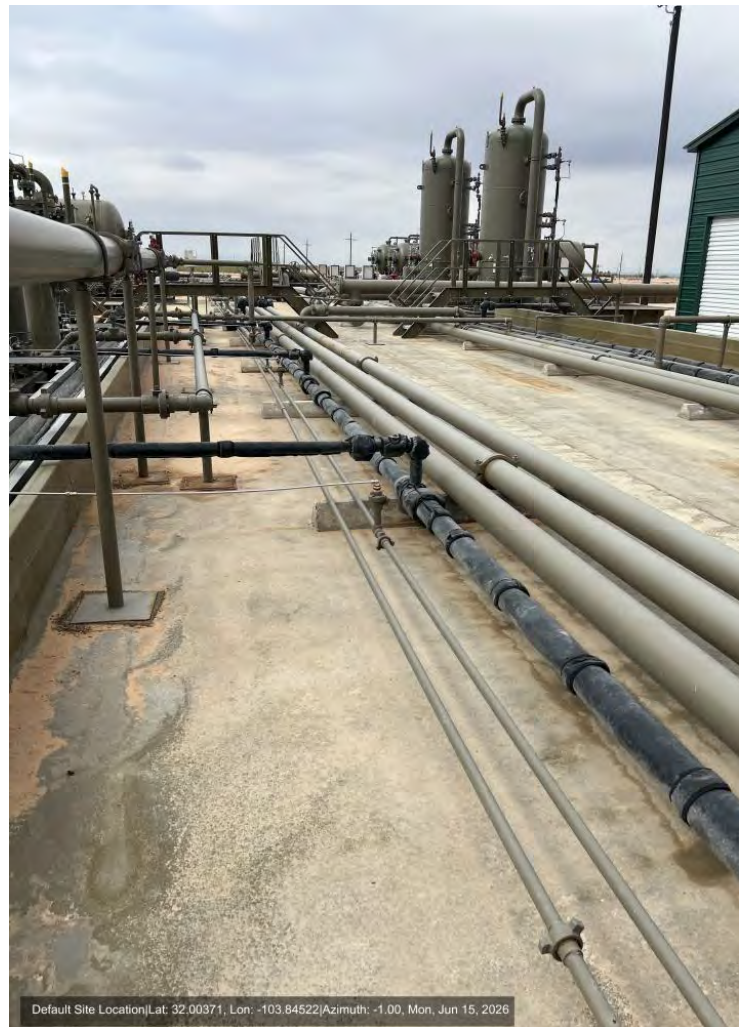
Date: 6/15/2026  
Time: 09:30  
Notes: Looking SW. Northeast corner of 1.5 ft containment on inside near piperun. Trace layer of sand in some areas was easily brushed away and liner inspected. Clear of inspection inhibiting debris, compromises and is in good condition.  
Latitude: 32.00371111111111  
Longitude: -103.84522222222222  
Direction: W

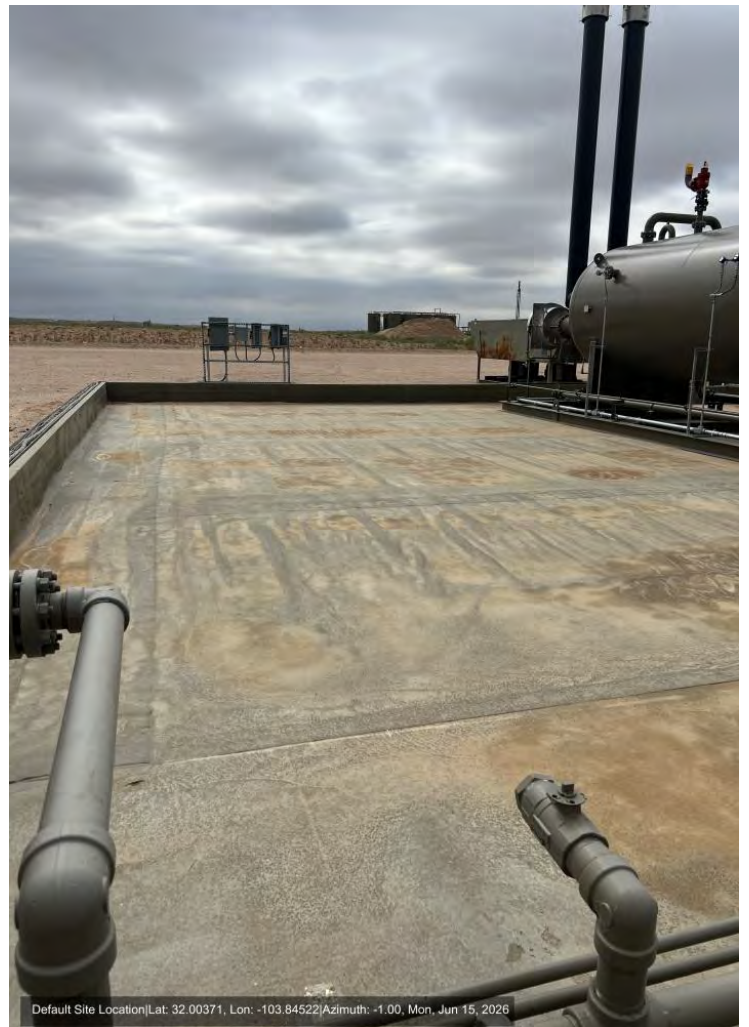
Date: 6/15/2026  
Time: 09:30  
Notes: Looking E. East side of 1.5 ft containment on outside from piperun. Trace layer of sand in some areas was easily brushed away and liner inspected. Clear of inspection inhibiting debris, compromises and is in good condition.  
Latitude: 32.00371111111111  
Longitude: -103.84522222222222  
Direction: SW

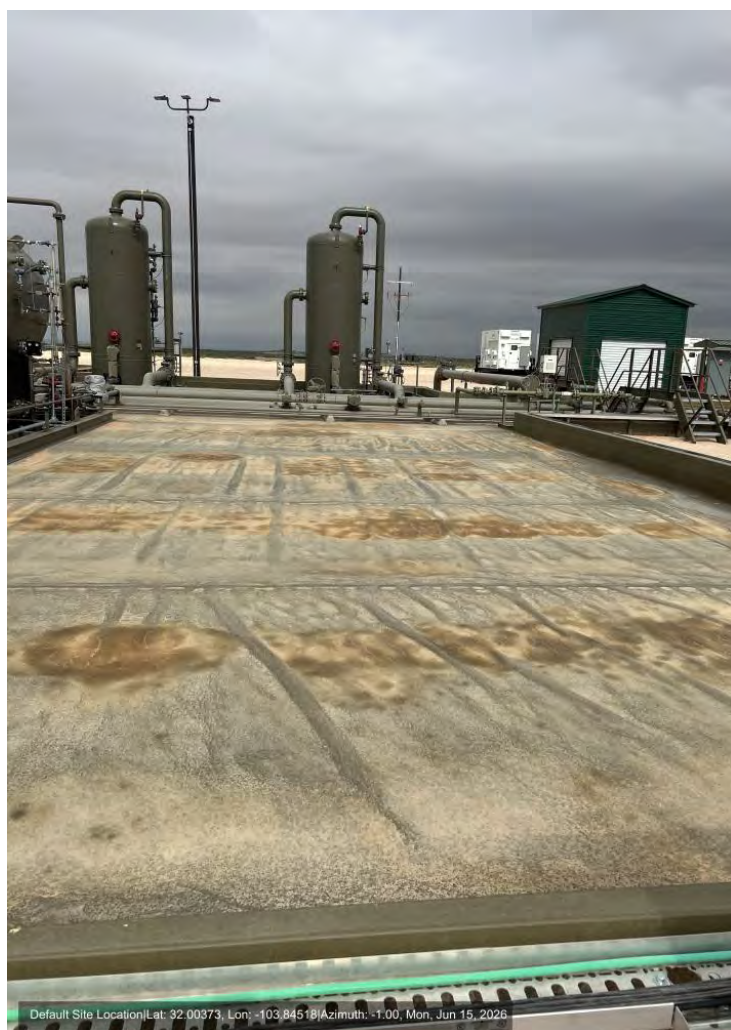
Date: 6/15/2026  
Time: 09:30  
Notes: Looking W. East side of 1.5 ft containment on outside. Trace layer of sand in some areas was easily brushed away and liner inspected. Clear of inspection inhibiting debris, compromises and is in good condition.  
Latitude: 32.00373333333334  
Longitude: -103.84517777777778  
Direction: S

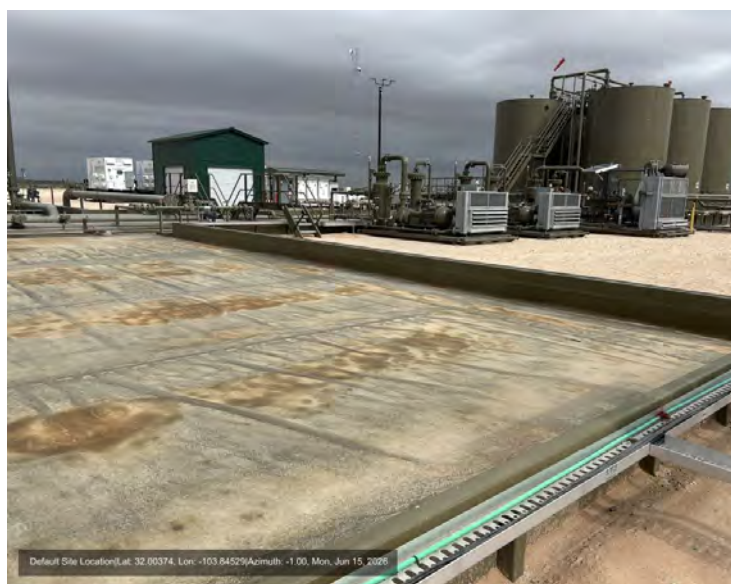
Date: 6/15/2026  
Time: 09:30  
Notes: Looking NW. East side of 1.5 ft containment on outside. Trace layer of sand in some areas was easily brushed away and liner inspected. Clear of inspection inhibiting debris, compromises and is in good condition.  
Latitude: 32.003741666666667  
Longitude: -103.84529166666667  
Direction: SW

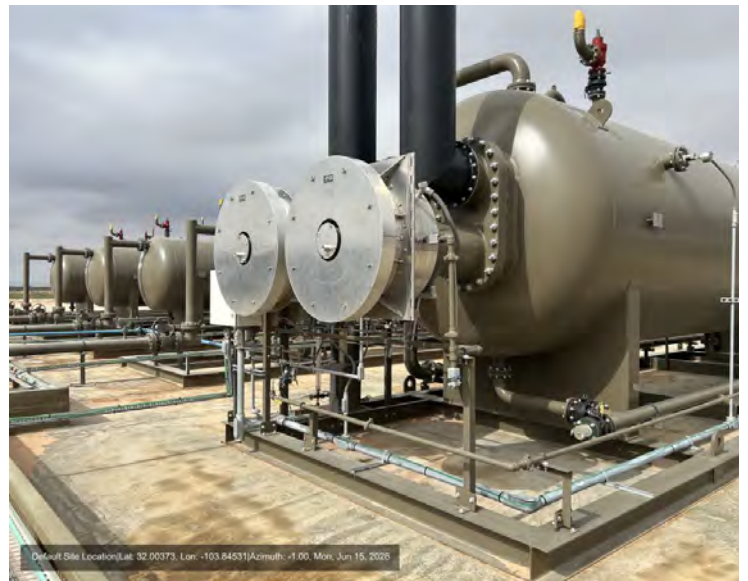
Date: 6/15/2026  
 Time: 09:30  
 Notes: Looking SW. Southeast side of 1.5 ft containment on outside along separators. Thin layer of sand in some areas was easily brushed away and liner inspected. Clear of inspection inhibiting debris, compromises and is in good condition.  
 Latitude: 32.00373333333334  
 Longitude: -103.84531388888888  
 Direction: SW

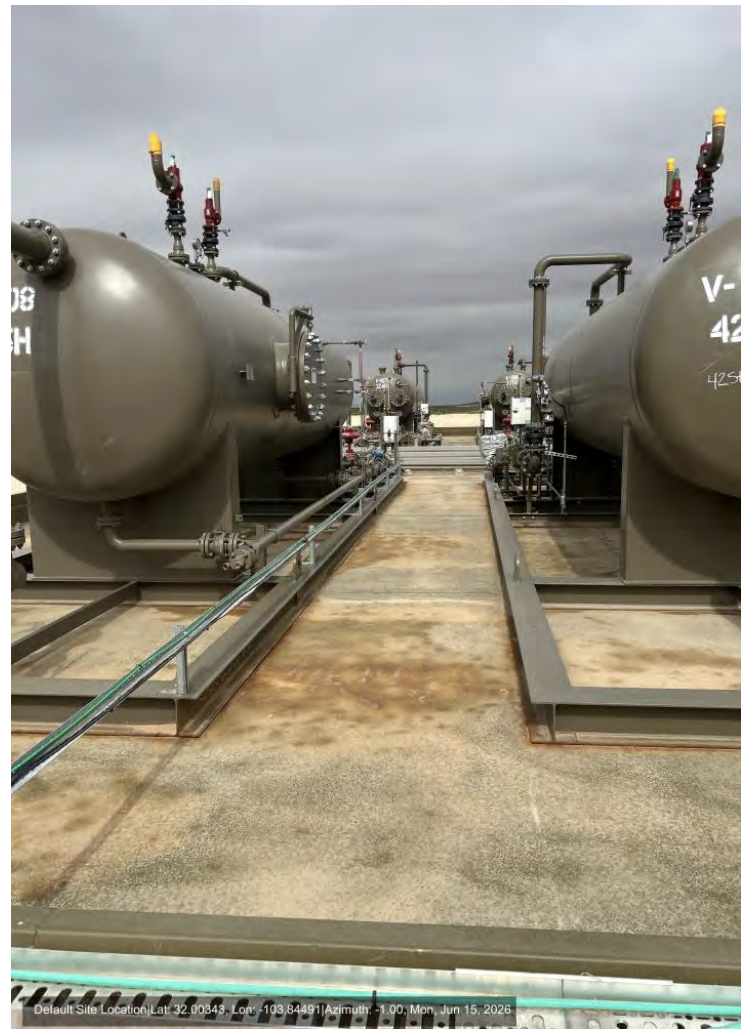
Date: 6/15/2026  
Time: 09:39  
Notes: Looking W. Southeast side of 1.5 ft containment on outside along separators. Trace layer of sand in some areas was easily brushed away and liner inspected. Clear of inspection inhibiting debris, compromises and is in good condition.  
Latitude: 32.00343333333334  
Longitude: -103.84491111111111  
Direction: S

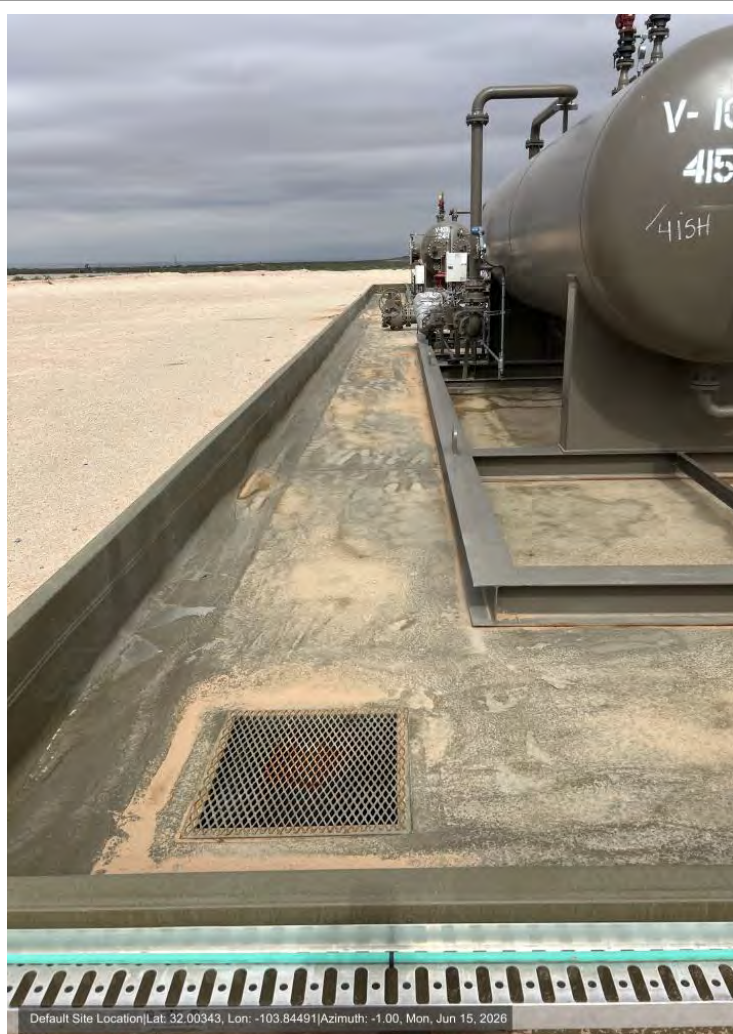
Date: 6/15/2026  
Time: 09:39  
Notes: Looking W. Southeast corner of 1.5 ft containment on outside along separators and sump. Thin layer of sand in some areas was easily brushed away and liner inspected. Clear of inspection inhibiting debris, compromises and is in good condition.  
Latitude: 32.00343333333334  
Longitude: -103.84491111111111  
Direction: S

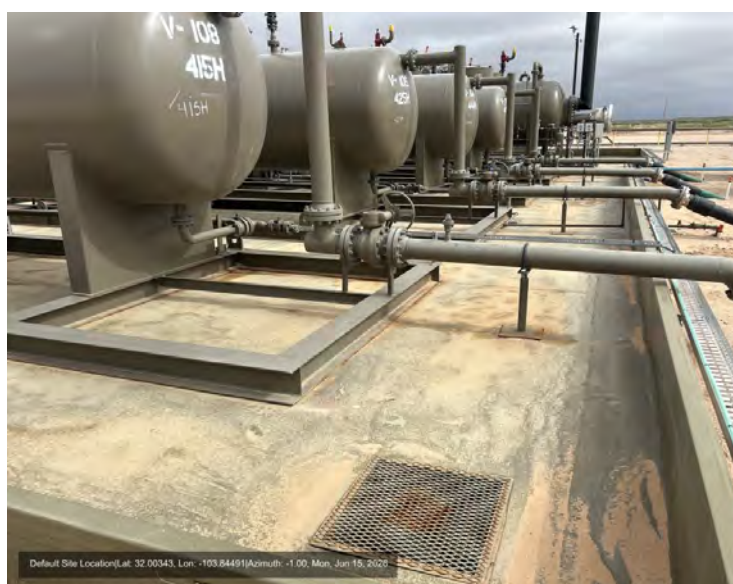
Date: 6/15/2026  
Time: 09:39  
Notes: Looking N. Southeast corner of 1.5 ft containment on outside along separators and sump. Thin layer of sand in some areas was easily brushed away and liner inspected. Clear of inspection inhibiting debris, compromises and is in good condition.  
Latitude: 32.00343333333334  
Longitude: -103.84491111111111  
Direction: E

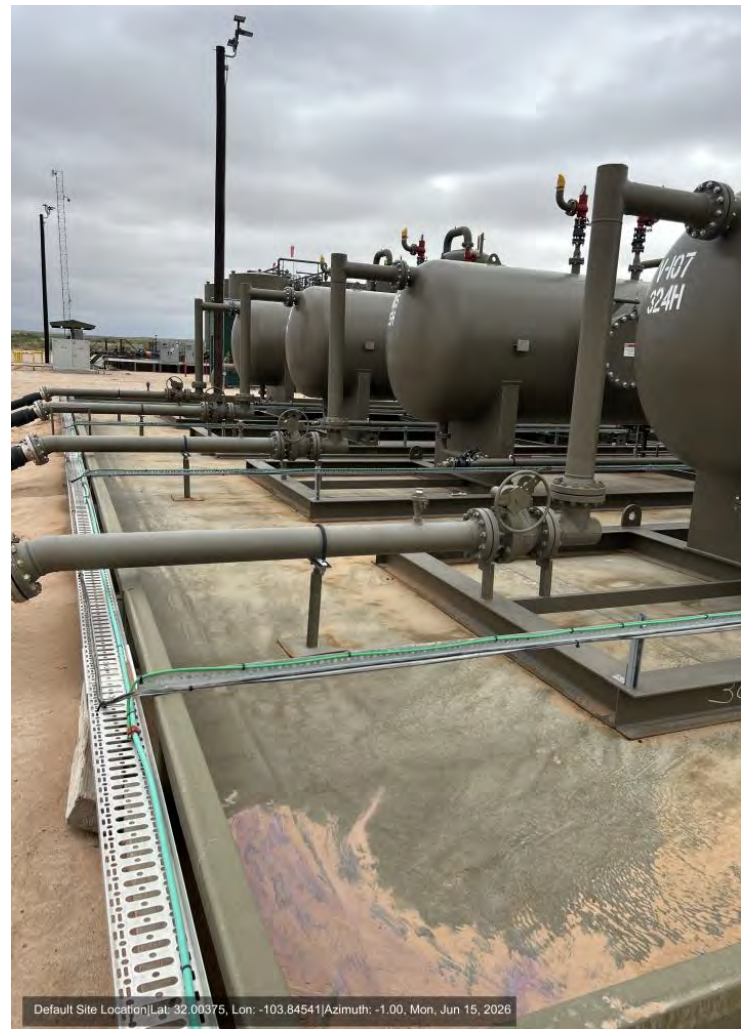
Date: 6/15/2026  
Time: 09:39  
Notes: Looking N. Southwest corner of 1.5 ft containment on outside along separators. Thin layer of sand in corner. Brushed away and liner inspected. Clear of inspection inhibiting debris, compromises and is in good condition.  
Latitude: 32.0037472222222  
Longitude: -103.8454055555554  
Direction: SE

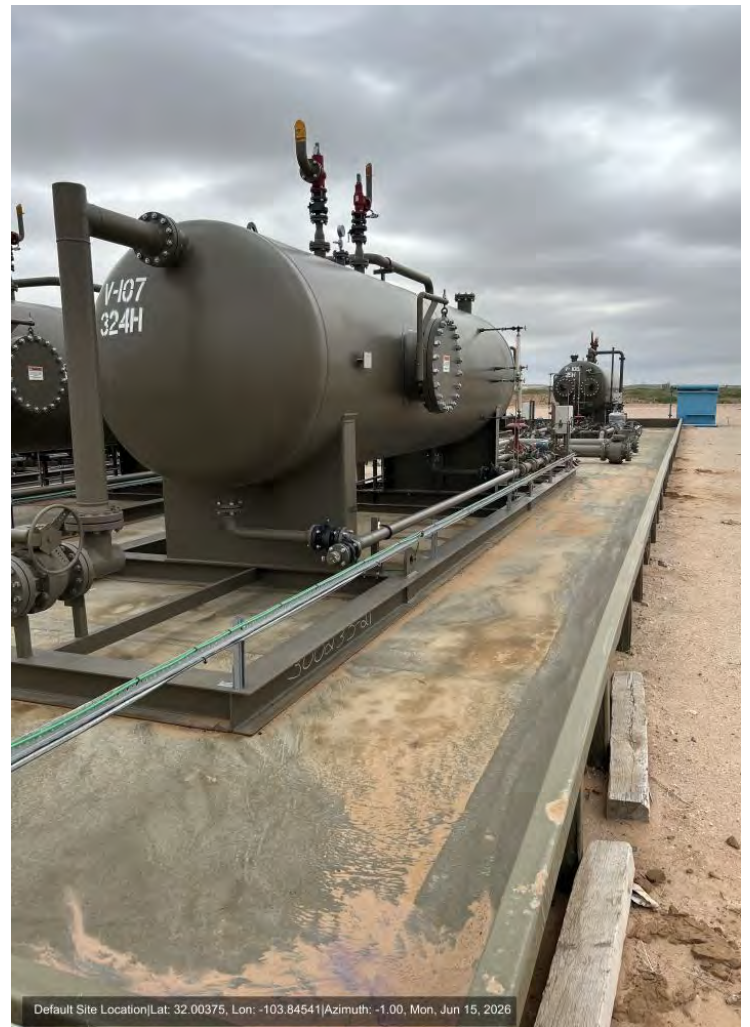
Date: 6/15/2026  
Time: 09:39  
Notes: Looking NE. Southwest corner of 1.5 ft containment on inside along separators. Thin layer of sand in corner. Brushed away and liner inspected. Clear of inspection inhibiting debris, compromises and is in good condition.  
Latitude: 32.0037472222222  
Longitude: -103.8454055555554  
Direction: SE

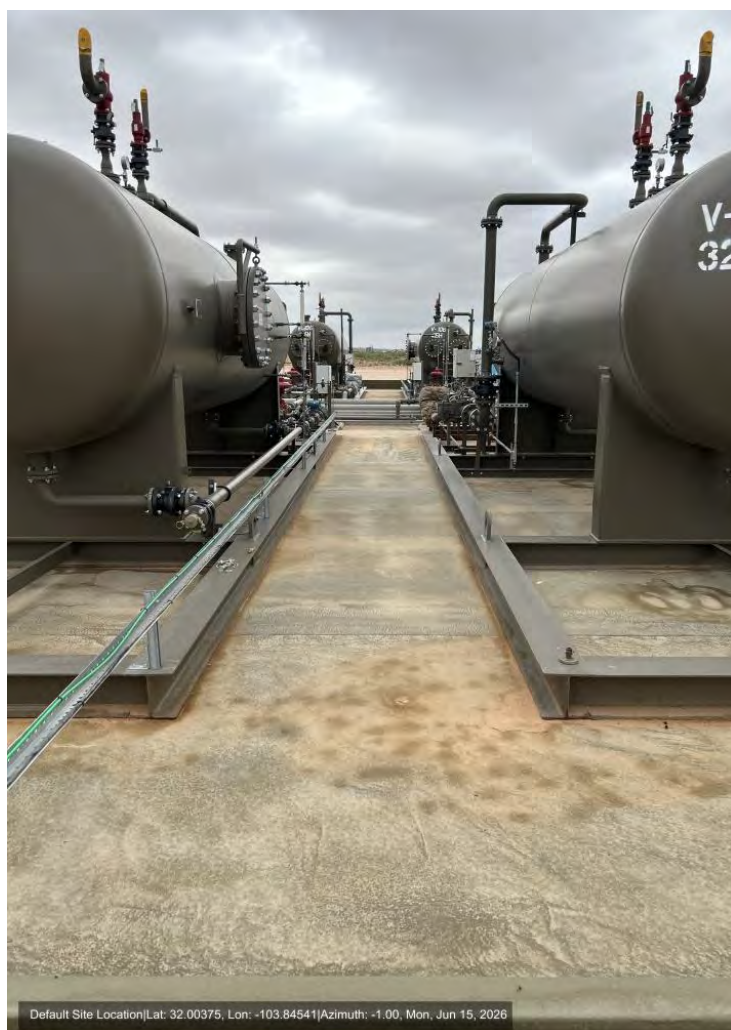
Date: 6/15/2026  
Time: 09:39  
Notes: Looking W. Middle/east side of 1.5 ft containment on inside along separators. Clear of inspection inhibiting debris, compromises and is in good condition.  
Latitude: 32.0037472222222  
Longitude: -103.84540555555554  
Direction: SE

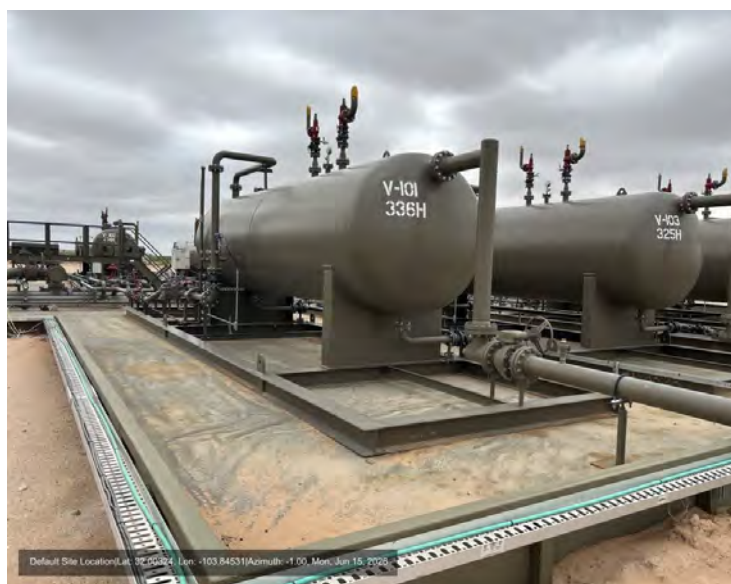
Date: 6/15/2026  
Time: 09:44  
Notes: Looking SE. Middle/west side of 1.5 ft containment on inside along separators. Thin layer of sand in corner. Brushed away and inspected. Clear of inspection inhibiting debris, compromises and is in good condition.  
Latitude: 32.003236111111114  
Longitude: -103.84531388888888  
Direction: E

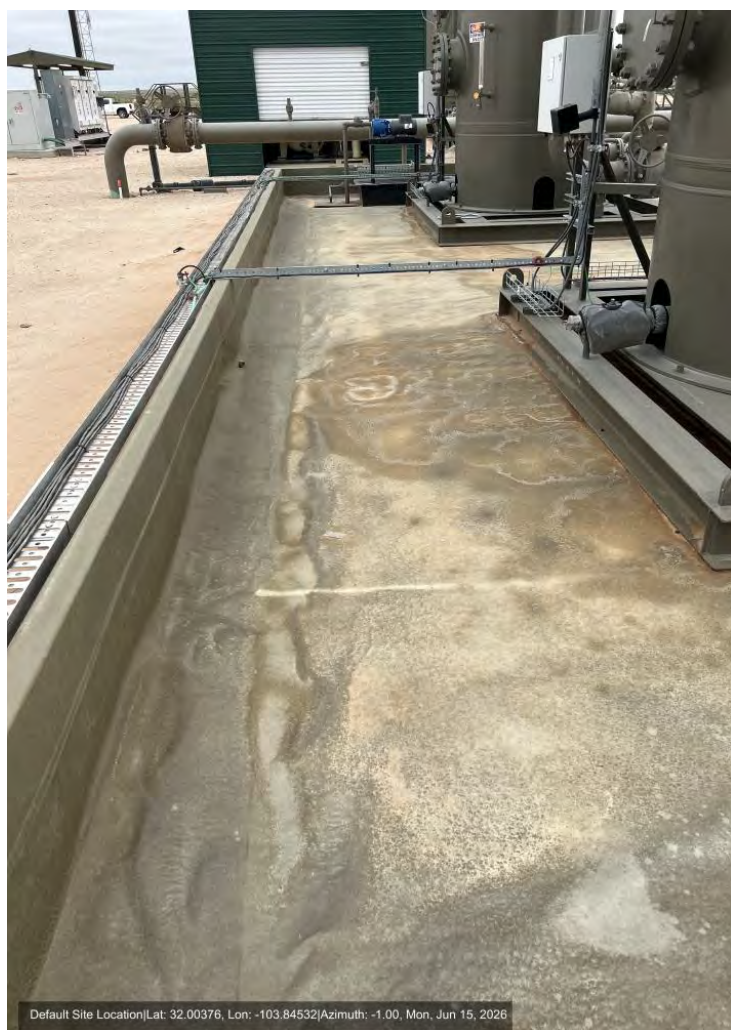
Date: 6/15/2026  
Time: 09:44  
Notes: Looking N. Middle/west side of 1.5 ft containment on inside along separators. Clear of inspection inhibiting debris, compromises and is in good condition.  
Latitude: 32.003758333333333  
Longitude: -103.84532222222222  
Direction: E

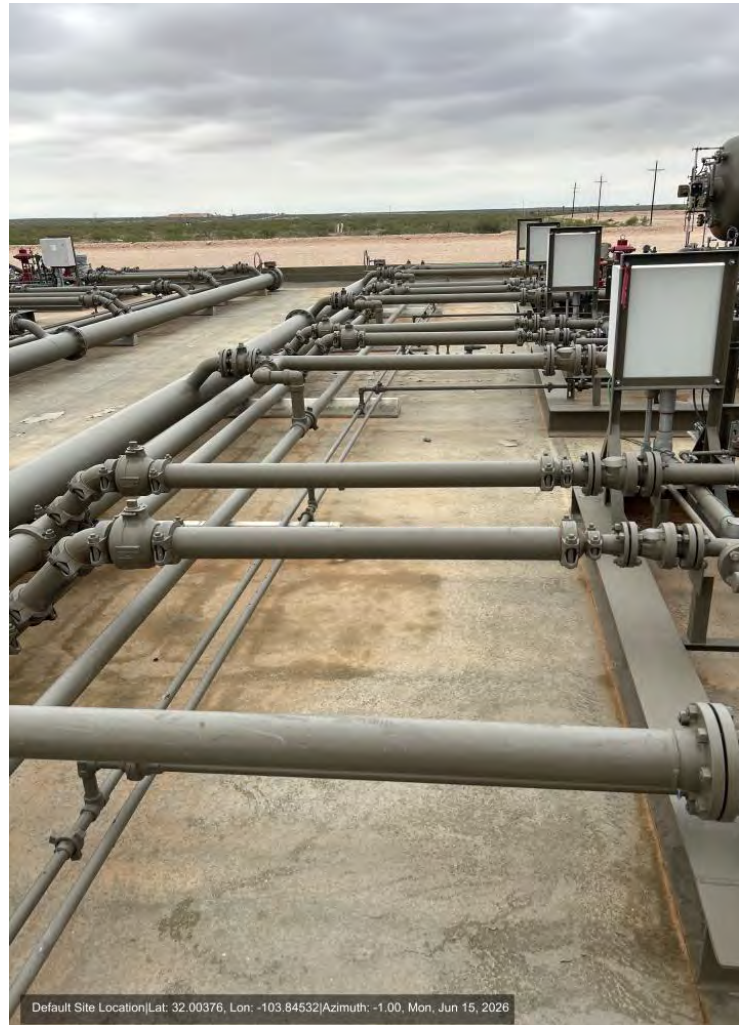
Date: 6/15/2026  
Time: 09:44  
Notes: Looking S. Middle/west side of 1.5 ft containment on inside along piperun. Clear of inspection inhibiting debris, compromises and is in good condition.  
Latitude: 32.00376111111111  
Longitude: -103.84532222222222  
Direction: NE

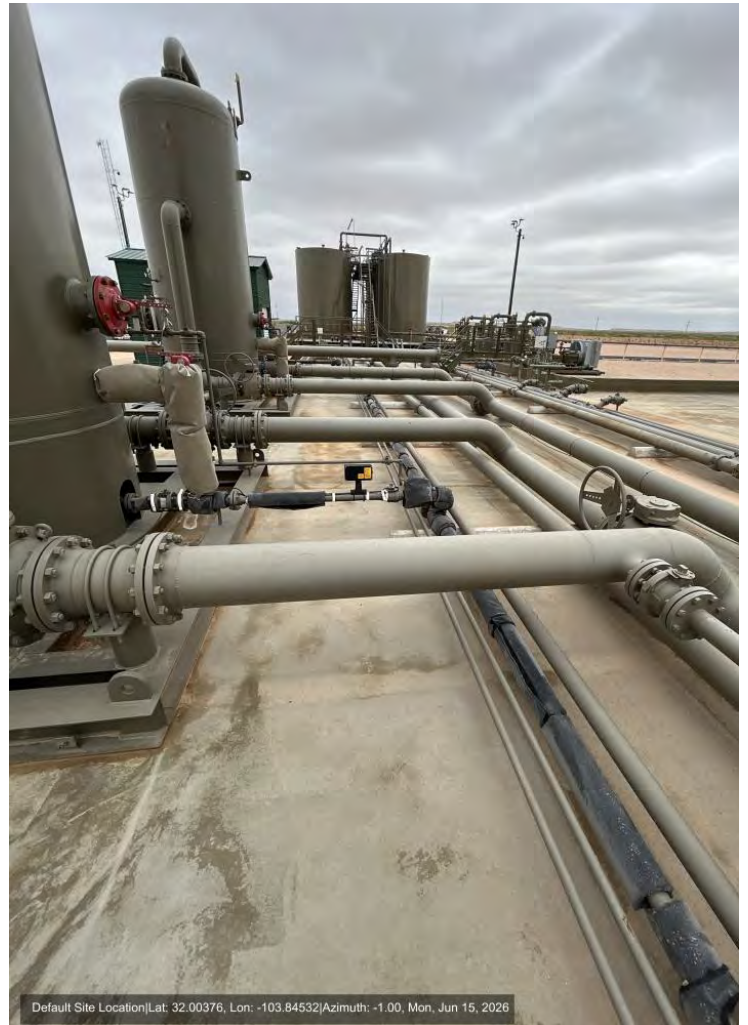
Date: 6/15/2026  
Time: 09:44  
Notes: Looking N. Middle/west side of 1.5 ft containment on inside. Fully intact and good condition.  
Latitude: 32.00376111111111  
Longitude: -103.84532222222222  
Direction: NE

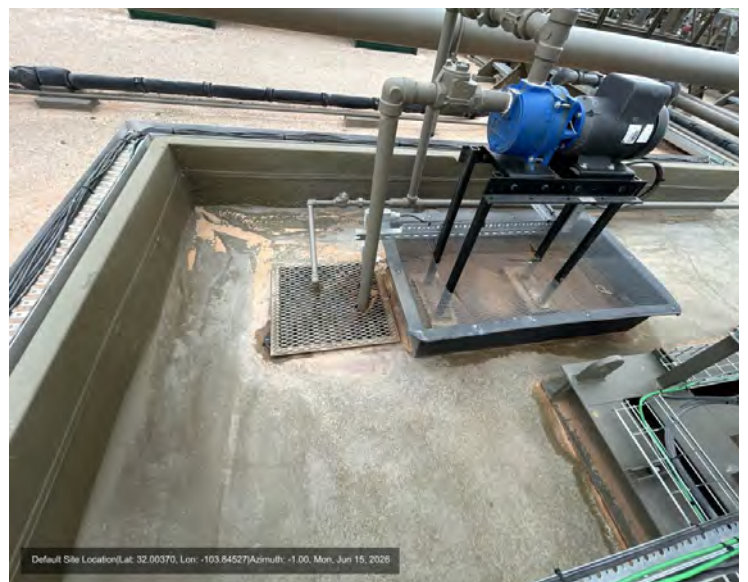
Date: 6/15/2026  
Time: 09:44  
Notes: Looking N. Middle/west side of 1.5 ft containment on inside at sump. Clear of debris and good condition.  
Latitude: 32.00369722222222  
Longitude: -103.84526944444444  
Direction: NE

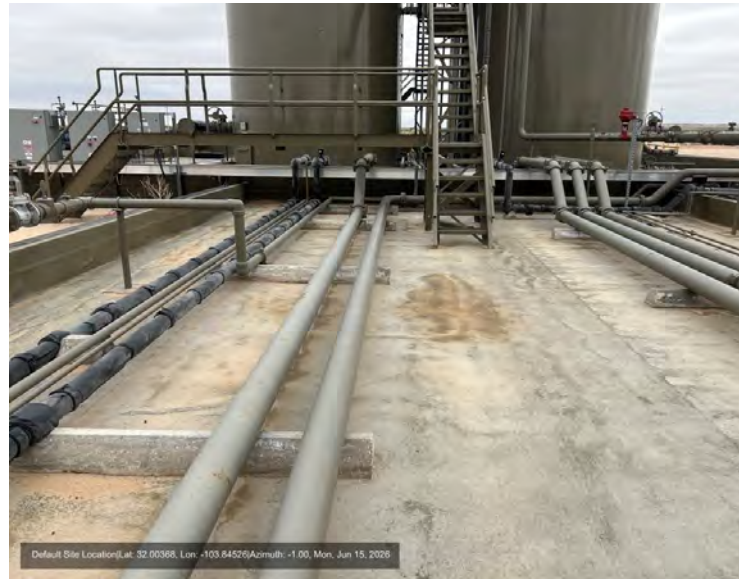
Date: 6/15/2026  
Time: 09:44  
Notes: Looking N. Northwest side of 1.5 ft containment on inside. Clear of debris and good condition.  
Latitude: 32.00368055555555  
Longitude: -103.84526111111111  
Direction: NE

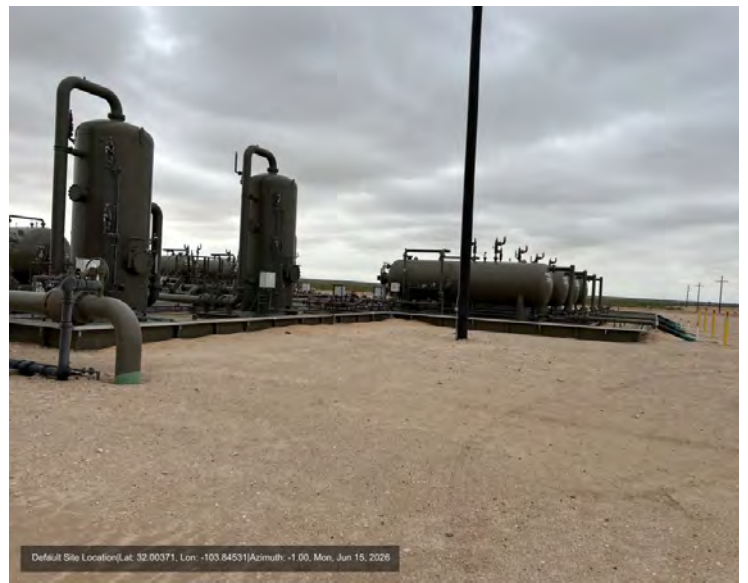
Date: 6/15/2026  
Time: 09:51  
Notes: Looking SE. West side of 1.5 ft containment on outside. Fully intact and good condition.  
Latitude: 32.003711111111111  
Longitude: -103.84531388888888  
Direction: SE

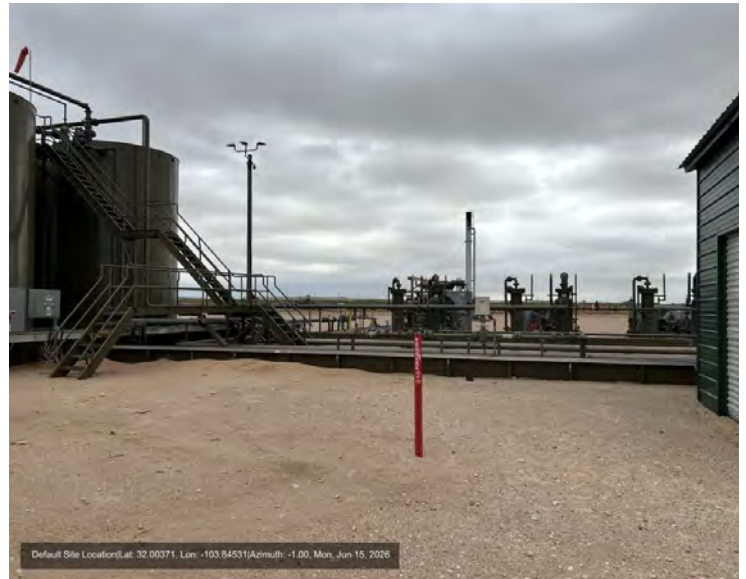
Date: 6/15/2026  
Time: 09:51  
Notes: Looking E. Northwest side of 1.5 ft containment on outside. Fully intact and good condition.  
Latitude: 32.00371111111111  
Longitude: -103.84531388888888  
Direction: SE

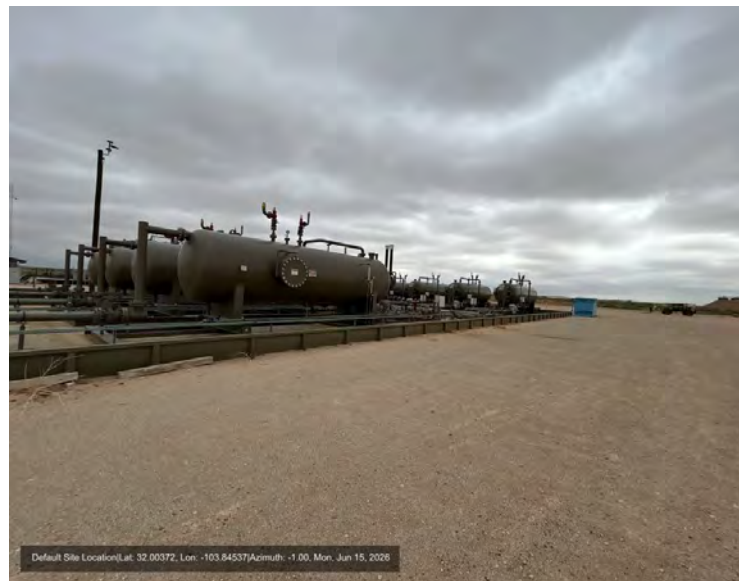
Date: 6/15/2026  
Time: 09:54  
Notes: Looking ENE. South side of 1.5 ft containment on outside. Fully intact and good condition.  
Latitude: 32.00372222222222  
Longitude: -103.84536666666666  
Direction: W

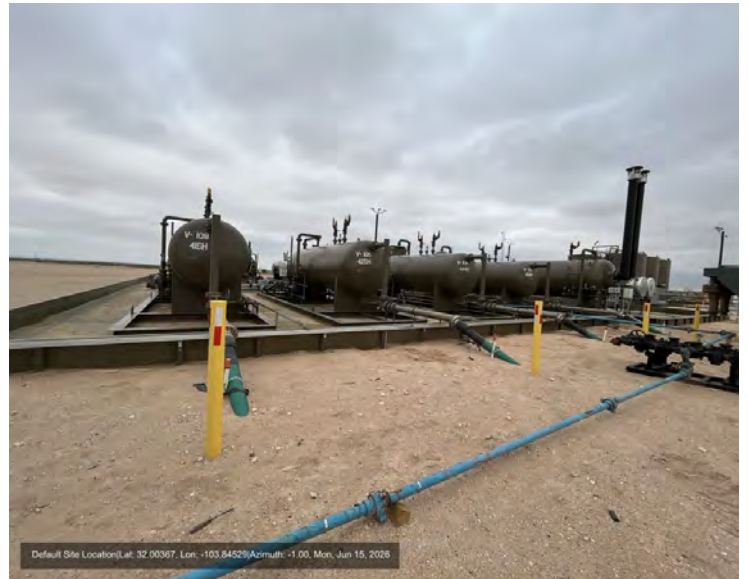
Date: 6/15/2026  
Time: 09:54  
Notes: Looking W. Southeast side of 1.5 ft containment on outside. Fully intact and good condition.  
Latitude: 32.00366666666667  
Longitude: -103.84529166666667  
Direction: W

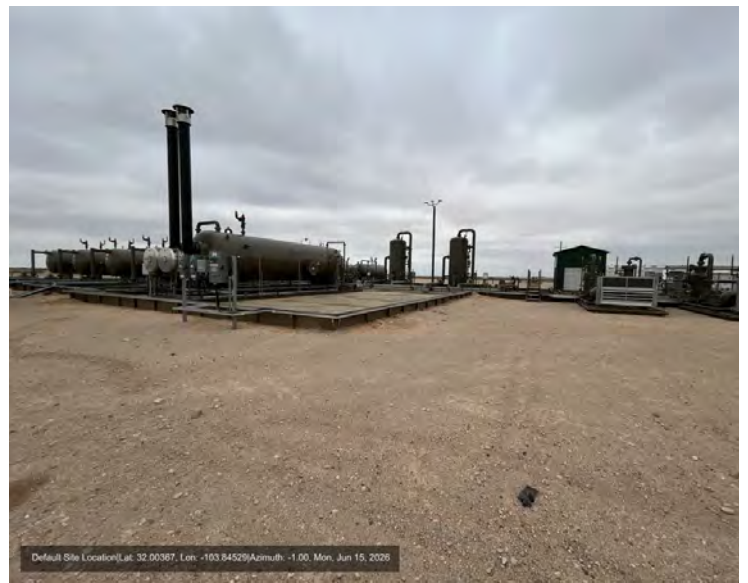
Date: 6/15/2026  
Time: 09:54  
Notes: Looking W. East side of 1.5 ft containment on outside. Fully intact and good condition.  
Latitude: 32.00366666666667  
Longitude: -103.84529166666667  
Direction: W
