**Re: Remediation Work Plan  
Corral Canyon 8 Satellite  
Incident Number nAPP2600251804  
Eddy County, New Mexico**

XTO Energy, Inc  
Corral Canyon 8 Satellite Battery  
Incident Number: nAPP2600251804  
Unit K, Section 08, T 25S, R 29E  
Eddy County, New Mexico

# **Environmental Karst Study Report XTO Corral Canyon 8 Satellite Eddy County, New Mexico**

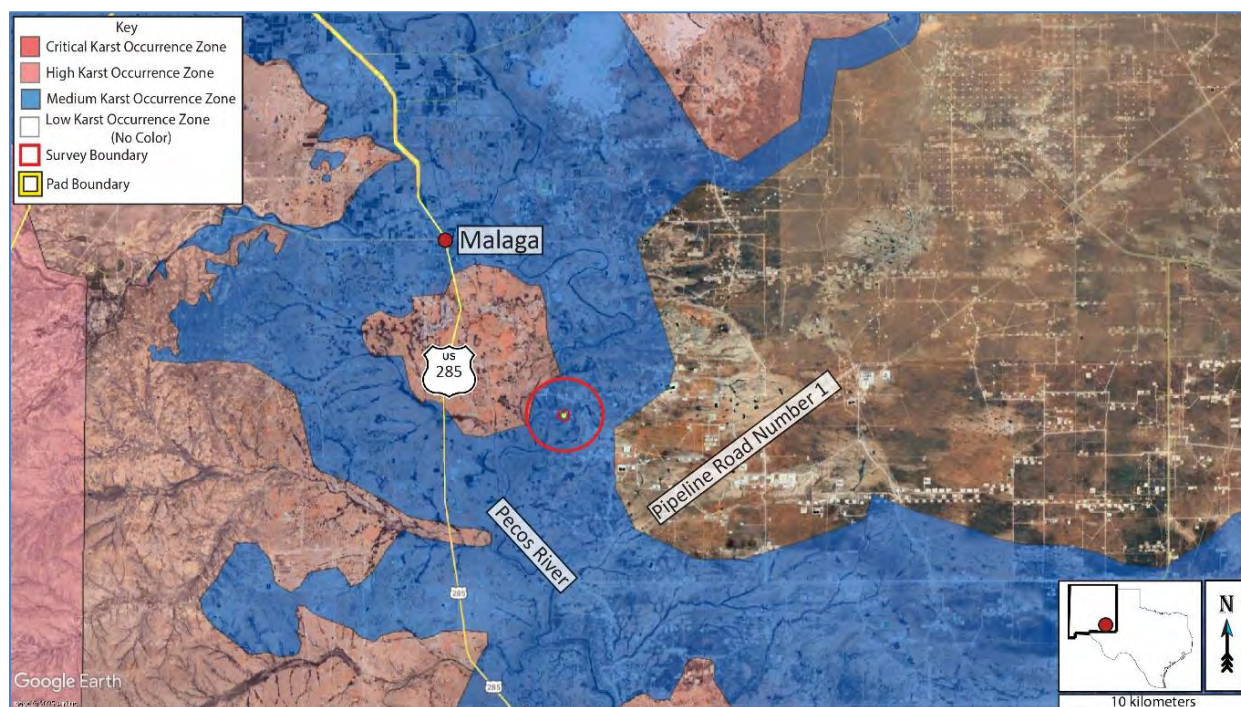
The Bureau of Land Management (BLM) categorizes all areas within the Carlsbad Field Office (CFO) zone of responsibility as having either low, medium, high, or critical cave potential based on geology, occurrence of known caves, density of karst features, and potential impacts to freshwater aquifers<sup>[4]</sup>. These designations are also recognized by the New Mexico State Land Office (NMSLO). This project occurs within a **MEDIUM** karst occurrence zone (MKOZ)<sup>[5]</sup> (**Figure 1**).

**Figure 1: Karst occurrence zone overview.** Background image credit: Google Earth. Image date: August 21, 2024. Image datum: WGS-84.

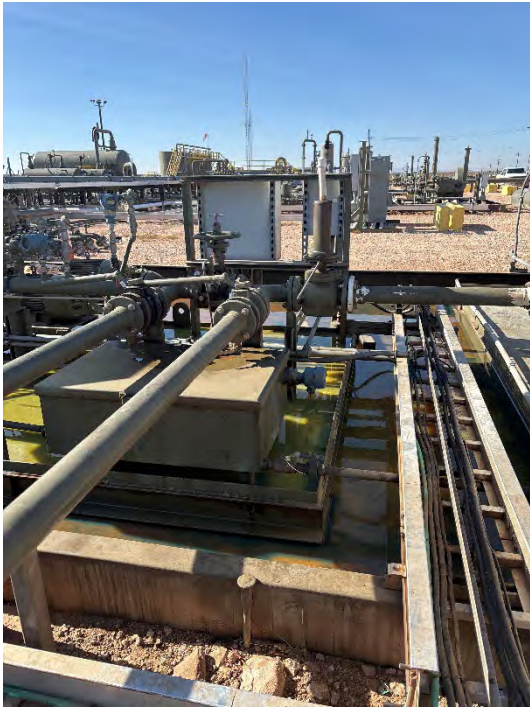
| <u>Photograph</u><br>1 | <u>Date</u><br>12/31/2025 | |

| <u>Description</u><br>Initial release | | |

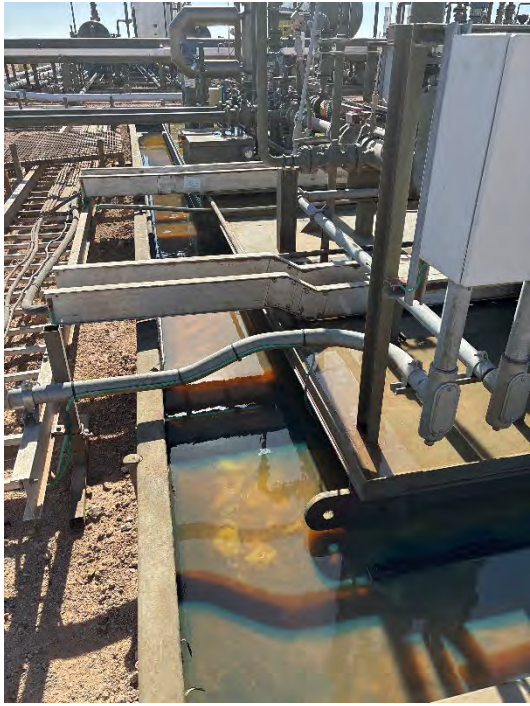
| <u>Photograph</u><br>2 | <u>Date</u><br>12/31/2025 | |

| <u>Description</u><br>Initial release | | |

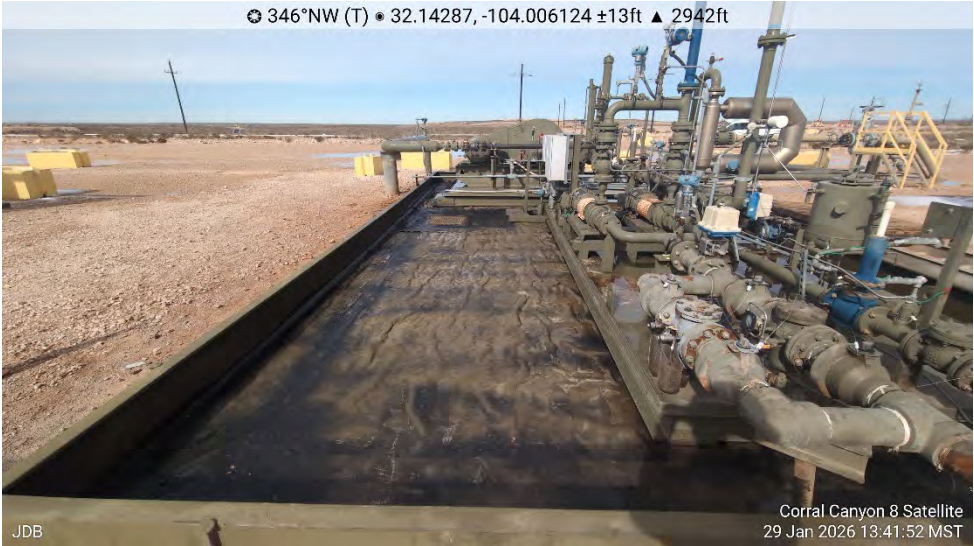
| <p><u>Photograph</u><br/>3</p> | <p><u>Date</u><br/>01/29/2026</p> | <p>346°NW (T) • 32.14287, -104.006124 ±13ft ▲ 2942ft</p> <p>Corral Canyon 8 Satellite<br/>29 Jan 2026 13:41:52 MST</p> <p>JDB</p> |

| <p><u>Description</u><br/>Liner inspection activities</p> | | |

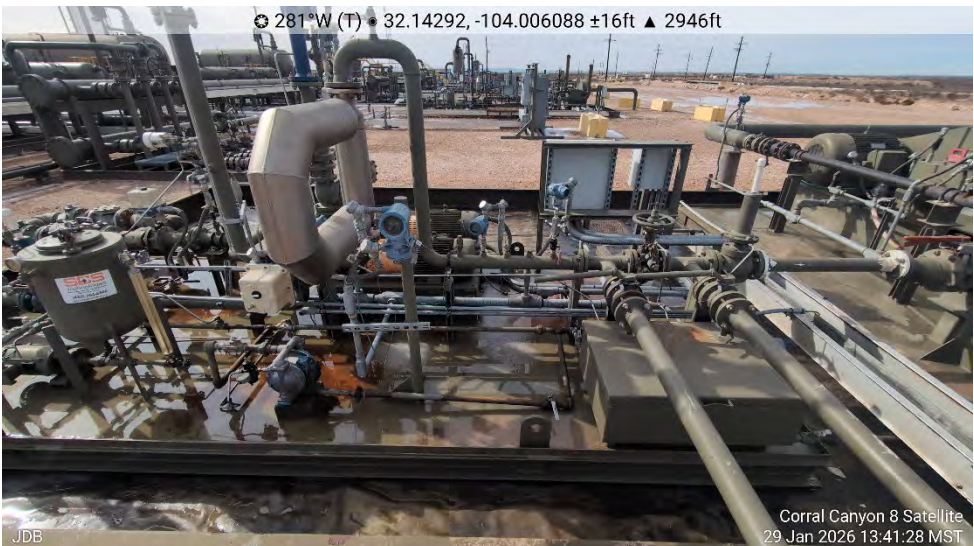
| <p><u>Photograph</u><br/>4</p> | <p><u>Date</u><br/>01/29/2026</p> | <p>281°W (T) • 32.14292, -104.006088 ±16ft ▲ 2946ft</p> <p>Corral Canyon 8 Satellite<br/>29 Jan 2026 13:41:28 MST</p> <p>JDB</p> |

| <p><u>Description</u><br/>Liner inspection activities</p> | | |

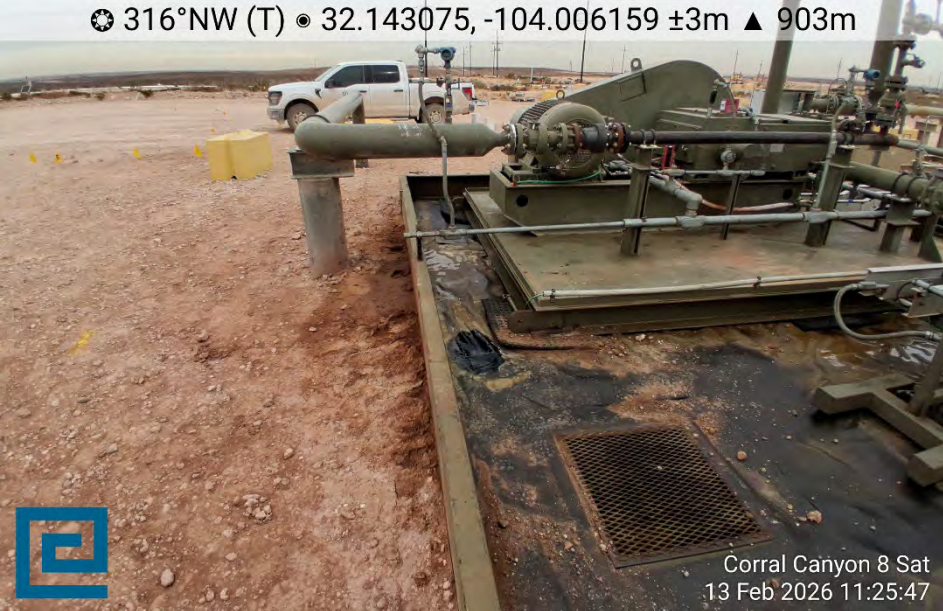
| <u>Description</u><br>Patched liner, BH01 | | |

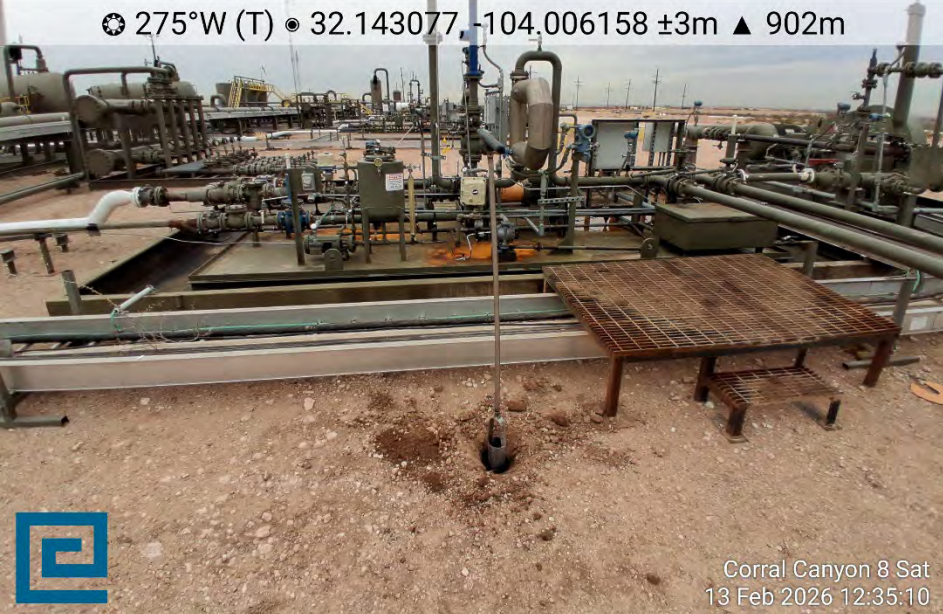
| <u>Description</u><br>Lateral delineation activities, BH03 | | |

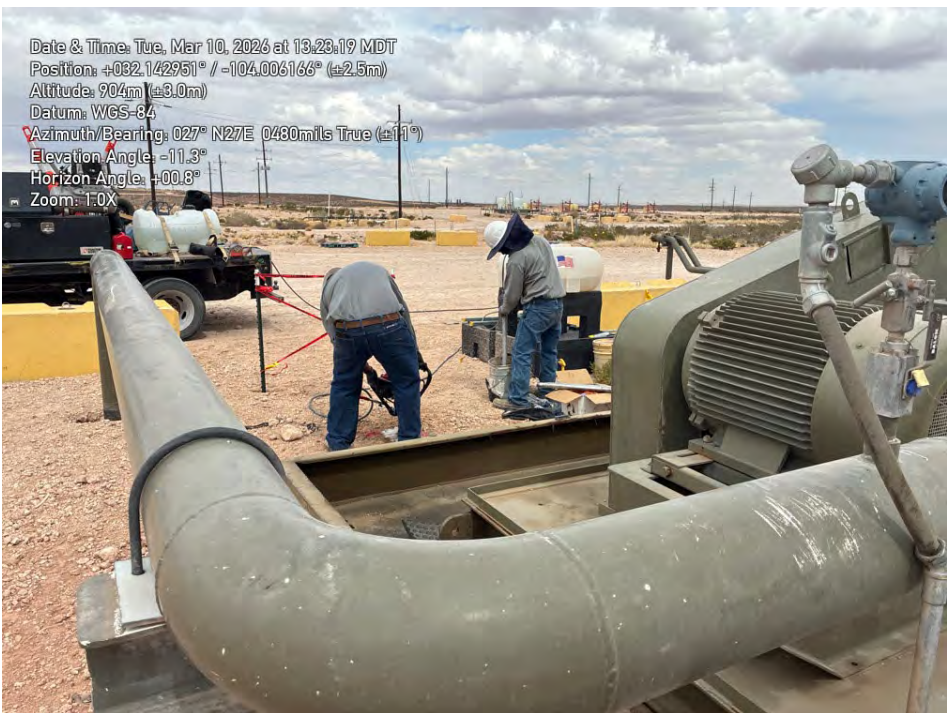
| <p><u>Description</u><br/>Lateral delineation activities via core drill, BH02</p> | | |

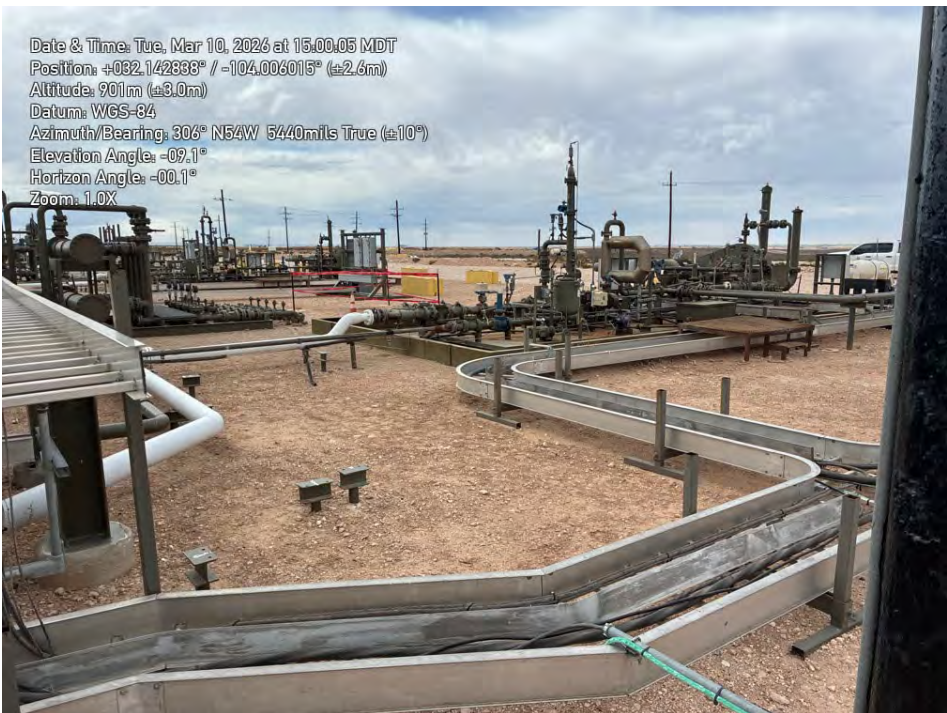
| <p><u>Description</u><br/>Containment overview with restricted access west of containment</p> | | |
