**CHEVRON BASS #4**

**Remediation / Reclamation Closure Report**

**nAPP2603421572**

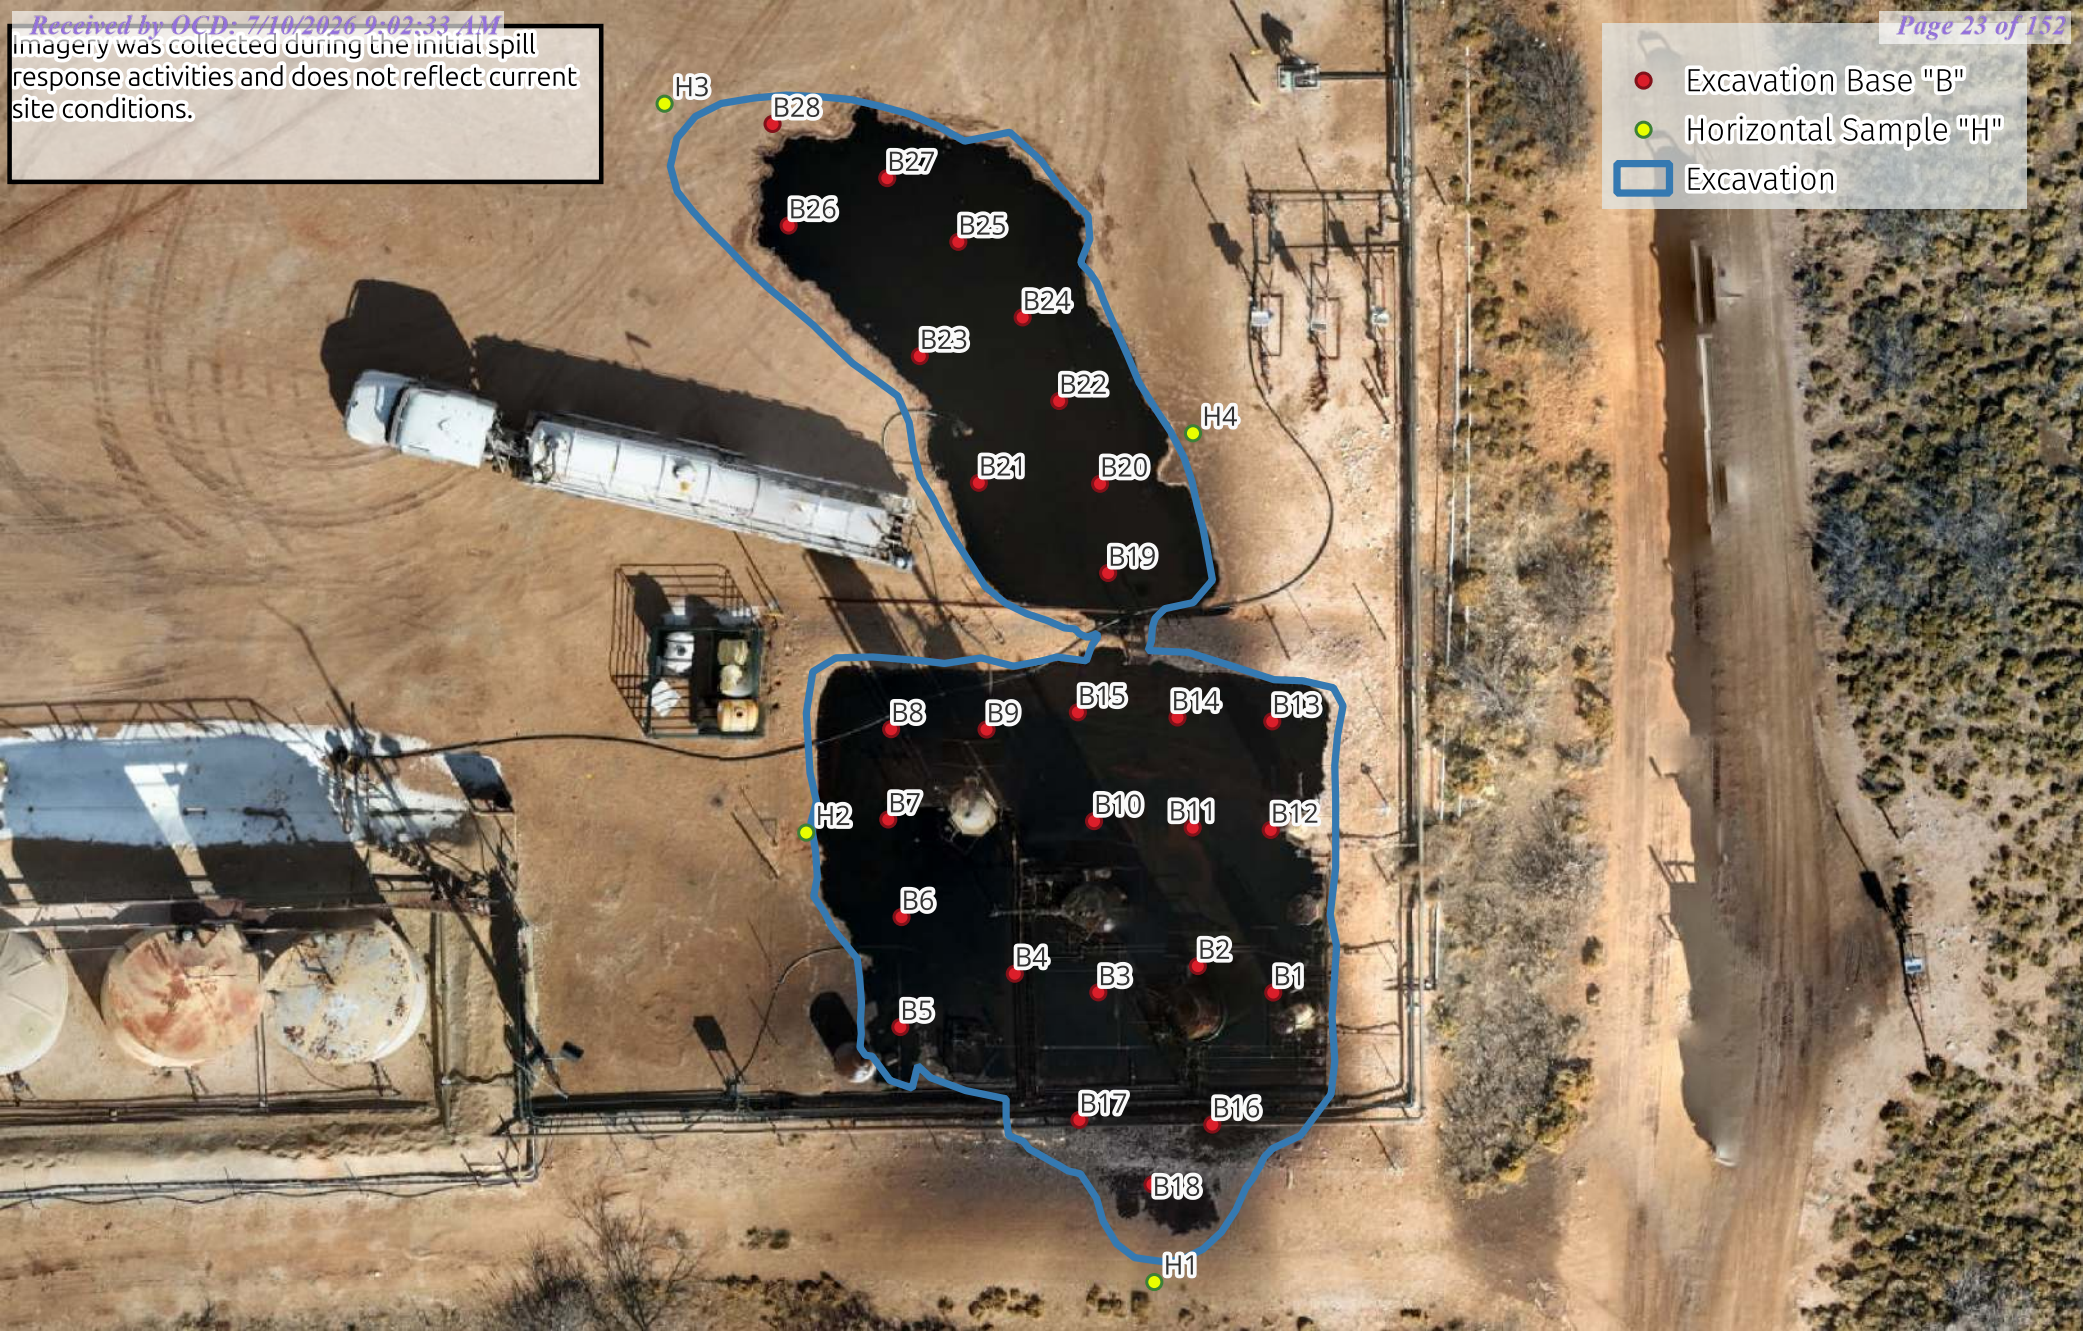
Paloma Permian AssetCo, LLC  
CHEVRON BASS #4 Heater Incident  
Incident #nAPP2603421572  
32.5382238,-103.6980195 NAD83  
BLM

- Excavation Base "B"
- Horizontal Sample "H"
- Excavation
