# UU LINE LEAK

## Remediation Action Plan

NMOCD Incident No. nAPP2218244166  
UL "B", Sec. 13, T17S, R34E  
32.8424°, -103.5129°  
Lea County, New Mexico

May 22, 2026

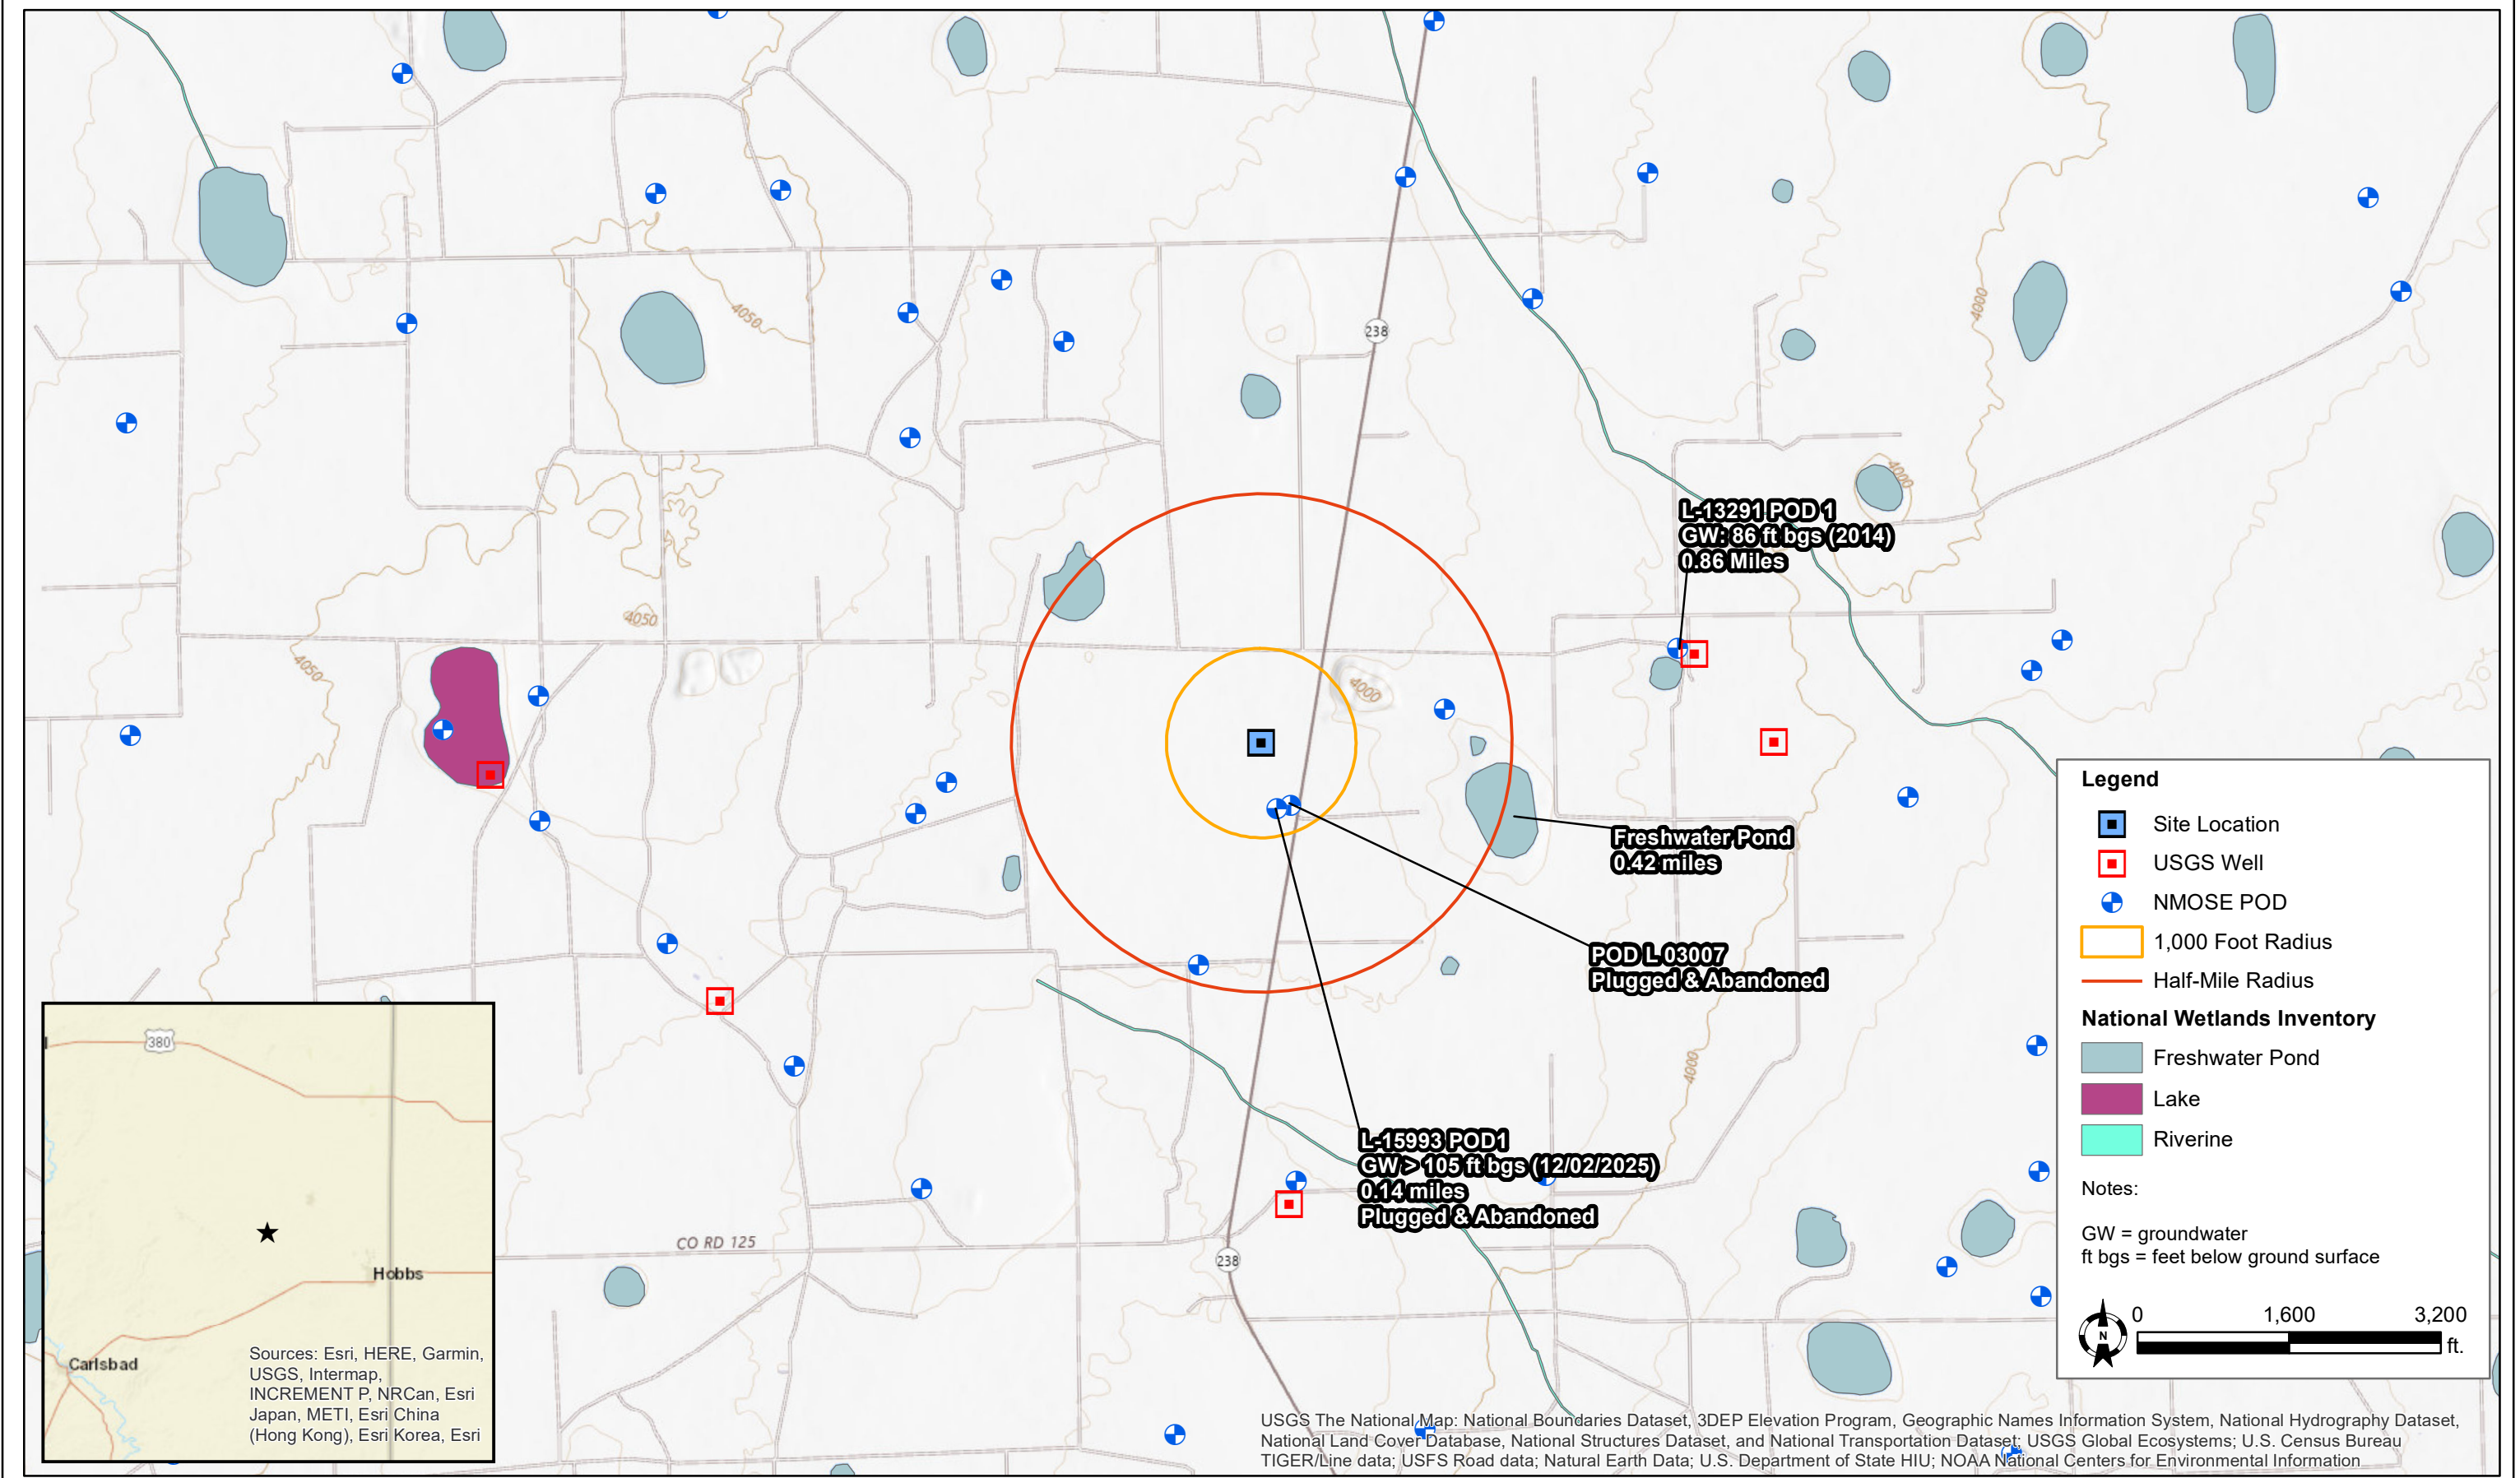
Figure  
1

Site Location & Characteristics  
Map

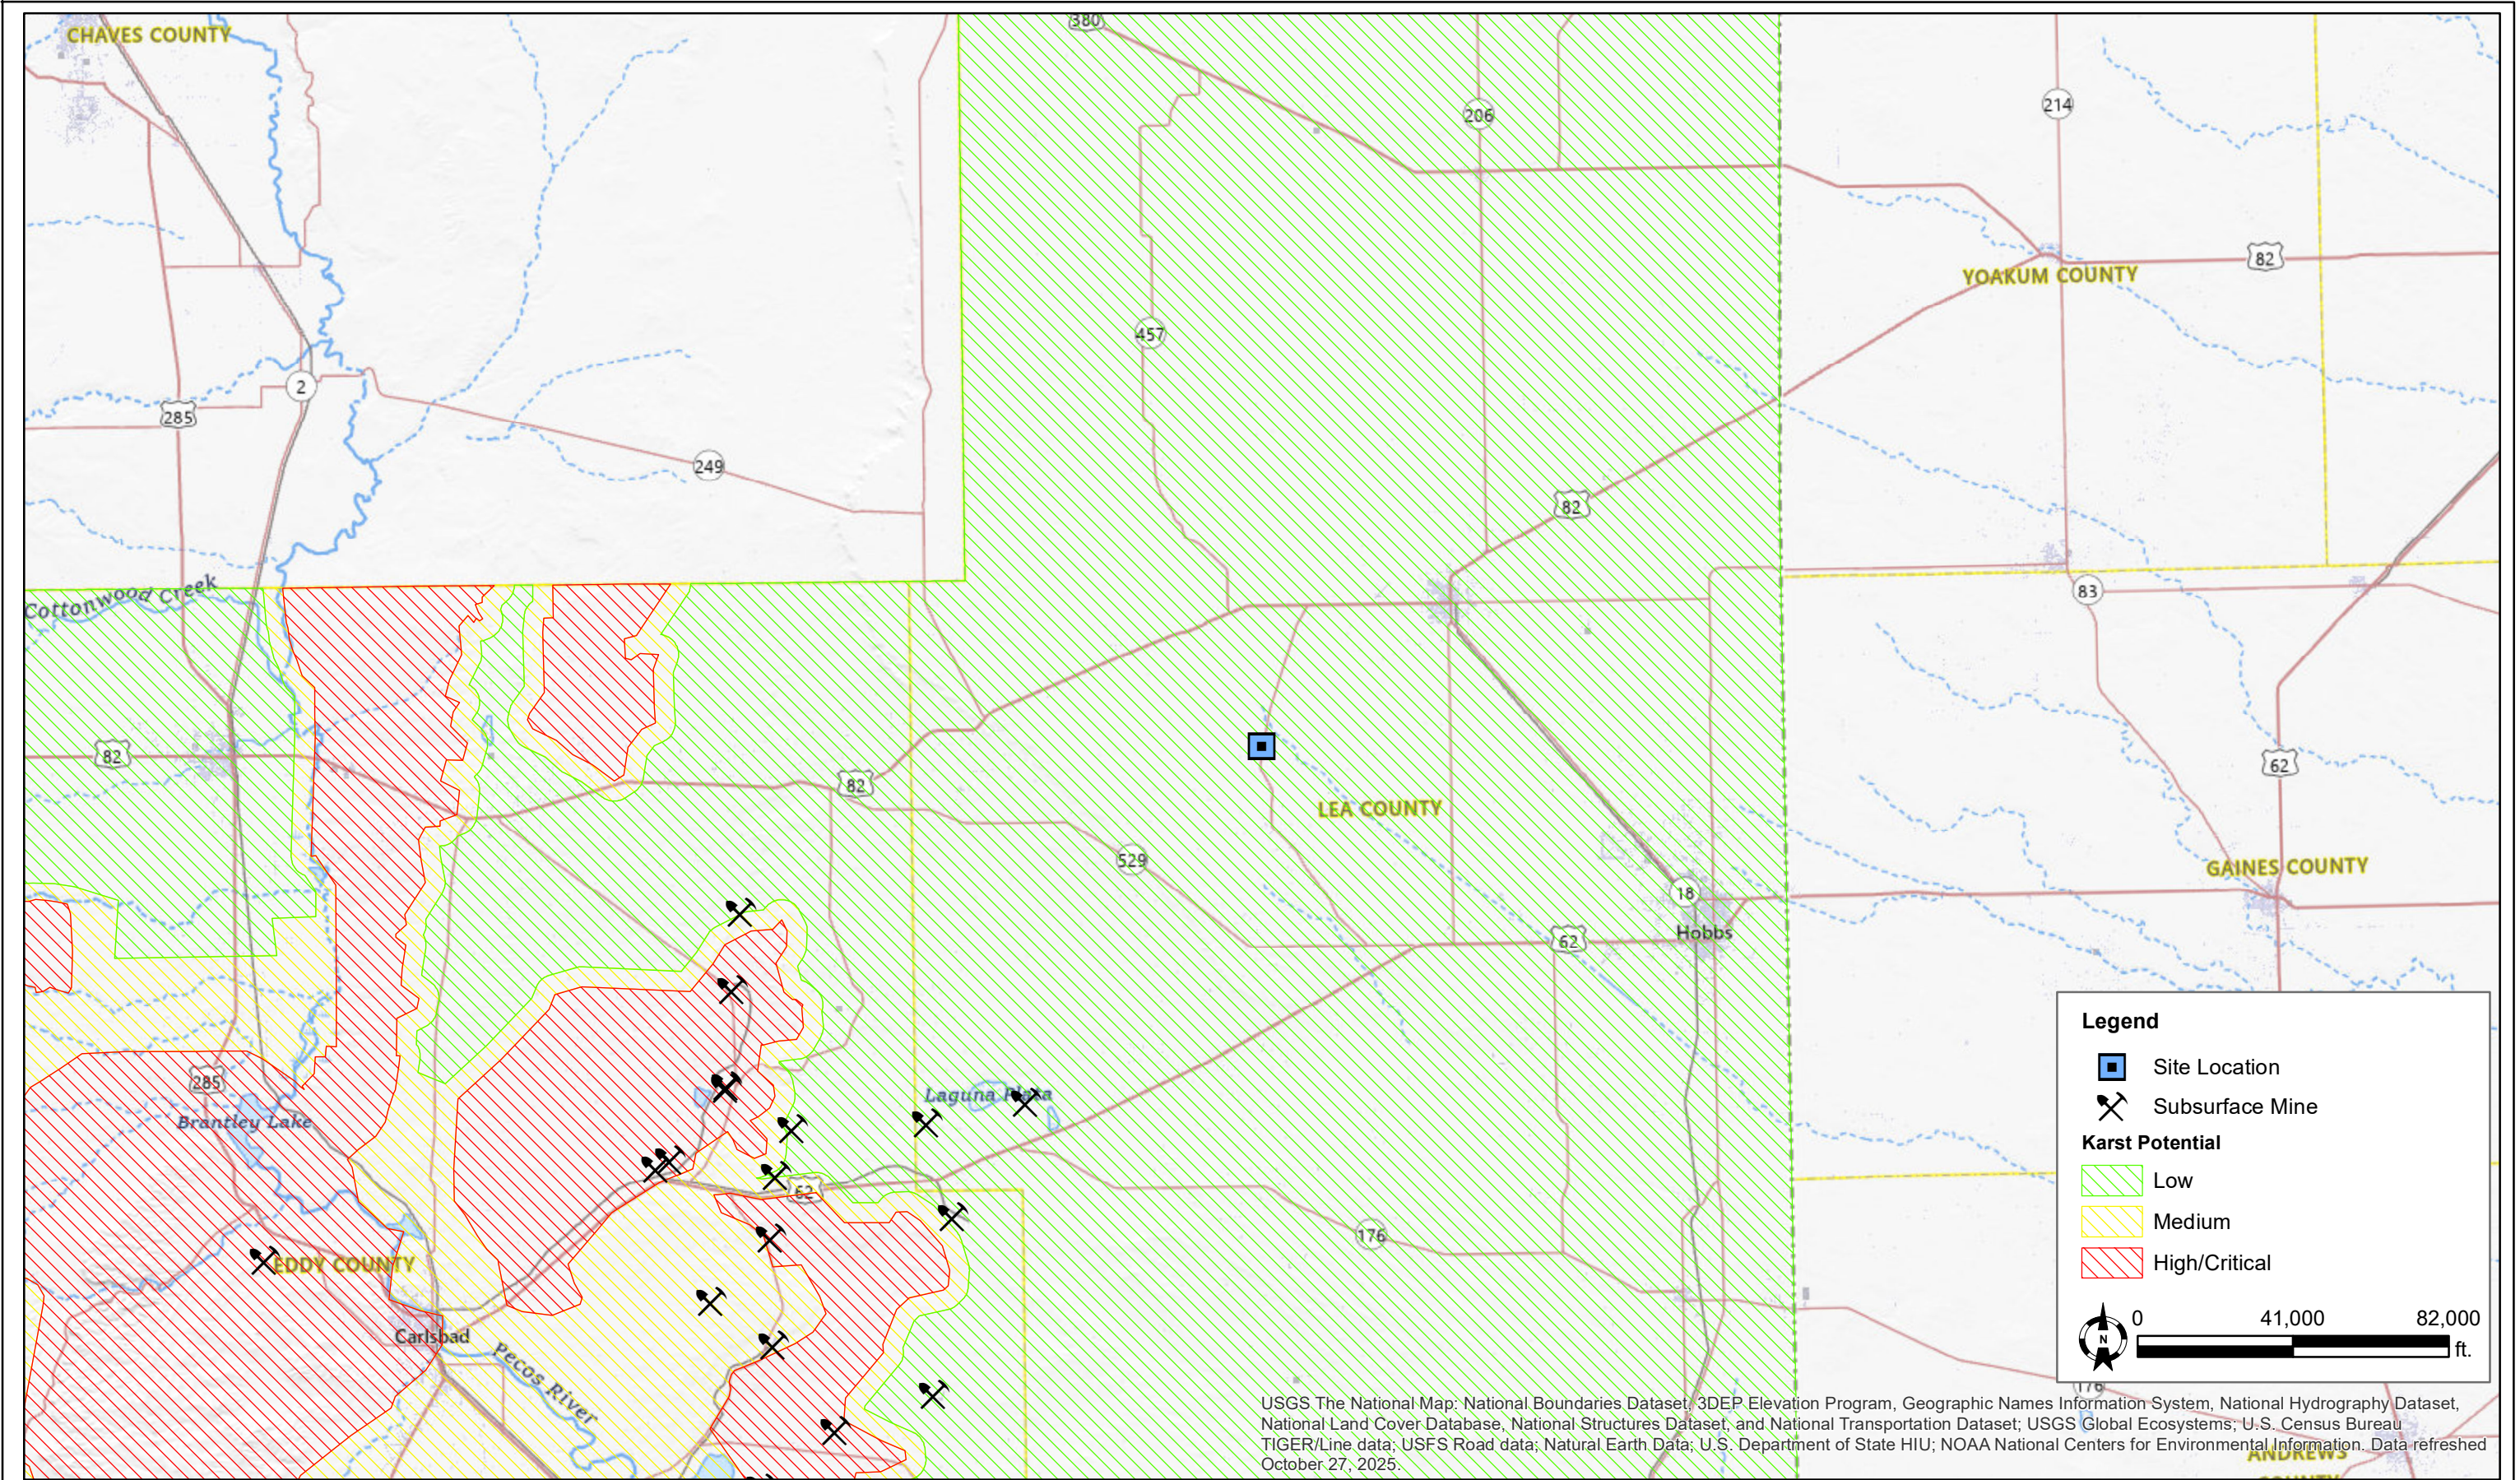
Figure  
2

Karst Potential & Subsurface  
Mine Map

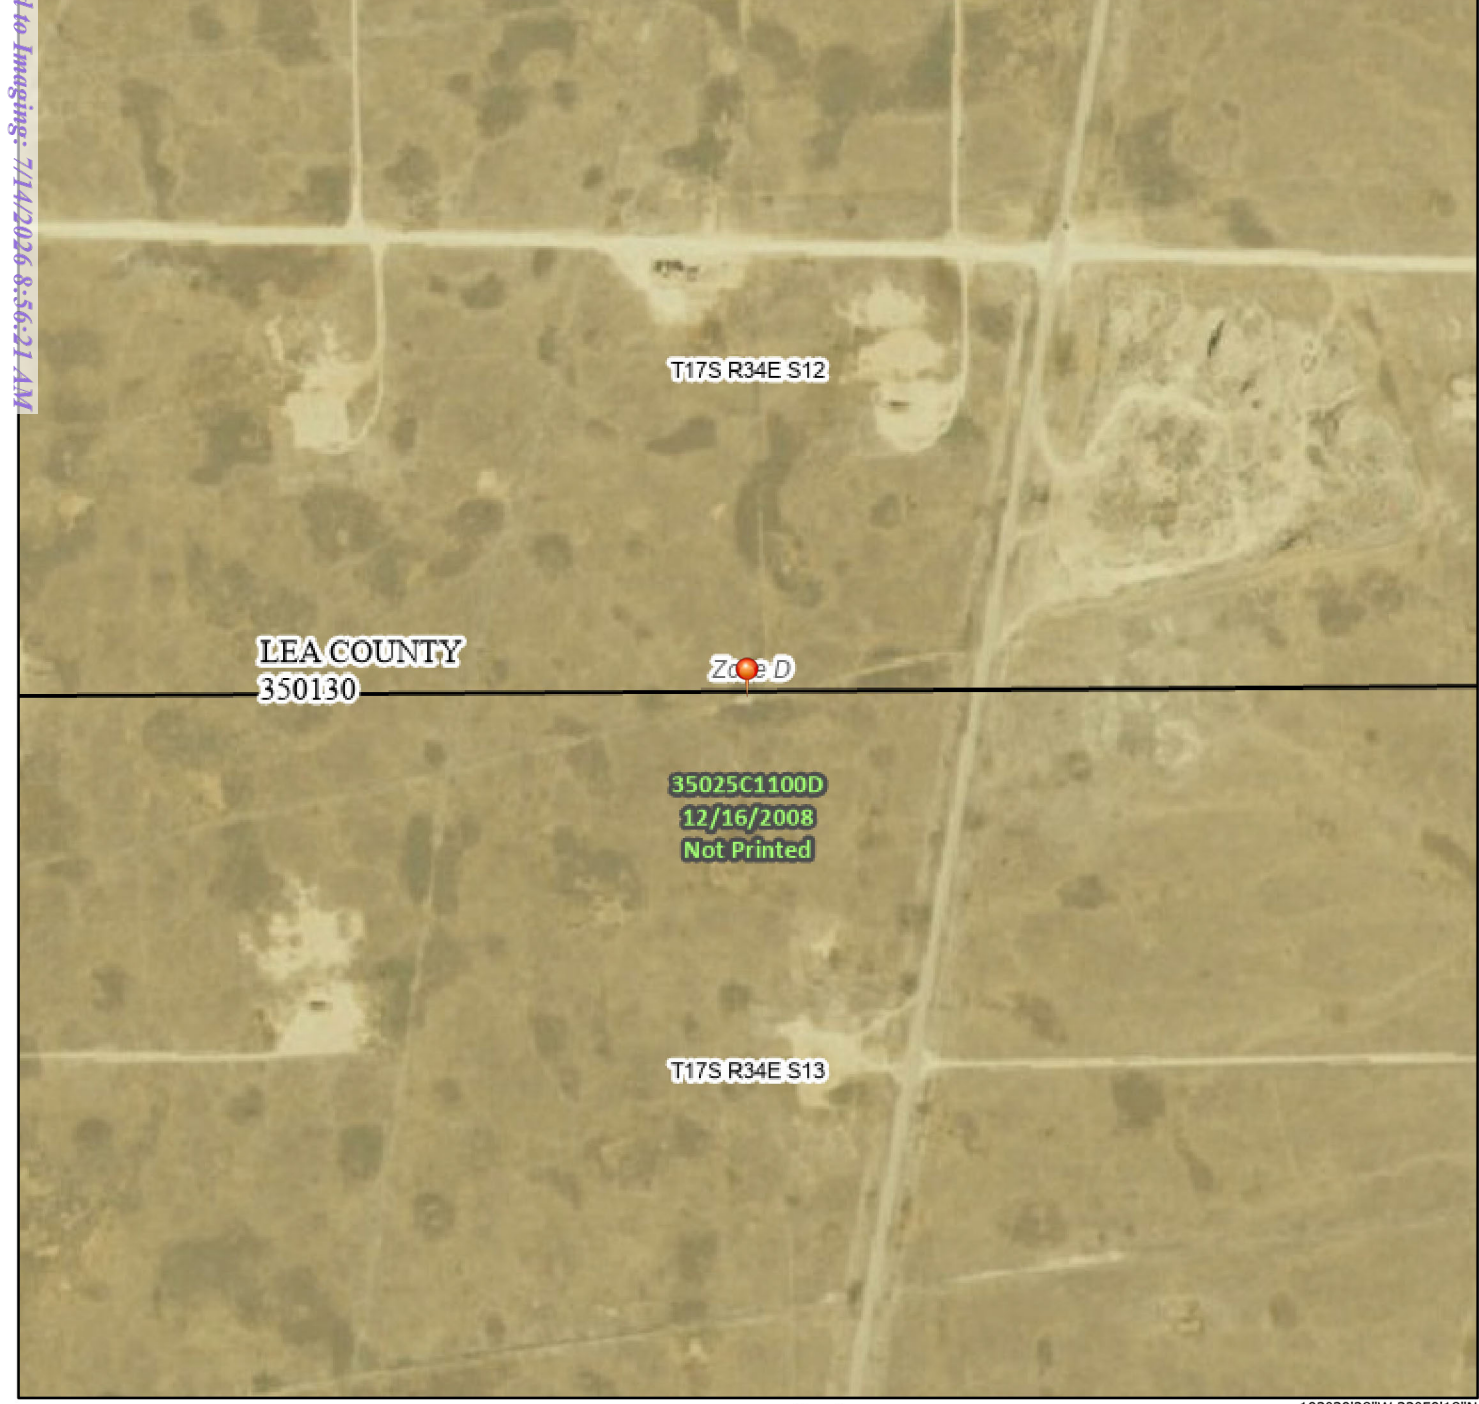
# National Flood Hazard Layer FIRMMette

Review of flood map data published by the Federal Emergency Management Agency (FEMA) indicates the site is not located within a 100-year floodplain. A copy of the FEMA FIRMete Map can be found attached as Figure 4.
