### Report Type: Work Plan nAPP2414143487

| Site: | Atoka Bank/Heartthrob CTB | | | | | |
| Company: | EOG Resources | | | | | |

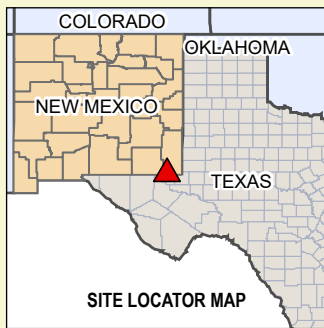
**FIGURE 1**  
**SITE LOCATION MAP**  
**ATOKA BANK/HEARTTHROB CTB**  
**LEA COUNTY, NEW MEXICO**  
**32.224234°, -103.594581°**

Tetra Tech, Inc. (Tetra Tech) was contacted by EOG Resources (EOG) to assess a release that occurred at the Atoka Bank/Heartthrob CTB (Atoka), Unit C, Section 17, Township 24 South, Range 33 East, Lea County, New Mexico (Site). The spill site coordinates are 32.224237°, -103.594576°. The site location is shown on **Figures 1 and 2**.

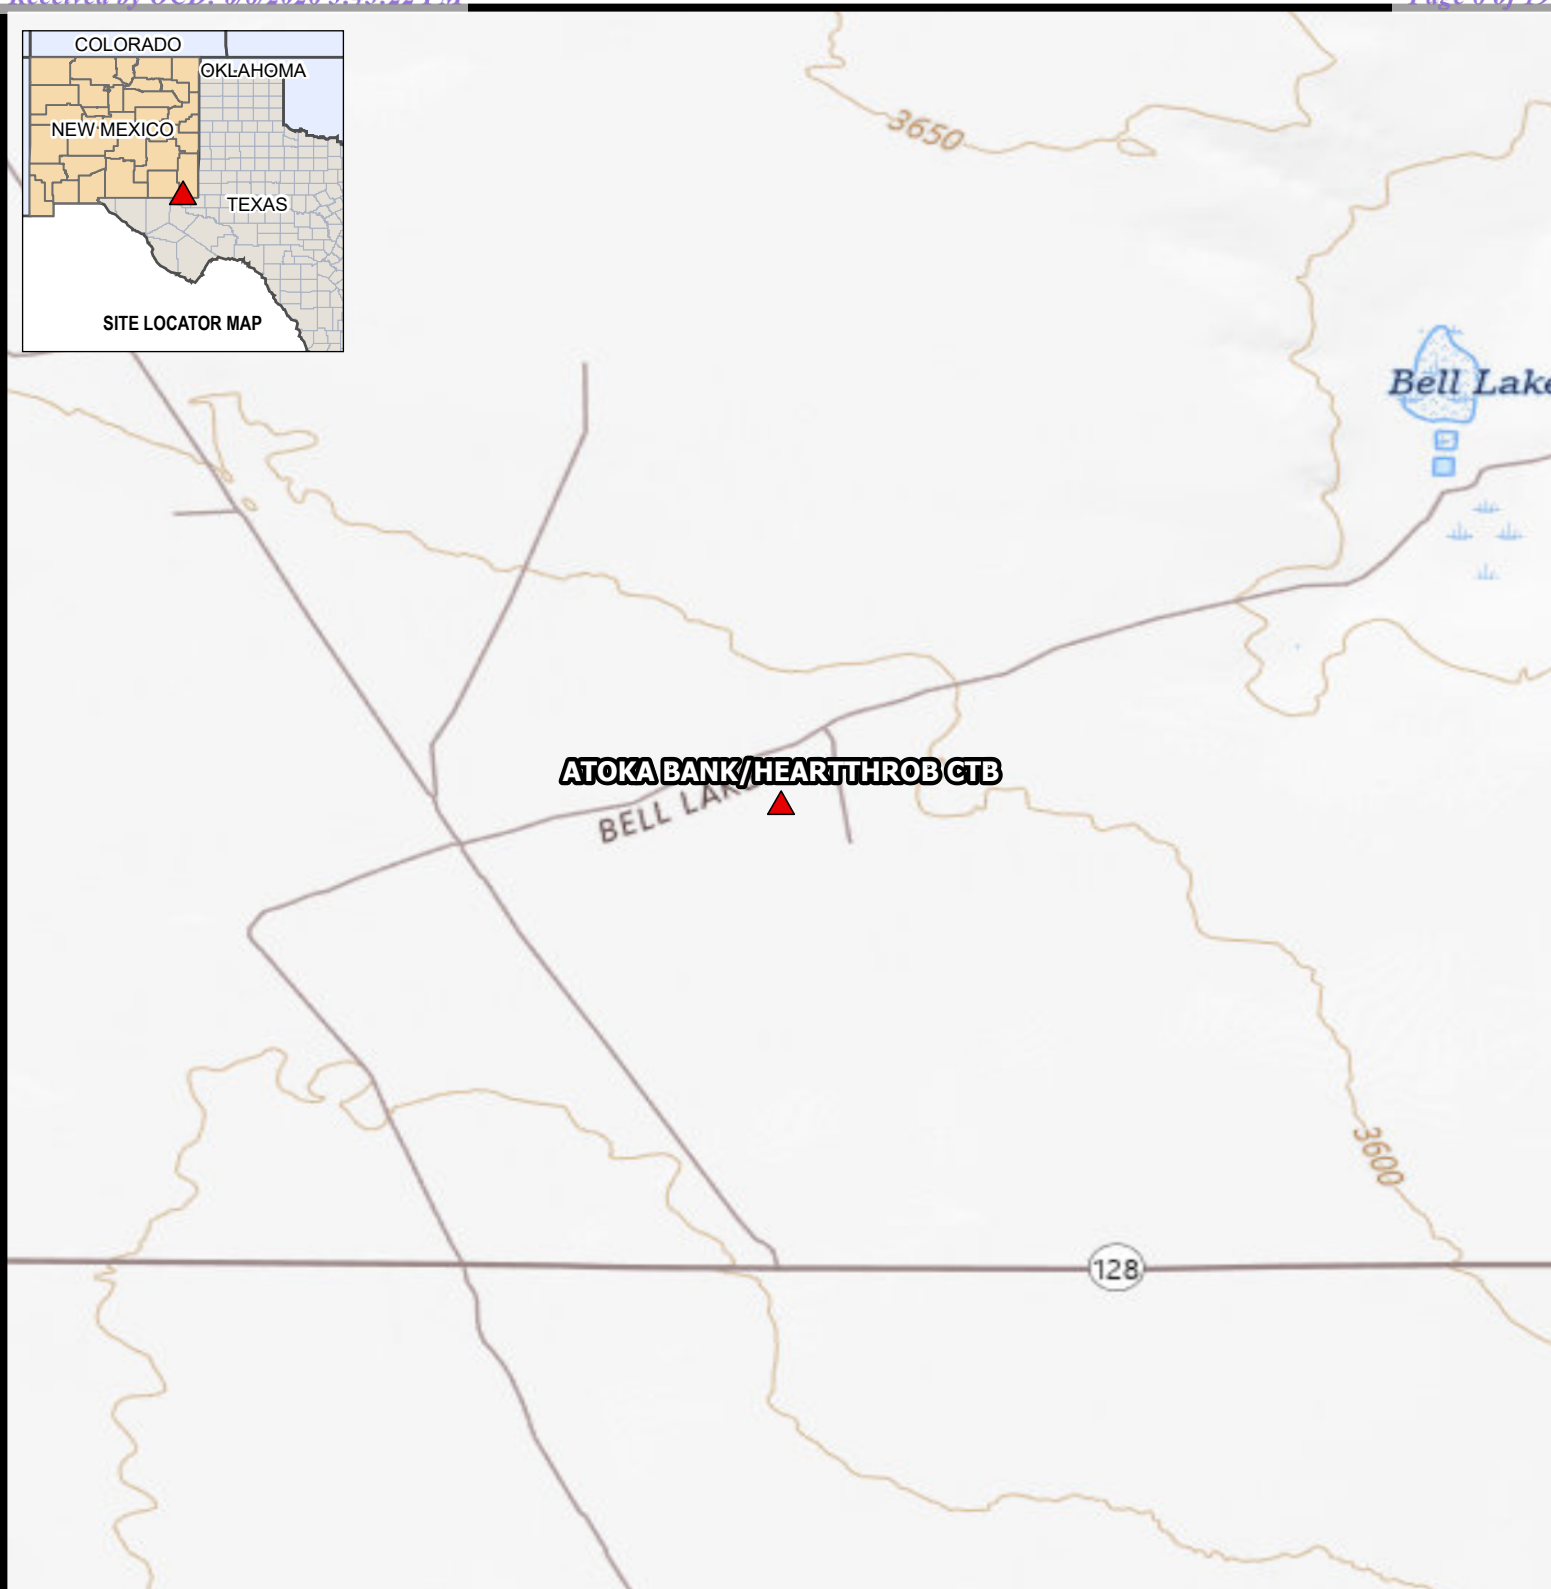
Name: Figure 1 - Atoka Bank

▲ SITE LOCATION
