Standard Safety and Supply

Remediation Closure Report  
B Hardin Battery  
nOY1801657371  
API # 30-025-36046  
32.7429733, -103.1983261  
P-13-18S-37E

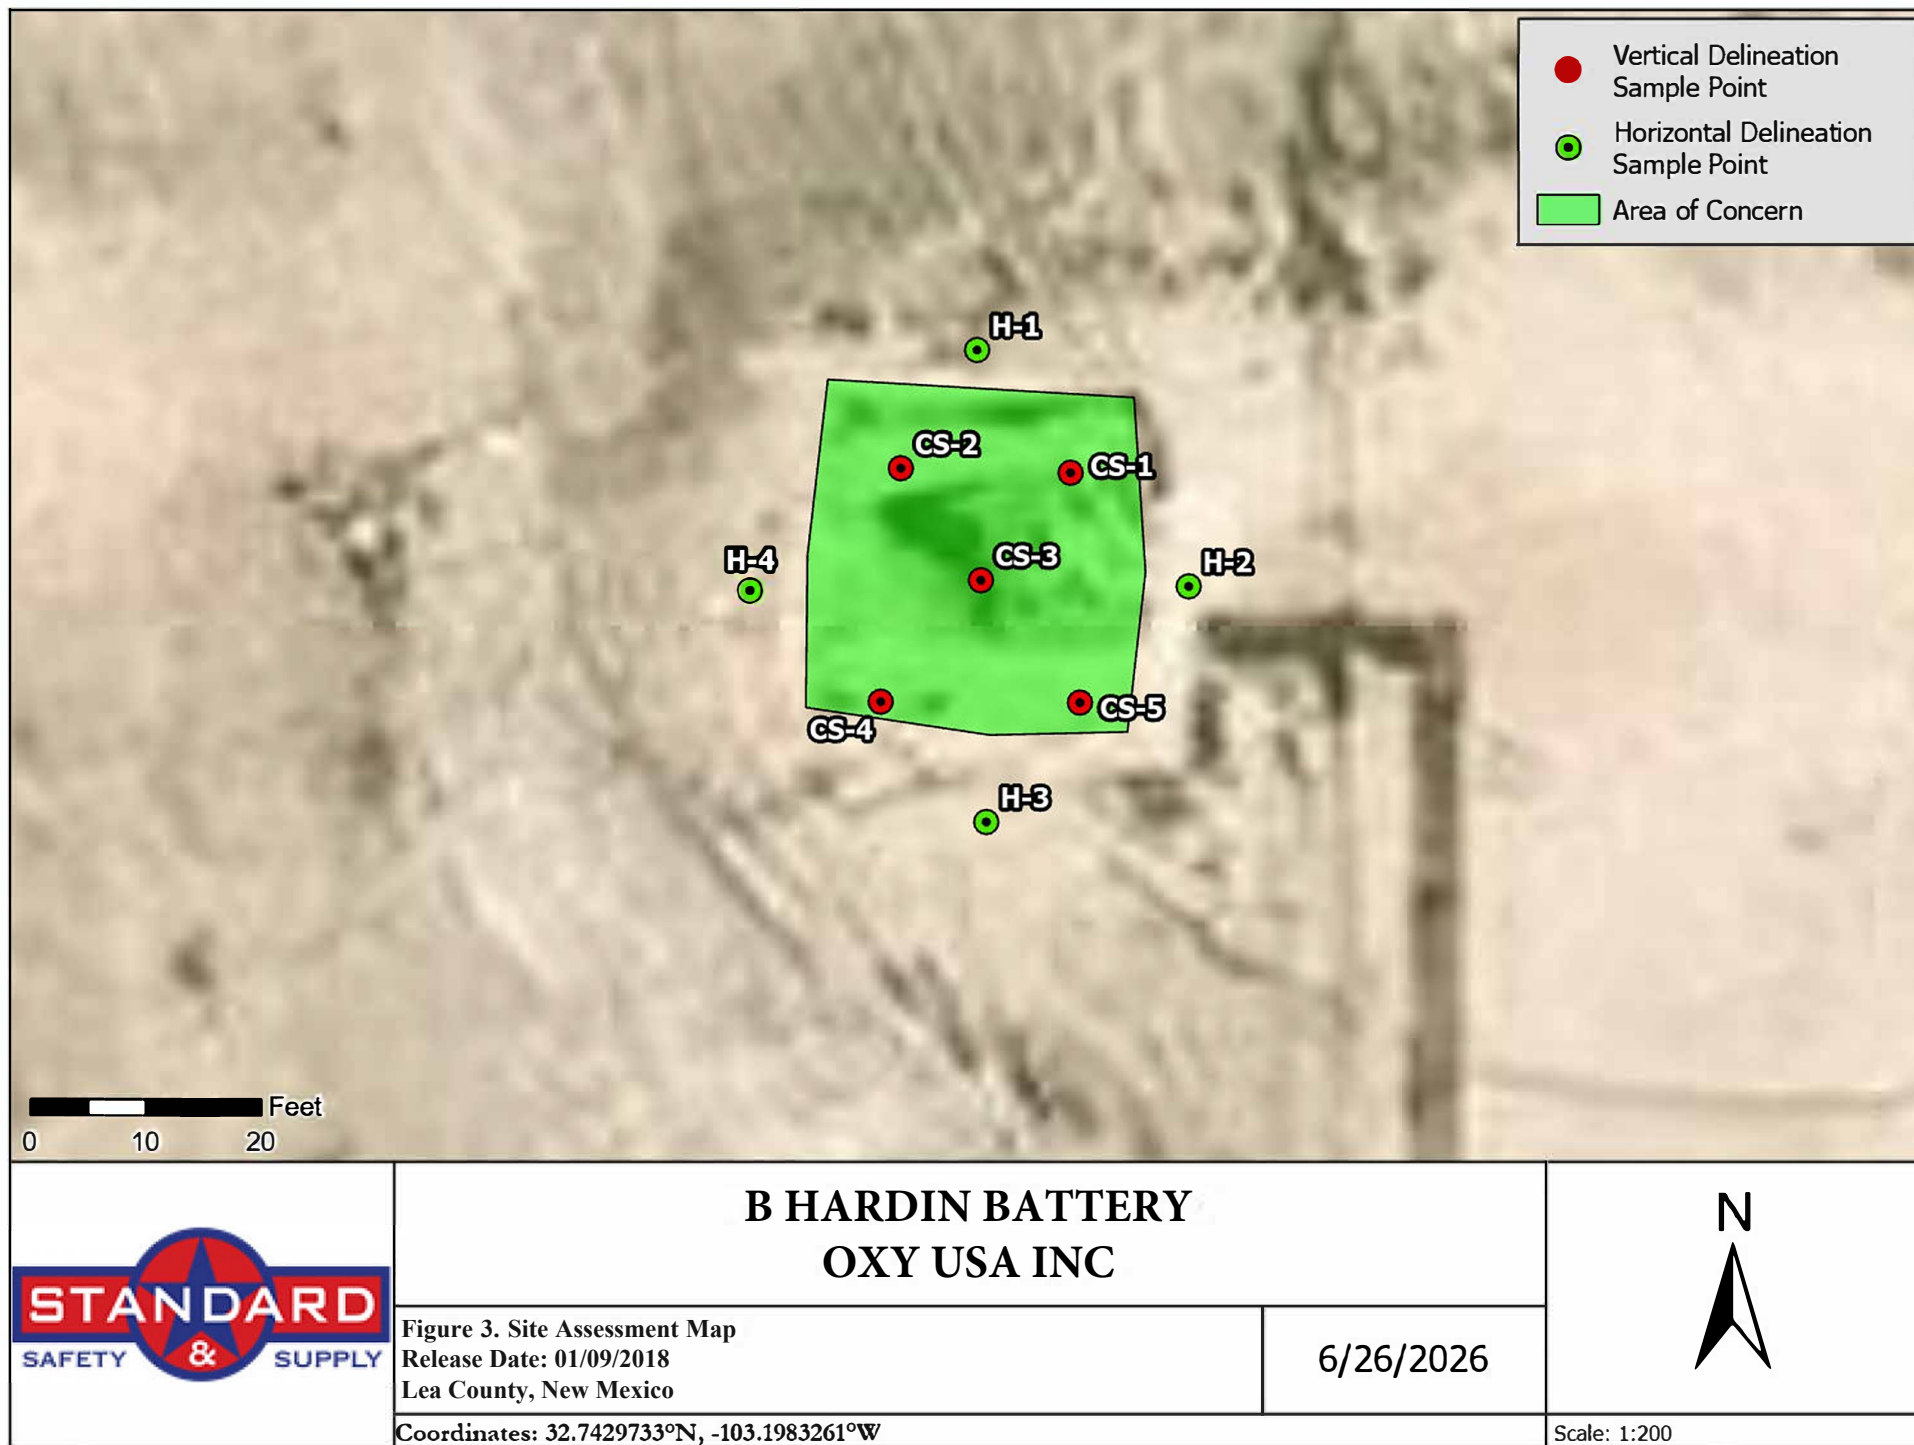
Ten (4) horizontal sample points (H-1 to H-4) were collected at a surface (0) depth and one (1) ft bgs. Five (5) vertical samples points (CS-1 to CS-5) were collected at a surface (0) depth and one (1) ft bgs. Soil samples were placed into lab provided containers, onto ice then transported to Cardinal Laboratories in Hobbs, New Mexico, for the analysis of benzene, toluene, ethylbenzene, and xylenes (BTEX 8021B), Total Petroleum Hydrocarbons (TPH 8015M) and chloride (4500-Cl-B). Analytical results indicated that horizontal delineation and vertical delineation was not achieved at that time.

Laboratory results of sample points CS-5 & H-1 indicated that TPH concentrations exceeded closure criteria limits at depths ranging between surface (0) and one (1) ft bgs.

The delineation data can be found in this report under Attachment A: Table 1 Delineation Assessment Analytical Data Table, the delineation sample locations are located under Attachment B: Figure 3 Delineation Assessment Map, and the lab report and chain of custody can be found under Attachment E: Laboratory Analytical Method Documentation with Chain-of-Custody

The analytical data can be found under Attachment A: Confirmation Assessment Analytical Data Table. The site assessment sample locations can be found under Attachment B: Figure 3. Photographs of the site can be found under Attachment D: Photolog. The laboratory report can be found under Attachment E: Laboratory Report and Chain-of-Custody Documentation.

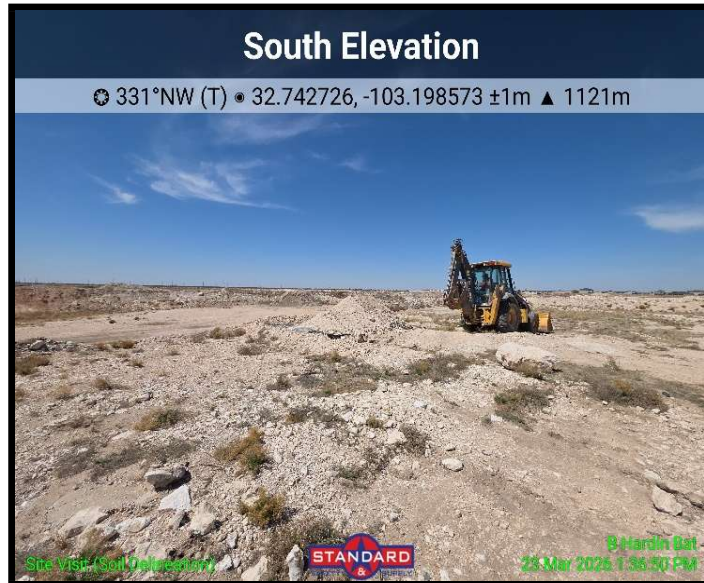
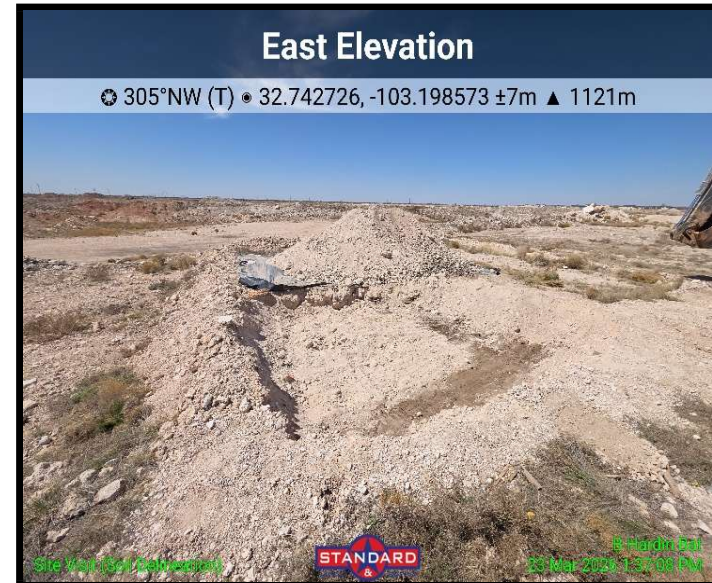
Remedial Activities

Standard began remedial actions at the Site on March 23<sup>rd</sup>, 2026, to remove the impacted soils identified during the initial site assessment.

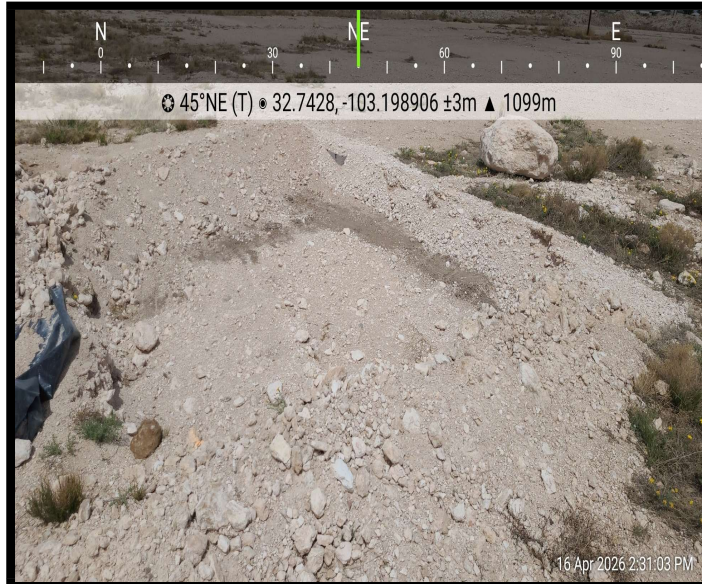
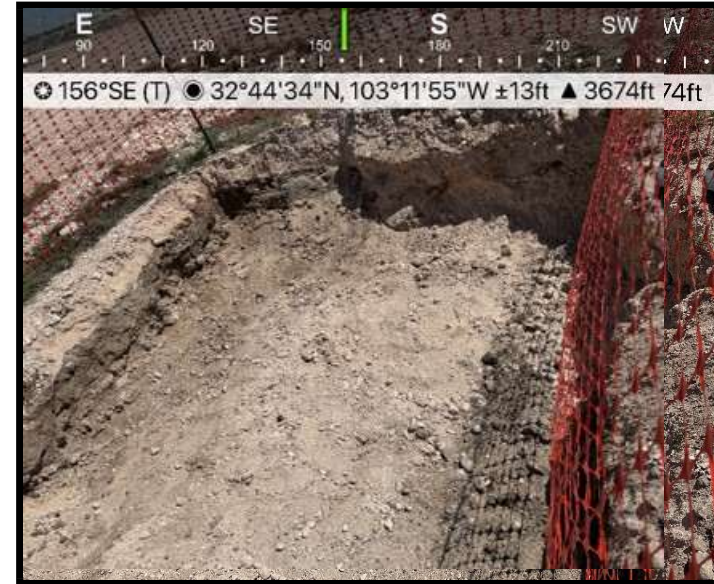
View of Excavation (4/16/26)

View of Excavation (5/13/26)

On April 16<sup>th</sup>, 2026, Standard was onsite to perform a confirmation sampling event where two (2) base sample (BH-1 & BH-2) and two (2) sidewall sample (SW-1 & SW-2) were collected. Soil samples were placed into lab provided containers, onto ice then transported to Cardinal Laboratory in Hobbs, New Mexico, for the analysis of benzene, toluene, ethylbenzene, and xylenes (BTEX 8021B), Total Petroleum Hydrocarbons (TPH 8015M) and chloride (4500-Cl-B). Proper chain-of-custody was followed during the collection and delivery of the samples to the laboratory. Analytical results indicated that one (1) composite confirmation sample (BH-1) exceeded closure criteria for the Site for total TPH concentration.
